Caracus Earthquake 1967, Revisited

R.I. Skinner

ABSTRACT: This paper examines the types of earthquake damage which occurred throughout and near the city of Caracus, Venezuela, in 1967. Attempts were made to deduce the mechanisms of damage and collapse, and their causes. The character of the earthquake motions were estimated, and included large microzone effects due to varying depths of alluvium throughout the city, and a very severe ground lurch towards the north at the Macuto Beach resort. New Zealand responses to lessons from the Caracus earthquake are discussed. A more detailed account is given in the author's original report (Skinner 1968).

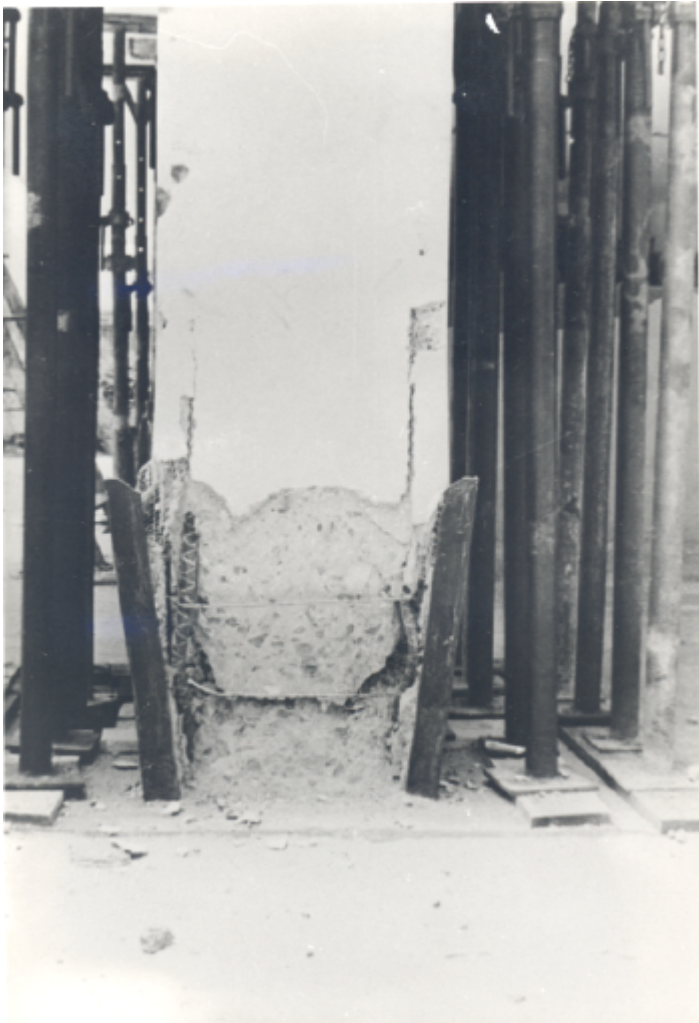
Figure 1(b) shows damage to the corner column which would have been subject to cyclic end moments and shears, and cyclic changes in vertical loads due to overturning forces on the building. The light widely spaced ties had ends turned through only 90° at the corner bars.

Figure 1(b): San Bosco, damage at the base of a first-storey corner column.

The ties unwrapped when the surface spalled and were therefore unable to provide compression in the caged concrete. Buckling of vertical steel indicated a column height loss of 1-2 cm.

Repair and strengthening was provided by effective reinforced concrete sheaths over the first three storeys of the columns. Damaged concrete and plaster was removed from the columns. Details of the steel cage towards the upper end of an interior column are shown in Figure 1(c). Notice the use of heavier steel ties with reduced spacing towards the column ends.

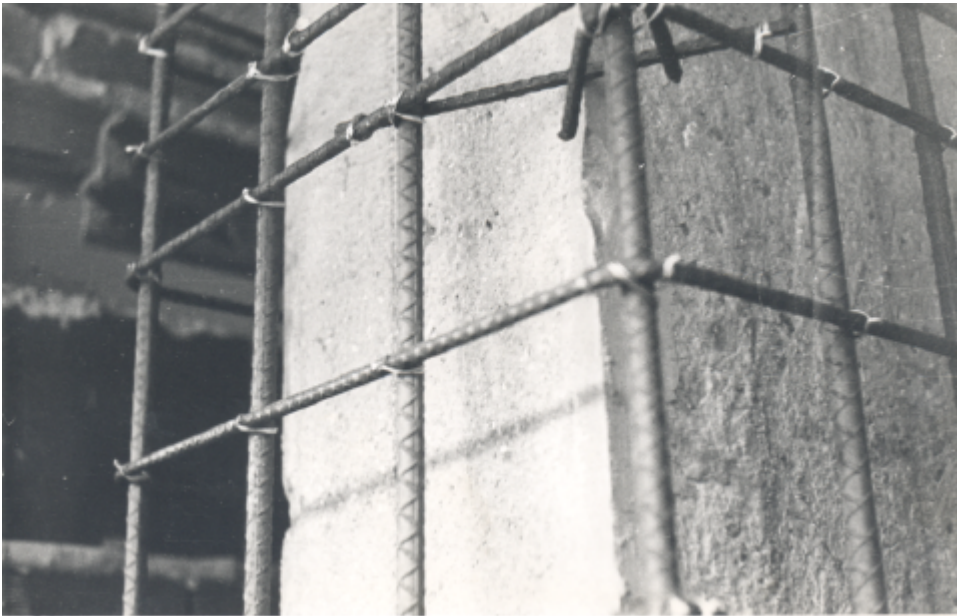
Figure 1(c) : San Bosco, reinforcing steel for the upgrade of a first storey column.

Also, tie ends have been bent around corner bars through 135° so that they will not unwrap when surface concrete is shed, a procedure which has long been accepted as necessary to provide ductile reinforced concrete members. Vertical cage steel was carried through the second and third storey floors.

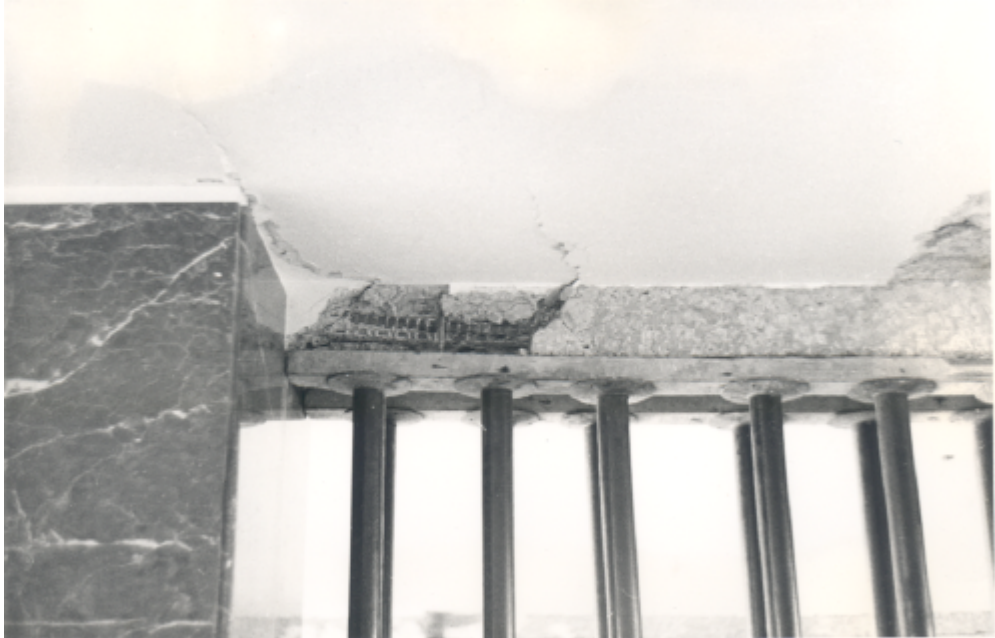
The 8-bay by 2-bay and the 8-bay by 1-bay residential blocks are connected by two link blocks which contain the stairways and lifts. Shallow longitudinal beams are contained within the thickness of the waffle floors. Transverse beams are deeper and suffered damage next to the interior columns up to the sixth floor level. There was also associated floor damage and severe panel damage up to the sixth floor.

Figure 2(b) shows typical damage to the protruding lower third of a first storey beam which has shattered with little ductility, and with little development of compression concrete by the excessively spaced stirrups. The waffle floors appeared to suppress damage at the upper surfaces of the beams. Also shown is a sample of the extensive props provided throughout the seriously damaged areas of many buildings.

Figure 2(b): Residencia Union, damaged end of a first storey beam.

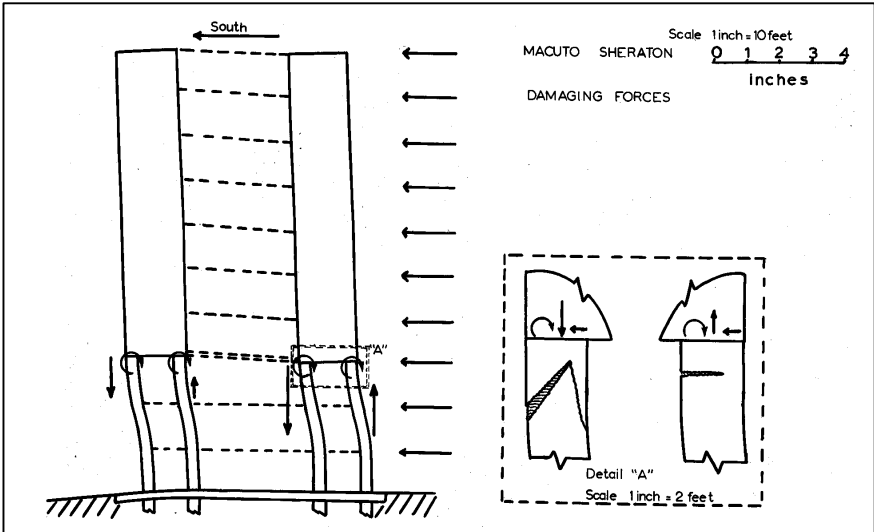
While not a typical building, the Macuto Sheraton Hotel is chosen because it illustrates most clearly the impulsive unidirectional damage which occurred in all buildings and some other structures at Macuto beach. Figure 3(a) shows a simplified cross-section of the 10-storey 11-bay hotel which ran east-west close to the east-west sandy beach. The damage to the tops of the northern pair of cylindrical columns is illustrated in the Figure 3(a) inset.

Figure 3(a): Macuto Sheraton Hotel, forces and damage at the top of the cylindrical columns

This damage is fully explained by a single loading pulse towards the south on all the building masses. This would result in the illustrated beam-end forces and in the illustrated pattern of column-top damage. Figure 3(b) shows the top of the compressed cylindrical column. The spiral transverse reinforcing was substantial and did not unwrap, but suffered some tension failures. However, these ties were completely inadequate for the very large diameter columns, and had a capacity to generate a compressive stress of only about 1.5 MPa.

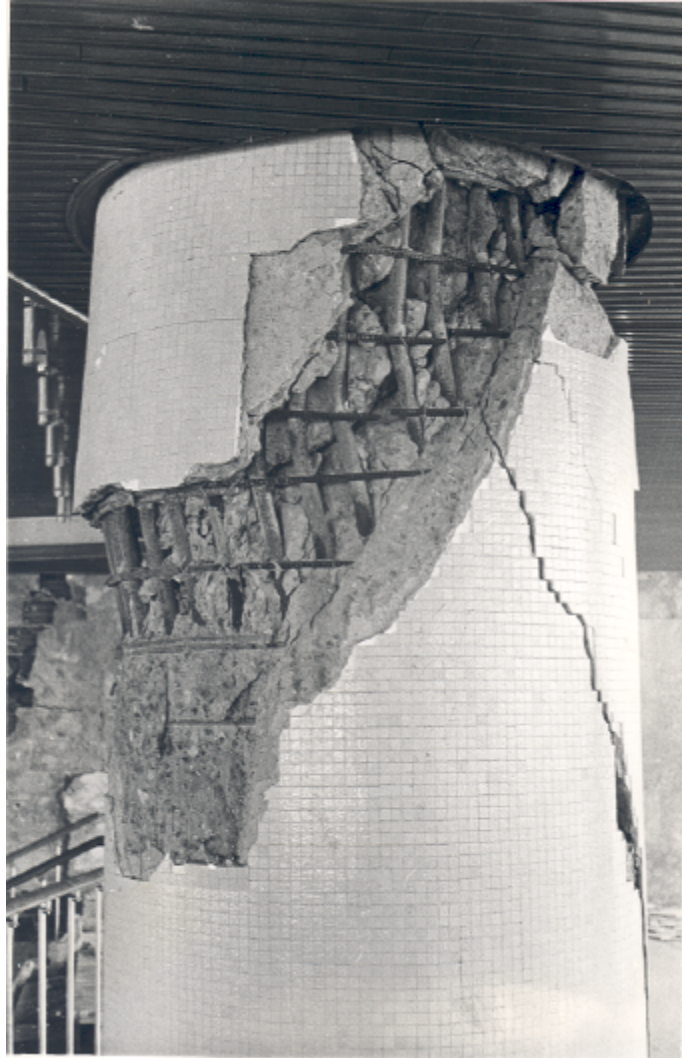
Figure 3(b): Macuto Sheraton, detail of a compressed and damaged column
