Observations on the Performance of Residential Concrete Slabs under Seismic and Soil Liquefaction Conditions

C.W Ashby

2012 NZSEE
Conference

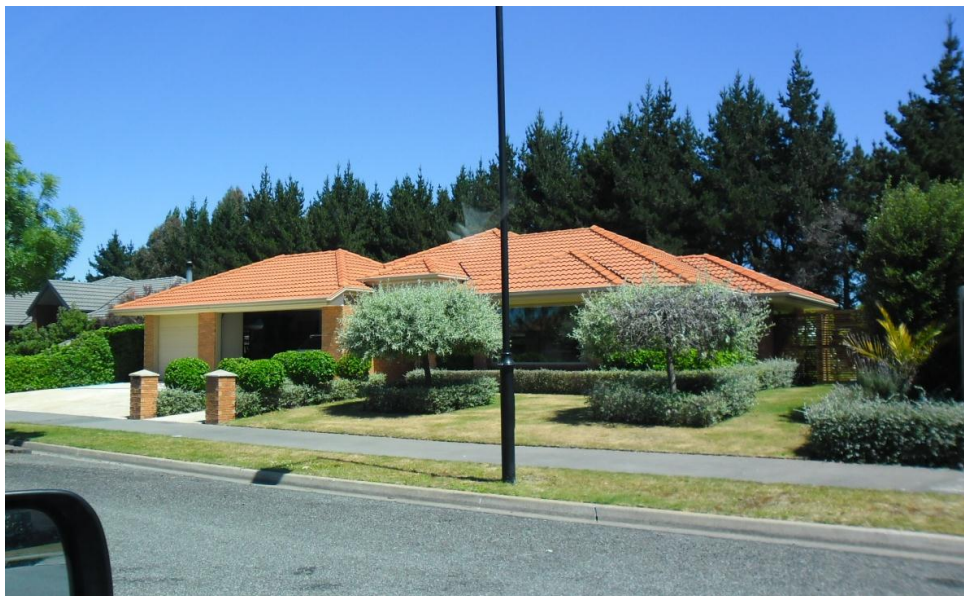
The photo below is of a previously “written off” house with cracked unreinforced concrete floors, saved from the demolition by crack repair methods and brought back to code compliance condition. In this particular case there was no liquefaction on site and floor slab levels were within new house tolerances and did not require releveling. This is now the writer’s new residence.
