Soil liquefaction and slope failures during the 2011 Tohoku, Japan Earthquake

R.P. Orense

**2012 NZSEE
Conference**

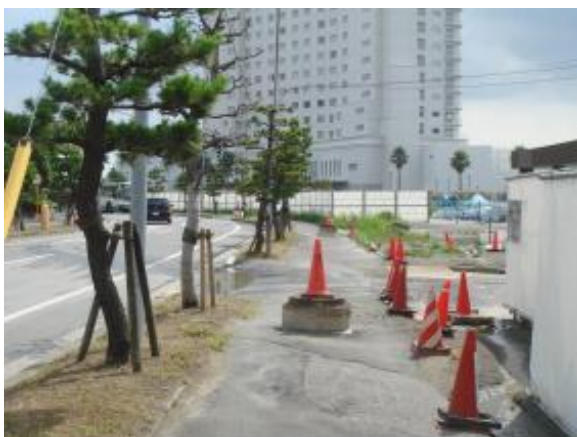
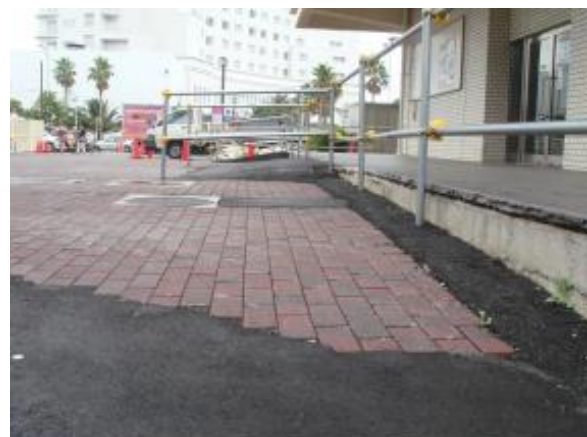
In Tokyo, located about 380 km away from the epicentre, Japan Meteorological Agency (JMA) intensity 5 was reported, with peak accelerations ranging from 0.1-0.2g and significant duration of shaking of 100-200 sec. The long duration of shaking triggered soil liquefaction at many sites in the reclaimed areas located adjacent to Tokyo Bay. Most of the sites were reclaimed as recent as the 1970s, although reclamation works in Tokyo Bay dated as far back as the 1800s. Many residential and commercial buildings in these reclaimed islands were affected by ground deformation (lateral spreading and settlement) induced by liquefaction. Road pavements buckled, manholes were uplifted and lifeline facilities were damaged (See Figure 4a). Ground subsidence was also observed, especially near buildings supported by pile foundations (see Figure 4b). More detailed description of liquefaction-induced damage in Tokyo Bay is presented elsewhere (Orense et al. 2011).

Figure 4: Observed liquefaction-induced damage in Urayasu City: (a) uplifted manholes over a section parallel to the road; and (b) ground settlement adjacent to pile-supported building.

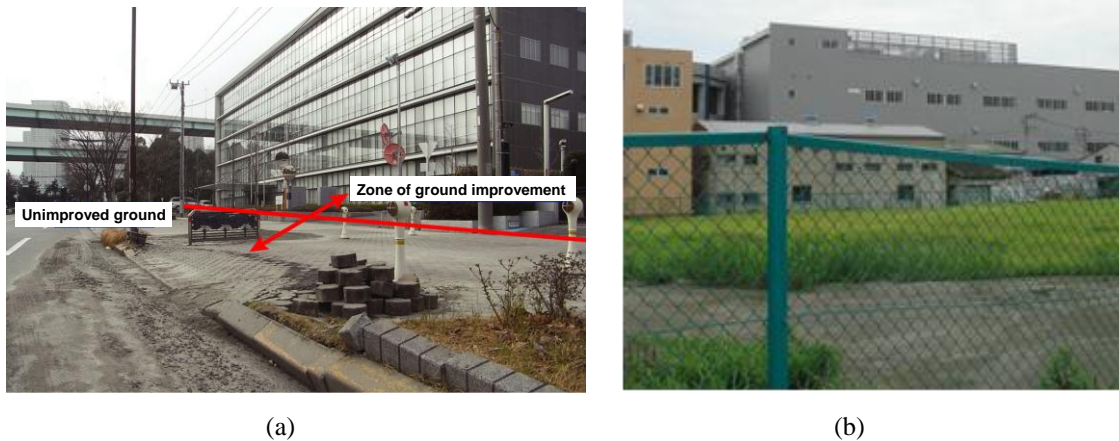
Figure 5: (a) Excellent performance of SCP-improved ground in Tatsumi; and (b) an undamaged building resting on improved ground in Shin-kiba while adjacent to it, sand boils were everywhere.

Many sites near Tokyo Bay, especially those in the reclaimed areas, were remediated during the economic bubble in the 1980s. Sites improved by sand compaction piles (SCP), gravel drains, and cement deep mixing method performed well in the earthquake. Figure 5(a) shows a medical centre building in Tatsumi whose foundation ground was improved by non-vibratory SCP method (or SAVE compozer method). It can be seen that although liquefaction-induced damage, such as ground settlement and sand boils, occurred outside the improved area, no damage was observed within the improved zone. The foundation ground of the building shown in the background of Figure 5(b) was remediated against liquefaction and the building was undamaged. Just a few meters away, sand boils were evident in the unimproved ground.

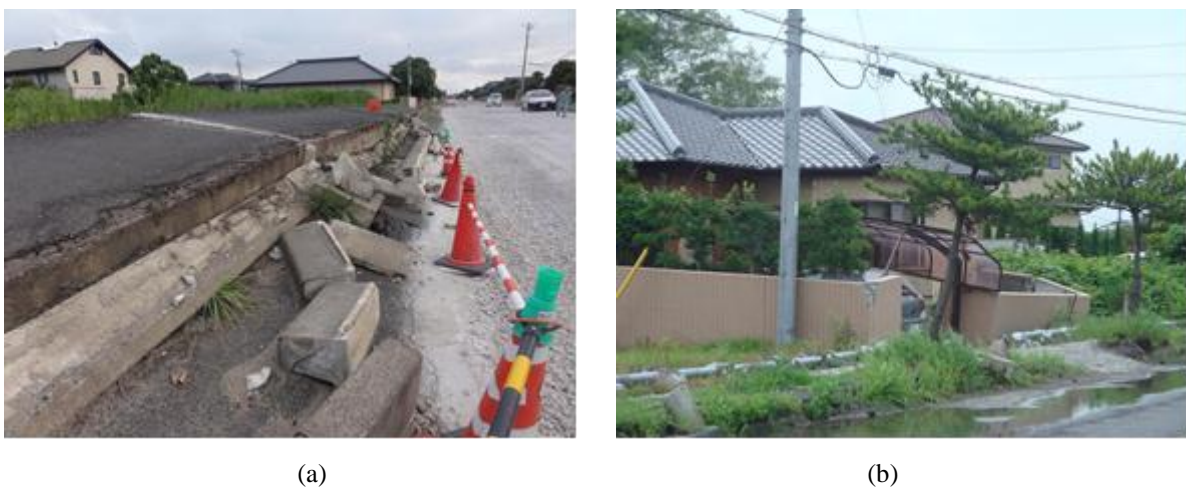
In Kamisu City located adjacent to Tone River, ground subsidence and distorted pavements were observed in many places. Figure 6(a) shows a stretch of road which subsided by about 50 cm. Buckled pavements, sand boils and popped-up manholes were seen in the vicinity. Another area of extensive liquefaction was observed in Hinode, Itako City, which was formerly a lake. Many residential houses suffered damage as a result of uneven settlement and lateral spreading (see Figure 6b). Electric poles were tilted, buried water pipelines were compressed and buckled, and many roads were damaged. When the visit was made four months after the earthquake, the community remained in its damaged state. Basic necessities, such as electricity and water supply, have not been restored to some houses making life difficult to those who decided to stay in the area. The ground adjacent to the primary school building settled by about 30 cm, and this necessitated the installation of ramps to enter the building. The building itself was on pile foundation and suffered very little structural damage.

Figure 6: (a) A portion of the road in Kamisu City which settled due to liquefaction; and (b) damaged house as a result of liquefaction in Itako City.

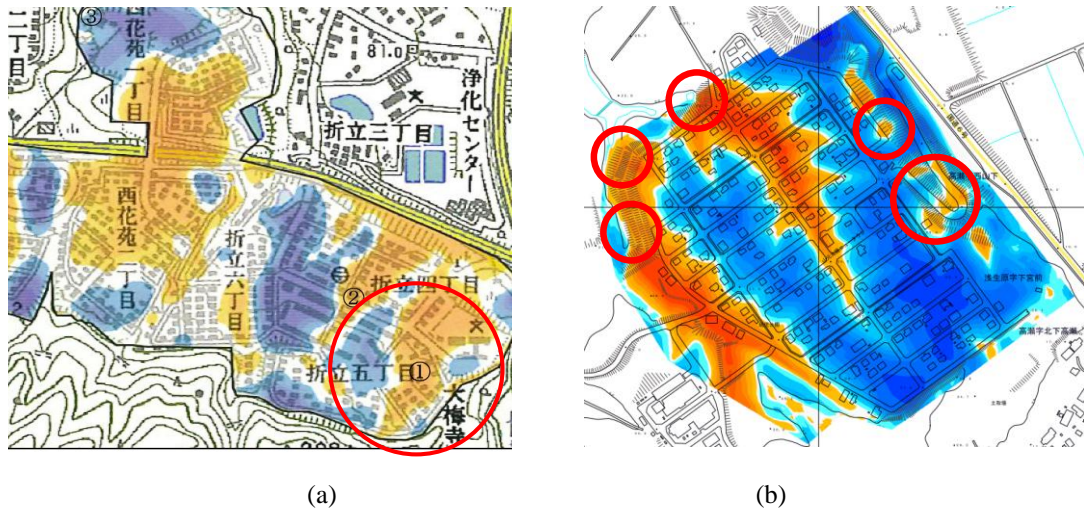
In Miyagi Prefecture alone, hundreds of slope failures were observed in many areas, such as in Oritate, Midorigaoka, Sakuragaoka and Taiyo New Town to name a few. Figure 8 illustrates the thickness distribution of cuts (darker region) and fills (lighter region) in Oritate and Taiyo New Town and the locations of observed slope failures. These sites were developed as residential areas in the 1970s by cutting and levelling off some parts of the hills and using the excavated materials as fill for the valleys, thereby creating a flat terrain with least transport of soil. To level off the residential land, cuts were made on the hills as high as 10-15m, while valley floors as deep as 15-20 m were filled up. Most of the slope failures in these areas were observed at the boundaries between fill and cut sections.

Figure 8: Housing site foundation maps showing the thickness distribution of cut and fill sections (after Fukken Gijutsu Consultant, 2008): (a) Oritate District; and (b) Taiyo New Town, where circles indicate the locations of failed slopes.

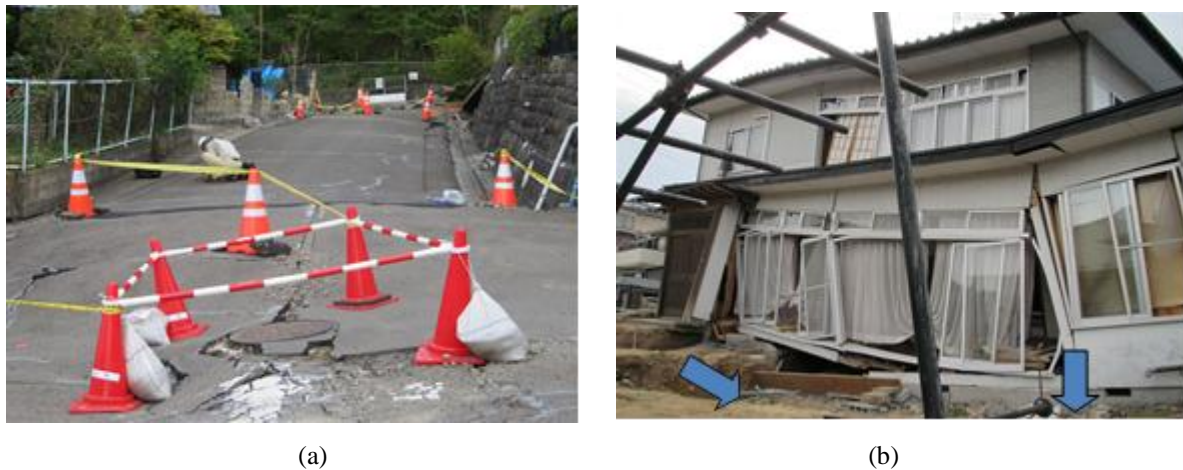
Oritate District (Aoba Ward), located in the western part of Sendai City is a new residential development in the hills. Of the 142 houses in the area, 55 in the eastern part of the district have been damaged by slope failures. Figure 9(a) shows the slope failure directed towards the left of the photo, resulting in a portion of the road being compressed by the slide. Damage due to differential settlement under houses at the boundary between cut and fill was also significant (Figure 9b).

Figure 9: Slope failure in Oritate 5-chome: (a) damaged road; and (b) deformed house.

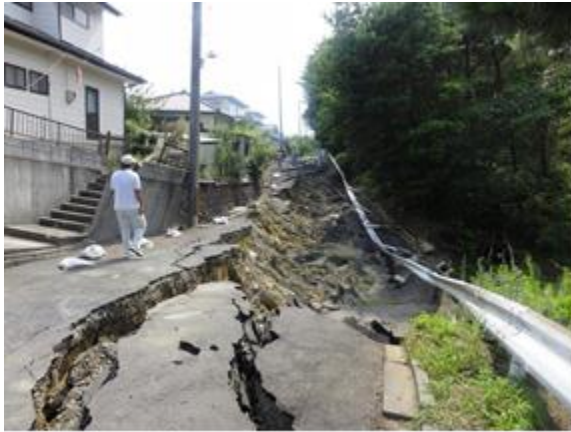
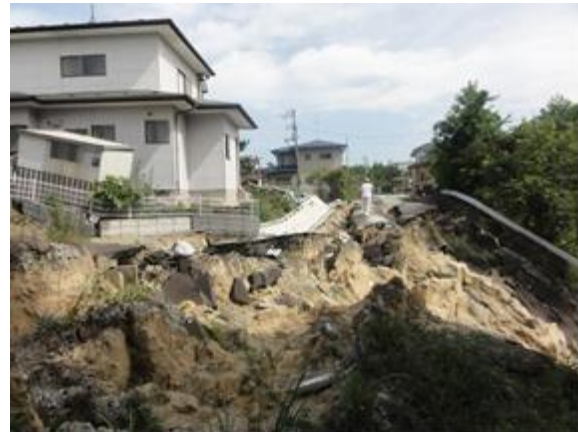
The Taiyo New Town housing site is located in the central part of Yamamoto, a coastal town on the southern edge of Miyagi Prefecture. It is located on the hilly region to the west of Route 6, which traverses the prefecture in an almost north-south direction. In fact, Route 6 appears to be the dividing line between the coastal plain on the east and the 40-50m high mountains on the west of the prefecture. The site has about 200 houses when the earthquake occurred. The failure shown in Figure 10(a) is located on the northern edge of the slope adjacent to a steep ravine. In this section, a portion of the road embankment collapsed over a distance of 15-20 m, and the fill materials flowed down the slope. A house adjacent to the road and located on top of the crest tilted, together with the fence and road railings. Figure 10(b), on the other hand, is located on the western section of the residential site. A 2-story house on top of the slope was damaged due to vertical offsets and extensional failure resulting from slope movement. The house was tilted, exposing its foundation. A more detailed description of the slope failures in Taiyo New Town is reported by Hyodo et al. (2011). Investigation of the local geology of the site revealed that the original ground consisted of tuffaceous sandstones of the Yamamoto Formation. Subsequent boring data showed that the sandstones were weakly consolidated and exhibited high degree of weathering towards the surface, with the surficial layer turning into sandy soil. Thus, the material used to fill up the valleys consisted of sandy soils from the weathered tuffaceous sandstones.

Figure 10: Slope failure in Taiyo New Town: (a) collapsed portion of a road; and (b) house precariously hanging on top of a failed slope.

The number of failed hillside embankments (valley-filled embankments and widening embankments) has highlighted the vulnerability of these sites to very large ground accelerations, which are rarely experienced. Estimates of accelerations were in excess of 1.2g on top of the fill sections. Some failed sites manifested flow-type of failure similar to those induced by soil liquefaction; hence, the role of ground water in triggering these slides needs to be investigated.
