Analyses of State Highway Bridges Damaged in the Darfield and Christchurch Earthquakes

J. H. Wood

John Wood Consulting, Lower Hutt.

2012 NZSEE
Conference

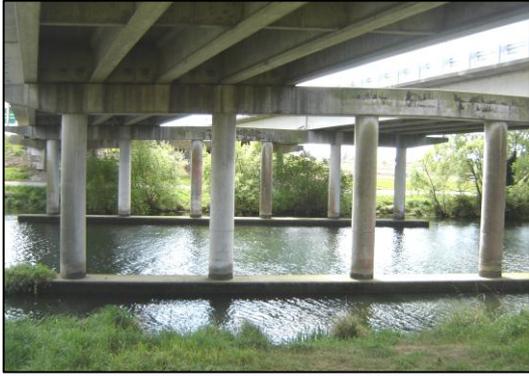
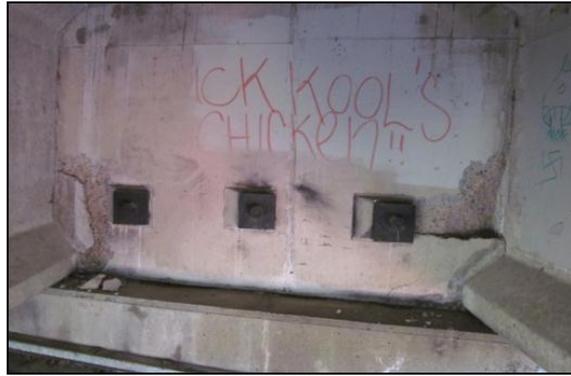
Figure 1. Kaiapoi Railway River Bridge. Photo on right shows abutment diaphragm damage.

Structural damage occurred in the Darfield Earthquake. There was no visible increase in damage following the lower ground accelerations in the Christchurch Earthquake or subsequent aftershocks. The main damage was the failure of the diaphragms between the span beams at the abutments (see Figure 1). There was severe spalling at the bottom corners of all diaphragm sections and cracking across the top corners in some sections suggesting primarily a shear failure of the connection to the beams near the bottom of the diaphragms. This connection consists of two 32 mm diameter rods passing through the end blocks of the span beams (near the top and bottom) and across the complete diaphragm to lap with 20 mm diameter bars cast into the outer beams. Although the diaphragms have vertical stirrups, apart from the transverse connection bars they have very little horizontal reinforcement. They are loaded by three linkage bolts positioned about 380 mm from the bottom edge of the diaphragm sections.

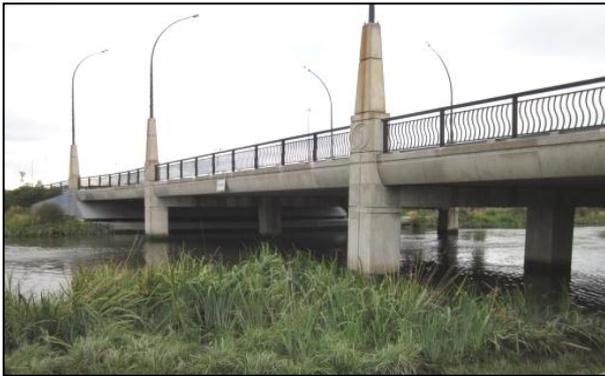
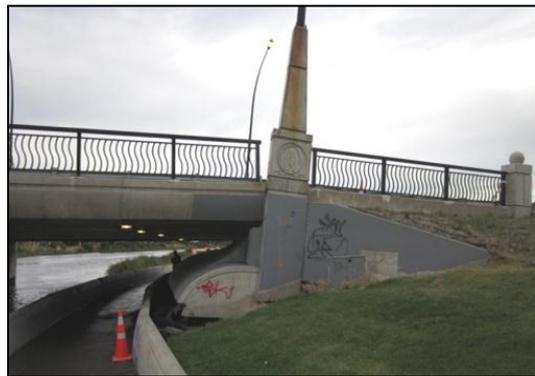
Figure 2. Anzac Drive Bridge. Photo on right shows abutment rotation from lateral spreading

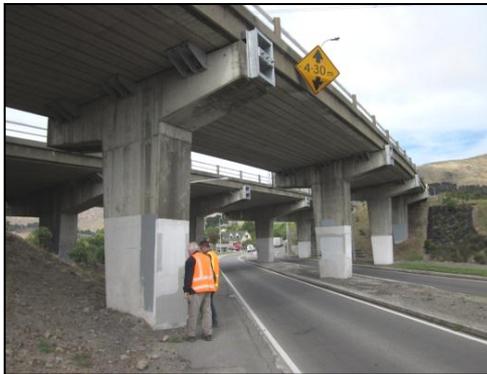
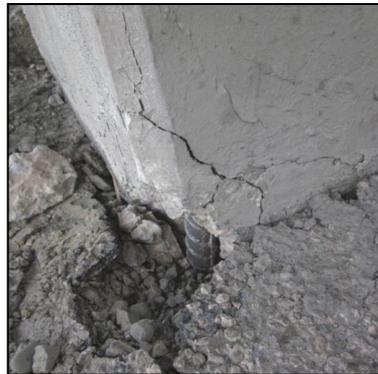
Figure 3. Port Hills Road Overpasses. Photo on right shows spalling (plastic hinge) at base of pier.

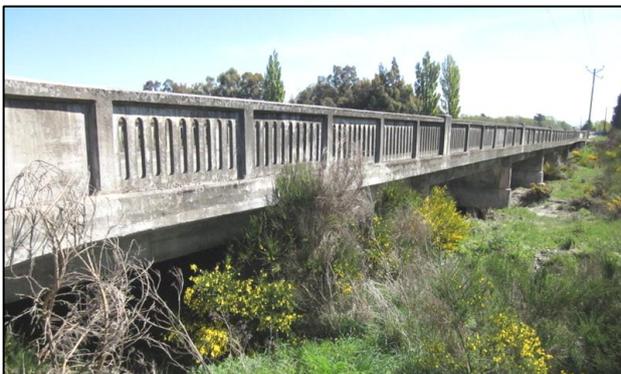
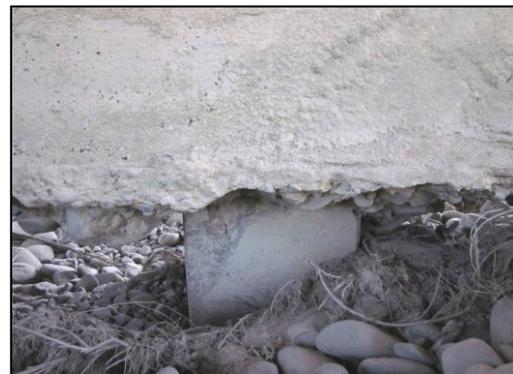
Figure 4. Hawkins River Bridge. Photo on right shows spalling at the top a pier pile.

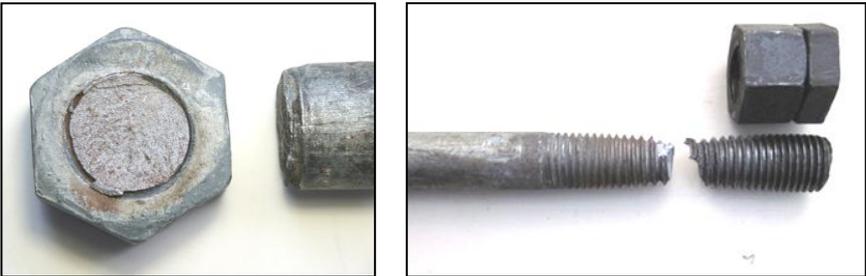
Two of the twelve 38 mm diameter galvanised mild steel linkage bolts on the eastern side of the northern-most pier (Pier B) failed with fractures occurring through threads on the head end of the

The testing showed that the bolts had at least their design strength. The failures at the head ends indicated that because of clamping by relative transverse movements between the span ends on the piers, the heads were loaded more heavily than the threaded ends. Although the overall elongation of a uniformly loaded bolt was good, the elongation in a non-uniformly loaded bolt might only be a few millimetres. Failures in the threaded and nut ends are shown in Figure 7.

Figure 7. Linkage bar failures. Left – head failure on bridge. Right – thread failure in tests.

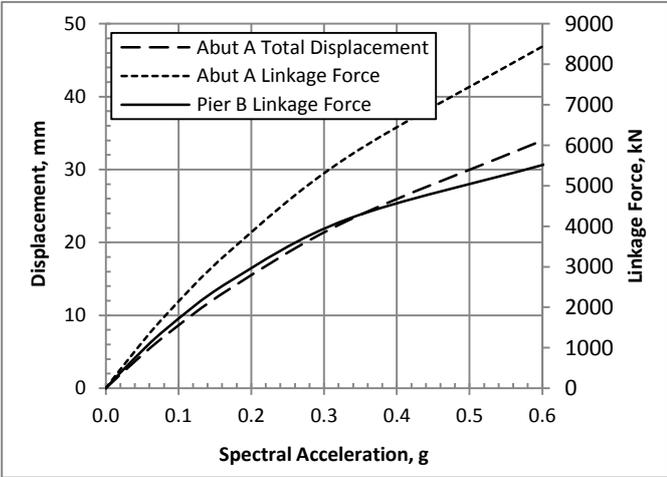
Results from the analysis are summarised in Figure 10 which shows the linkage forces at the pulled abutment (Abutment A) and the closest pier (Pier B) plotted as a function of the spectral acceleration acting on the superstructure.

Figure 10. Longitudinal analysis results for linkages.

The longitudinal analysis results indicated that the abutment linkage bolts would yield at a response acceleration of about 0.45 g and that the abutment diaphragms would fail in shear at a response acceleration of about 0.3 g. Because of the failure of the diaphragms it was not possible to positively identify whether the linkage bolts at the abutments had reached their yield load. However, the analyses indicated that the load in the linkage bolts would have been sufficient to fail the diaphragms.
