Christchurch City lifelines – performance of concrete potable water reservoirs in the February 2011 Christchurch Earthquake and summary findings

2012 NZSEE
Conference

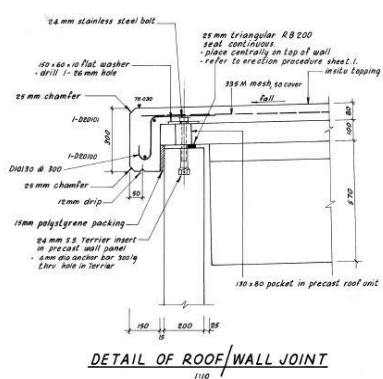
Figure 1 - McCormacks roof-to-wall dowel detail

Roofs to the two McCormacks Bay reservoirs are of composite construction, comprising precast prestressed tee units with an in situ topping and a 300 overall depth overhang around the top of the wall – refer to Figure 1 for details. Restraint bolting is provided between the roof and the walls, with the bolts passing through a pocket in the roof unit flanges and screwed into inserts at the top of the wall. Reservoir No.2 (1995) has 120 bolted inserts compared to 40 inserts in Reservoir No.1 (1984). The %NBS values estimated from detailed seismic assessments, for this detail, are 45-50% and 10-15% for Reservoirs No.2 and No.1 respectively.

The calculations suggest the likely performance on 22 February 2011 has been that, once bolts have yielded / failed the roof has translated with the overhanging nib impacting the reservoir wall. The strength of this nib for bending, shear and tension is limited and in Reservoir No.1 excessive roof movement has occurred which has smashed the overhanging roof nib, resulted in the precast roof tee units engaging the wall, punching out of wall concrete and damage occurring at the ends of the tee unit webs (Figures 2 and 3). Less damage has been observed in the roof of Reservoir No.2 possibly due to it having three times the number of bolted connections. However, physical investigations undertaken on the Reservoir No.2 bolted connections indicate that of the three connections that were cored / exposed two of the bolts had fractured.

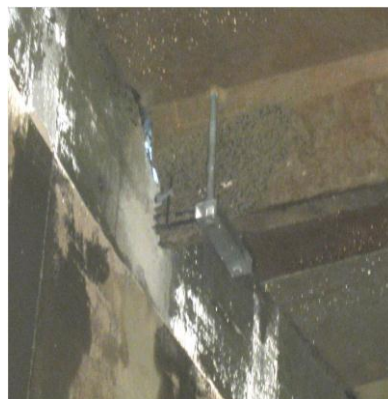
Figure 2 - McCormacks roof / wall impact damage

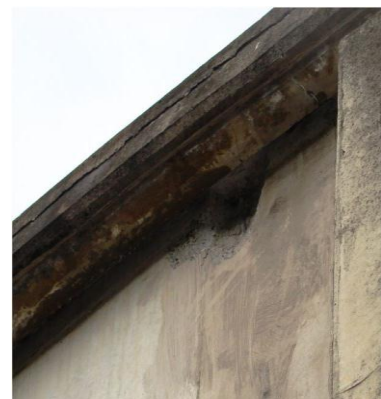
Figure 3 - McCormacks roof overhang

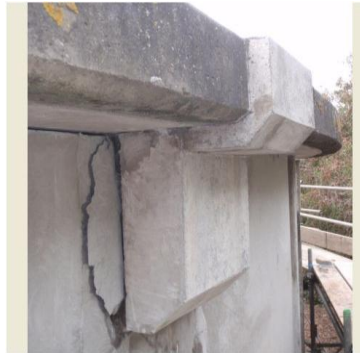
The Upper Balmoral (1986) roof comprises precast beams that slot into the 150 mm thick reservoir wall and pilasters with compressible packing between the beams and the wall and with grout filling the gap at the ends of the beams at pilasters (refer Figure 4). Under horizontal earthquake loading the roof beams have punched off the thin skin of pilaster concrete with the beams then impacting the wall and resulting in major cracking and damage to the top of the wall (Figure 5). Although there is reinforcement connecting the roof to the wall this passes through a duct cast into the beams and thus provides minimal resistance to lateral loading. Calculations indicate this detail achieves approximately 15% NBS.

Figure 5 - Upper Balmoral wall damage

Upper Balmoral	Repairs completed December 2011 and reservoir returned to service. Repair and retrofit included a concrete ring beam around the top of the wall (tied to the roof) and an internal ring beam connecting the base of the wall to the base-slab.
Clifton 3	Repair and retrofit completed, returned to service December 2011. Repair / retrofit included break-out and reconstruction of the damaged column, jacking of the roof vertically and fitting of a concrete ring beam at the top of the wall to restrain the roof against lateral movement

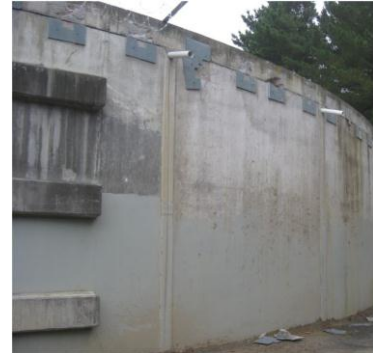
Figure 6 - Worsleys Rd reservoir No.1 epoxy bonded shear plates

The two Worsleys Road reservoirs were constructed circa 1968. The roofs for these reservoirs are of in situ construction and post-tensioned. As for the Clifton 3 reservoir, there is no physical connection between the roof and the wall but the perimeter of each roof steps up and across the wall with a 25 mm gap between the roof and the wall all around. The roof is free to slide on top of the wall until this gap closes up and it impacts the inside surface. Castellated / interlocking steel shear plates were retrofitted to Reservoir No.1 in the mid 1990's, epoxy bonded to the roof and the wall (with nominal temporary locator bolts). Approximately 50% of these shear plates were damaged in the September 2010 earthquake with further damage to all remaining pairs of plates occurring 22 February 2011 (refer Figure 6). This has resulted in areas of wall and roof concrete subsequently requiring repair. Of note is that the damage to the Reservoir No.2 roof and wall appears to be minimal with only some dislodging of the compressible packing between the roof and the wall observed.

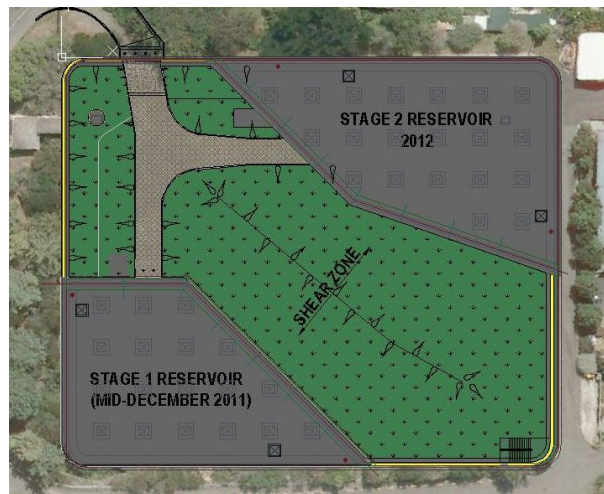
At the Huntsbury reservoir site extensive geotechnical investigation indicated that an underlying shear zone, extending diagonally across the reservoir footprint, exists and which is considered the main reason for the observed structural damage. The Christchurch Earthquake appears to have reactivated an underlying shear zone resulting in movement occurring on planes of weakness in the rock. Given the on-going period of increased seismicity and likelihood that this shear zone could remain active for some time, the final configuration of the site reinstatement is two smaller reservoirs constructed in the corners of the current reservoir footprint as shown in Figure 7.

Figure 7 – Huntsbury No.1 Reservoir – shear zone and proposed site reinstatement

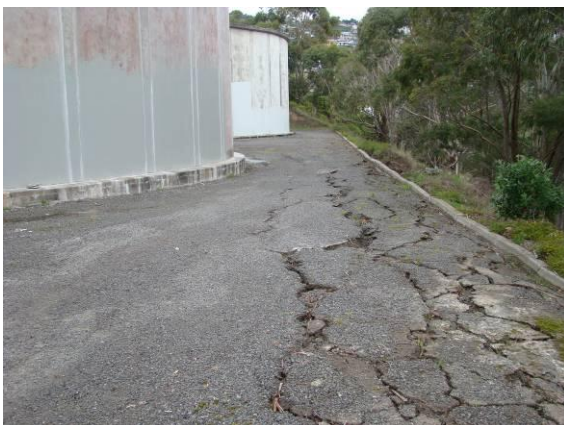
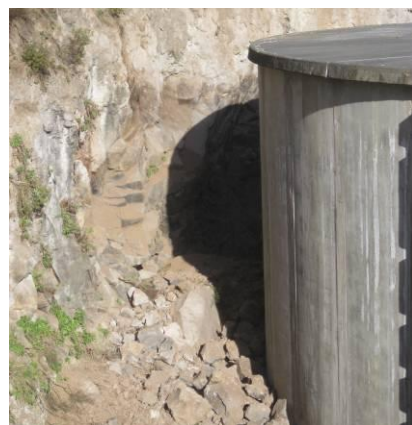
The McCormacks Bay reservoirs site requires extensive stabilisation. The access road to the reservoirs has significant cracking, settlement of up to 500 mm and slumping towards the slope below the reservoirs (Figure 8). The stacked basalt block gravity wall supporting this road partially collapsed on 22 February 2011 resulting in rockfall hazards to the road and residents below, and requiring the installation of emergency temporary rockfall fences to mitigate short term rockfall risks. A permanent piled replacement retaining wall is currently proposed along the edge of the road.

Figure 8 – McCormacks Bay reservoirs – access road damage and rock fall around reservoirs

The construction platform for the reservoirs was cut into rock and there is a near vertical face, with a height of up to approximately 21 m, behind the reservoirs. The large ground accelerations that were experienced at the site on 22 February and 13 June 2011 led to significant loosening and dislodgement of material from the rock face. Rock and material has piled up behind the reservoirs and some rocks may have impacted the reservoir wall (Figure 8). It is currently proposed that reinforced steel mesh and a grid of rock anchors and soil nails be installed over the full extent of the cut face.
