Former Magistrates' Court Building – Strengthening and Performance

Opus International Consultants Ltd.

2013 NZSEE
Conference

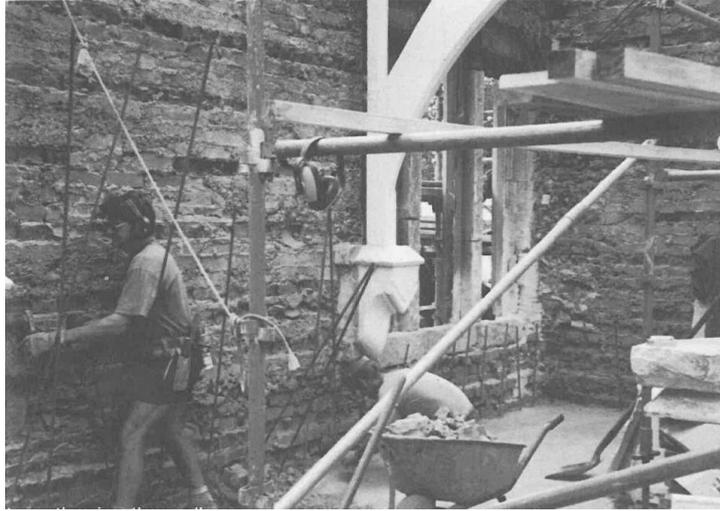
Figure 2.1: Interior stripped out and new ground floor installed prior to installation of reinforcement and sprayed concrete to the walls.

- Installation of a new concrete slab throughout the ground floor level as shown in Figure 2.1. This photo is taken at first floor level;
- Installation of new plywood ceiling diaphragm installed under the existing timber roof trusses and throughout the first floor part of the building; and,

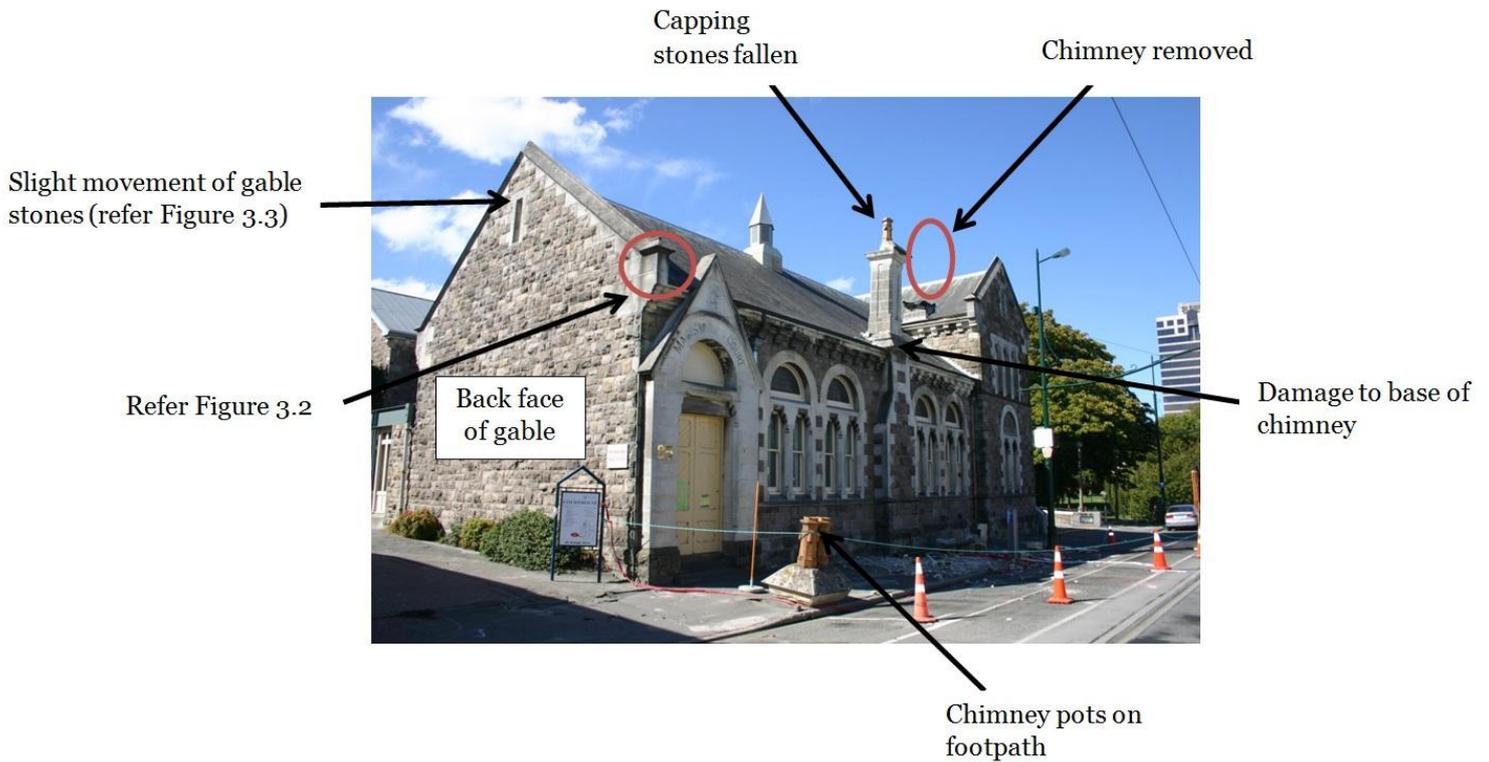
- Two of the four chimneys sustained damage and had partially fallen, see Figure 3.1.
- Movement of some stonework at the top of some gables, Figure 3.2 and 3.3.
- Minor cracking to some remaining brickwork.
- Potential minor opening of shrinkage cracks in the sprayed concrete.

Figure 3.1: West and South elevation taken after February 22nd 2011 earthquake

The key securing works involved the deconstruction and careful removal of the damaged chimneys to secure storage.

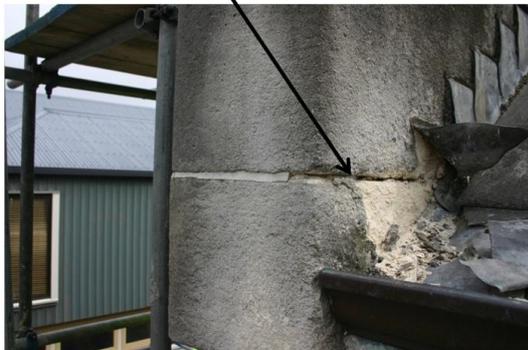
Rocking damage of stone of gable connection to roof

Figure 3.2: Rocking damage to stonework at bottom of gables **Figure 3.3: Movement of stonework at top of gables**

The shotcrete walls were found to extend only to the underside of the roof rafters that sat against the gable wall. Rocking of the upper portion of the gable about the interface between shotcrete and brick caused damage to the stonework (Figure 3.2), with the potential for partial collapse of stones or stone fragments into public spaces. In addition, the pointing and mortar at the apex of the gables had failed.

To address this hazard, and to prevent further damage to the heritage fabric, it was decided to remove the capping stones along the full length of the gable, deconstruct the apex of the affected gables and extend the concrete backing up to the underside of the capping stones before reinstatement and pinning into the concrete backing. Figures 4.4 and 4.5 indicate the works in progress and the completed west gable.

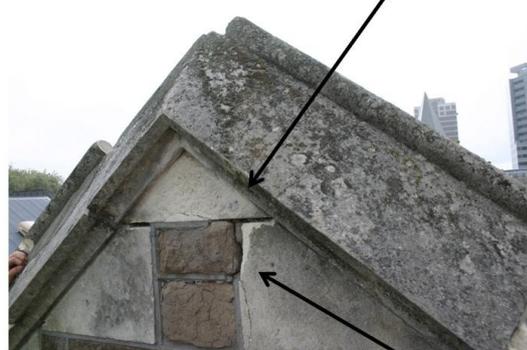
Loss of pointing and loose mortar

Relative horizontal displacement of stone

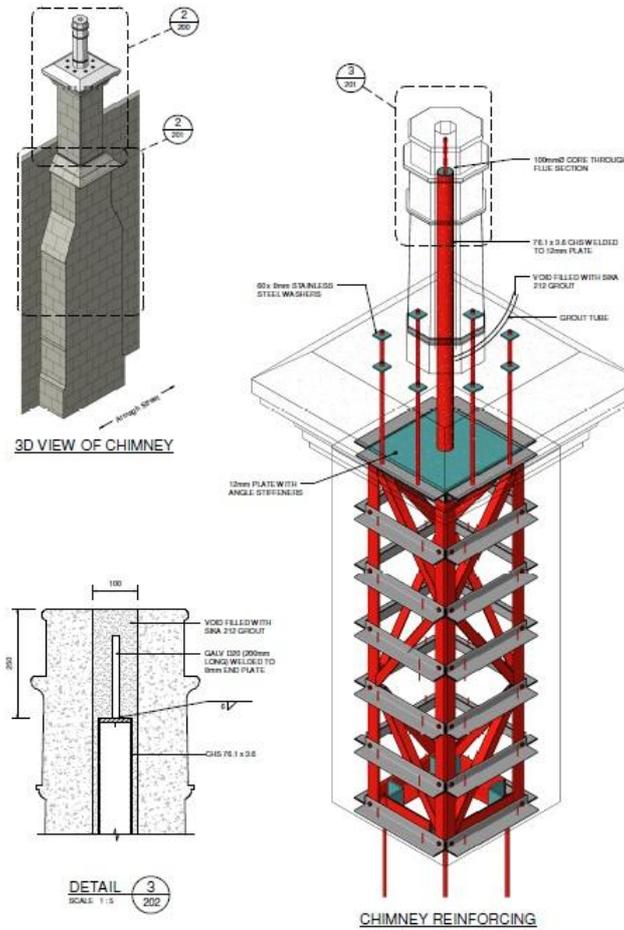
Figure 4.1: Chimney strengthening details

The larger chimneys were approximately 700mm x 700mm square and stood approximately 3 m from the base to the capping piece. The main design consideration was how to secure the stone chimneys in an effective manner that would resist overturning and limit strain in the stonework so as to prevent fragments of the soft Oamaru stone from falling onto public areas.

The first step was to reduce the mass of the chimneys. Replicas constructed of alternative materials, such as fibreglass, were not acceptable solutions from a heritage perspective, so the option of cutting the original stone down to a veneer was proposed. It was determined by the stonemasons that the soft Oamaru stone could be cut down to a minimum of 100mm. Steel frames of equal angles were prefabricated and installed to provide the skeleton required to rebuild the chimneys to their original dimensions and appearance.

The challenge was the restraint of the steel frames at the base, with some chimneys having no breast below the roof level, and the outside line of the chimney projecting beyond the face of the wall below. A combination of deep drilling to install rods to the base of the wall and steel struts to resist overturning was adopted, as shown in Figure 4.1.

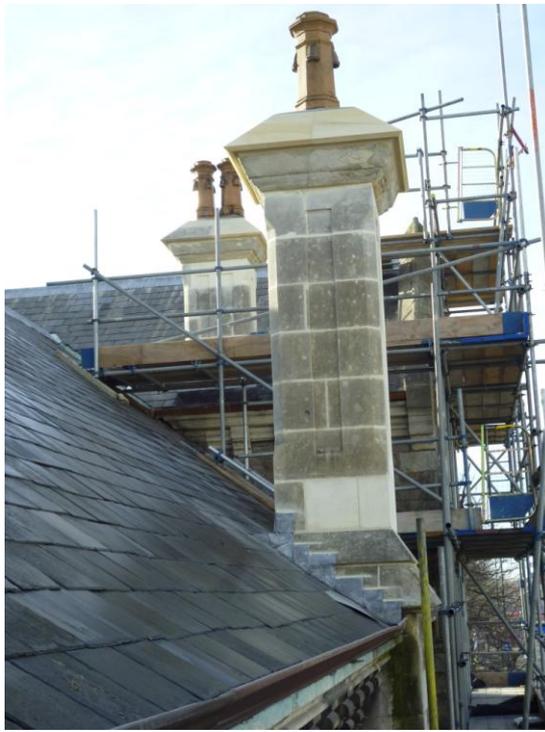
Figure 4.2: Rebuilt chimneys along Armagh Street frontage

Through all of these stages, careful consideration was given to the heritage fabric of the building. Roof slates were carefully removed to expose the existing structure and limitations were placed on altering the original building, including removing the original sarking under the roof tiles. The highly weathered nature of the original stone chimney masonry meant that some were damaged during the deconstruction stage. Figure 4.2 shows the chimneys along the Armagh Street frontage following the reinstatement.

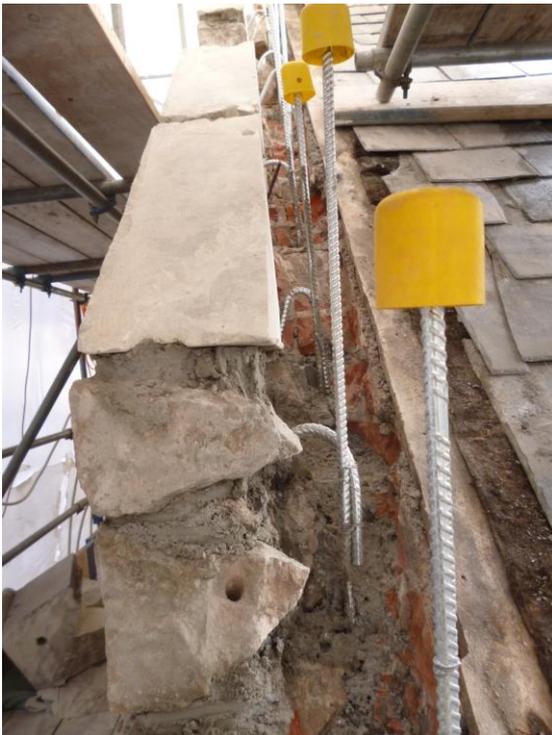
Figure 4.3: Work in progress on repair of west gable

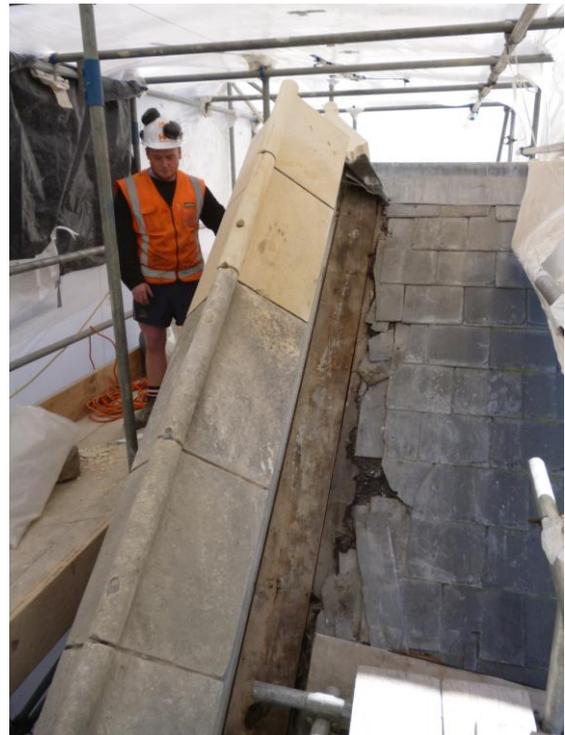
Figure 4.4: Stonework repairs on west gable complete

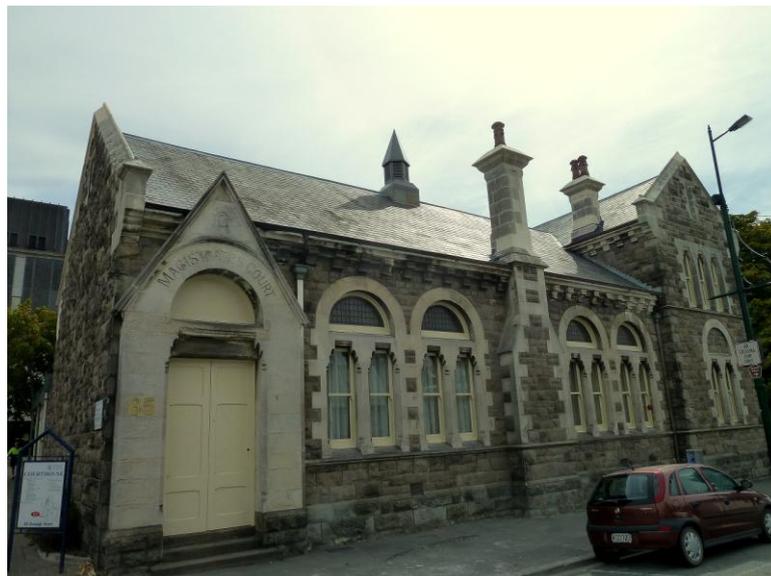
Figure 4.5: Armagh Street frontage following completion of repairs and strengthening

The use of a 1:2:9 (cement:lime:sand) mix, to achieve a 5-6MPa after 24 months, was considered the most appropriate short-term conservation-based solution. This was, however, in conflict with engineering requirements for a minimum 1:1:6 mix to attain a reasonable structural strength. The

variety and strengths of mortar mixes were extensively debated - does one lose a building due to a strong mortar mix causing masonry failure over time, or weak mortar resulting in seismic failure? The compromise, as an immediate temporary solution, was the use of a 1:1:6 bedding joint mix with a 1:2:9 pointing mix (20mm deep or 2.5 times the joint width) in areas of the worst failure. As mitigation, the team recommended a future assessment of all mortar joints to determine all causes of failure and water penetration. It was also agreed that tests be carried out on the performance of a number of different mortar mixes in identified areas around the building over a number of years to determine the optimum mix for a permanent solution.
