# Provisional Seismic Assessment and Improvement of Napier's Art Deco Buildings

2013 NZSEE  
Conference

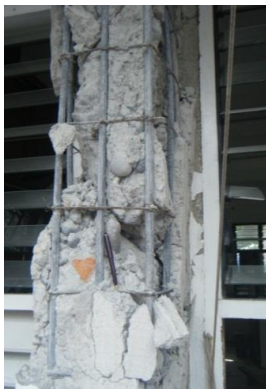
Figure 1. Poor quality concrete material is vulnerable to crushing and shearing.

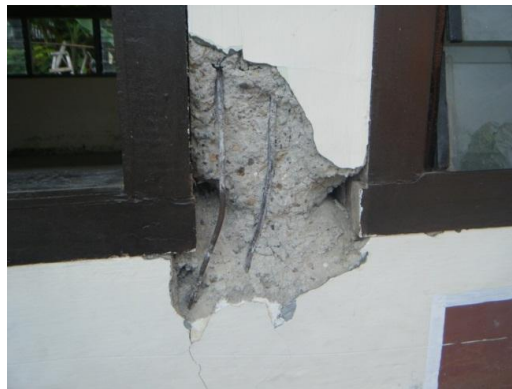
Figure 2. Poor reinforcement detailing with a lack of transverse reinforcement and insufficient longitudinal reinforcement.

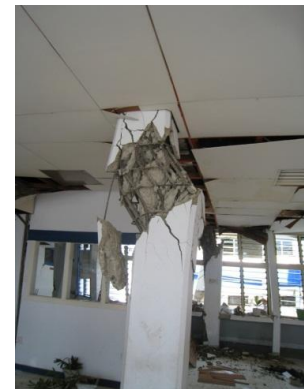
Figure 3. Plastic hinge formed in non-ductile column-sway mechanism.

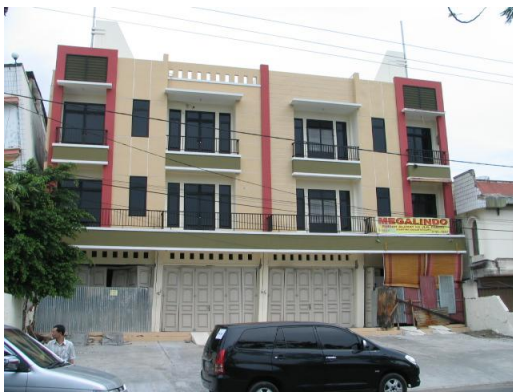
Figure 4. Soft-storey deformation.

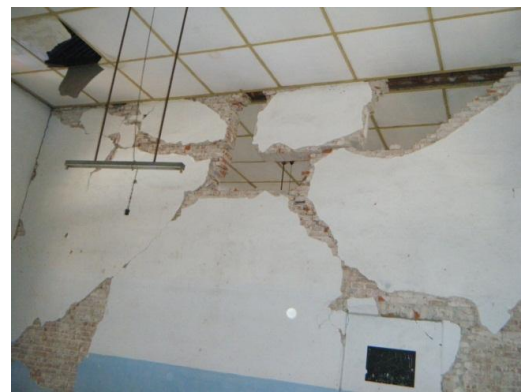
Figure 5. Shear cracking in infill wall material.

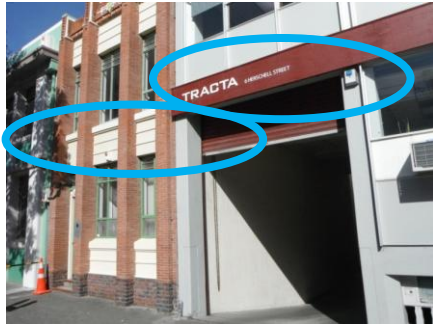
Relatively speaking, the vertical irregularities in Napier's Art Deco building stock are fairly minimal, although a few examples do exist, especially in buildings that have had annexed portions constructed. The most significant potential structural weakness of some individual Napier buildings appears to be pounding potential. The two types of pounding are illustrated in Figures 6 and 7 along with corresponding photographed examples from Napier.

Figure 6: Floor mis-alignment between buildings in Napier could possibly lead to “pounding effect” during an earthquake (bottom row image from NZSEE 2006).

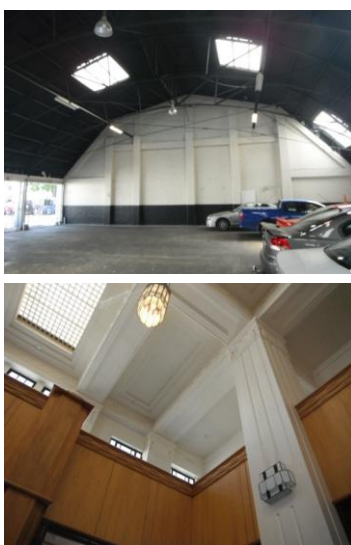
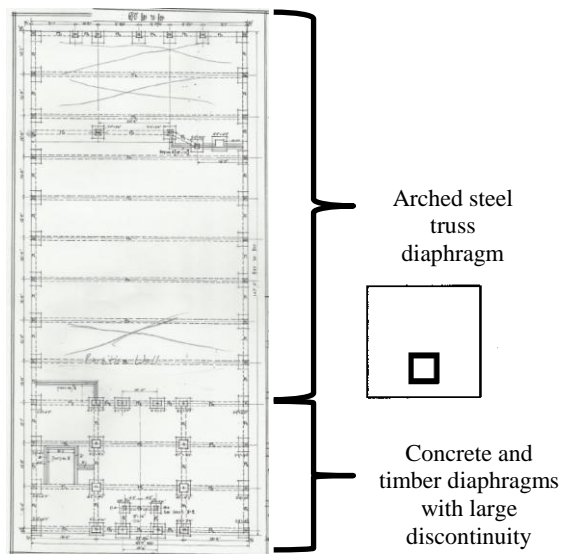
One building in Napier serves as a clear example of potential plan irregularities. This building is constructed of an RC frame with exterior and interior columns and concrete and timber diaphragms on one end and a potentially more flexible arched steel truss diaphragm with no interior columns on the other end, as illustrated in Figure 8. An earthquake with strong motions acting parallel to the boundary between the two systems may cause a torsional reaction. Other potential plan irregularities observed in Napier included large portions of diaphragms missing for open lobbies, light wells, and courtyards. Stairwells that are large, oddly shaped, or eccentrically placed within a building may also pose as plan irregularities if they are expected to greatly affect the building’s response to lateral forces. In some of the smaller buildings inspected in Napier, stairwells made up large portions of the building footprints. In corner buildings in Napier, the two walls facing the streets are often constructed with lighter non-structural materials than the non-structural materials used for the other two backside (i.e., not visible from the main roads) walls, which often include heavy masonry infill.

Figure 8. Example of plan irregularity in a Napier Art Deco building based on different construction materials, configurations, and placement of interior columns at one end (architect withheld to help keep building anonymous).

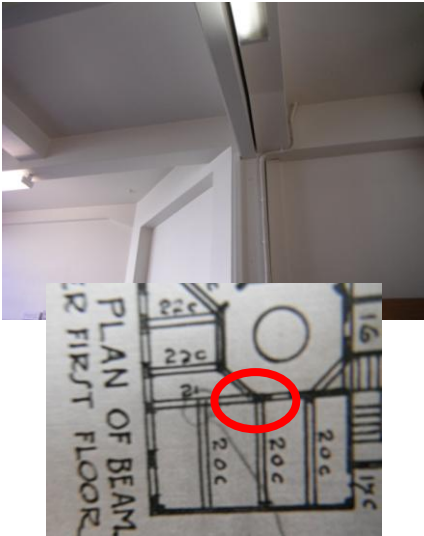
While the concept of plan irregularities generally applies to the “global” effects of building response during an earthquake, other components observed in Napier’s Art Deco buildings may affect the building locally. As exhibited in Figures 9-11, some beam and column centerlines observed in Napier that do not align, possibly resulting in the beam transferring a torsional load into the column during an earthquake. Irregularly shaped columns were observed that may resist lateral loads torsionally with resulting higher stresses, as well as an elevated floor space in a building that is irregularly shaped and connected to the surrounding structure eccentrically, possibly resulting in this floor twisting during an earthquake and increasing the loads on some localised portions of the surrounding structure.

Figure 9. Beam and column centerlines do not align.

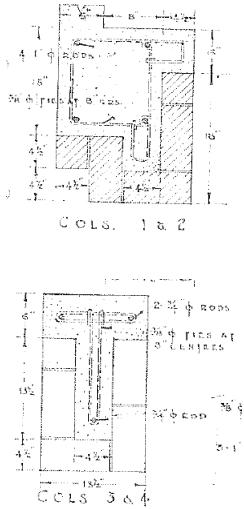
Figure 10. Irregularly shaped columns (architect withheld to help keep building anonymous).

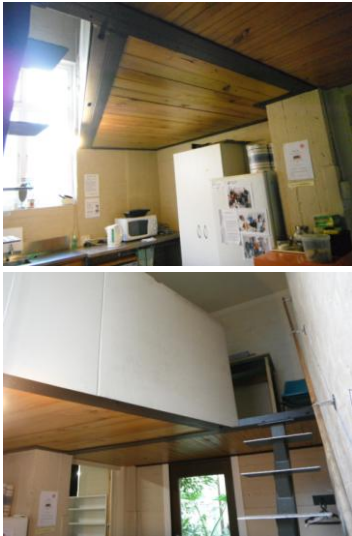
Figure 11. An elevated floor space in a building is irregularly shaped and connected to the surrounding structure eccentrically.
