Lessons learnt from the performance of buildings incorporating tilt-up construction in the Canterbury Earthquakes

C.R. Urmson, A.M. Reay & S.H. Toulmin

Alan Reay Consultants Ltd., Christchurch, New Zealand.

2013 NZSEE
Conference

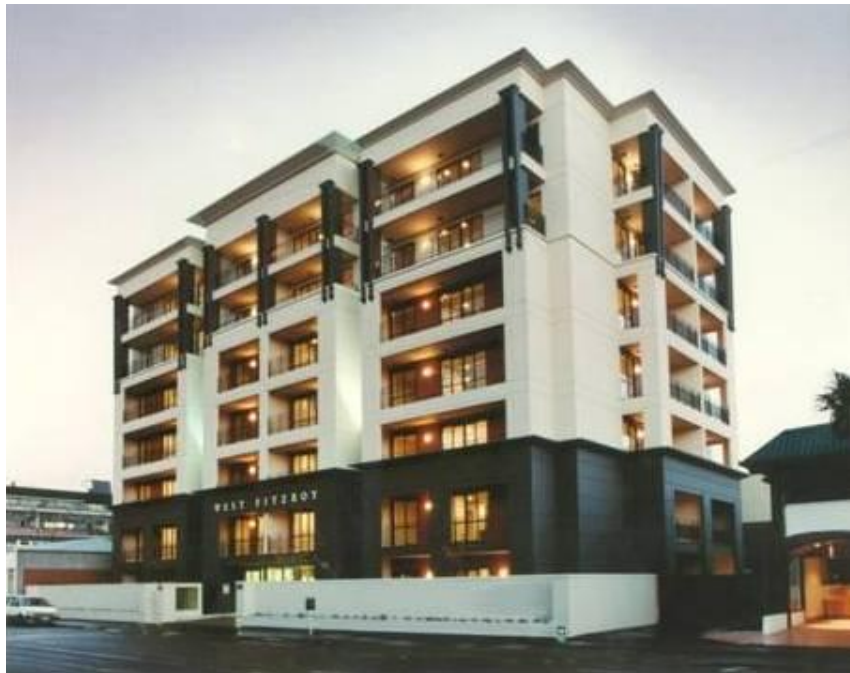
Figure 1. The seven-storey West Fitzroy Apartments building in central Christchurch is an example of a multi-storey tilt-up building which has performed exceptionally well during the Canterbury Earthquakes

The seven-storey West Fitzroy Apartments building (Fig. 1) located within the Christchurch CBD is a well-performing tilt-up concrete building. Constructed in 1998, the building received awards from the New Zealand Concrete Society, the Association of Consulting Engineers New Zealand, and the American Tilt-Up Concrete Association. The structure is constructed primarily of tilt-up concrete shear wall panels and a proprietary hollow-core flooring system with an in-situ concrete floor diaphragm. The building suffered relatively minor damage with the most significant relating to differential settlement of the shallow foundation system.

Cracking of the walls was limited to the base of the cantilever concrete shear wall panels in the predetermined plastic hinge zone. Well detailed confined regions exhibited no spalling in the cracked regions and cracks were well distributed over the potential hinge zone. Ducted panel splices are used at panel joints throughout the building and no instances of joint failure or damage have been identified. In general the building has performed very well and has been occupied throughout the

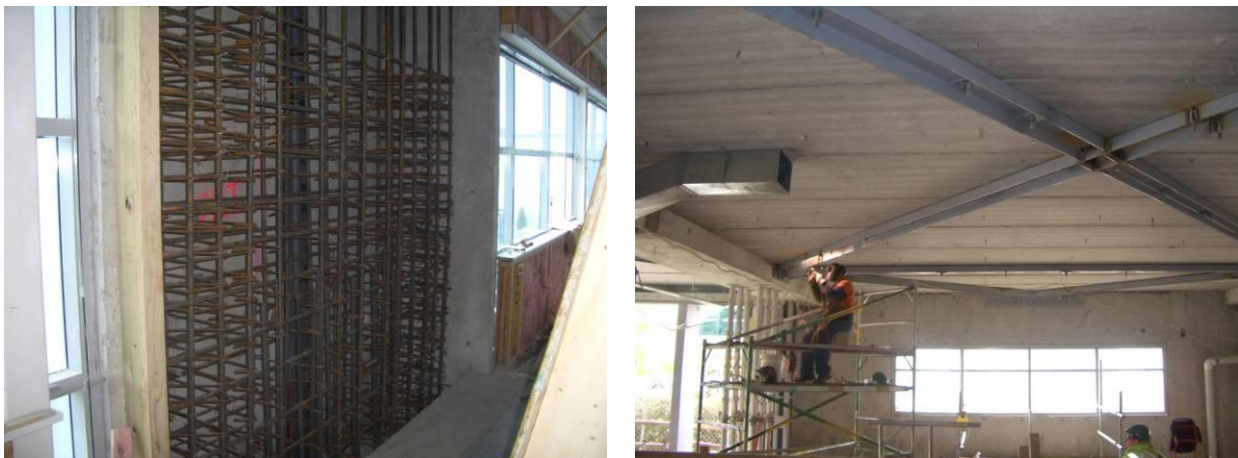
The Statistics New Zealand building is a 4000m² three-storey tilt-up concrete office building located within the Christchurch CBD. The structure is constructed primarily of precast concrete tilt-up shear wall panels and a proprietary hollow-core flooring system with in-situ concrete floor diaphragm. Although the building performed well in terms of life safety objectives, building damage meant that the building could not be occupied after the February 22nd, 2011 earthquake. Damage included cracked shear walls with damaged reinforcing steel, liquefaction-induced settlement and extensive damage to non-structural elements.

Figure 2. Repair and upgrade of Statistics New Zealand: a) New in situ reinforced concrete shear walls; b) Diaphragm strengthening using steel bracing to underside of floors

Following the earthquakes, an economically viable repair methodology was implemented. New screw piles and enlarged foundation beams were constructed, and one corner of the building was raised 60mm back to level using hydraulic jacks. New in-situ reinforced concrete shear walls were poured adjacent to the existing ones (Fig. 2a), and significant cracks were repaired using epoxy injection in redundant walls. The floor diaphragm was strengthened using steel bracing to the underside of the floors (Fig. 2b), and new roof bracing was added. This bracing also formed part of the temporary works. Seismic bracing of all suspended services was upgraded from the original construction. Not only was the repair work able to reinstate the building substantially to its pre-earthquake condition, but it was also sufficient to upgrade the building to 100% of New Building Standard.

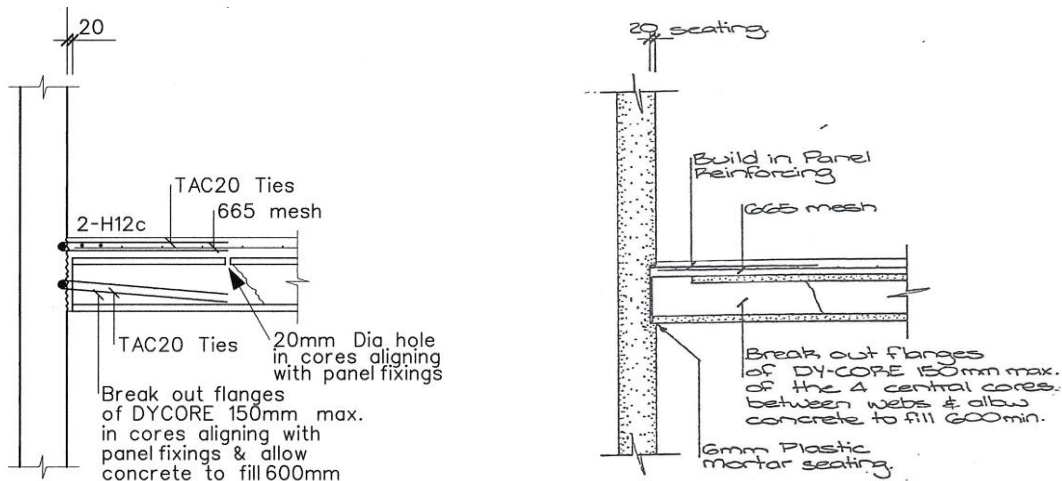
earthquake sequence with the exception of mandatory downtime enforced by the initial CBD red zoning. Whilst repairs are necessary, the damage is considered minimal with respect to the building seismic performance. Some of the key features of the West Fitzroy Apartments building which contributed to its successful performance include well distributed shear walls, well detailed yielding regions with confinement steel, confined ducted splice connections and a well tied foundation system. Floor-to-wall connections utilised proprietary TAC20 seating systems (Fig. 3a), and no failure of this system has occurred.

Figure 3. Common existing floor-to-panel connections: a) Proprietary TAC20 seating system; b) Rebate in panel with panel reinforcing tied in to topping

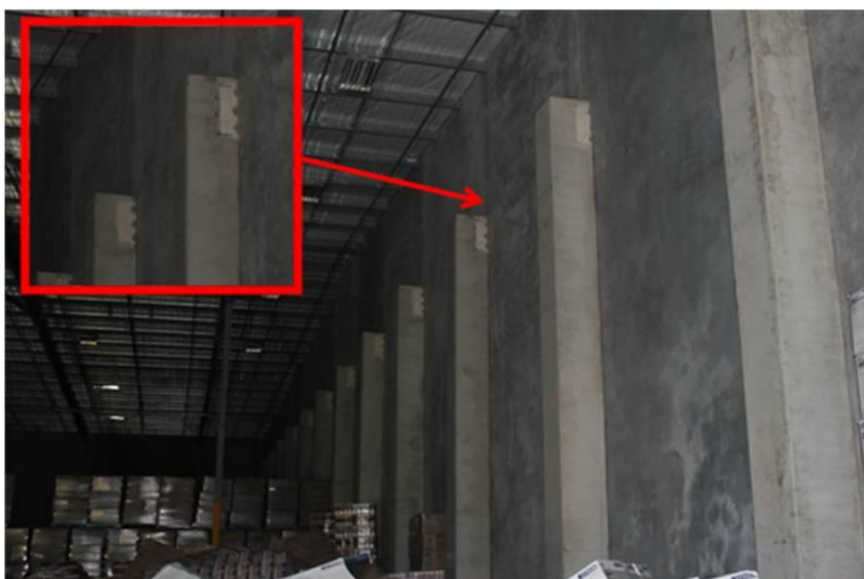
Despite the extremely high accelerations, the majority of the panel connections performed well and did not result in the collapse of any tilt-up panels (Fig. 4). The building was able to be reoccupied within days following some minor remedial works.

Figure 4. Example of ductile cast-in anchors as part of the main lateral load-resisting system demonstrating good performance under seismic actions. Inset: spalled vermiculite fire-rating material showing evidence of movement of the connection under seismic actions

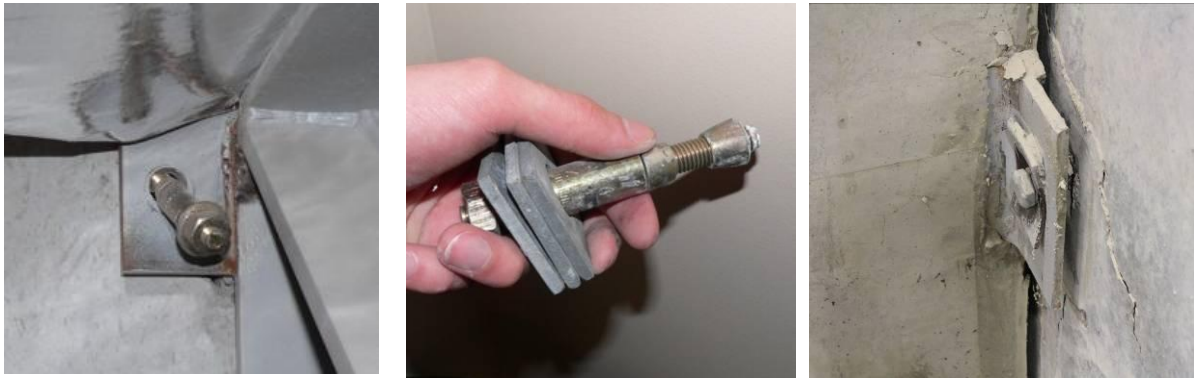
There have been several instances of panels failing at anchorages (Henry and Ingham, 2011; Clifton et al., 2011). Poor performance appears to have been associated with expansion anchors (Fig. 5a & b) and older single-bolt ‘clip-plate’ connections, although no major panel failures are known to have been caused by the latter. Bolted panel connections which incorporate ductile cast-in inserts (Fig. 5c) have typically displayed superior performance. Where these have been installed correctly, no failures have been observed as a result of seismic damage. In some cases, connection configuration has caused less desirable behaviour, particularly connections with no allowance for movement arising from drying shrinkage, thermal actions, differential settlement and prying action on bolts to panels.

Figure 5. Examples of performance of bolted panel connections: a, b) Pullout of expansion anchor; c) Ductile cast-in anchor showing surface panel spalling

Design of new tilt-up panels, as well as repair and retrofit of existing tilt-up panels, should have a three-fold aim with respect to panel connections:

- A strength hierarchy for face loads, whereby the panel connections are stronger than the panels themselves – this ensures that damage occurs along yield lines, rather than being focussed at single connection points;
- Ductile panel connections, for example by utilising yielding elements within the concrete or alternatively by having cast-in inserts which are able to engage panel reinforcing steel on pull-out, to prevent sudden failure if the connections are overloaded;
- Adequate allowance for movement arising from shrinkage and thermal effects, to prevent pre-earthquake weakening of the connection.
