Common Structural Deficiencies Identified in Canterbury Buildings and Differences in the Standard Practice in US and NZ

Simpson Gumpertz & Heger Inc., San Francisco, United States of America.

2013 NZSEE
Conference

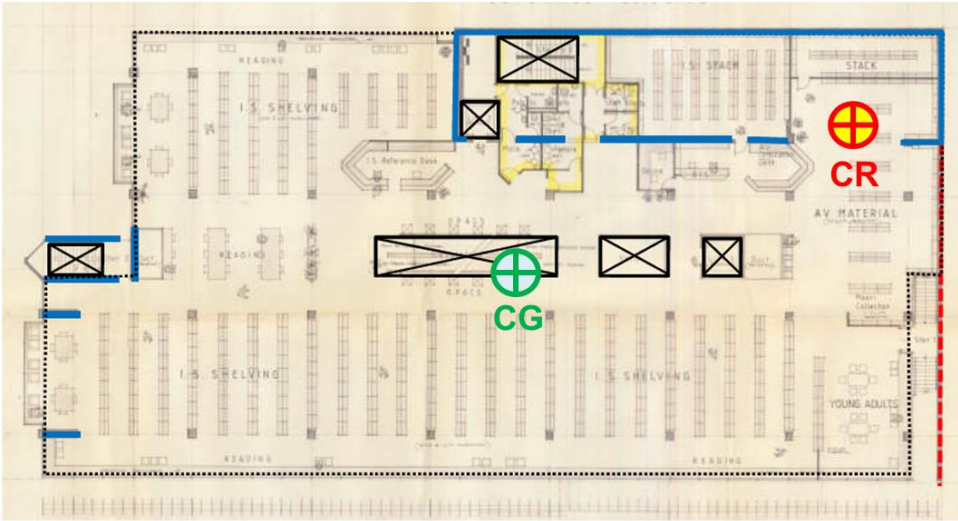
Figure 2.1: Floor plan

Stiffness and strength plan irregularities are not uncommon in New Zealand’s existing building stock. This has been highlighted in the tragic collapse of the Canterbury Television (CTV) building, the Pyne Gould Corporation (PGC) building collapse, and significant damage to the Grand Chancellor. The authors have assessed numerous other buildings with similar significant structural irregularities that experienced damage but no collapse. The floor plan below is from a four story concrete building located in Christchurch that was constructed in the late 1970s. This plan shows a large reinforced concrete core wall and a reinforced masonry wall at one end of the building. This unbalanced lateral resisting system results in a large eccentricity between the centre of mass and centre of rigidity and leads to a highly torsional building response, which was consistent with observed earthquake damage to the outlier walls, foundations, and contents. When assessed using NZS1170.5, we discovered excessive demands on the shear walls, diaphragms, and gravity columns, and identified this as an

earthquake prone building (less than 33% of the current building code).

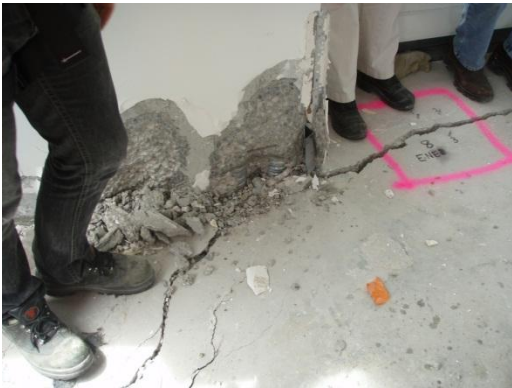
The authors have observed many buildings with a lack of proper consideration of diaphragm forces and a lack of robustness in precast concrete flooring systems. This includes reliance on wire mesh for shear reinforcement, lack of adequate shear transfer to vertical resisting elements, little to no consideration of collectors, and minimal seating area for precast floor units and consideration of lateral displacement compatibility. These problems are widespread in buildings assessed by the authors and have been discussed by others (Royal Commission 2012). These problems are well documented in the investigation and subsequent deconstruction of the Clarendon Tower. With typical precast floor details, the thin topping slab tore away from the perimeter moment resisting frame and the precast floor units shifted on their supports and in some locations were on the verge of collapse. The photo below shows a large crack in the topping slab at the interface of the perimeter moment frames.

Figure 5.1: Precast floor damage at Clarendon Tower

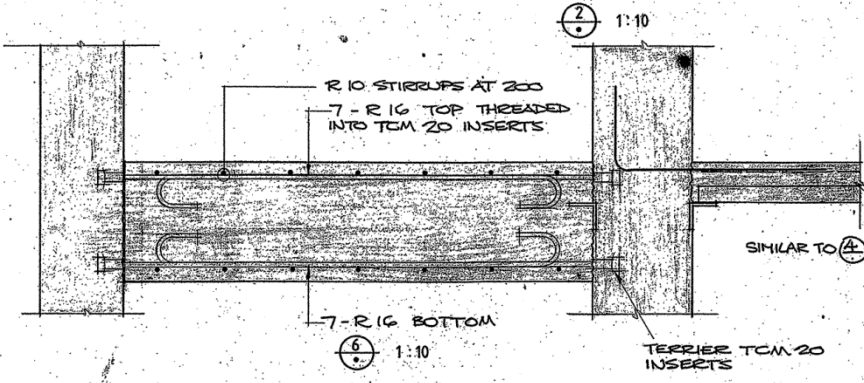
Given the popularity of precast concrete, there is a wide spread use of cast-in inserts and embedded steel plates for connections, and the authors have found many instances where they are used in critical load paths. They often do not have the capacity to meet the required demands nor develop the strength of the element attaching to them, which can lead to a brittle breakout failure of the threaded insert or embedded plate. This deficiency has been widely recognized and the SESOC Interim Design Guidelines have recommended cast-in inserts not be used for primary structural load paths. The detail shown below is an example where cast-in inserts were used to connect reinforcing steel to a cast-in place concrete wall. There are openings on either side of the wall and therefore the load path to one of the building's main lateral resisting elements is delivered entirely through these cast-in inserts. The capacity of the inserts was considerably undersized and we observed the beginning of a pullout failure.

Figure 5.2: Collector detail with cast-in inserts
