# GENERAL OBSERVATIONS OF BUILDING BEHAVIOUR DURING THE 8TH OCTOBER 2005 PAKISTAN EARTHQUAKE

Jitendra K Bothara<sup>1</sup> and Kubilây M O Hiçyılmaz<sup>2</sup>

## SUMMARY

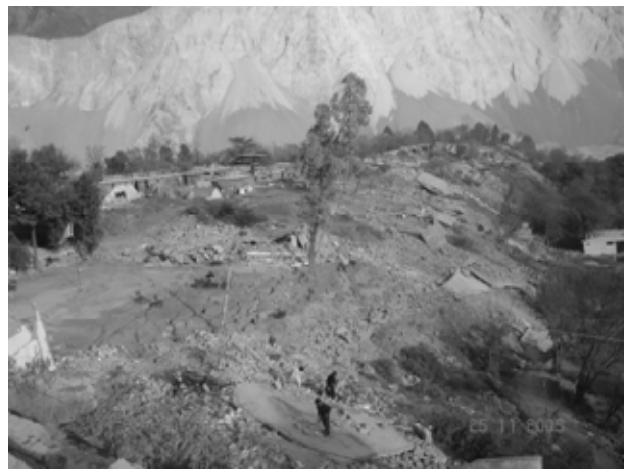
vertical component and 30-45 seconds of strong shaking. However, Figure 3 shows intense earthquake shaking just north of Muzaffarabad where the shaking caused total destruction of a military camp, soil spreading and landslide. Strong motion records in Abbottabad (35 km from the rupture zone), Murree (34 km), and Nilore (54 km) show maximum horizontal peak ground accelerations (PGA) of 0.231g, 0.078g and 0.026g, respectively; and vertical PGAs of 0.087g, 0.069 g and 0.03g, respectively (MAEC, 2005). A maximum horizontal PGA of 0.16g was reportedly recorded at the crest of the Tarbela Dam (located approximately 78 km distant) and 0.1g at the base, as was 0.1g at the downstream toe of the Mangla Dam (approximately 90 km distant) (Ilyas, 2005). However, it should be noted that the earthquake intensity showed directivity and rapidly attenuated with distance. There was virtually no destruction just 50 km away from the fault line, except in Abbottabad, where most of the damage was concentrated in the soft valley floor. According to Mahajan *et al* (2006), Muzaffarabad and Balakot, both severely affected areas, suffered seismic intensities of MMI XI and XI+, respectively.

Figure 3. Total destruction of a military camp north of Muzaffarabad. Note the roof slabs thrown off the buildings and an earthquake induced landslide in background across Neelum River. The landslide dammed the river.

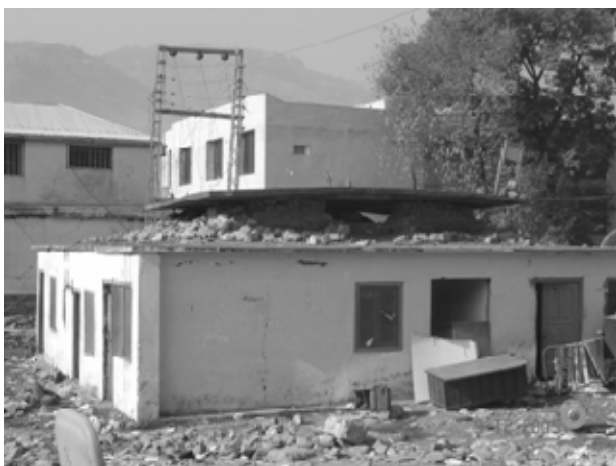
**Figure 4. Destruction of second storey of a stone masonry building without lateral displacement.**

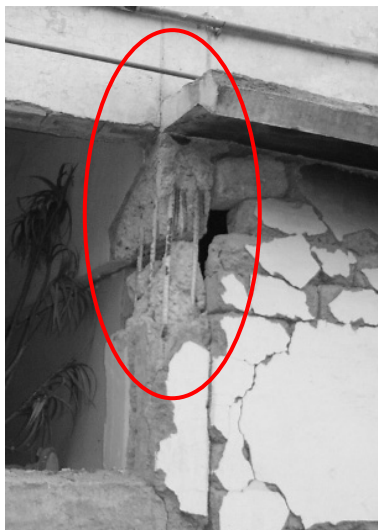
a). A failed column (note that there are not any stirrups for more than 700 mm).

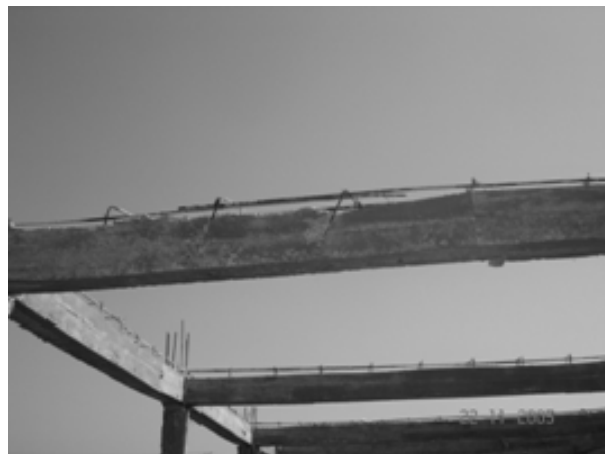
b). A typical reinforced-concrete frame building under construction. (Note: deficient lap length, splice location of column bars; the poorly compacted concrete, and the poorly built frame).

(Figure 11b). Proper construction of form work is rarely practised so that important cement fines leach out during concreting. The importance of adequate cover for durability is not practised or understood. Curing of concrete is still not practised as an integral part of the concreting process. There is generally a complete lack of understanding as to how reinforced concrete structures need to be detailed to give reasonably safe building behaviour during earthquakes. Figure 14c is a photograph of a floor slab in a RC frame building without reinforcement near its support, which was exposed when unreinforced part of the slab fell off during the earthquake. In the area, many buildings with first storey in masonry and upper one in reinforced concrete frame has been seen. Figure 14d shows a similar building. The columns of the second storey of this building started from the first floor slab and they were not continuous into the foundations. During the shaking, the bottom storey collapsed - leading to hanging of the columns above.

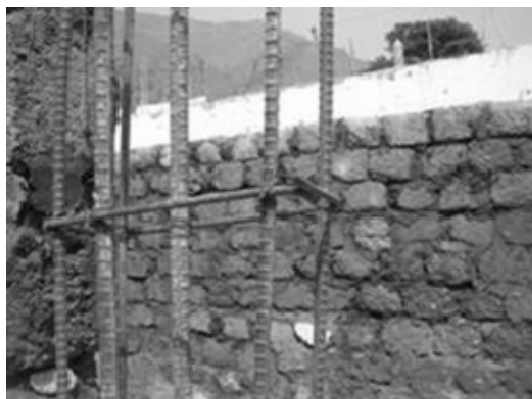
c). Open stirrup.

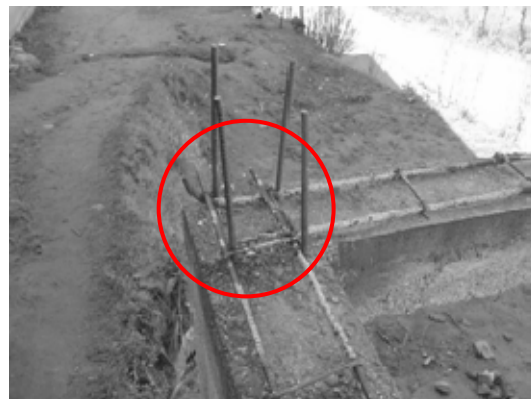
d). Anchorage of beam bars in column (note that there are not any hooks at the ends of bars).

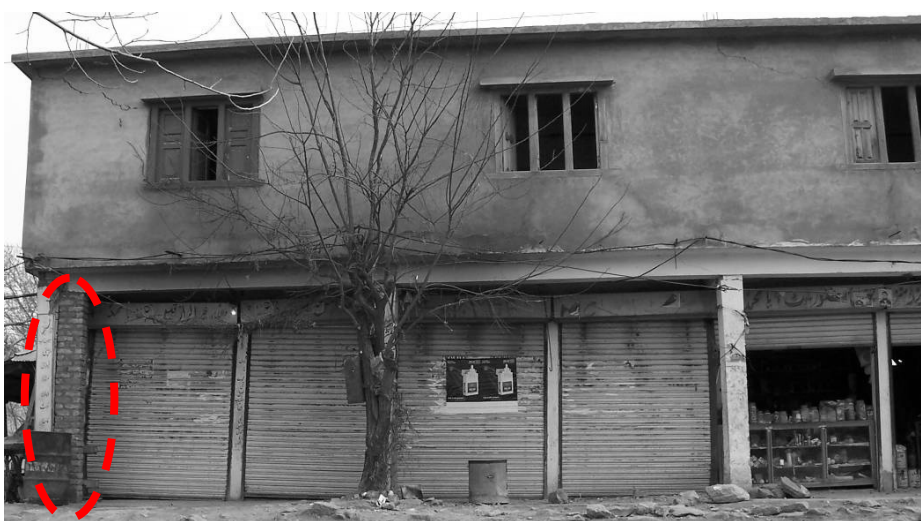
*Figure 12. Masonry columns instead of reinforced concrete column.*

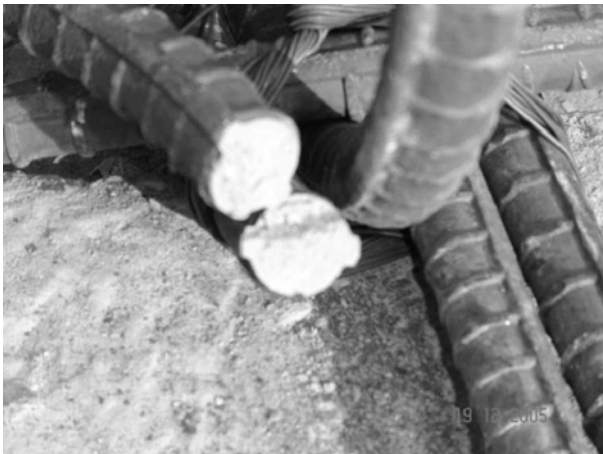
a). Snapping of reinforcement during bending.

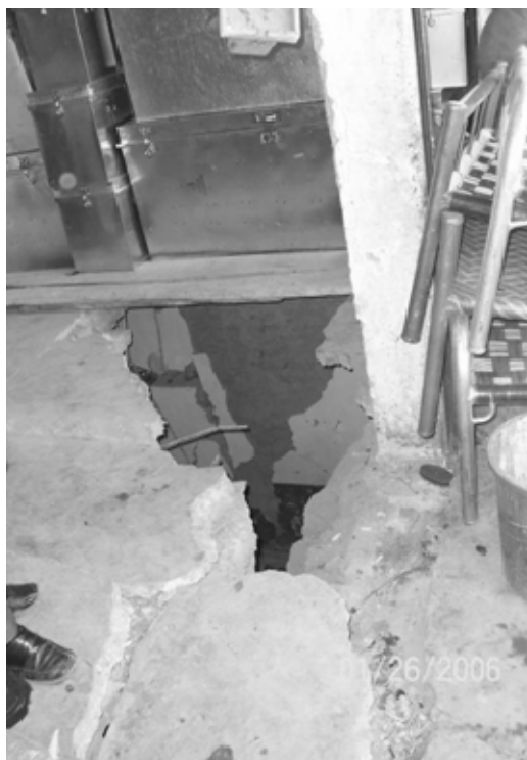
c). RC slab of second floor with almost no reinforcement.

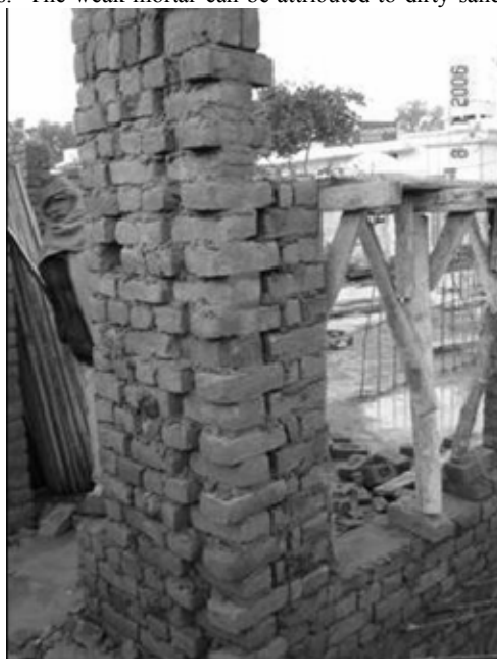
Similarly, from Figure 15a, which was taken after the earthquake, the deficiencies in masonry construction are evident. Thick mortar layers and non-filling of vertical joints are common in masonry construction (Figure 15b). It is normally accepted that plaster will cover these deficiencies. The mortar, in most cases, was so weak that it can be easily crushed with the fingers. It was not able to bind the masonry units together. The problem was more prominent in stone masonry buildings because of the smooth surface of the rubble stones. The weak mortar can be attributed to dirty sand, bad

a). Brick masonry house under construction (note the quality of masonry and keys for connection at the wall junction).

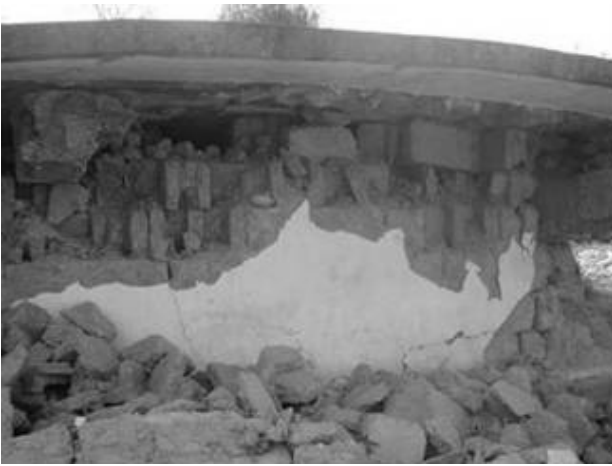
mixing, the use of a low cement: sand ratio (1:8 or so), and no curing of the masonry wall. The concrete blocks were far weaker than is acceptable (Figure 15c). It is expected that their compressive strength would be less than 6-7 MPa. Concrete blocks are of poor quality because of the poor quality of the concrete and aggregate, a lack of compaction and very little or no curing. Walls made from hollow blocks are neither reinforced nor filled with concrete to form reinforced block masonry walls as practised in many countries.

c). Hollow block masonry building (note the crushing of the block shell).

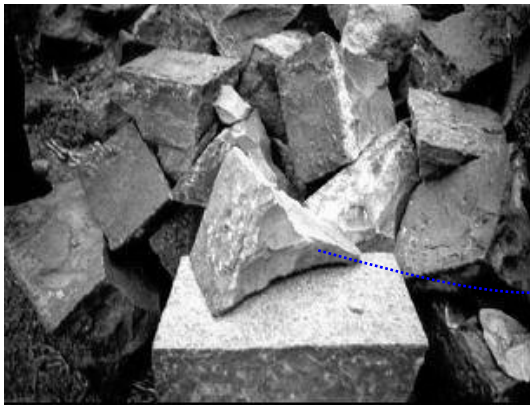
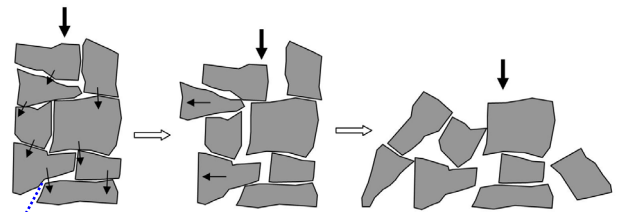
Figure 16a is a picture of wedge-shaped dressed stone ready for wall construction. These stone wedges make the wall very vulnerable to a catastrophic collapse mechanism. Figures 16b and Figure 16c show other deficiencies in the construction of stone walls or buildings.

a). Wedge-shaped semi-dressed stones for wall construction with sketch indicating likely failure mechanism.

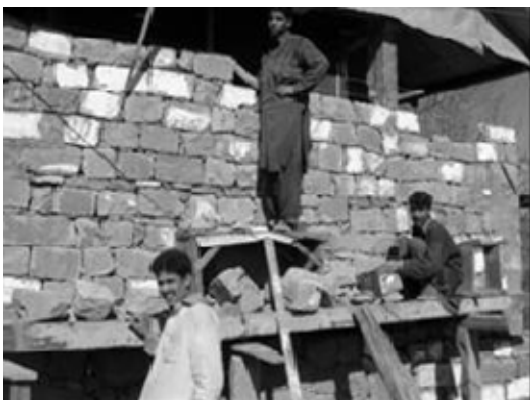
b). Semi-dressed dry stone wall construction after earthquake (also, very tall).

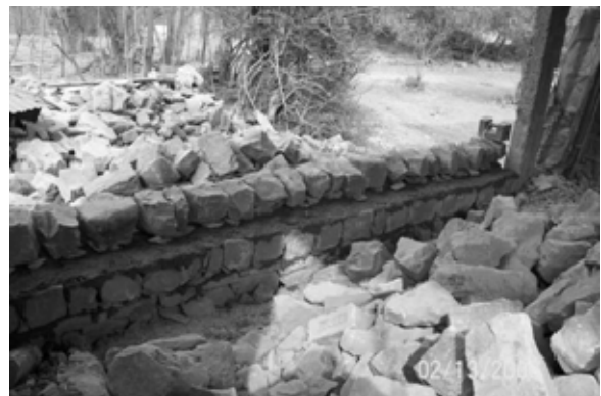
c). Undressed stone wall laid in mud mortar (note that there are no through-stones).

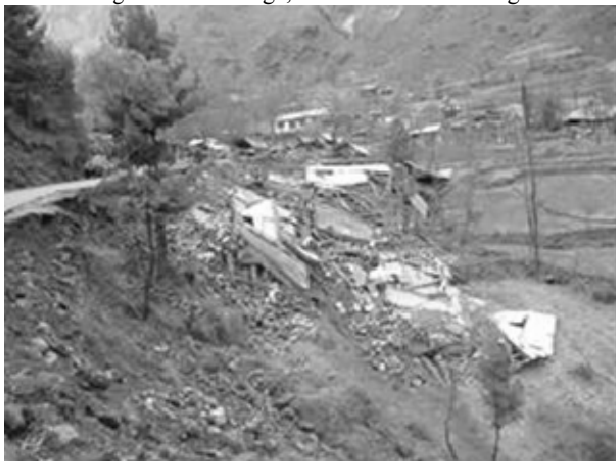
a). Total destruction of buildings constructed on the slope.

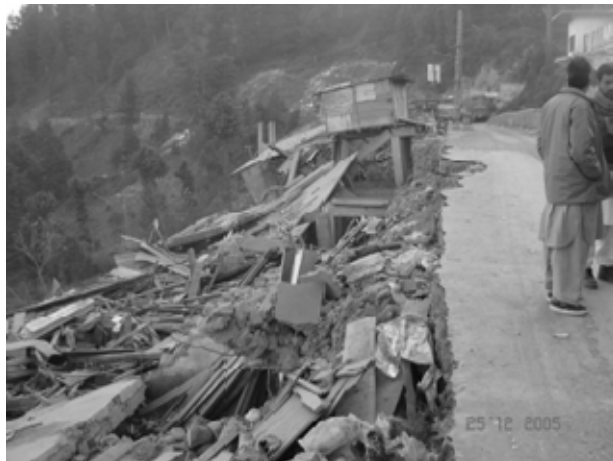
b). Destruction along the slope.

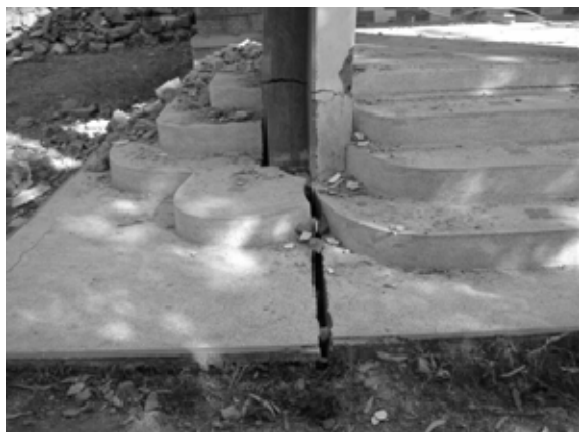
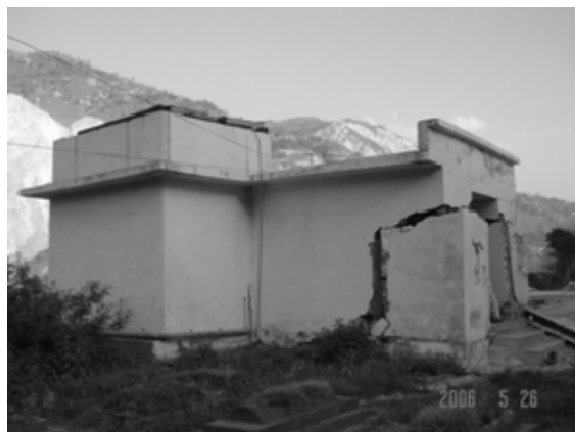
affected building performance. Figure 18 shows effects of soil-spreading on buildings.

*Figure 18. Expression of soil spreading in the form of cracks in floor and walls of houses.*

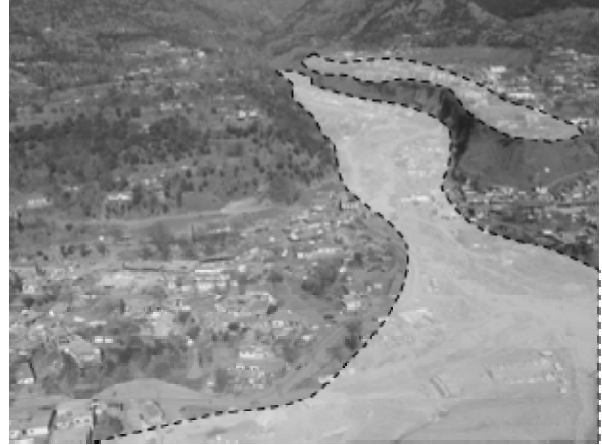
b). Flooding, rockfall and landslide hazard, Bagh, PAK.

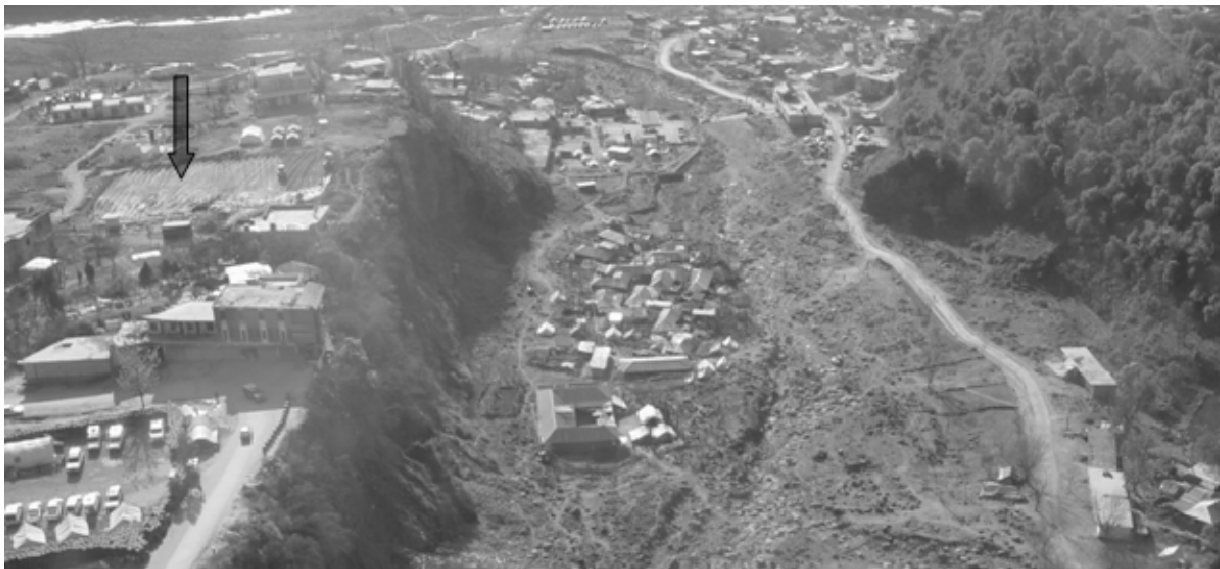
c). Cliff edge, falling hazards, flood plane in Bagh, AJK (site being prepared for a hospital, early 2006).

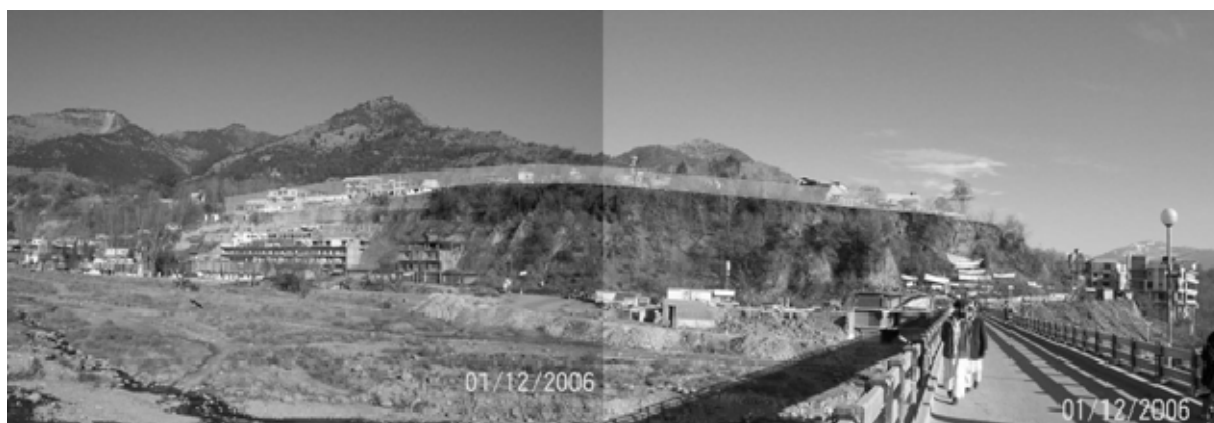
**Figure 20.** Entire Bagh town edge is built next to unsupported, unstable ground.

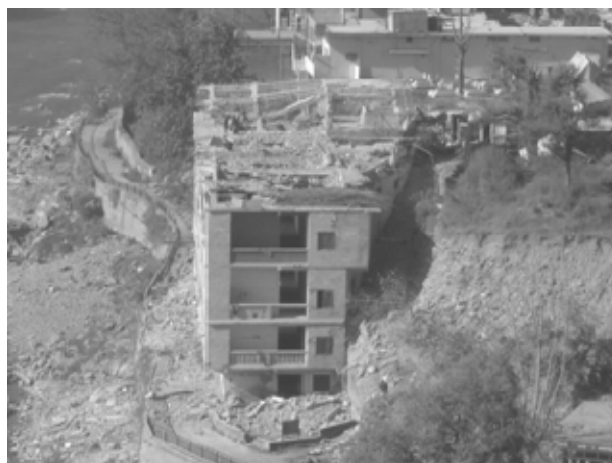
**b).** Six-storey building abutting hill slope, bottom four storeys abutting hill slope suffered minor to medium damage, whereas top two storeys suffered severe destruction (upper storey under demolition after the earthquake).

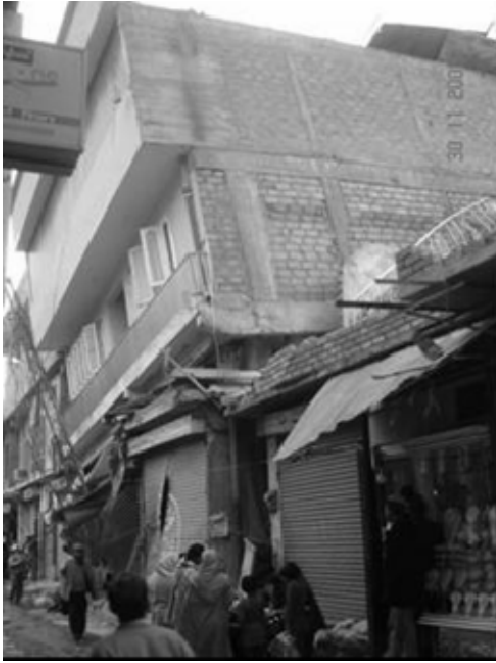
Existing configuration problems and mixed structural systems played a major role in the failure of many buildings. Many reinforced concrete frame buildings suffered soft or weak storey failures because of open ground floors and infill walls in upper storeys (Figure 22a). Interestingly in Rawalakot, relatively less affected area, the third storey of two buildings that connected these two buildings together totally collapsed (Figure 22b) presumably due to out of phase shaking of the buildings. Columns of the first storey also suffered damage in

a). Soft-storey failure.

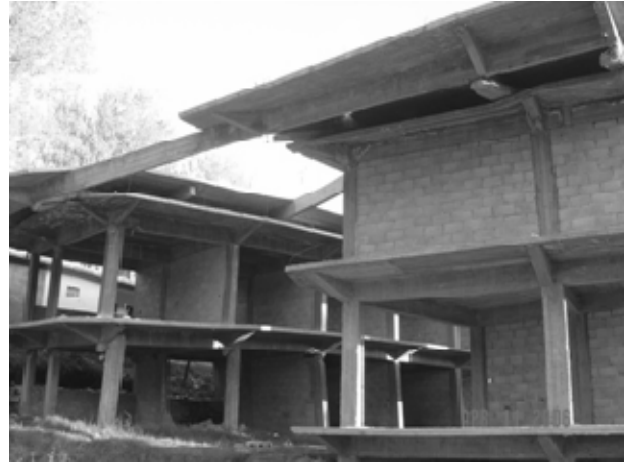
b). Collapse induced by connection of two buildings together.

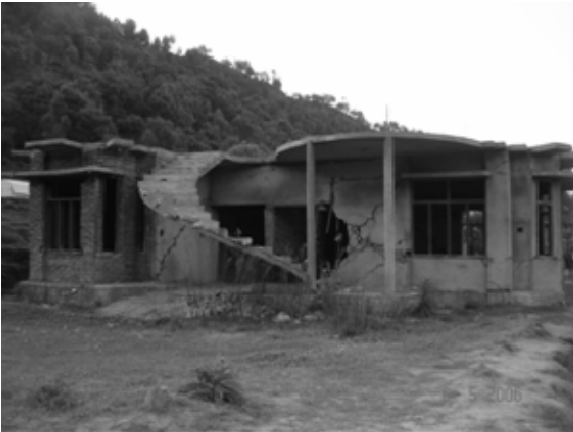
one of the building dislocating the building. Figure 22c shows a picture of a one-storey residential house in Bagh with rooms on the left-hand side and a large, open lounge on the right-hand side. The small rooms on one side and a large lounge on the other made the house torsionally active. This led to severe damage on the right hand side whereas the left side hardly suffered much damage. Figure 22d shows a stone masonry building where a wall collapsed because of the location of the opening in the corner. Because of the opening, there was no return wall to hold the wall together.

c). Torsional damage.

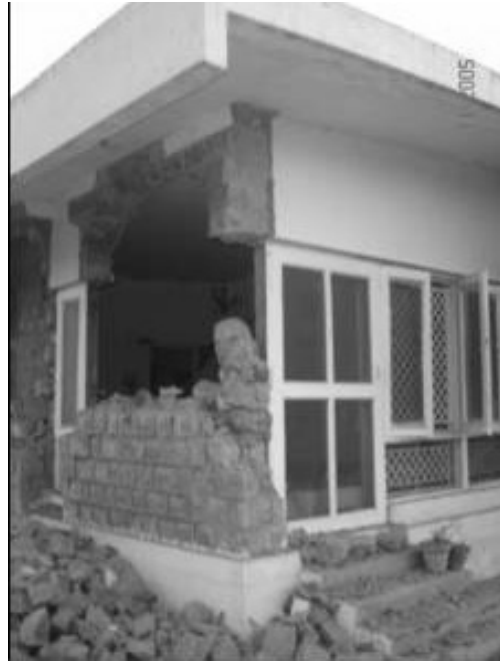
d). Opening in corner-induced damage.

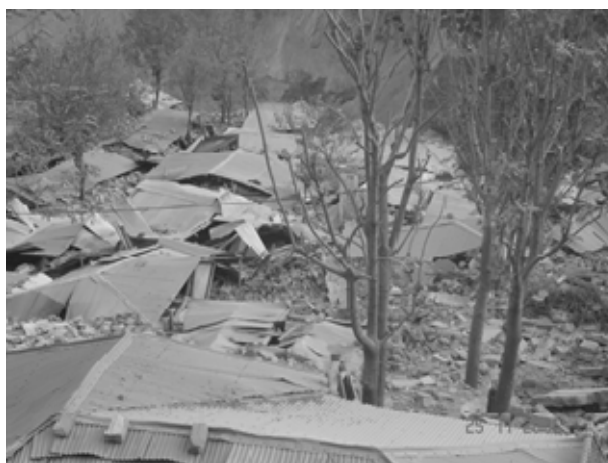
*Figure 25. A flattened village.*

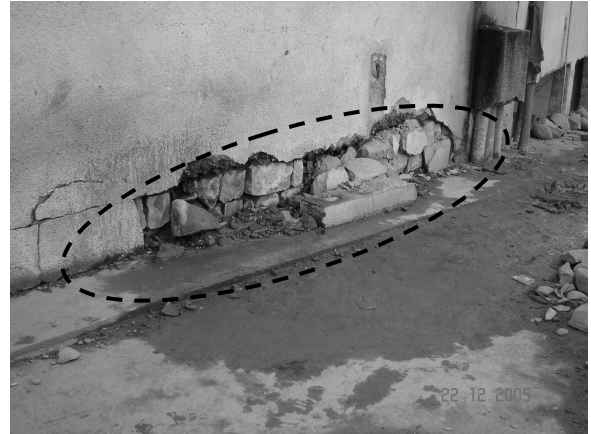
d). Onset of mechanism failure.

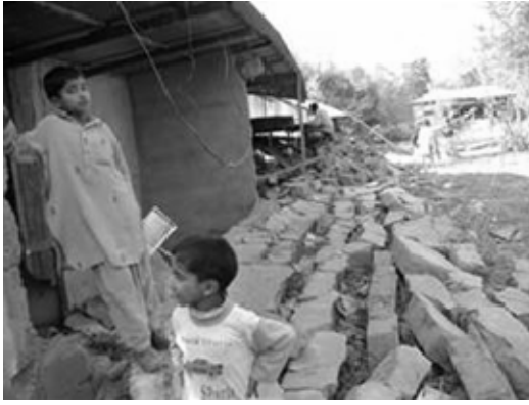
a). Out-of-plane failure of a block wall.

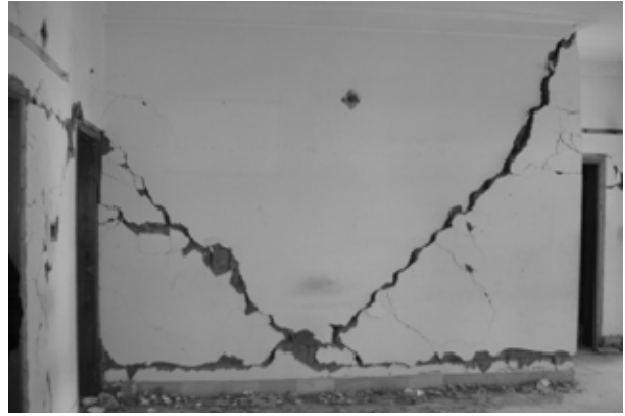
b). Diagonal shear and sliding failure of a brick wall.

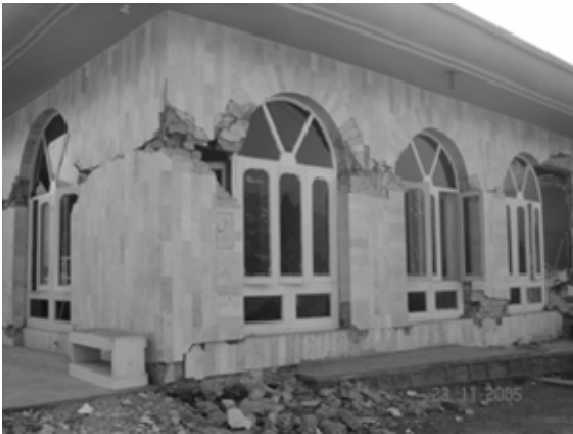
c). Rocking of brick-masonry piers and toe failure at top and bottom.

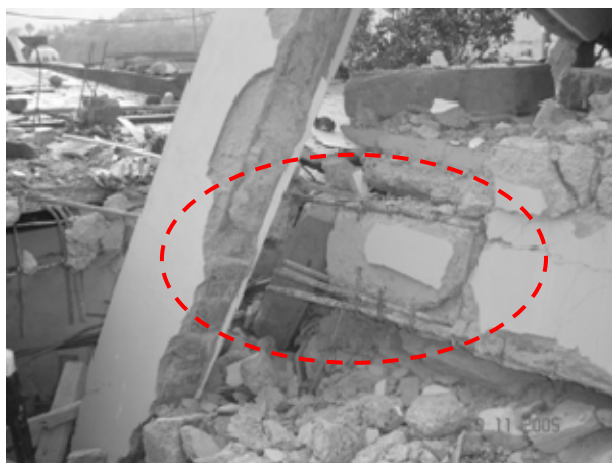
b). Anchorage failures of beam bars.

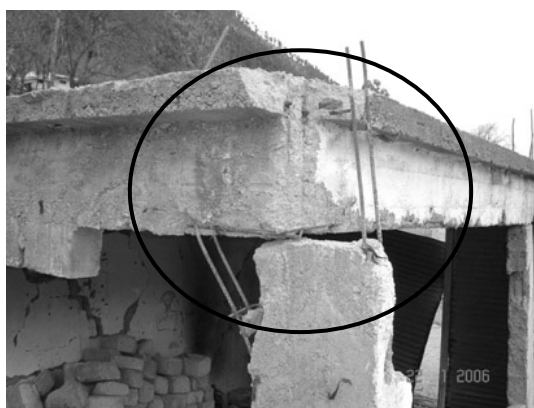
c). Cold-joint problem.

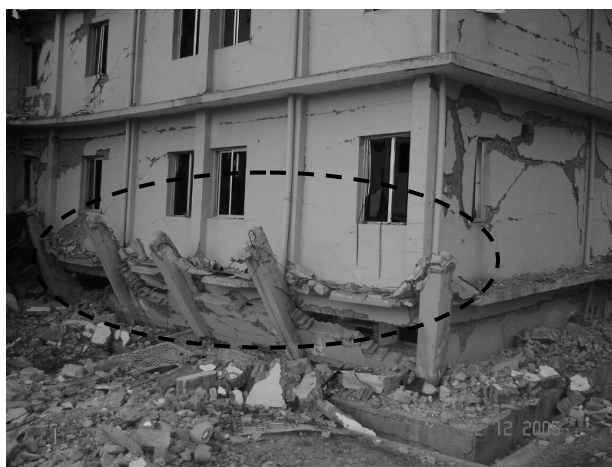
d). Shear failure of first storey columns.

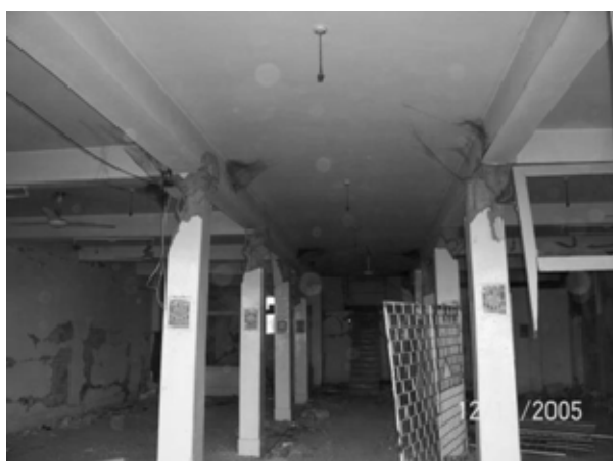
e). Initiation of plastic hinging of columns.

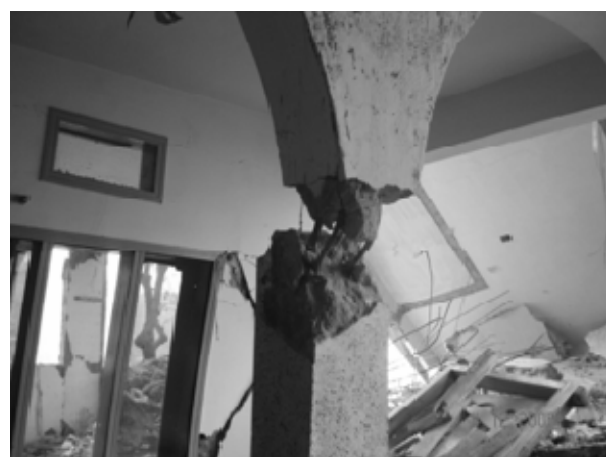
f). Failure of column due to sudden change of stiffness.

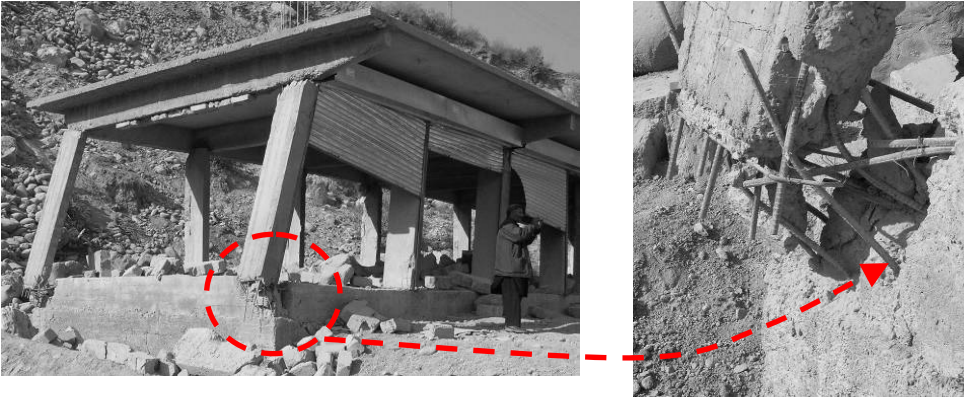
**g). Deficient lap length, and very poor lap location leading to partial collapse of the building.**

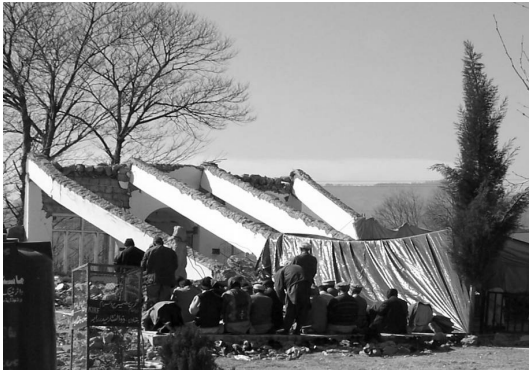
*Figure 31. Strong beams weak joint and columns.*

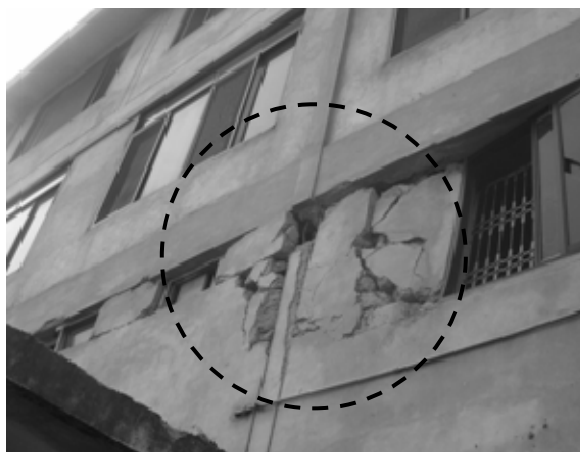
a). Building being supported by infill walls after failure of column.

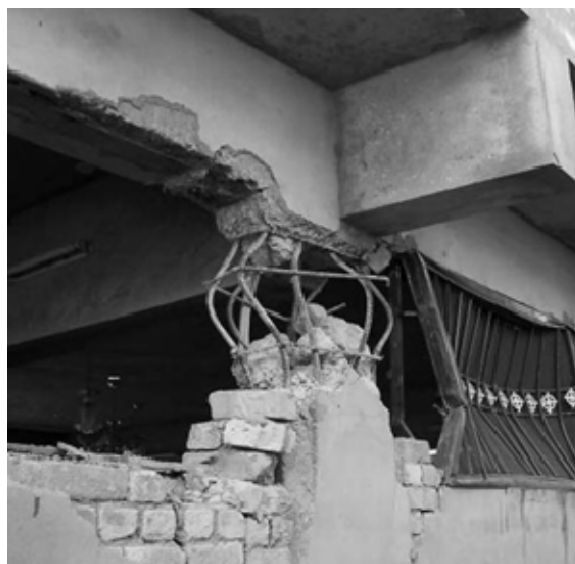
b). Short-column effect due to partial height masonry – surprising that the bars have not fractured.

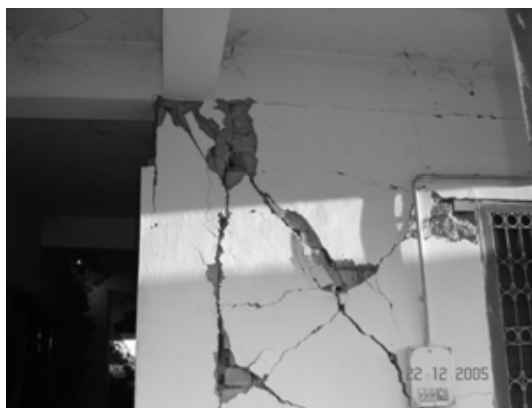
c). Failure of column due to shear forced by infill wall.

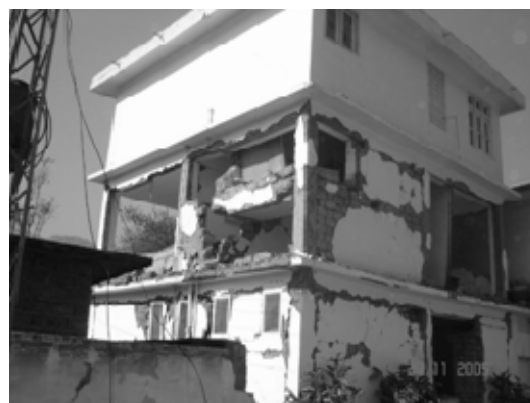
d). Onset of development of soft-storey mechanism.

Figure 32d is a picture of a building where the top storey virtually suffered no damage, whereas most of the damage is concentrated in the second storey. It is on the onset of a soft-storey mechanism. Out-of-plane failures (Figure 32e and Figure 32f) were common because of a lack of connection between frame and wall.

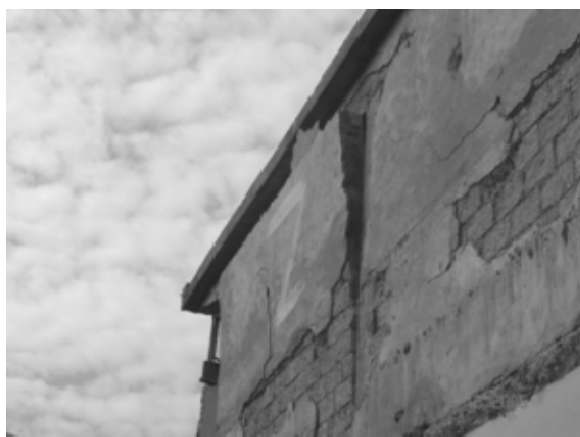
e). An infill wall on onset of out-of-plane failure in RC frame building.

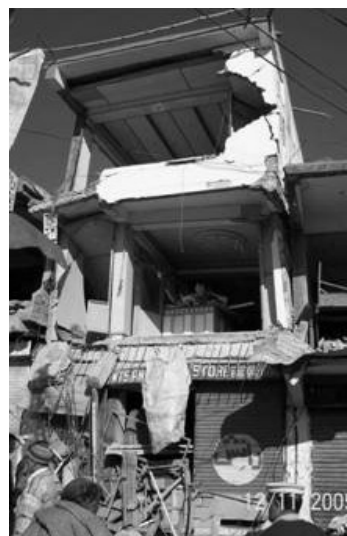
f). Out-of-plane failure of masonry in RC frame building.

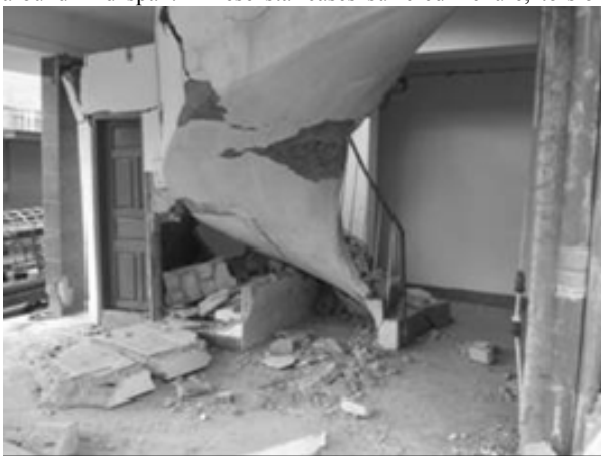
Spiral staircase (Figure 35a) suffered most of the damage around mid span. These staircases suffered flexure, torsion

a). A spiral staircase.

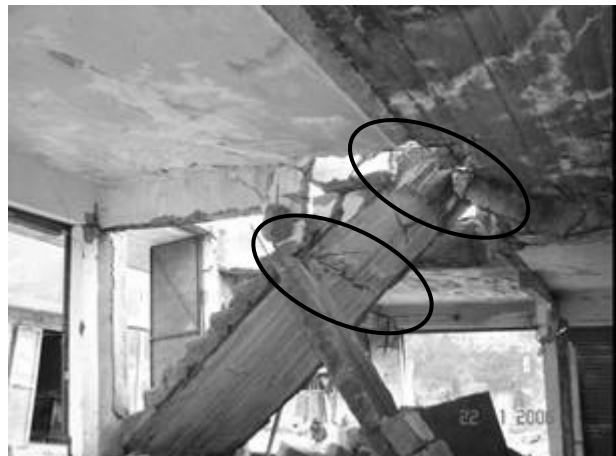
b). Failure due to ending of waist slab and puncture of the floor slab

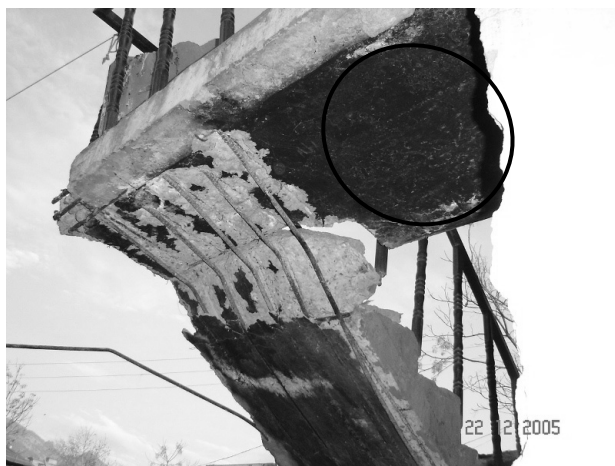
c). Ripping off of the waist slab reinforcement..

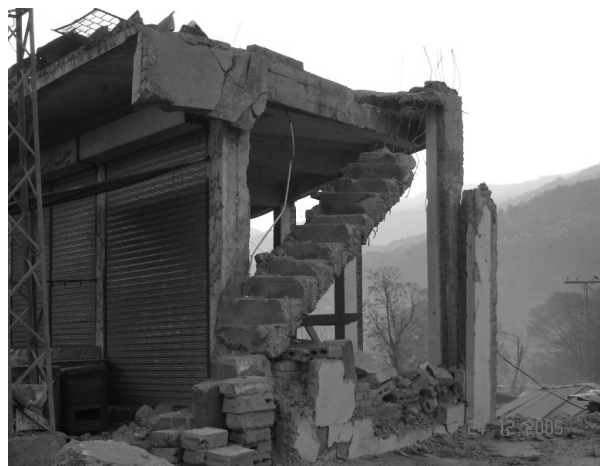
d). Broken waist slab (hanging by reinforcement)

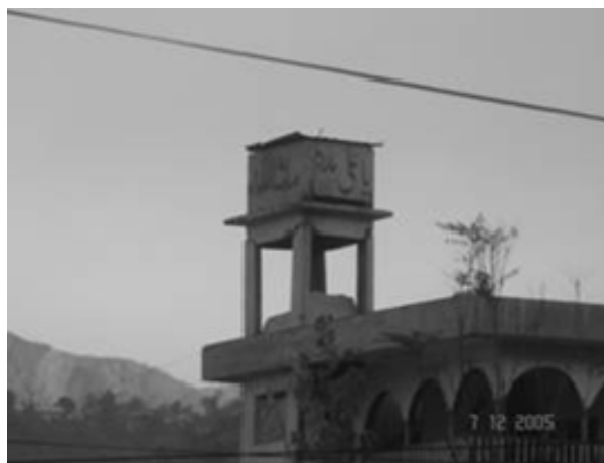
a). An elevated water tank in Muzaffarabad (note development of cracks at the top of columns).

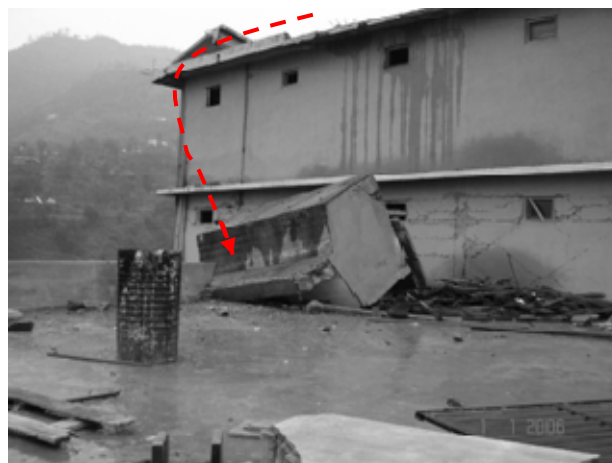
b). A water tank supported on two columns in Muzaffarabad that fell on neighbouring building.

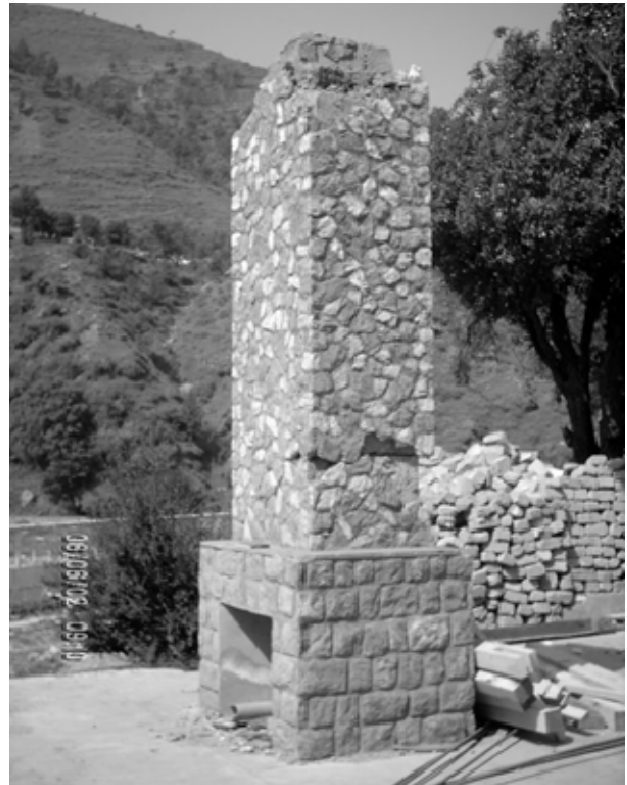
A fireplace chimney (Figure 37b) shows signs of a rocking failure. The chimney survived, although all the building structure around it collapsed.

b). A fireplace chimney.
