ENGINEERING SEISMOLOGY

W. R. Stephenson*

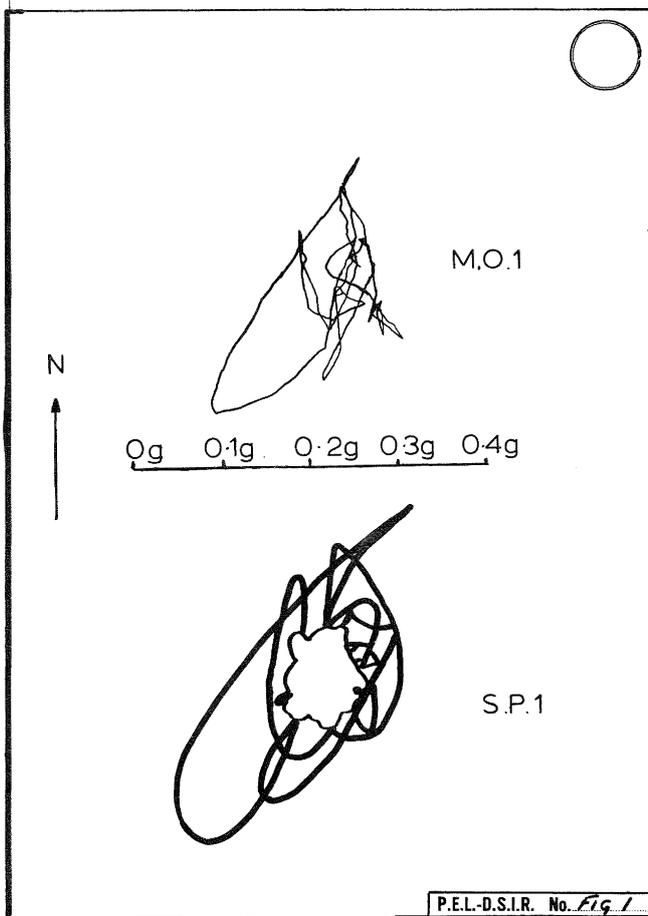
The aftershock that occurred at 12:45 GMT on June 5 gave the first direct comparison of a 3-component time base accelerograph (M01) with the simpler scratch-plate horizontal accelerograph (SP 1) developed at Physics and Engineering Laboratory. Figure 1 shows both the SP1 record, and its equivalent derived from the M01 at Westport Post Office. The scratch-plate type of instrument

gives a good idea of the number and direction of impulses, but only an approximate idea of their magnitude.
