# THE 1968 INANGAHUA EARTHQUAKE AND ELECTRICITY SERVICES

H. C. Hitchcock, B.E. (Hons.) M.N.Z.I.E. M.I.E.E.

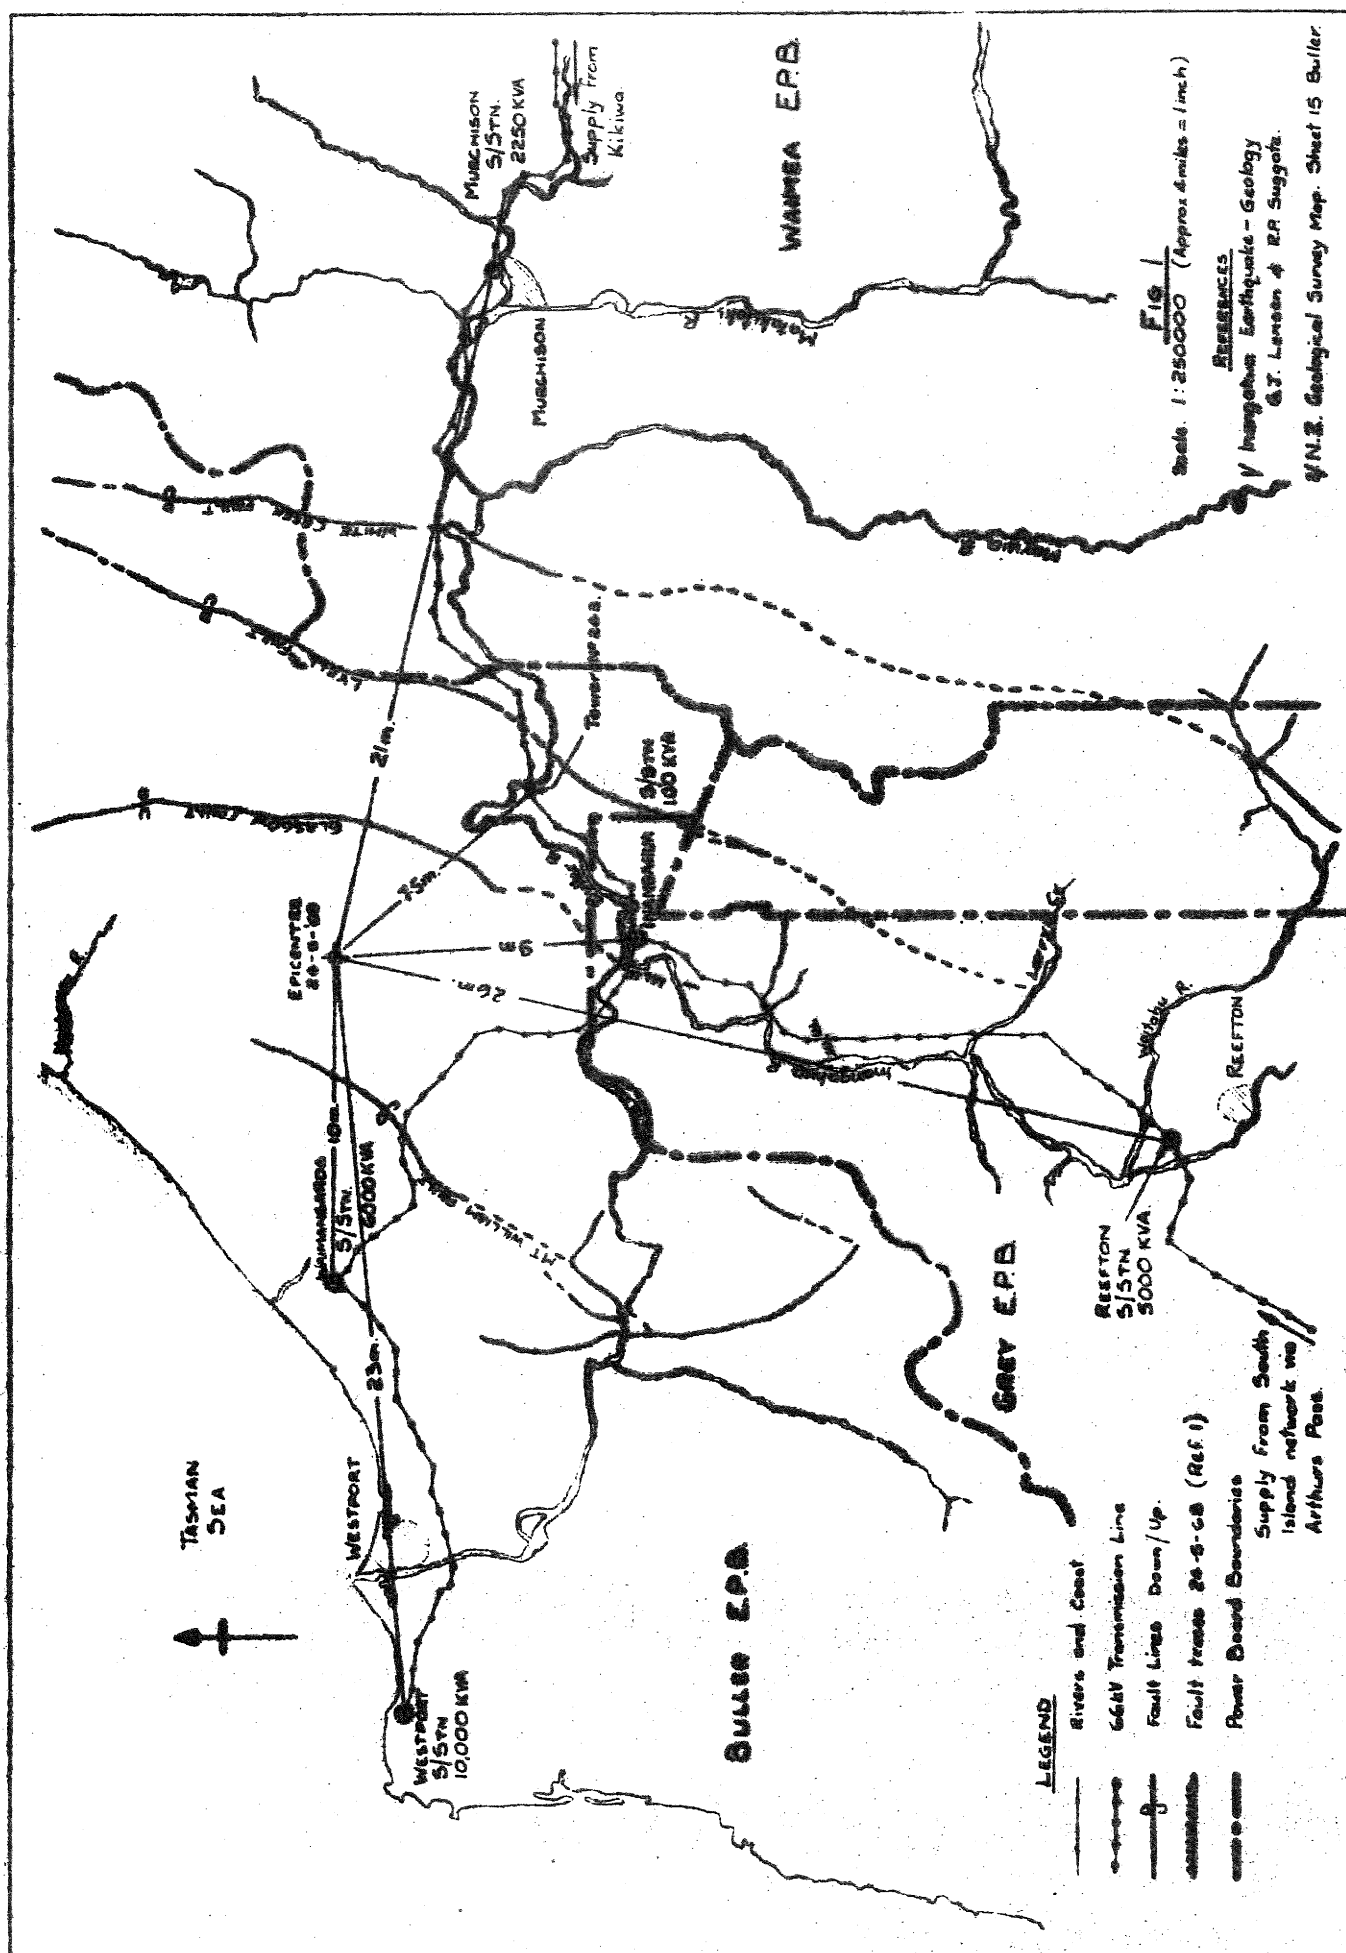
Earthquake loads on such structures are insignificant and the only real risk of failure is from disturbance to foundations. Fig. 2 shows how nearly this occurred in the Upper Buller Gorge near Lyell - at a point only 7.5 miles from the epicentre. The worse damage to towers themselves was on top of a ridge of poorly consolidated alluvial material near Dee Creek 2 miles north of Inangahua. The upper levels of the ridge were disintegrated with the violence of the shaking and the disturbance of the grillage footings was so great that an angle leg was fractured. Many towers were distorted to a lesser degree but none failed in service.

- (1) Anti-earthquake design of transmission lines consists primarily of selecting tower sites least likely to be affected by earthquakes. The advice of a geologist was sought in selecting routes for deviations made necessary by ground failures in the Buller Gorge.
- (2) The damage to battery and control panels emphasizes that earthquakes design must attend to minor detail with great care if major provisions are not to be nullified.

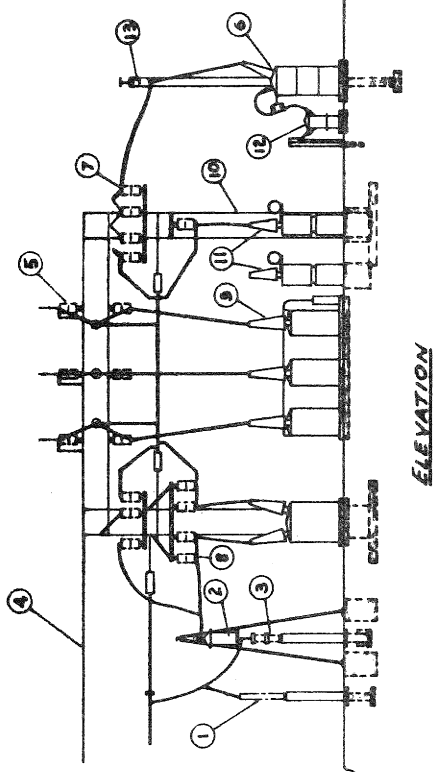
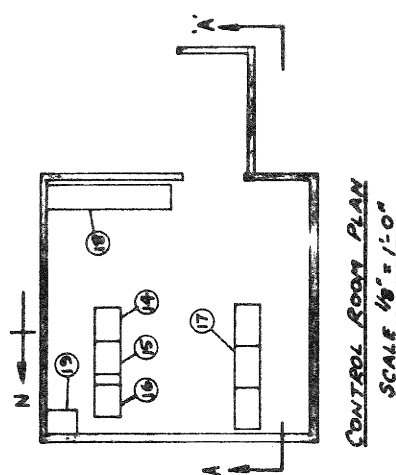
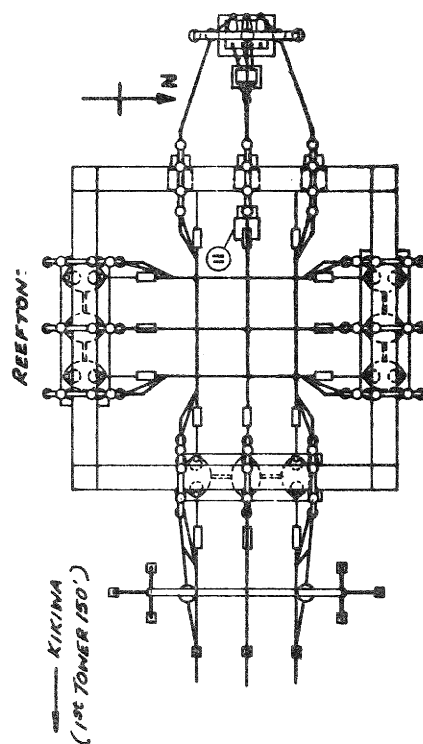
SWITCHGEAR & STRUCTURE PLAN

Inangahua Substation (Fig.3) was 9 miles from the epicentre but was in the zone of maximum ground damage and shaking.

In the small control building the station battery and the control, relay and communications panels were overturned because of inadequate fastening.

In the outdoor switching station the lattice steel switching structure was undamaged and its foundations undisturbed as were the bulk oil type circuit breakers and their foundation slabs. Three of the 66 kV insulator stacks in the airbreak switches were snapped off because jumpers did not have enough slack to allow for relative movement between the steel structure and adjacent equipment. The broken insulator stacks swung down on the ends of the jumpers and damaged the transformer neutral bushing and the support insulators for the power line carrier coupling capacitors.

- (3) The damage caused by tight jumpers repeats experience at Napier in 1931. The "earthquake release clamps" devised at that time were found unsatisfactory because they gave trouble in storm conditions and became increasingly difficult to design for higher current ratings. It is a continuing challenge to engineering ingenuity to devise connections which are tidy and will not clash in the wind but which allow earthquake movement.
