3. HASTINGS BOYS' HIGH SCHOOL
ADMINISTRATION BUILDINGS,
HASTINGS, HAWKE'S BAY, NEW ZEALAND

I.J. Garrett*

Client: N.Z. Department of Education

Consultant Services by Ministry of
Works and Development

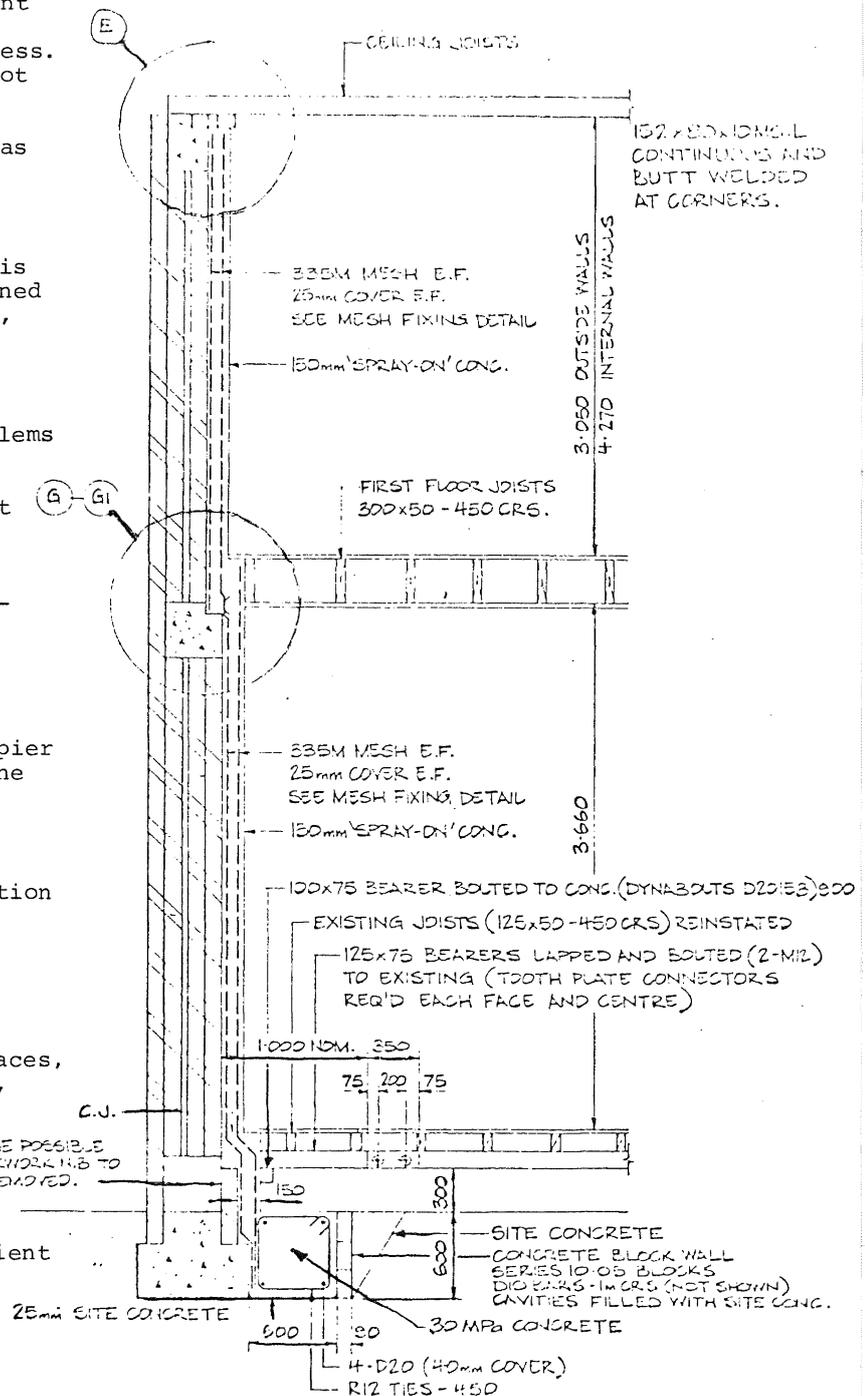
TYPICAL SECTION - 150mm 'SPRAY-ON' CONG.

The structure was strengthened for in-plane and face loadings by forming reinforced concrete walls, using sprayed concrete, on inside faces of the existing walls. Footings were widened at the base, in poured concrete to spread the load of the extra weight added to the buildings. A poured concrete beam was also provided at first floor level. (see Typical Section attached).
