CASE STUDIES: EARTHQUAKE RISK BUILDINGS

1. STRENGTHENING OF STATE TRINITY CENTRE, CHRISTCHURCH

D.S. Evans*

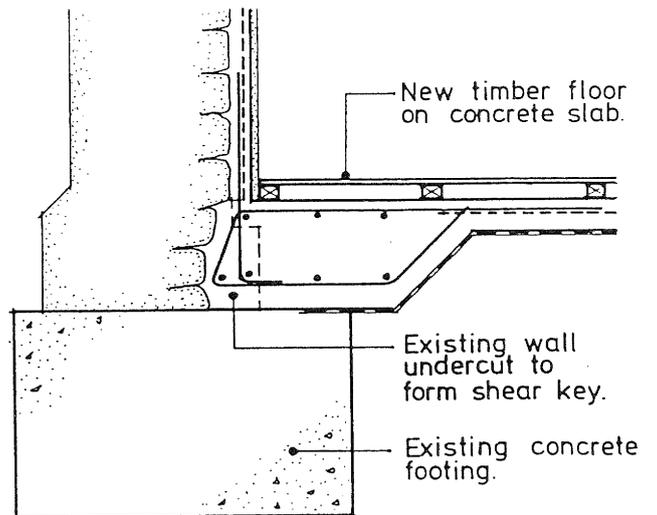
WALL STRENGTHENING DETAILS

Internal stone wall faces were plastered - on one side solid plaster approximately 50 mm thick and on the other lath and plaster with plaster face approximately 100 mm from stone face. It became apparent that if the plaster was removed and 75 mm of reinforced high-strength shotcrete attached to the stone walls we could achieve a strong box-like structure with channel-shaped walls at the side of the octagon (transept walls) possessing good shear and flexural strength. By temporary removal of some of the stonework at the top of the walls we could cast an in-situ tie band around the perimeter. At the front of the gallery we could place a tie across the width of the nave hidden within the gallery railing and an attempt could be made to apply a small compressive stress in the tower stone walls by installing a "pre-stressing system" from tower roof to foundation level.

Walls were then stripped of plaster and pockets formed on a 1.5 metre grid so as to enable the stonework and new concrete walls to be tied together. Forming of pockets effectively dovetailed was not difficult. Mesh was fixed over the face of all walls and additional trimming bar reinforcing placed around all openings. Because of the difficulty in cleaning the stonework of plaster dust and very loose mortar it was decided to steam clean the walls. This was most effective and produced an excellent surface for the shotcrete to be applied to. (Important to notify the Fire Brigade before commencing!) 75 mm of shotcrete was then applied to the walls and they were later hand-plastered. In stages an in-situ band was cast to tie walls at high level. Truss joints were strengthened by addition of bolted steel side plates. Most joints being different necessitated
