EDGECUMBE EARTHQUAKE — SOME NOTES ON ITS SOURCE, GROUND MOTIONS, AND DAMAGE IN RELATION TO SAFETY

by David J. Dowrick

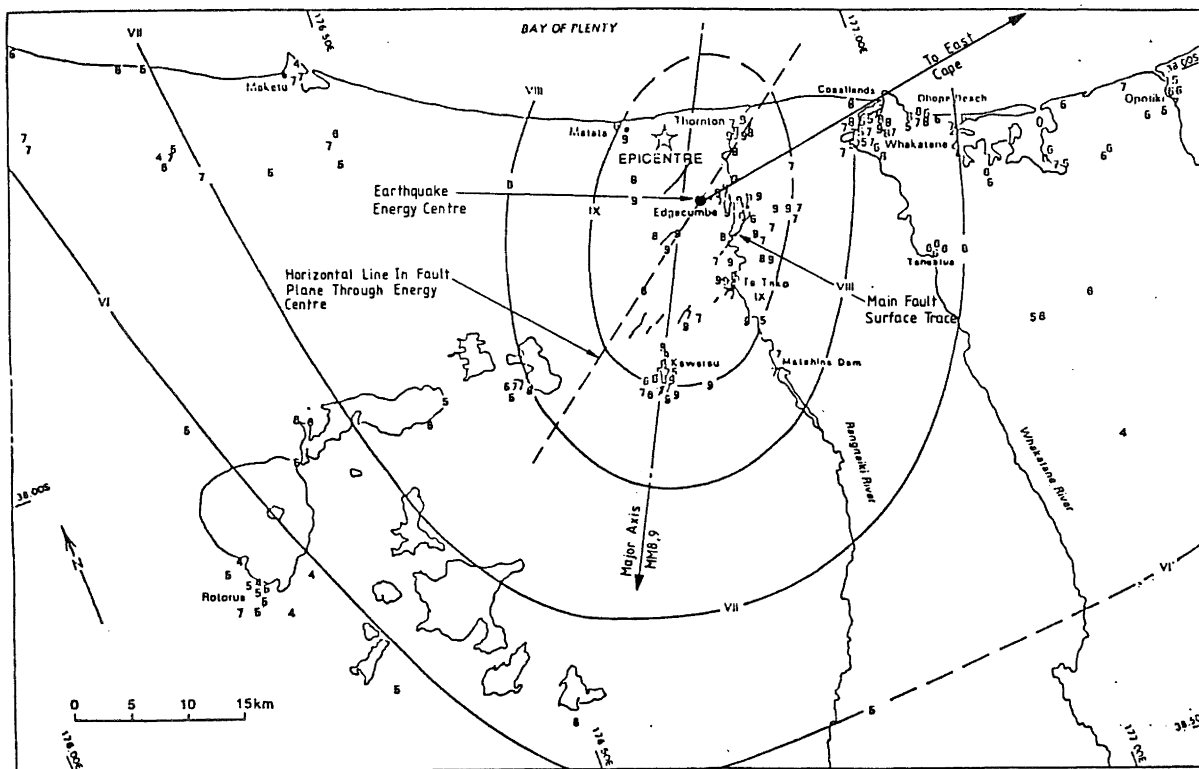
As shown in Figure 1, surface deformation included multiple surface breaks with the main surface rupture being 7 km long with a maximum vertical displacement of 2 m. The latter displacement was essentially downthrow, with no transcurrent displacement. Establishing the size and shape of the fault rupture surface is difficult to do with certainty, but studies by Darby [2] show that the rupture surface would have an area of about 100-120 km² and that the main fault plane would dip at an angle of about 39° to the horizontal. A focal depth of 8 km implies that the bottom of the rupture surface was 8 km below the Rangitaiki Plains.

Figure 1, adapted from Lowry et al [3], is a map of isoseismals showing intensity on the Modified Mercalli (MM) scale. The inner isoseismal pattern is fairly symmetrical, with the strongest isoseismal being MM9. As would be expected from a non-vertical fault plane, neither the surface trace of the main fault nor the epicentre lie on the major axis of the inner isoseismals.

FIGURE 1. STRONG MOTION AREA SHOWING EPICENTRE, FAULT RUPTURES, INTENSITIES, ISOSEISMALS, ENERGY CENTRE, FAULTING (ADAPTED FROM LOWRY ET AL, REF 3).

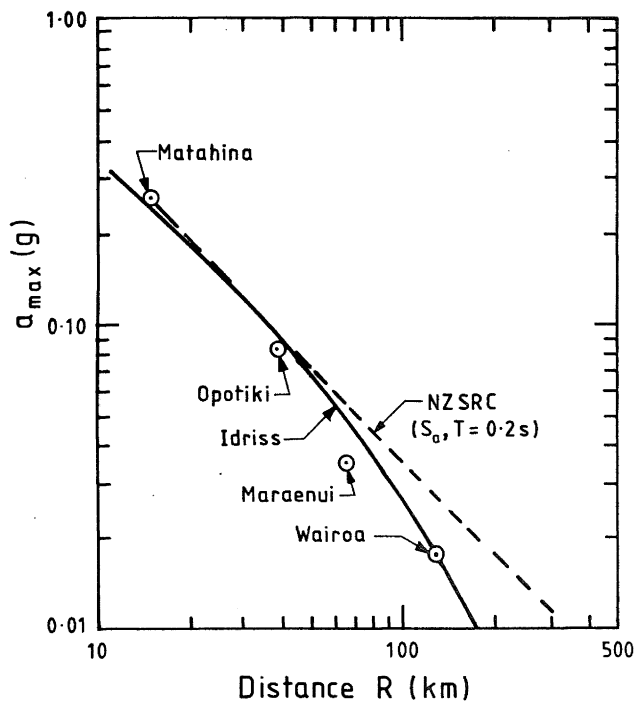
peak ground accelerations from the 1968 Inangahua earthquake [6]. The level of this line on Figure 2 has been arbitrarily set to start from the field data point for Matahina dam.

Both the Idriss and NZSRC curves fit the data points quite well, particularly the former. The standard deviation of the $\log_1 a$ values for the four data points in relation to Idriss's curve is 0.08, which is less than half the residual standard deviation of 0.165 found by Idriss for his data set. No comparable significance test of the fit of the NZSRC curve can be carried out, as only its slope is known.

FIGURE 2. ATTENUATION OF PEAK GROUND ACCELERATION FOR EDGECUMBE EARTHQUAKE, COMPARED WITH NEW ZEALAND AND WESTERN USA MODELS.

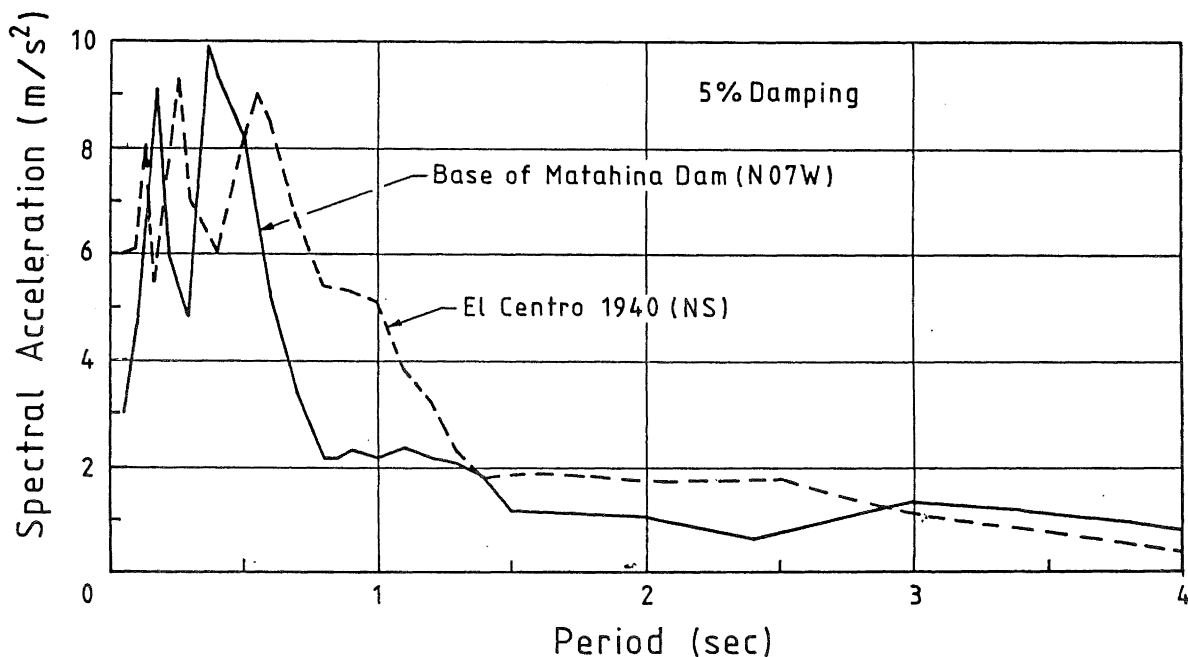
The ground shaking at the base of the Matahina Dam was the strongest acceleration history so far recorded in New Zealand, and was similar in strength to the El Centro 1940 earthquake record which has long been used as a basis for design loadings in this country. This is evident from a comparison of response spectra from these two records as plotted on Figure 3. It follows from Figure 1 that much of the area inside the (undrawn) MM8.5 isoseismal experienced shaking equal to or greater than the code design level for Seismic Zone A, our

FIGURE 3. ACCELERATION RESPONSE SPECTRUM FROM GROUND MOTIONS AT THE BASE OF MATAHINA DAM COMPARED WITH EL CENTRO 1940 (AFTER DOWRICK, REF. 8)

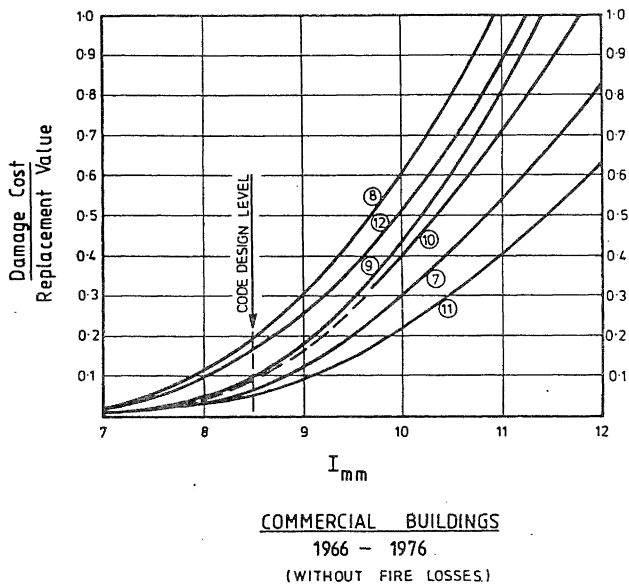
The degree of damage that we should expect near the centre of earthquakes such as Edgecumbe is indicated by the damage ratios plotted as functions of I_{mm} in Figures 4 and 5, where damage ratio^{mm} is the cost of the damage divided by the total value of the building (or other item) concerned. It can be seen that damage ratios between about 4% and 60% would be the norm for $8 \leq I_{mm} \leq 10$, depending on the type and age of structure, but as the curves are of mean values, damage ratios up to 100% (ie total write-offs) would not be exceptional (for

The damage ratios in Figures 4 and 5 are not directly comparable because they define the total values of the buildings differently. It should also be noted that the curves on Figures 4 and 5 are highly uncertain because of the scarcity of data, both world-wide and especially for New Zealand construction. This is especially true for the curve for post-1977 reinforced concrete construction on Figure 5, for which of course there was no New Zealand damage data available at the time of that study. Hence this curve was inferred entirely from overseas experience. The relationship between the Birss 1836-1877 and post 1977 curves is unsatisfactory; the two curves should be much nearer the same for about $I_{mm} < VIII$, ie at response levels less or not^{mm} much greater than the elastic limit, as the main difference in the damageability of structures of these two eras is in their post-yield performance.

FIGURE 4. DAMAGE RATIOS FOR NEW ZEALAND COMMERCIAL BUILDINGS (AFTER DOWRICK, REF 10) .

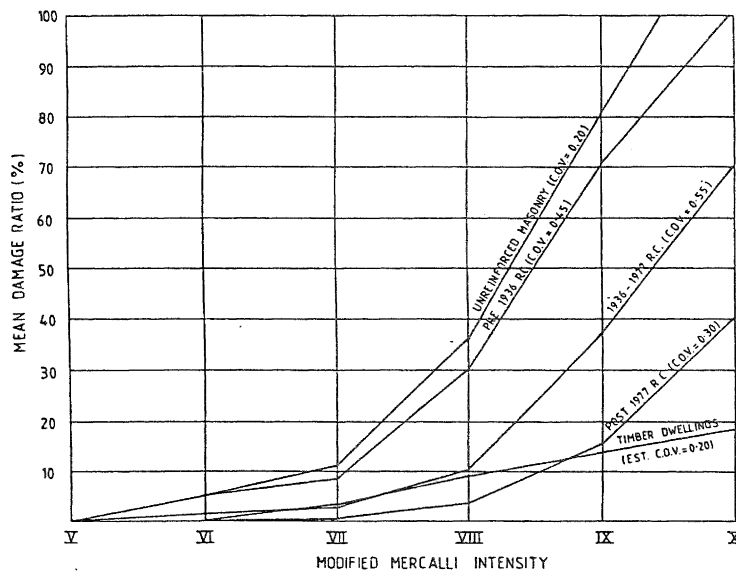
FIGURE 5. DAMAGE RATIOS FOR NEW ZEALAND BUILDINGS (AFTER BIRSS, REF 11).
