RECONNAISSANCE FIELD INVESTIGATION OF THE LANDERS EARTHQUAKE (M_s 7.5) OF JUNE 28, 1992, SAN BERNADINO COUNTY, CALIFORNIA, USA

Kelvin Berryman

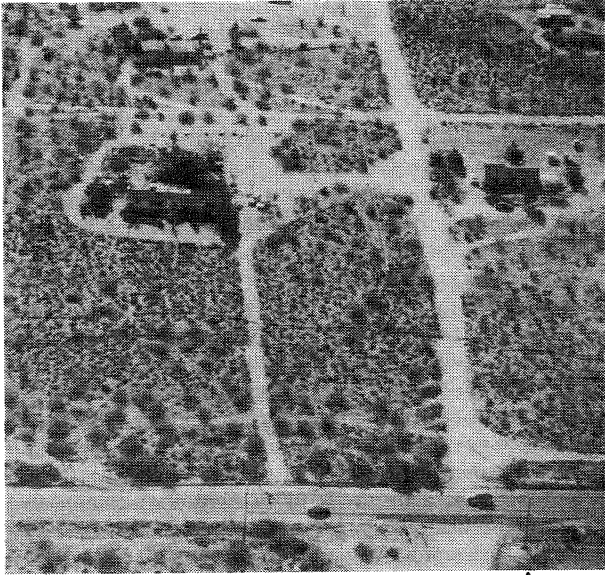
Figure 7. Aerial view of the Johnson Valley fault (7A), parallel and about 50 m east of California Highway 247 (foreground). Note the complex nature of surface faulting, and occurrence of cracks running at a high angle to the fault. Fig 7B shows a fence displaced 2.7 m right-lateral on the Johnson Valley fault in the same vicinity. At this site displacement occurred on two principal fractures in a deformation zone about 5 m wide. Location shown on Fig. 5.

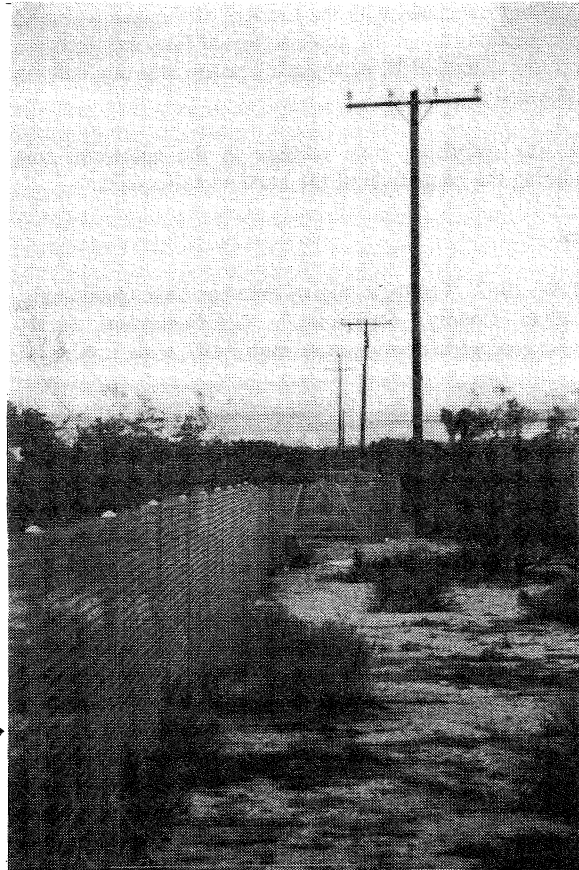
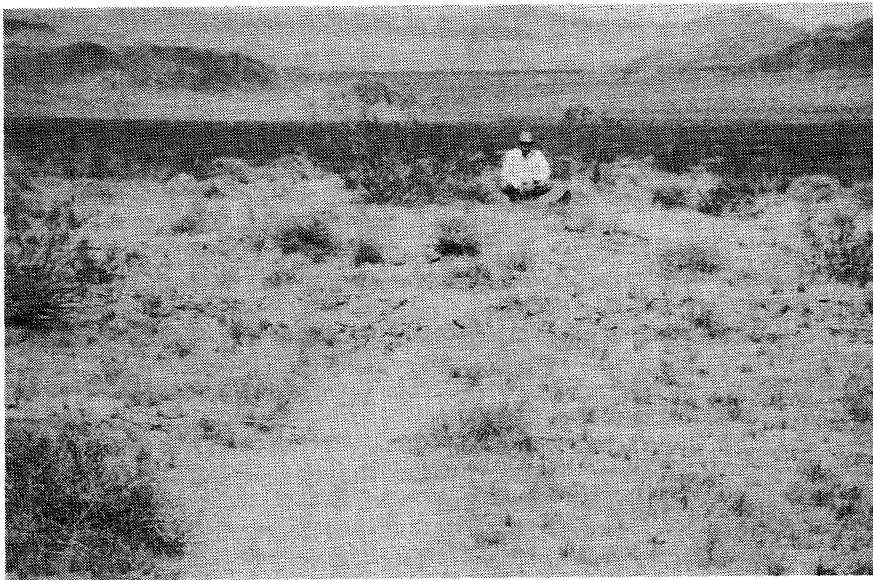
5. **Emerson Fault:** This strand of the 1992 faulting is about 25 km long and contains the maximum right-lateral displacements that occur in the vicinity of Bessemer Mine Rd. (Fig. 5) and reach 4.5 m right-lateral movement with about 1.0 m of vertical displacement (Figs. 7 & 8). The second subevent of the 1992 earthquake sequence occurred in this area. About 10 km NNW of Bessemer Mine Rd., fault rupture caused severe damage to a 110kV electricity pylon that straddled the fault. Three metres of right-slip was recorded on the gravel service road alongside the pylons. A second pylon route across the fault 2 km to the NNW was not damaged, both because no pylons straddled the fault and because the amount of right-slip had decreased to about 0.8 m.

Figure 8. Off-road motorcycle track displaced by 4.5 m right-lateral on the Emerson fault. Displacement occurs across four principal fractures, most of which also have minor upthrow to the east. Photograph taken looking east; location is shown on Fig 5.

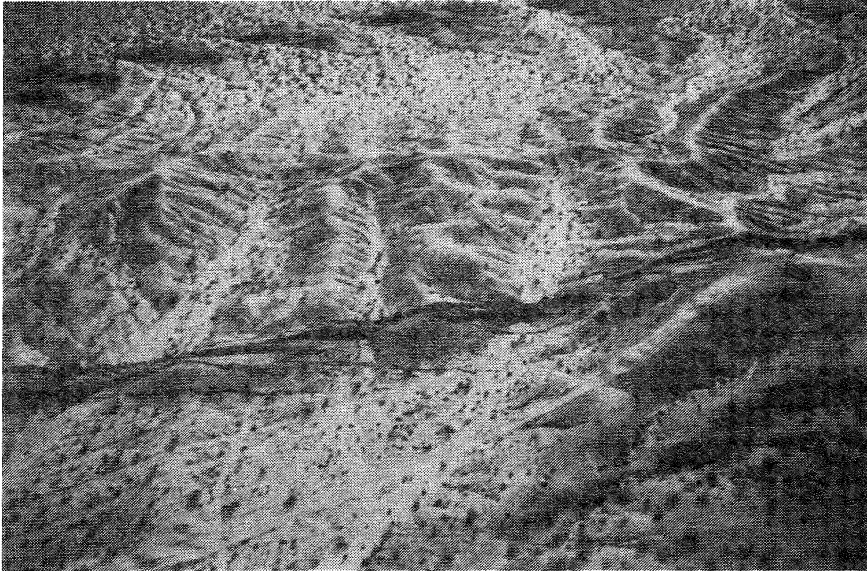
Figure 9. Aerial view of Emerson fault trace cutting across topography to the south of Bessemer Mine Rd. Right-lateral displacements of ridges and gullies in this area range from 3.5 m to 4.5 m. The trace is upthrown to the east by as much as 1.1 m locally. Location shown on Fig 5.

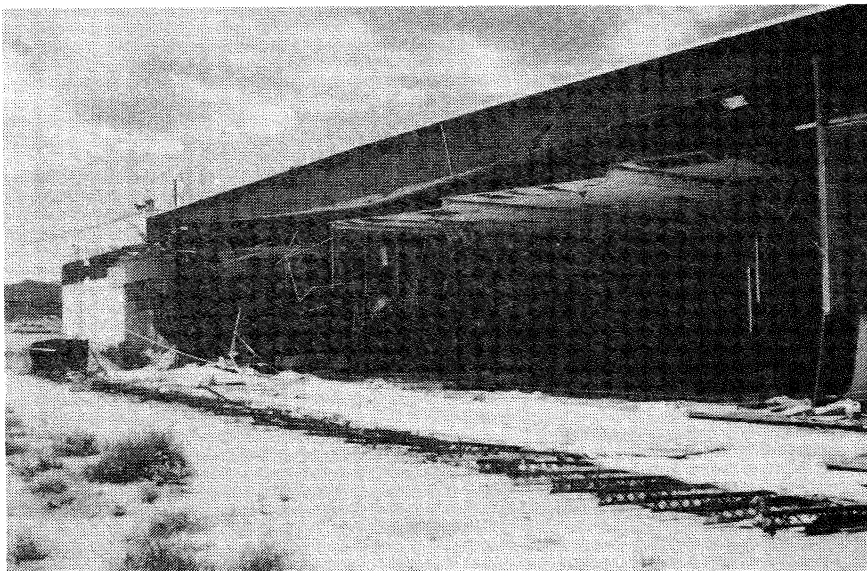
Figure 10. Collapsed east wall of the bowling alley in the eastern part of the town of Yucca Valley. Steel roof beams were not significantly damaged, but many false ceiling panels have fallen. The west wall of the building was constructed of concrete blocks that suffered only minor cracking. Location shown on Fig 5.

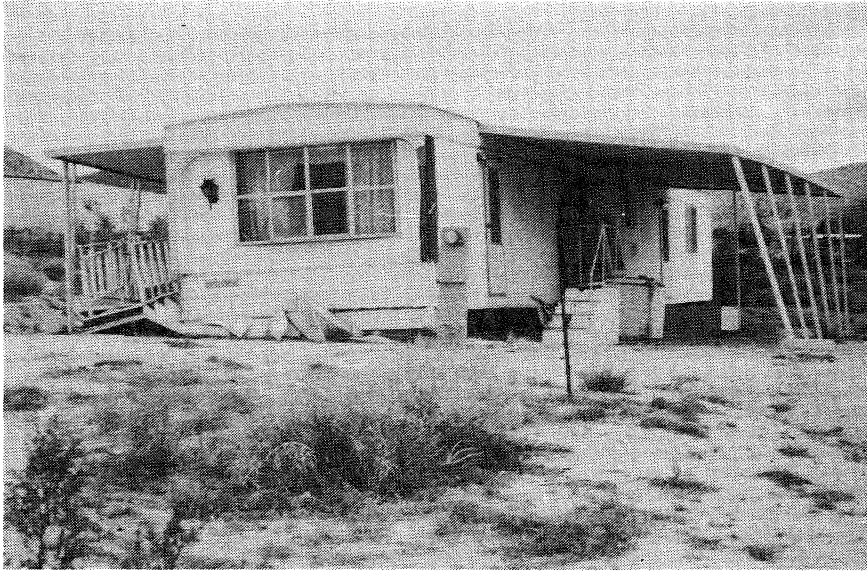
and I suspect not very well secured to the floor bearers. We saw many instances of these homes having been tipped from their pile foundation (Fig. 10), or else differential movement of the ground having caused severe distortion to the structure. Those trailer homes on a concrete foundation performed rather better, but major damage was still common because of the flimsy framing, low strength wall materials, and lack of diagonal wall bracing.

Figure 11. Damaged trailer house about 100 m west of the Johnson Valley fault. The trailer was apparently poorly tied to its wooden pile foundation. Location shown in Fig 5.

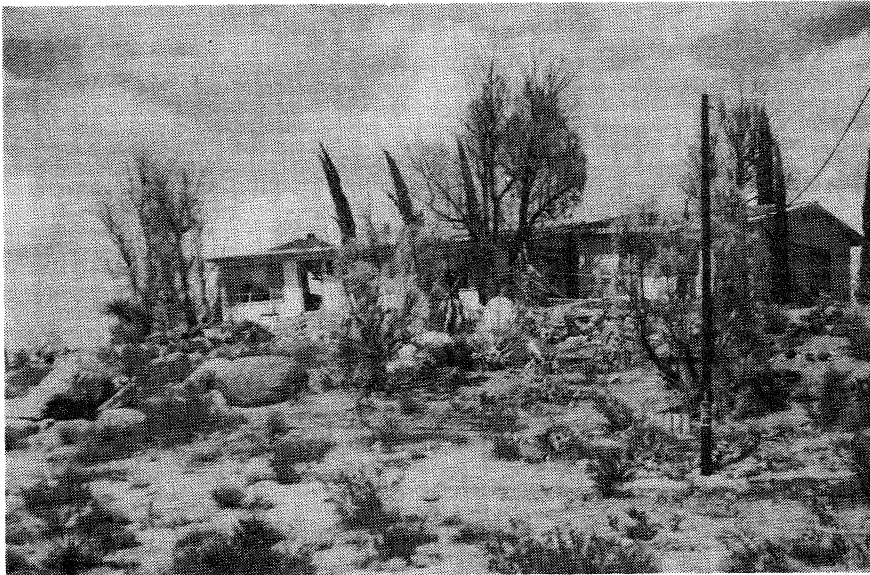
The most severely damaged house we saw provided a graphic example of the effects of energy focussing on hilltops. The house was built in the 1950's with timber framing on a concrete foundation. The trace of the Johnson Valley Fault (which sustained 2.5-3.0 m of right-slip at this locality) ran about 60 m west of the house. The hilltop was criss-crossed with a network of fractures but none of these had large displacements. This structure must have been very close to the point of collapse. It is fortunate that this house was unoccupied at the time of the earthquake, because although it did not collapse, the disruption to internal fittings and appliances was extreme (Fig. 11 & 12).

Figure 12. Exterior view of severely damaged "hilltop" house located about 60 m east of the Johnson Valley fault. Note that several trees have died (photo taken about two weeks following the earthquake) because of root damage. Location shown on Fig 5.

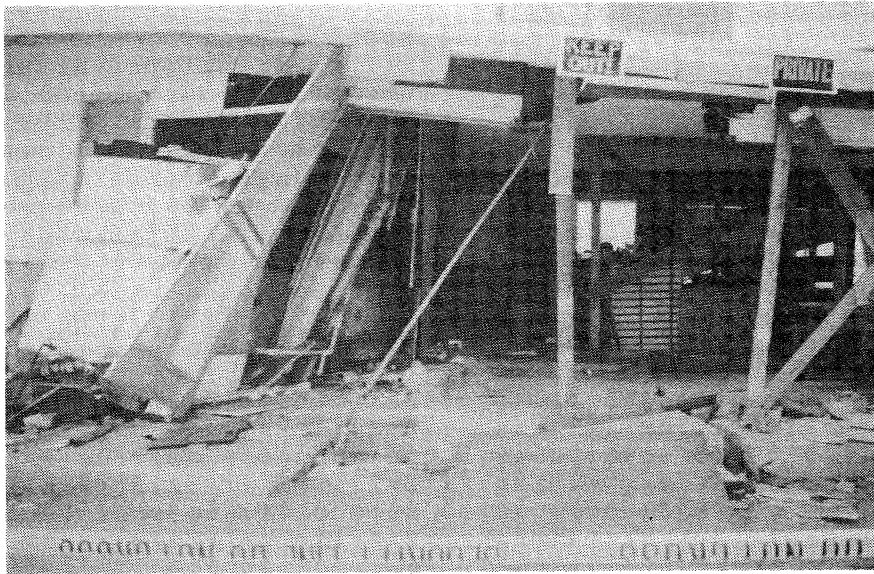
Figure 13. View of the interior of "hilltop" house, showing cracked concrete floor slab, extreme racking of exterior walls (about 1.5 m), and temporary bracing to stop total collapse so that possessions could be removed before demolition.
