EARTHQUAKE OF 7 DECEMBER 1988, SPITAK, ARMENIA REPORT OF THE NZNSEE TEAM VISIT OF 1989

P.R. Wood¹, J.B. Berrill², N.R. Gillon³, P.J. North⁴

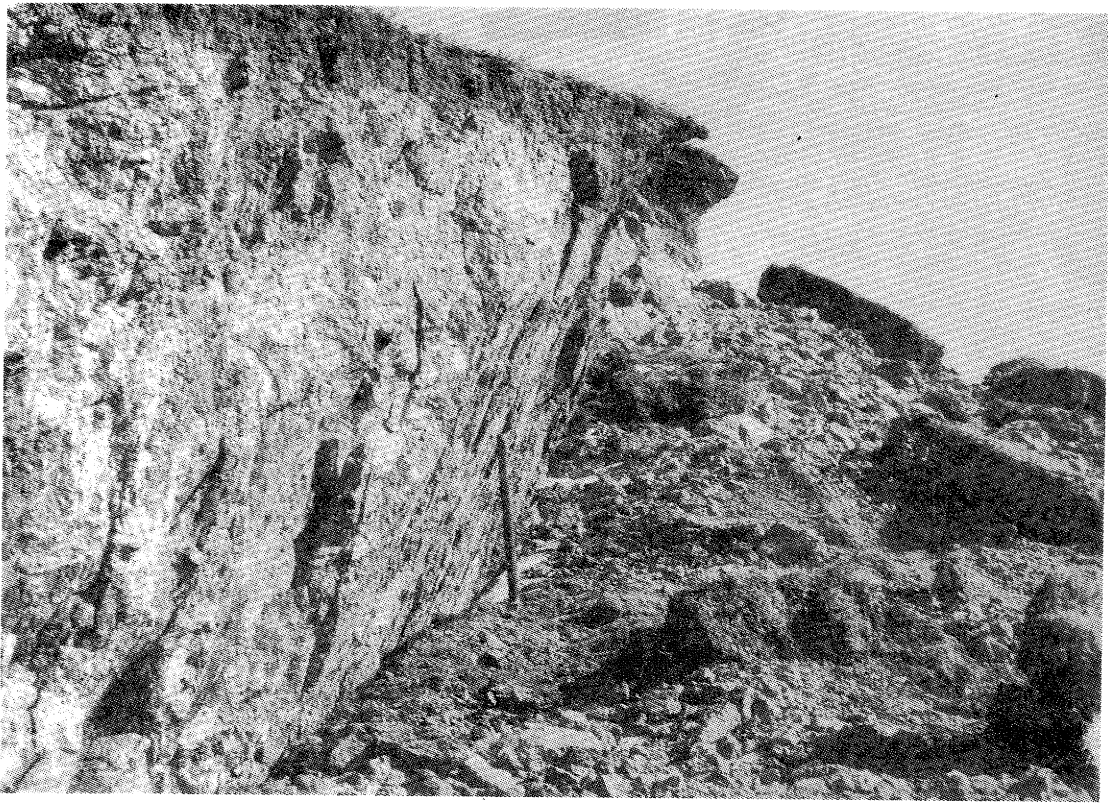
The displacement slip vector observed at the ground surface reaches a maximum of 2 metres vertical with up to 1.8 metres right lateral slip recorded by Trifonov *et al.*, along with fault plane dips of 37-85°.

Figure 10 Fault scarp produced by the Spitak earthquake (with hammer for scale). [from Trifonov et al. (1989)]

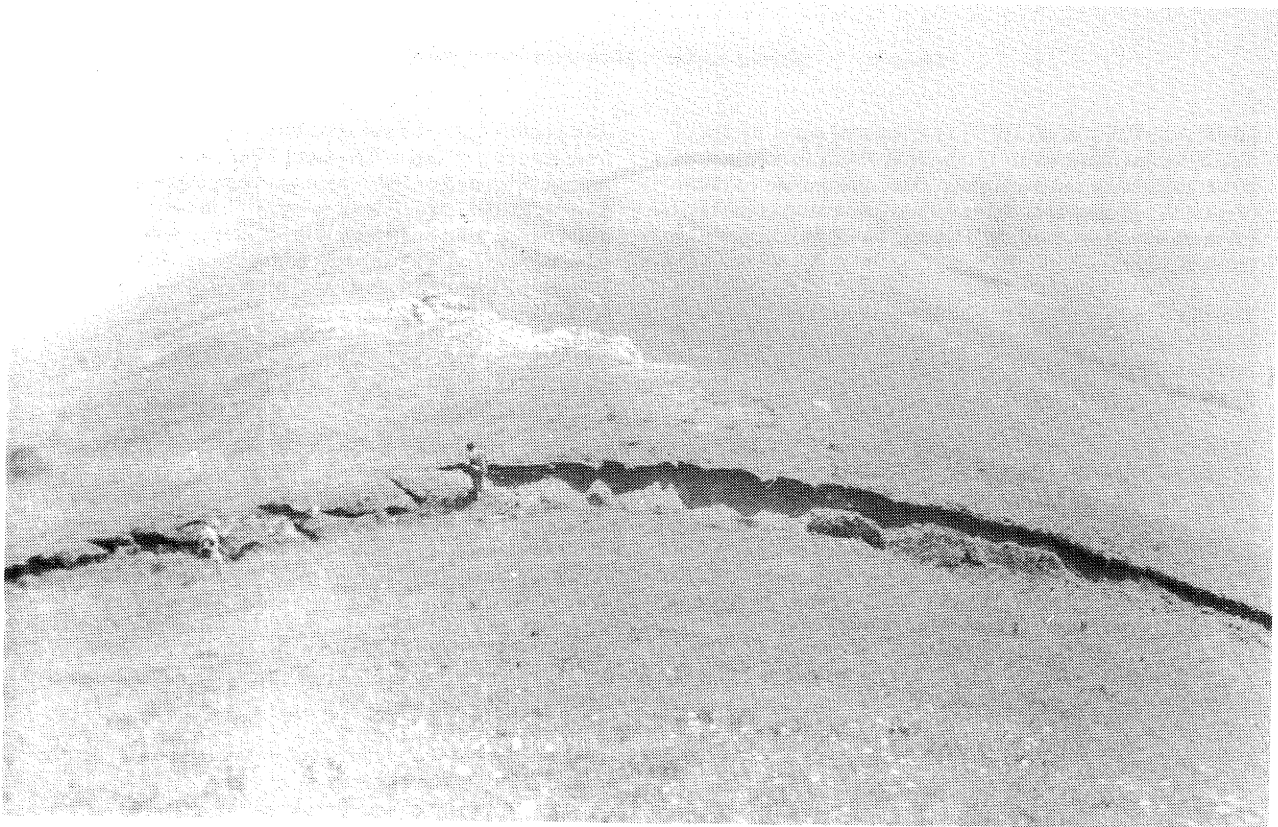
Figure 11 Surface rupture. [A. Karakhanian]

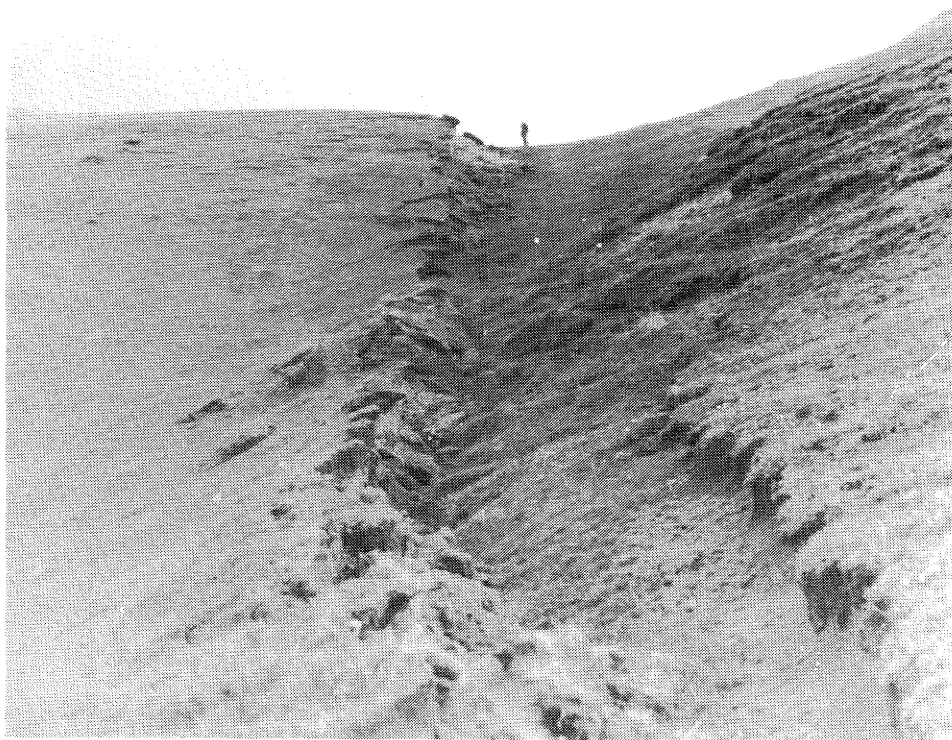
Figure 12 Surface rupture. [A. Karakhanian]

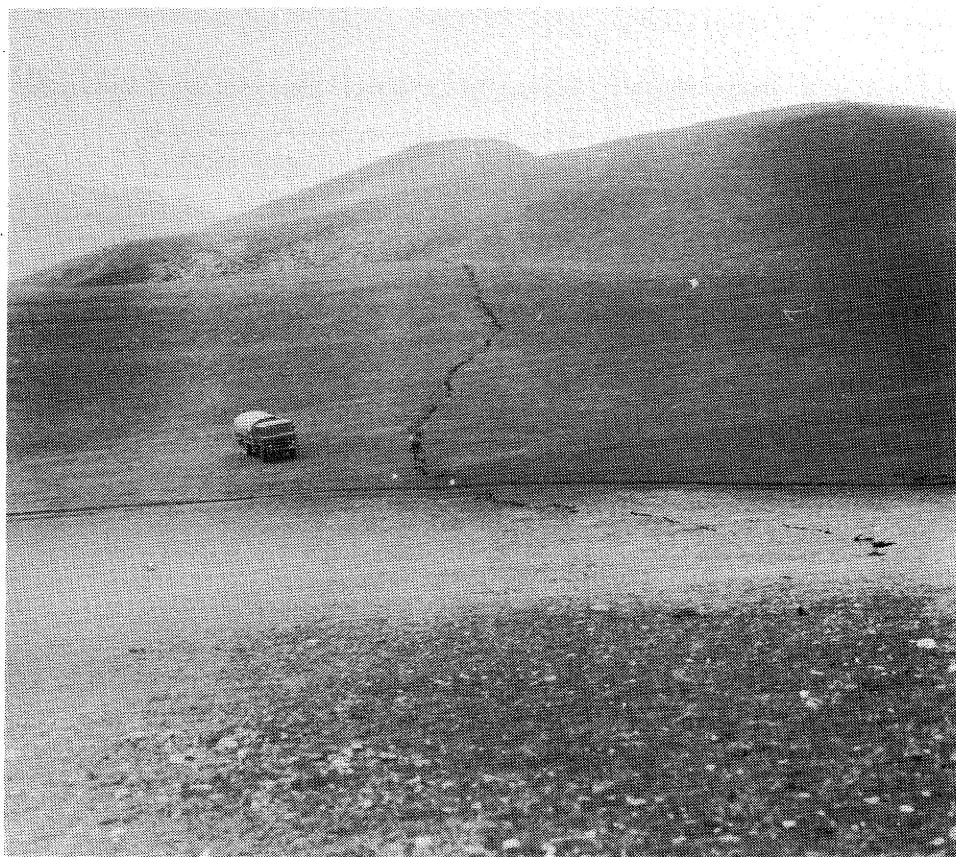
Figure 13 Surface rupture, near its NW end. [A. Karakhanian]

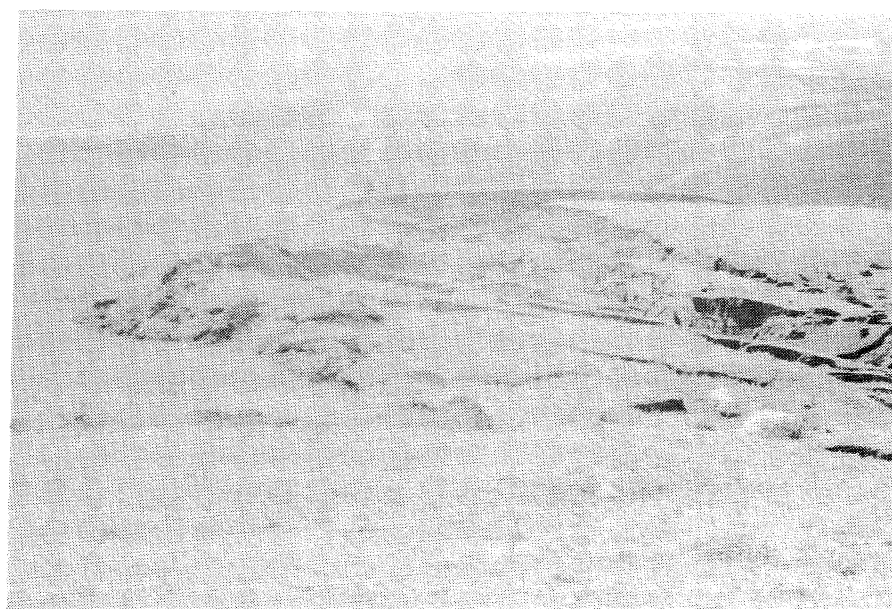
Slope failures were triggered by the earthquake [A. Karakhanian, pers comm.]. They include rockfalls from cuts, block slides (Figure 18), and earthflows.

Philip *et al.* [1992] note that landslides were more prevalent to the north west of the fault rupture and that the largest landslides occurred there. They suggest an association with a growing anticline above a blind fault - a rupture that did not propagate up to the ground surface but which did deform the ground above it.

Figure 18 *Landslide near NW end of fault rupture. [A. Karakhanian]*

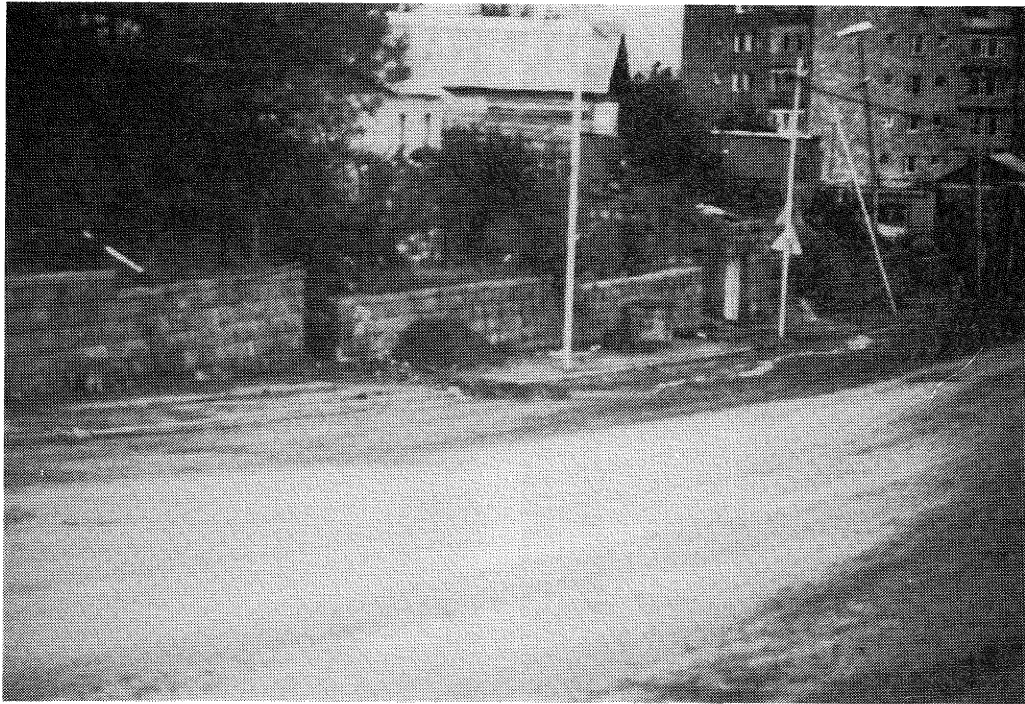
Apart from bridge abutments, no mass concrete retaining walls were identified in the epicentral area. A number of low cut-stone walls were seen at Spitak and most of these were undamaged or had at most one or two capping stones missing. Figures 20 and 21 show typical examples. The only wall that we saw to have suffered serious damage was found at the northern end of the precast concrete highway bridge under construction over the Pemback River at the time of the earthquake. Here, an old masonry wall, shown in Figure 22, about 2 m high, about 500 mm deep at the top and about 50 m long, retaining a horizontal backfill, had moved out of plumb by about 5 degrees over most of its length. At its highest point, a length of about 12 m had collapsed.

Figure 20 Stone wall, Spítak.

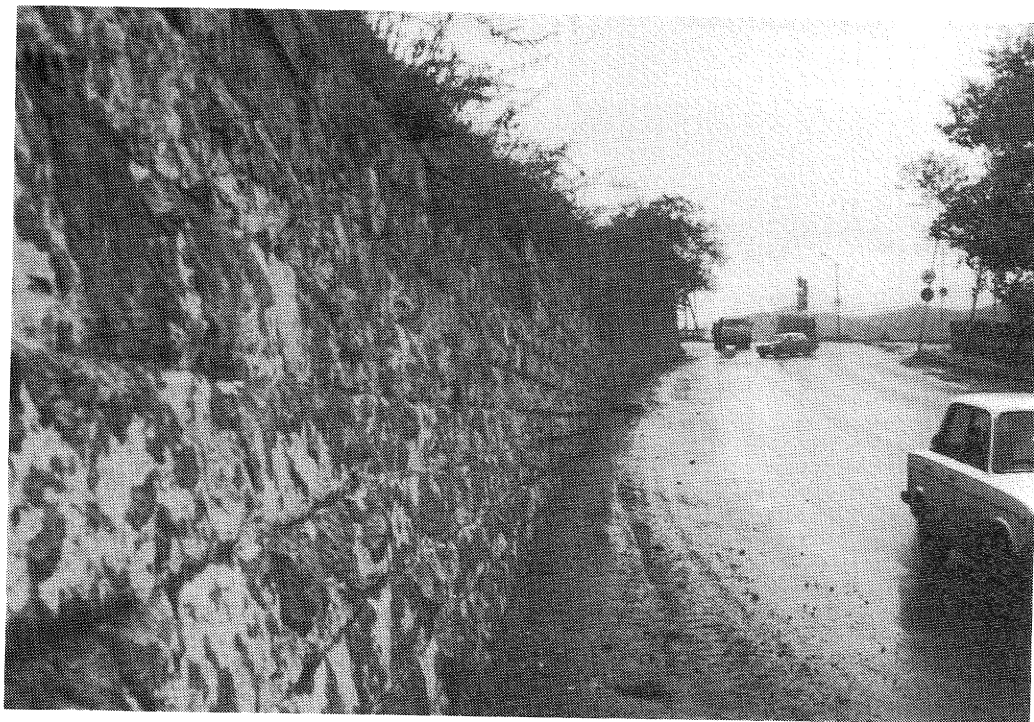
Figure 21 Cut stone wall, Spítak.

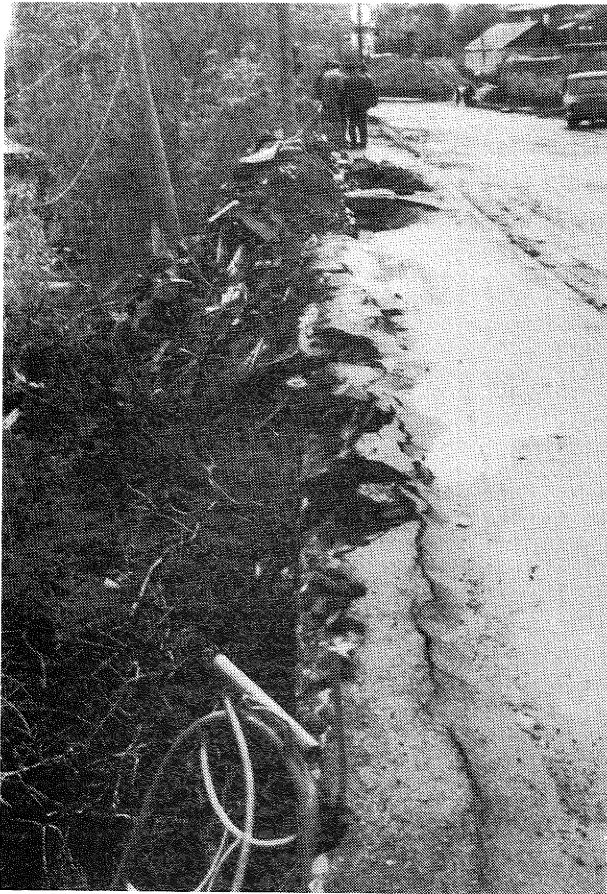
Figure 22 Collapsed wall, Spitak.

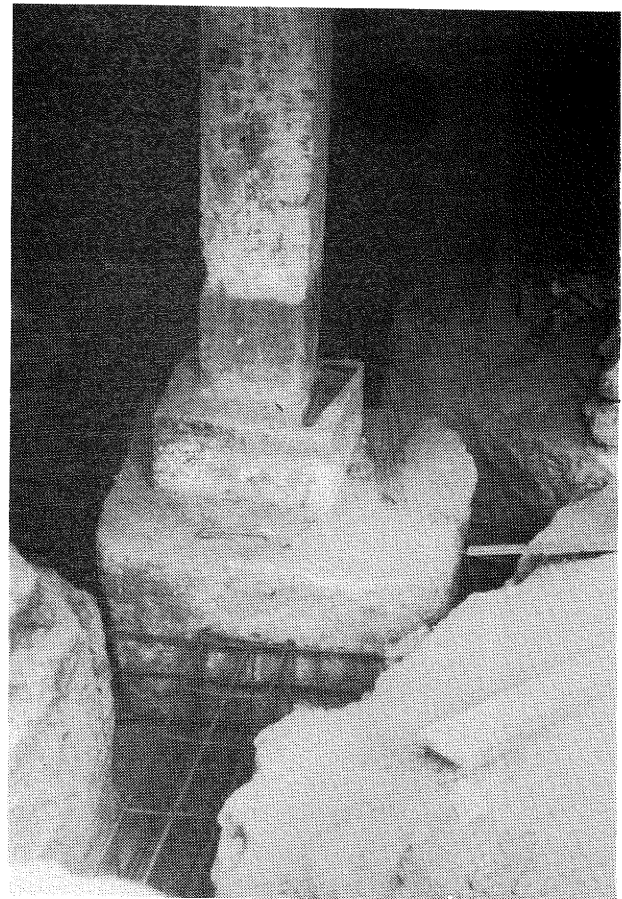
During our visit we observed a three storey masonry building in the old central section of Leninakan, one block from the Central Square, where pad foundations were being enlarged and tied together with ground beams (Figures 23 and 24). Excavation was also observed around the pad footings of a low rise steel-framed industrial building on the outskirts of Leninakan.

Figure 23 Spread footings being extended and tied together in old quarter of Leninakan.

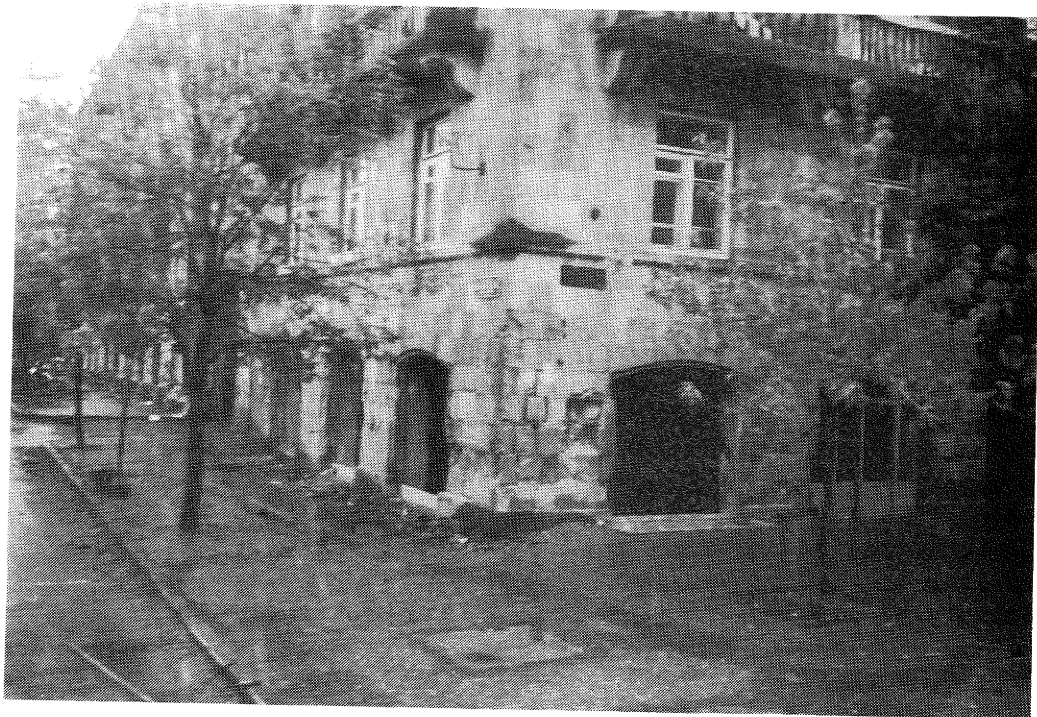
Figure 24 Building in which spread footings were being extended.

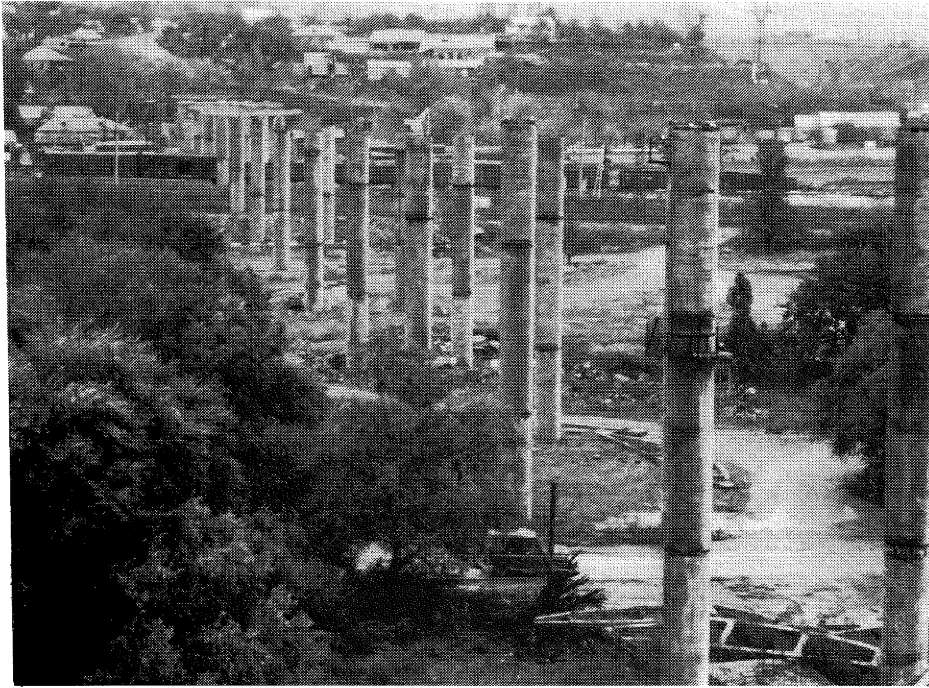
As a result of the earthquake, fault displacement offset the pier alignment at about pier 5. Some pier caps tilted on top of the shafts and some beams fell over, both in place and in stacks on the ground (Figures 26 and 27). Some of the pier shafts tilted slightly in the ground (Figures 26 and 27). The damage can be attributed to the effects of soft alluvial soils overlying the rock, in addition to the effects of displacement of the fault running through the site.

Figure 25 Precast, prestressed concrete highway bridge, under construction at Spitak at time of earthquake.

The authorities have decided to abandon the bridge although it is probably repairable at small extra cost. The other surprise was that the existing low level bridge at the site was apparently undamaged. It had high gravity retaining abutments and poor seismic detailing but it was founded directly on rock (Figure 28).

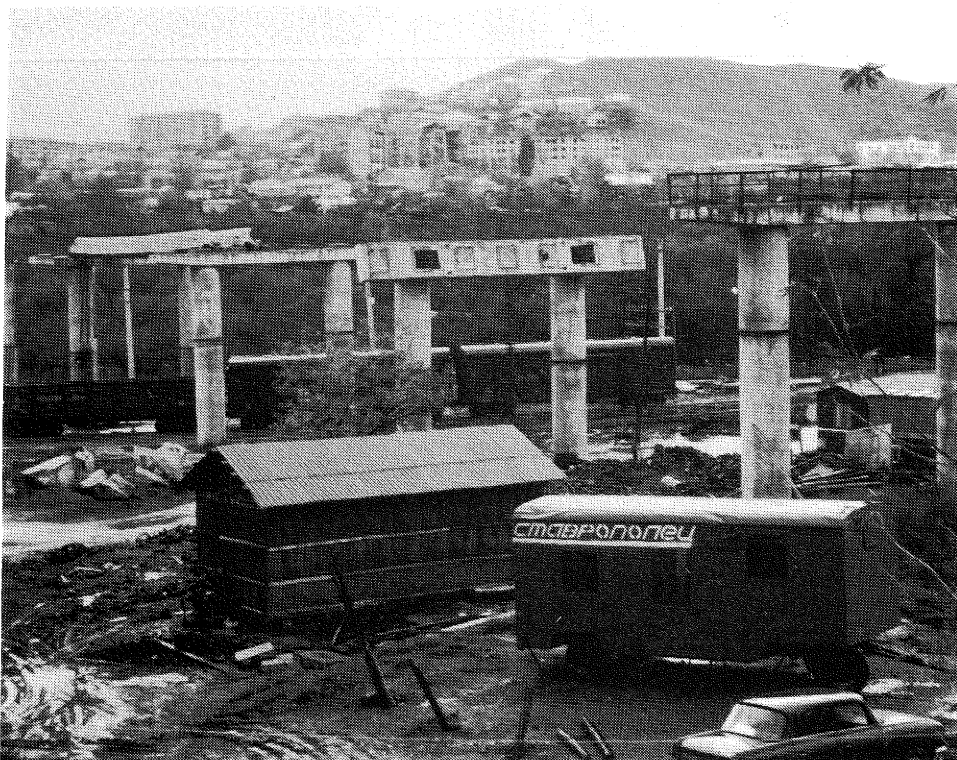
Figure 26 View of Spitak bridge, looking in the other direction.

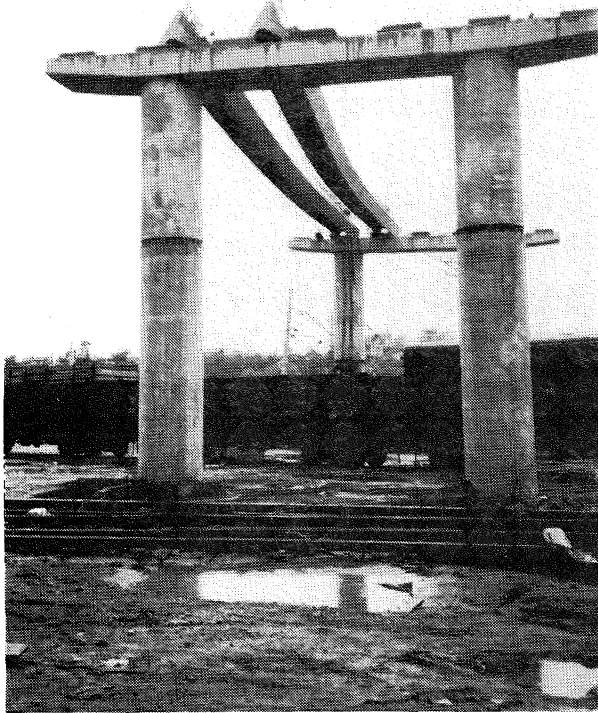
Figure 27 *Toppled precast beams, Spítak highway bridge.*

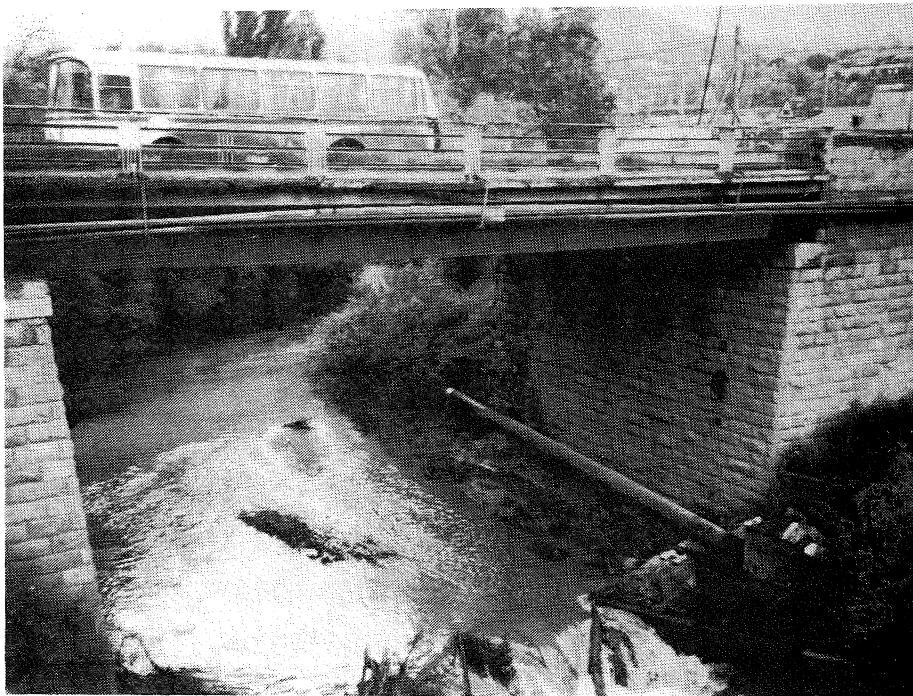
Figure 28 *Old bridge across Pembak River at Spítak, undamaged.*

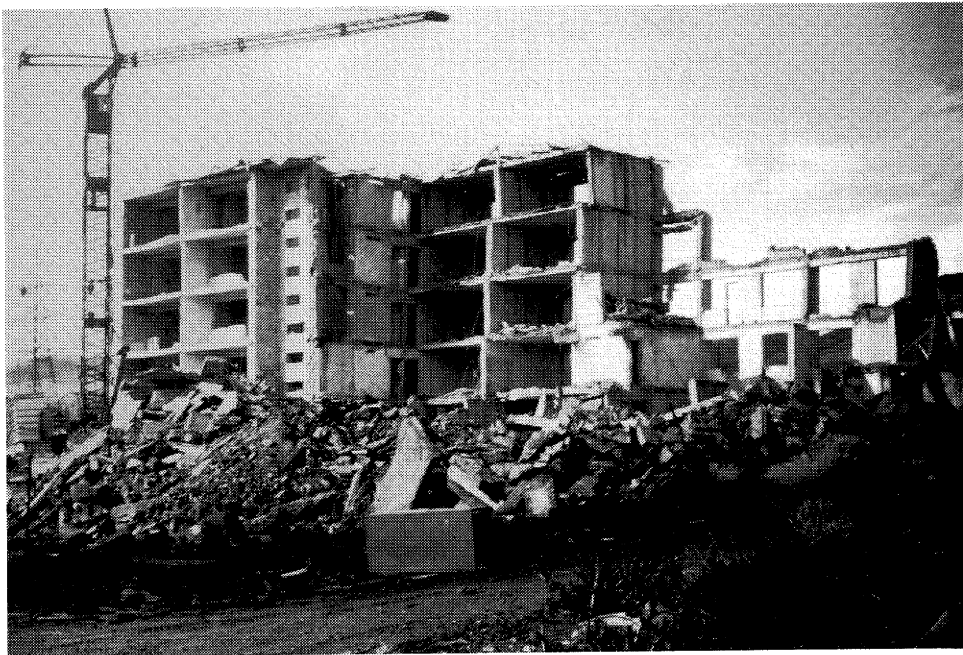
When our team visited the area, much of the damage had been cleared away but there were many severely damaged buildings left standing (Figures 29 and 30). Previous reconnaissance teams have recorded the damaged buildings well [e.g. Wyllie & Filson, 1989].

Figure 29 *Damaged reinforced concrete building, Spitak.*

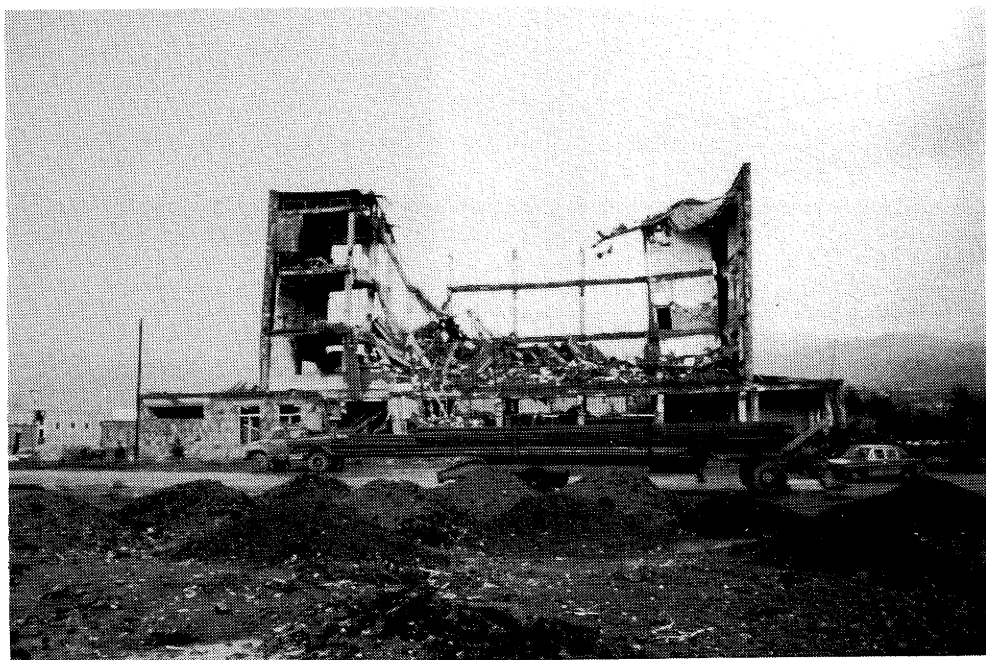
Figure 30 *The main telephone exchange in Spitak after the earthquake.*

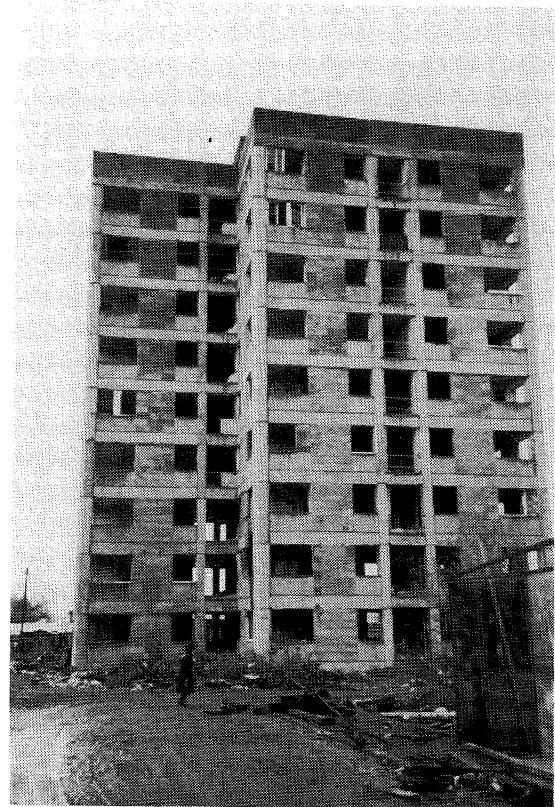
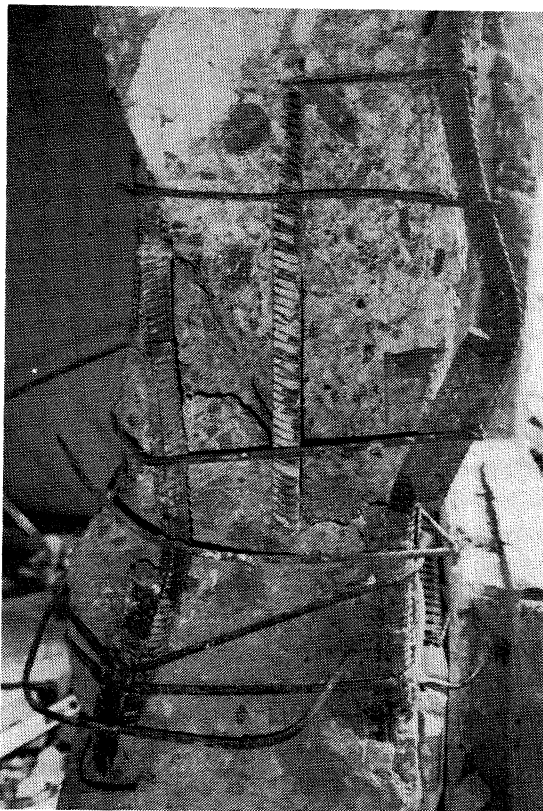
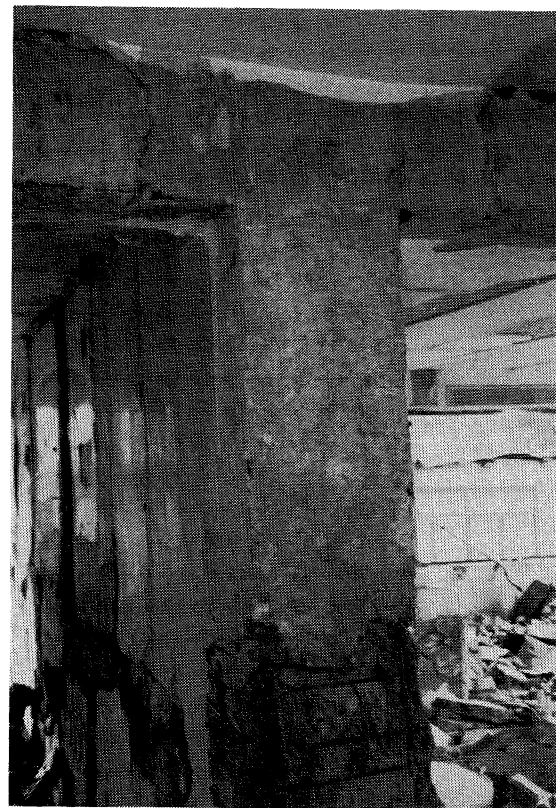
Most of the buildings that failed were of the Soviet Building Type 111 series, of 9 storey precast frame construction. Seventy eight had been built in Leninakan and only 6 survived the earthquake, but these, too, were damaged beyond repair. We examined the last one standing before it was demolished (Figures 31, 32 and 33).

Figure 31 Type 111 building, heavily damaged but still standing, at Leninakan.

Figure 32 Details of the Type 111 building.

Figure 33 Details of the Type 111 building.

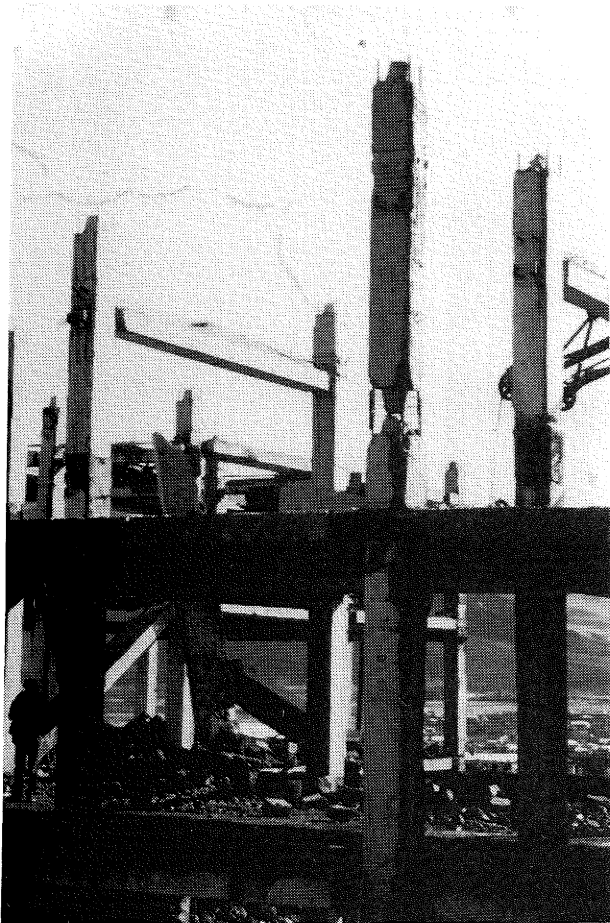
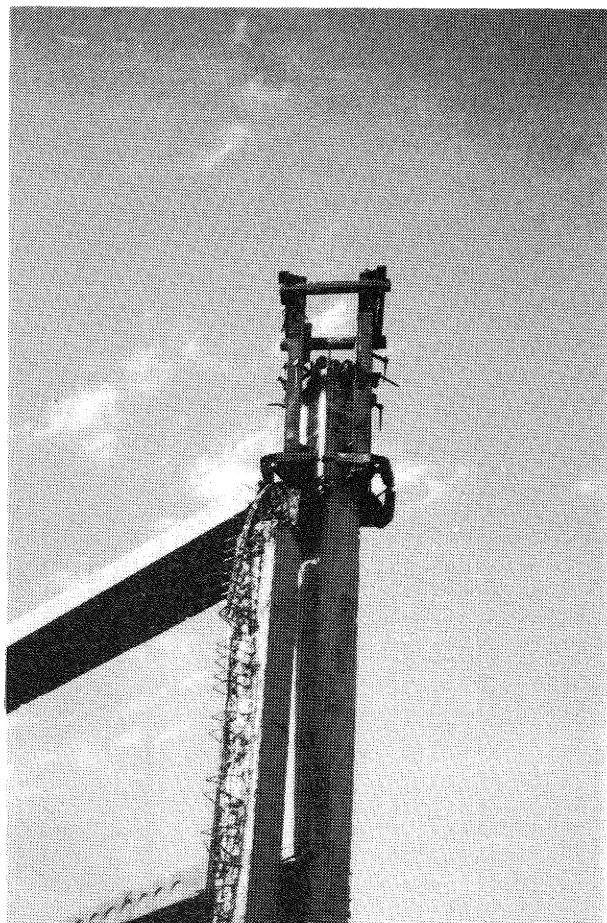
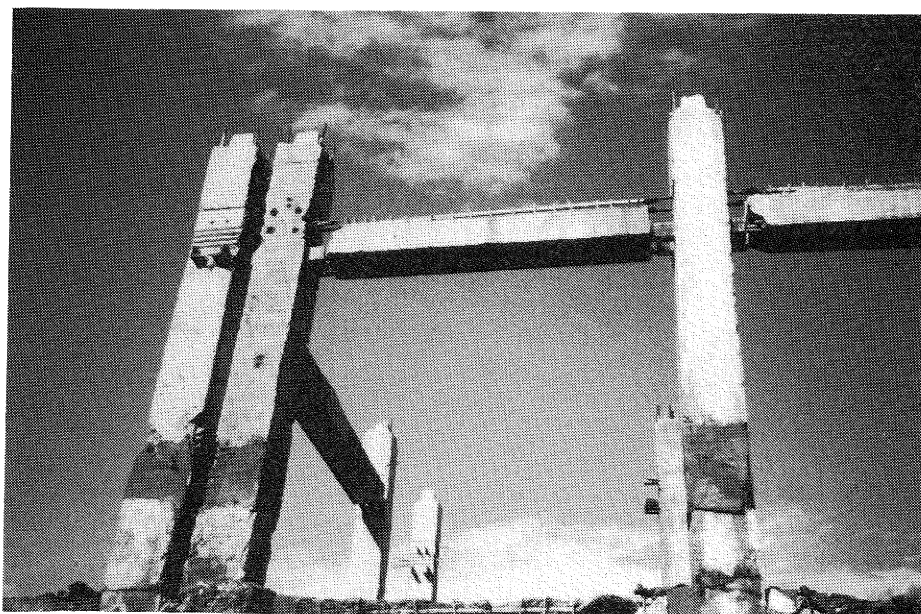
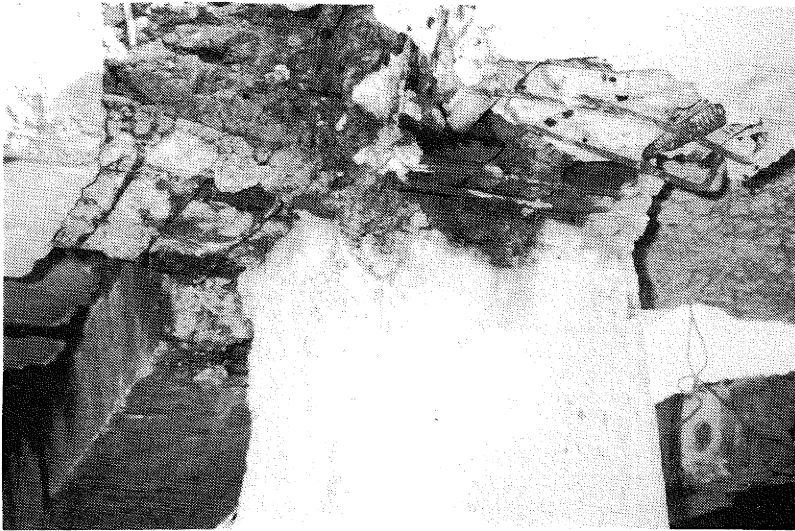
In Spítak the team also examined some frame buildings that had been under construction at the time of the earthquake and had not yet been demolished. They clearly indicated very low construction standards which exacerbated suspect joint details (Figures 34, 35, 36 and 37).

Figure 34 Precast concrete frame building, under construction at Spitak.

Figure 35 Precast concrete frame building, under construction at Spitak.

Figure 36 Precast concrete frame building, under construction at Spitak.

Figure 37 Precast concrete frame building, under construction at Spitak.

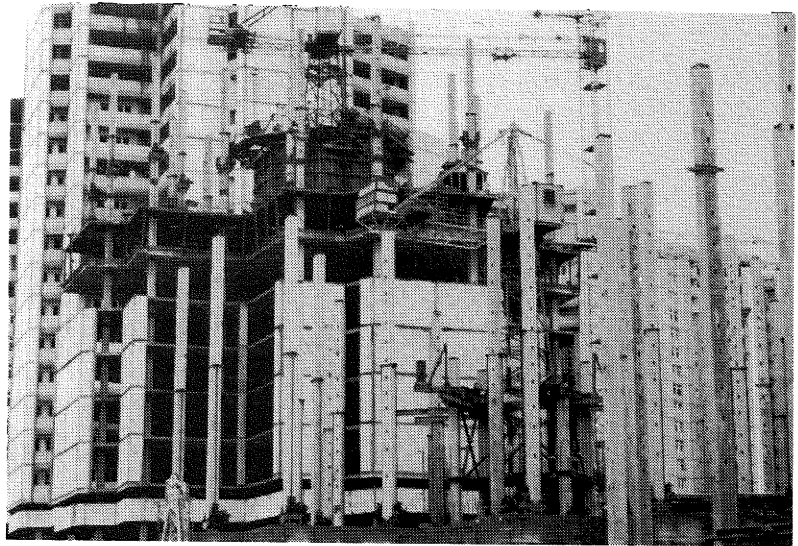
There were two high rise lift slab buildings in Leninakan and they both failed in the earthquake. One of 6 storeys stayed up but lost 30 cm in height because of crushing of the core at the first floor level. The second building, of 10 storeys collapsed completely. Many similar buildings could be seen under construction in Yerevan (Figure 38).

Figure 38 Lift slab building under construction on the northern outskirts of Yerevan. Similar structures collapsed in Leninakan.

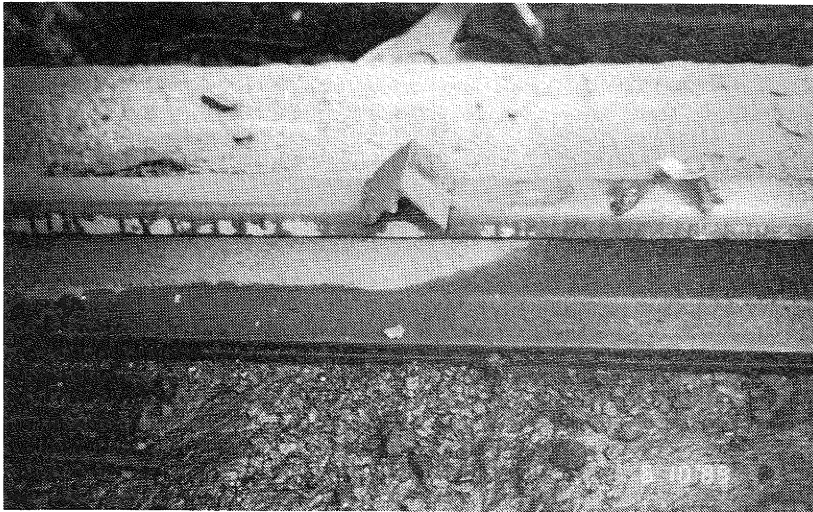
Many transformers are not anchored to the rails but are secured from rolling only by steel chocks welded to the rails (Figure 40). In one case, a transformer, in Spitak, jumped off its rails. The chocks intended to prevent the transformer from rolling failed to restrain it when the welds failed (Figures 41, 42 and 43).

Figure 40 Transformer support rail showing failure of wheel chocks.

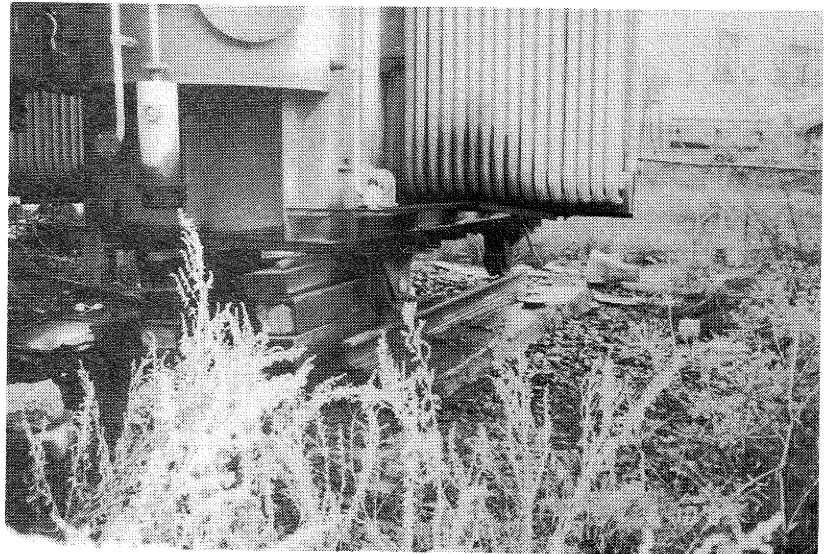
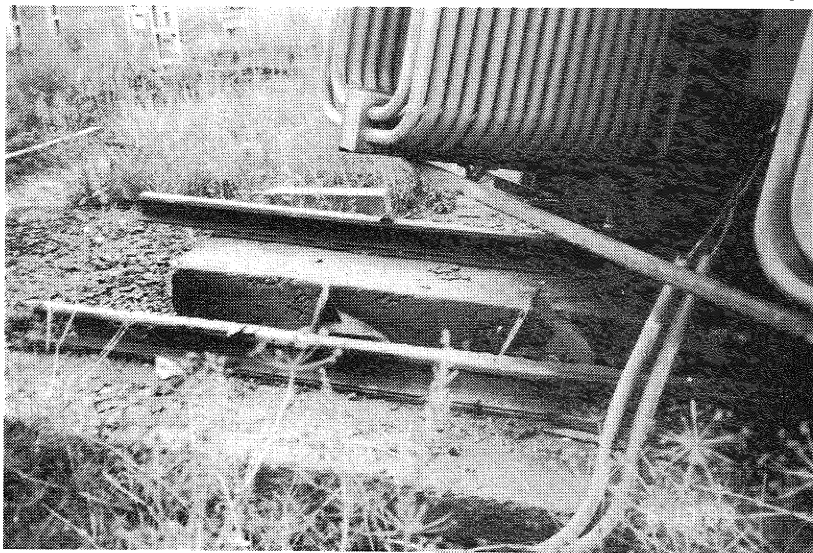
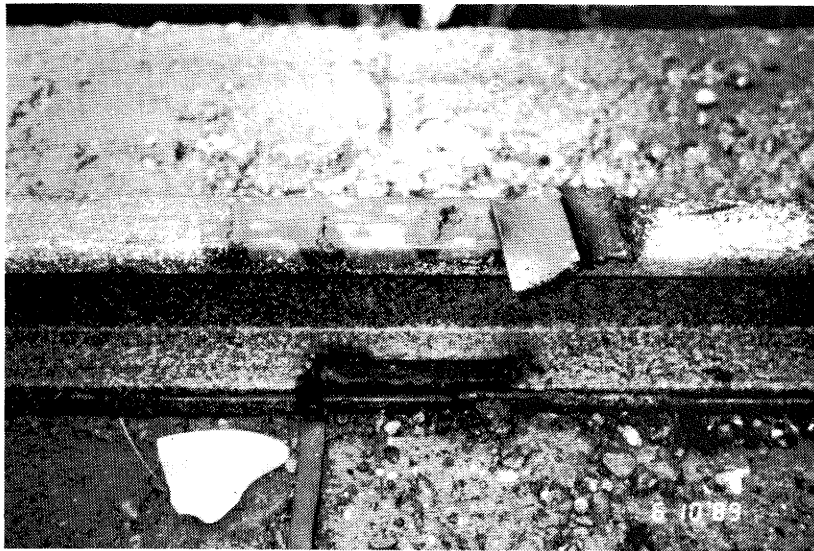
Figure 41 Transformer at Spítak jumped off track.

Figure 42 Transformer support failure at Spítak.

Figure 43 Failed wheel chocks on transformer support rail at Spítak.

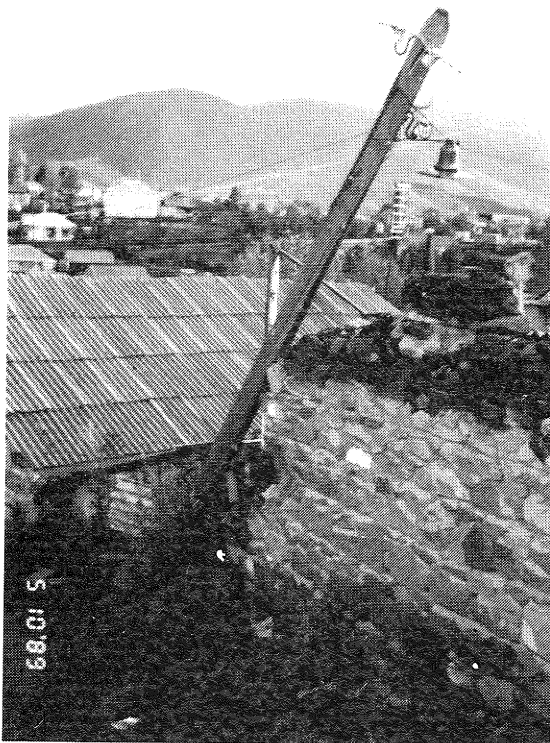
reinforced concrete, timber or rail iron ground posts (Figures 44, 45 and 46) and an A-frame pole with timber or reinforced concrete ground posts (Figure 47). Both types have wooden poles secured to the ground posts with wire ties. In Spitak a pole was observed to have failed, but it could not be identified as being a direct result of the earthquake shaking (Figures 48 and 49). High voltage transmission lines are supported on steel lattice type pylons anchored in concrete; these appear to have performed well. A number of power lines were supported on towers fixed to building roofs. Obviously these survived only when the building structures remained standing.

Figure 48 Power pole fixing failure at Spitak.

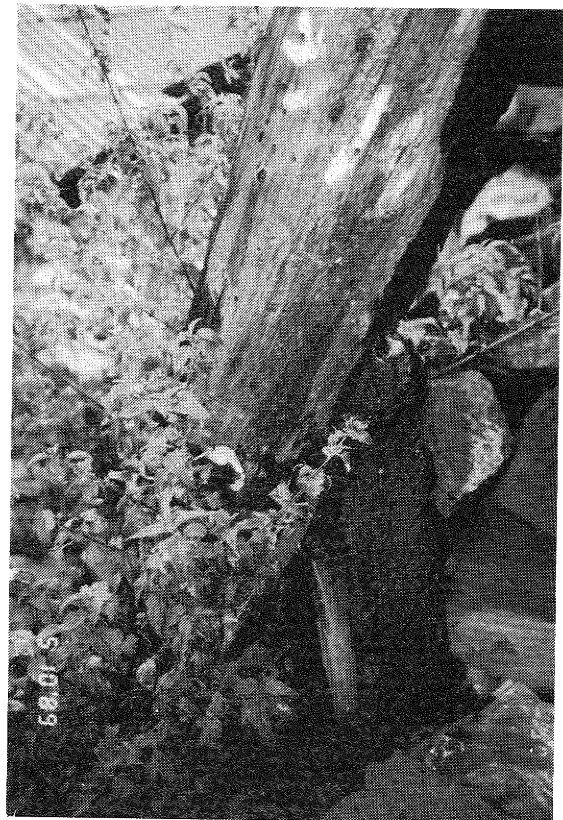
Figure 49 Close up view of power pole fixing failure at Spitak.

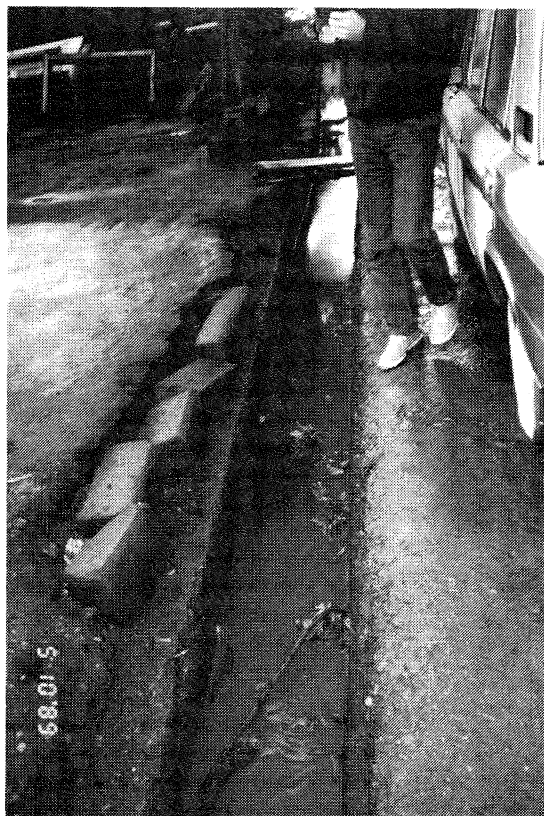
Figure 50 Stormwater channel dug up adjacent to curb blocks in Spitak.
