THE 1942 WAIRARAPA, NEW ZEALAND, EARTHQUAKES: ANALYSIS OF OBSERVATIONAL AND INSTRUMENTAL DATA

G.L. Downes¹, D.J. Dowrick¹, R.J. Van Dissen¹, J.J. Taber²,
G.T. Hancox¹ and E.G.C. Smith²

ABSTRACT

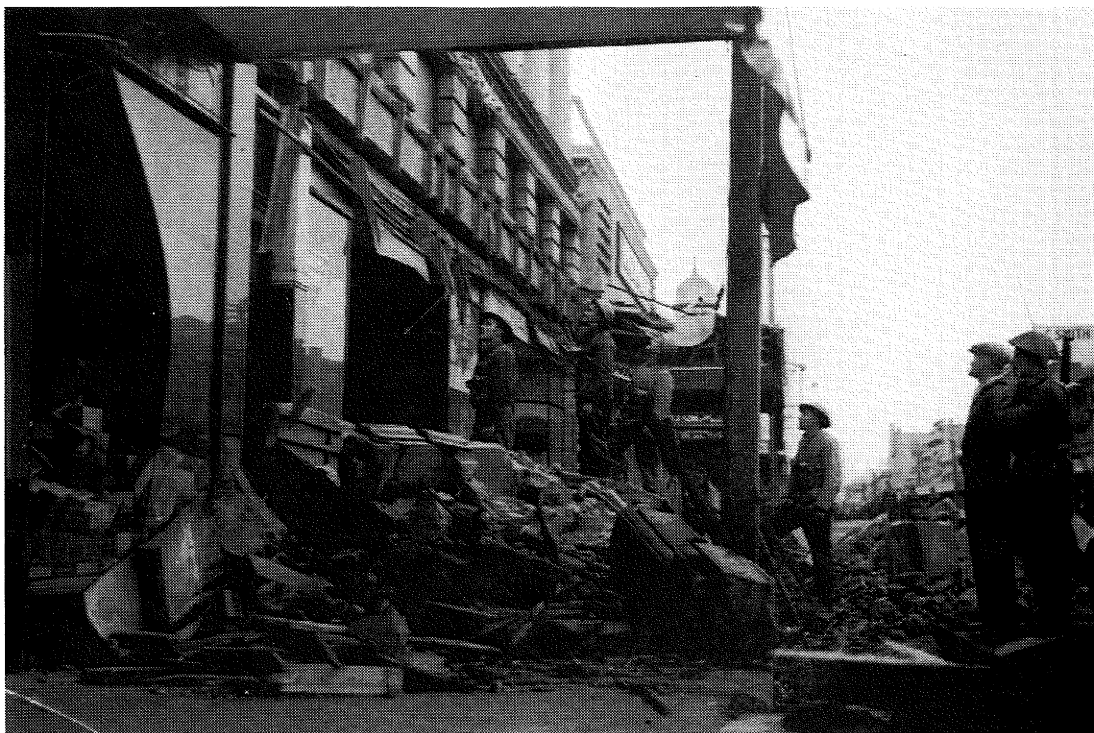
- 24 brick buildings were seriously damaged, and required partial or complete demolition (for example, Figure 6)
- 43 brick buildings were cracked only, or parapets and gable ends collapsed, and capable of reconstruction to earthquake standards
- 18 brick buildings suffered only minor damage.

Figure 6: A view of Queen Street, Masterton on June 25 1942. The debris is from the second storey of Gray's brick building housing Hannah & Co., and Bullick & Blackmore. The undamaged parapet of Woolworth's single storey 1937 reinforced concrete building may be seen just beyond Gray's. (Reference No. G-123912-1/2, "Evening Post" Collection, Alexander Turnbull Library, Wellington, New Zealand).

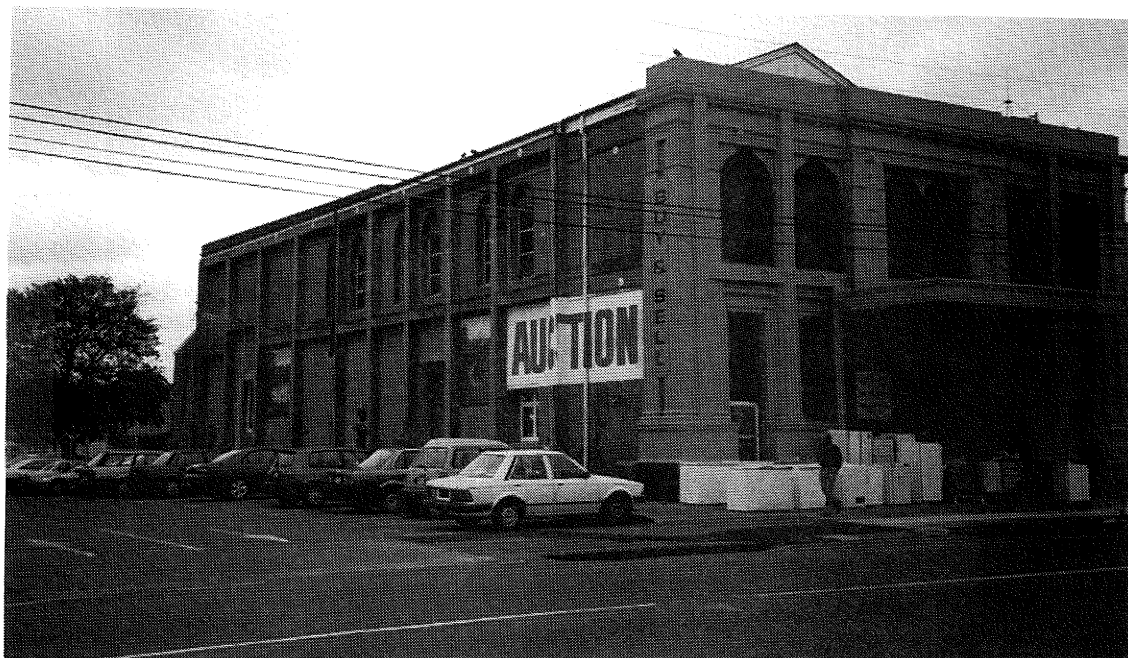
Figure 7: Present day view of the former Opera House, Masterton, showing reinforced concrete beams and columns attached to brickwalls in retrofitting mostly after 1934. (Photograph by D.J. Dowrick, 1998).

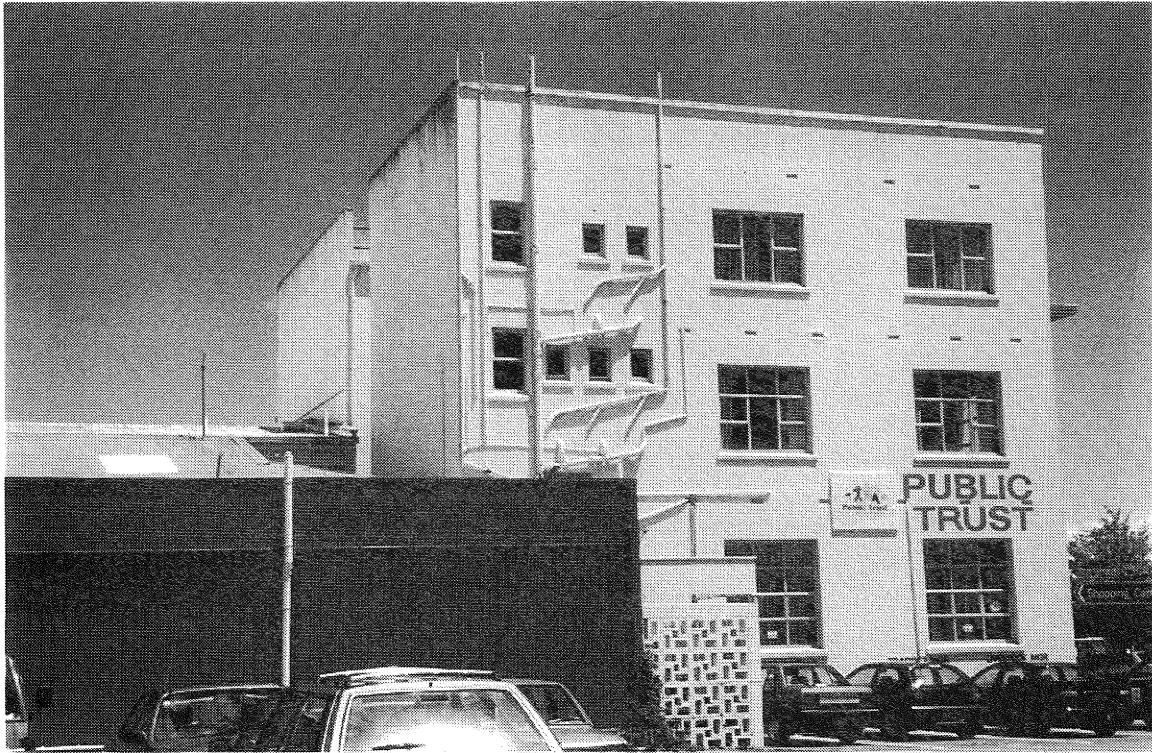
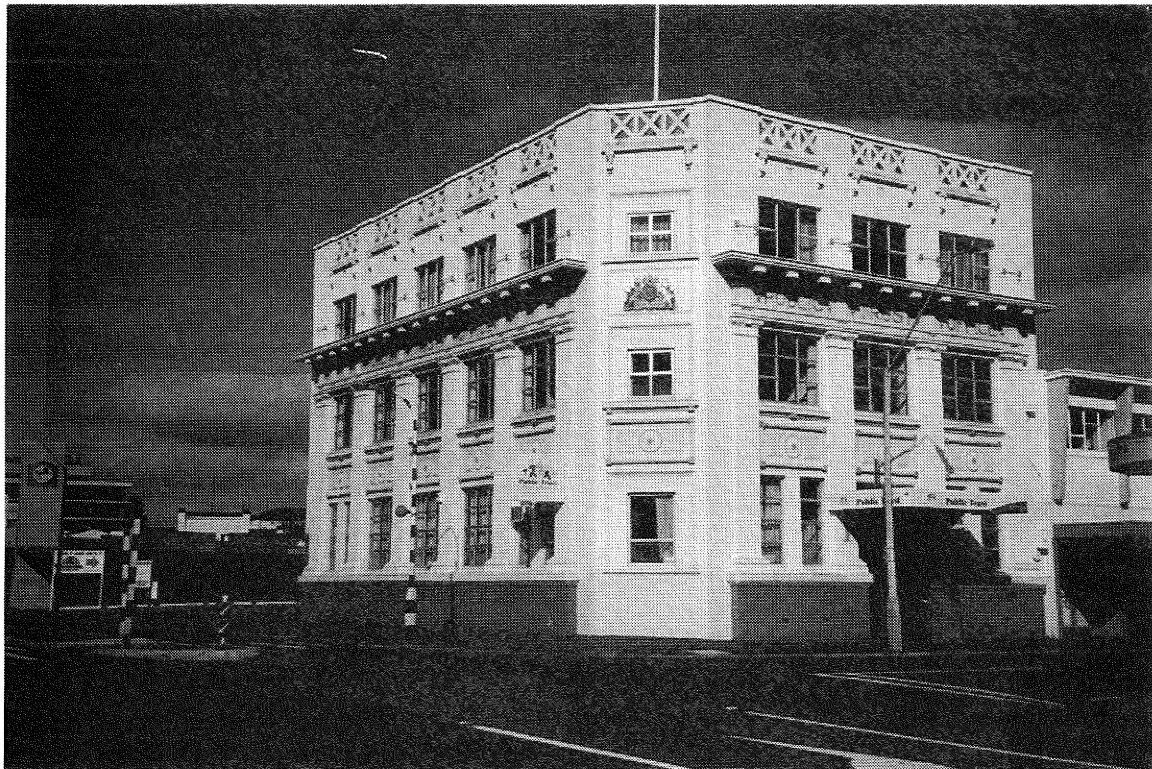
Of the 64 or so original reinforced concrete buildings in Masterton, some had brick infill, and only two (State Theatre and Woolworth’s shop) had been designed to resist earthquakes. Eight other buildings that had originally been of purely brick construction had been substantially retrofitted after the 1934 M_s 7.6 Pahiatua earthquake [24], for example, the Masterton Opera House illustrated in Figure 7. Most concrete buildings were undamaged. Three suffered moderate cracking, and a further ten or so were slightly cracked. Ironically, Woolworth’s shop was badly damaged when its roof was destroyed by falling brickwork from a brick building next door. One of the three-storey and one of the two-storey buildings are shown in Figures 8 and 9 respectively.

Figure 8: Present day views of 3-storey 1922 wholly reinforced concrete Public Trust building in Masterton, which “suffered no structural damage whatsoever” during the 1942 earthquakes (PGA~0.3-0.6g). (Photograph by D.J. Dowrick, 1998).

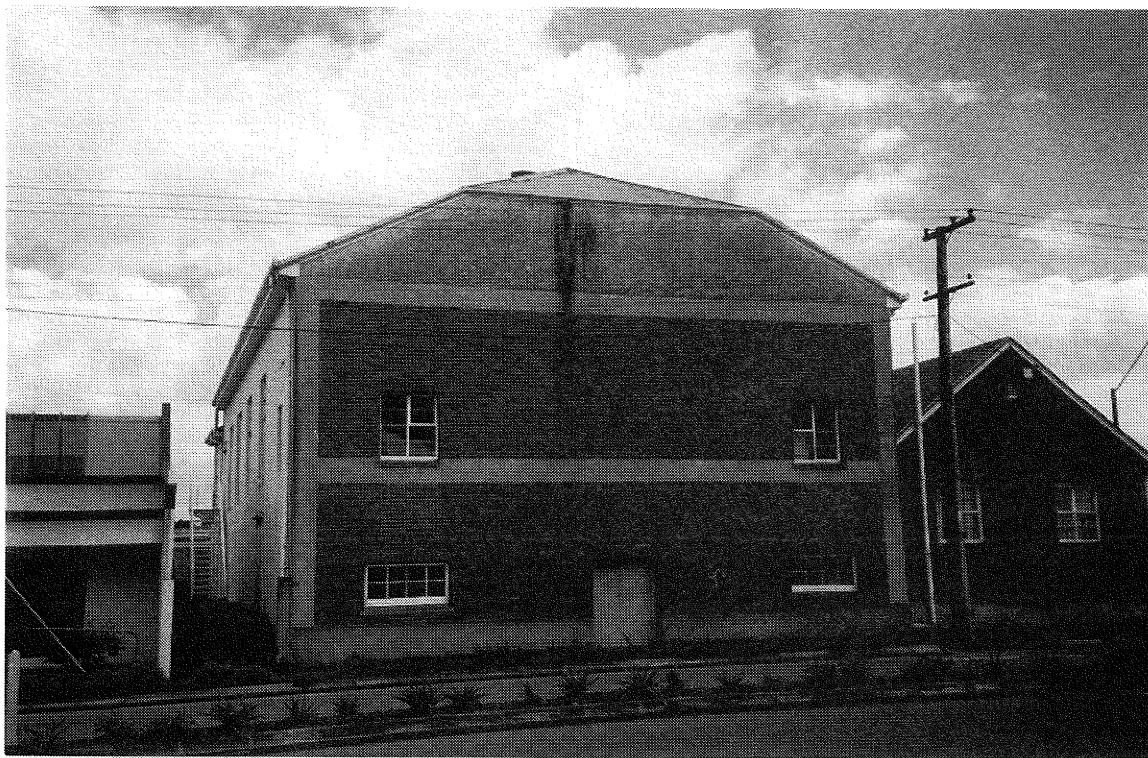
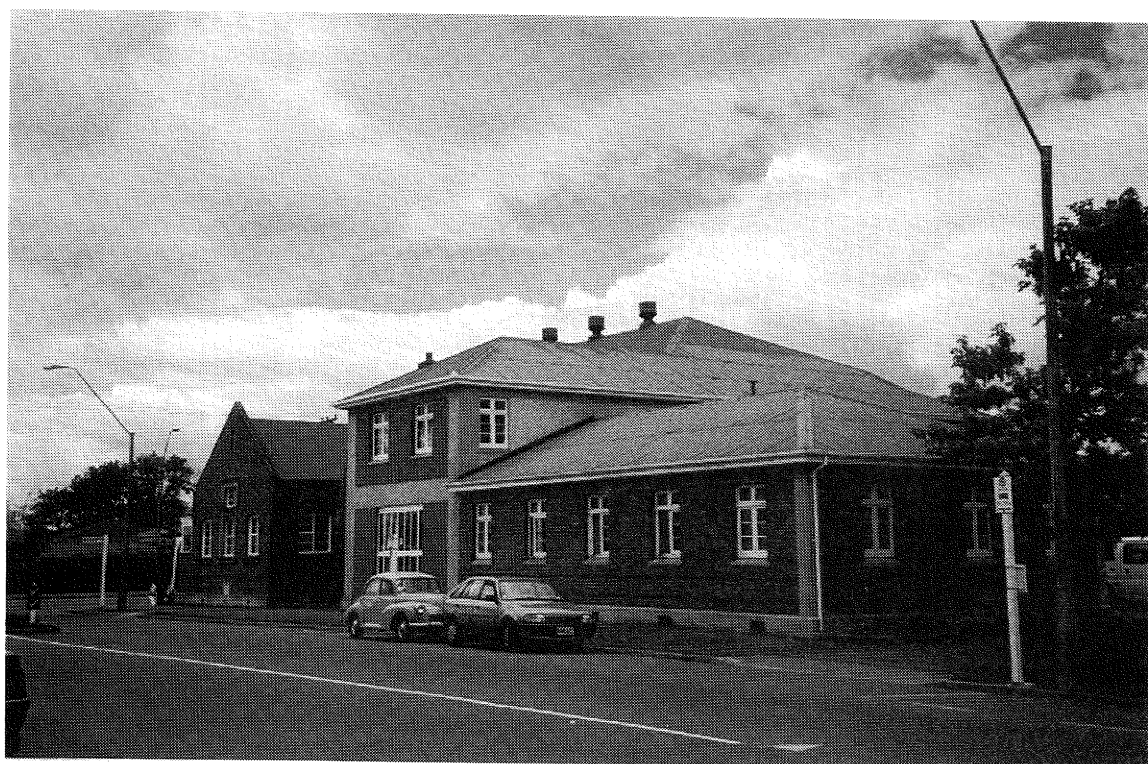
Figure 9: Present day views of 2-storey 1938 Knox Church Hall in Masterton, with a reinforced concrete frame and brick infill, which suffered little or no damage during the 1942 earthquakes. (Photograph by D.J. Dowrick, 1998).

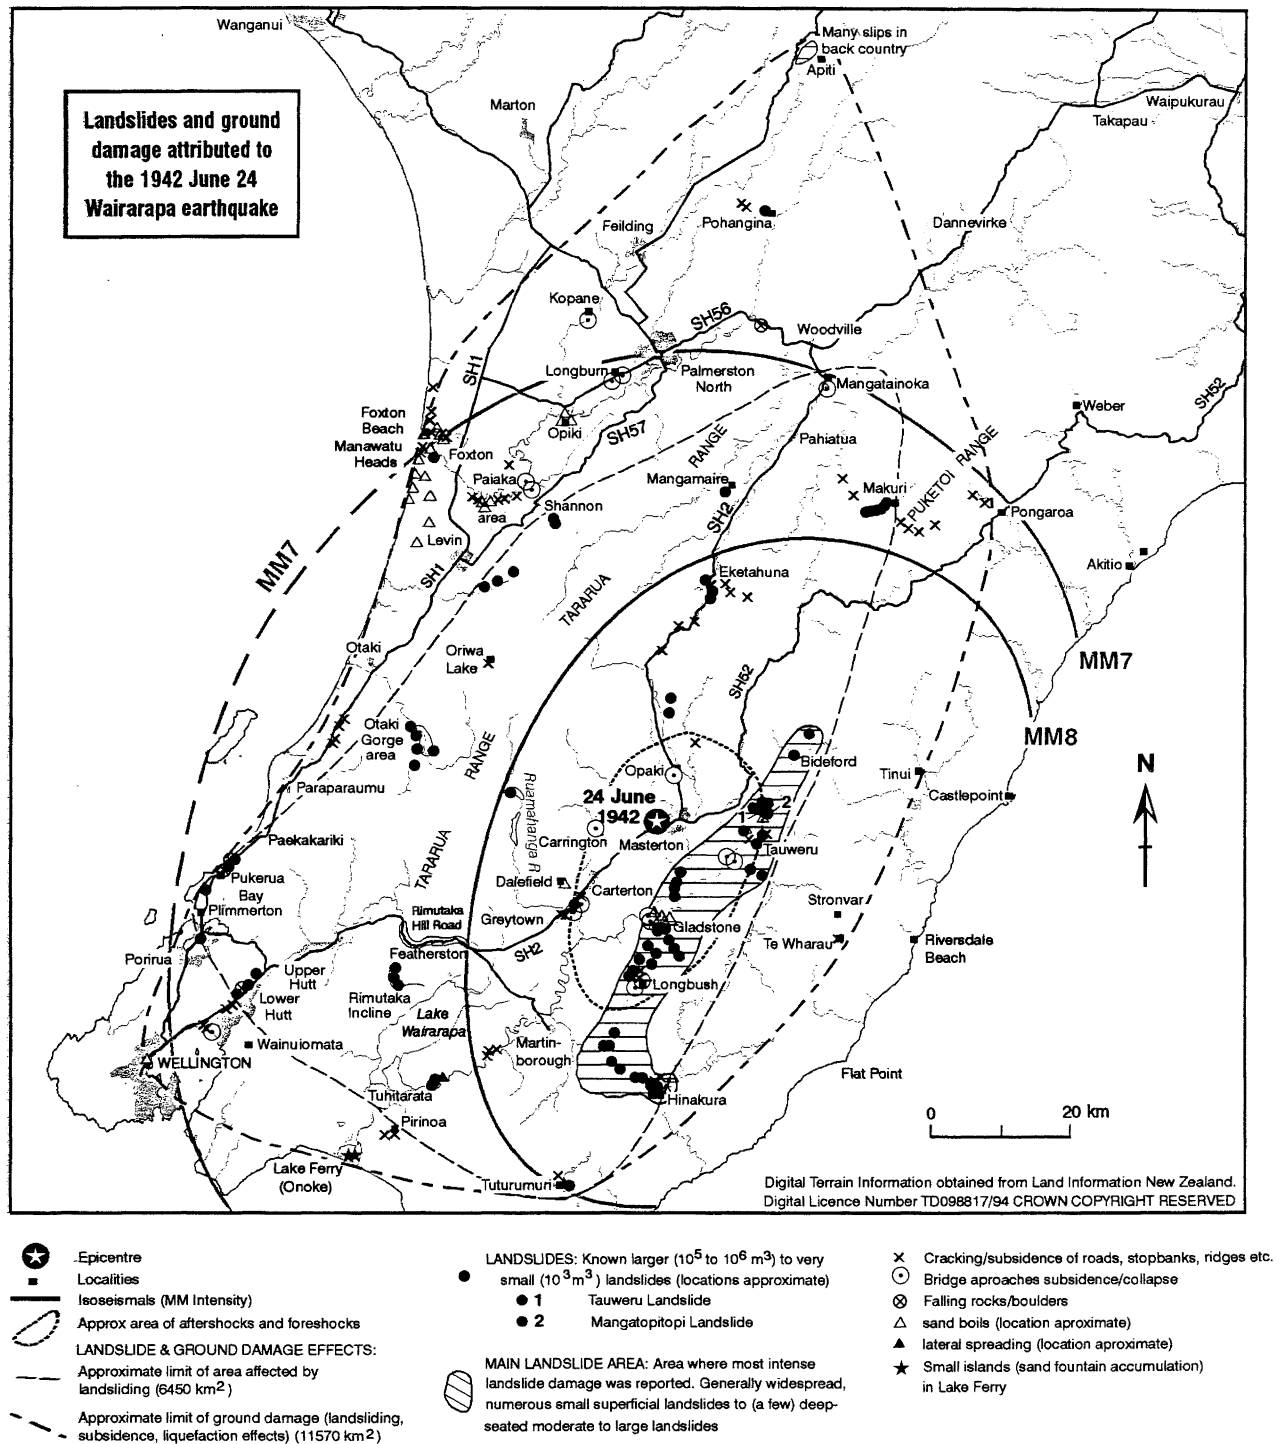
Figure 10: Geographic distribution of landslides and ground damage attributed to the June 24 1942 Wairarapa earthquake. Isoseismal lines are from Figure 3.

The June 24 earthquake caused significant, widespread landsliding and liquefaction-induced ground damage throughout an area of about 11,500 km² in the lower North Island centred near Masterton (Figure 10). This map shows the approximate locations and distribution of landslides, rock falls, liquefaction effects (sand and water ejections, lateral spreading), cracking and subsidence of roads, railway lines, and bridge approaches that were reported in newspapers, other archival sources or in [6].

The total area in which landsliding was reported was about 6,500 km². Strong shaking caused slope and road cut failures, embankment cracking, and subsidence at considerable distance from the epicentre. The most distant slope failures reported were in the Pohangina and Apiti areas (about 85 to 105 km north of the epicentre), and at Plimmerton and along the Hutt Road (about 70 km southwest of the epicentre).

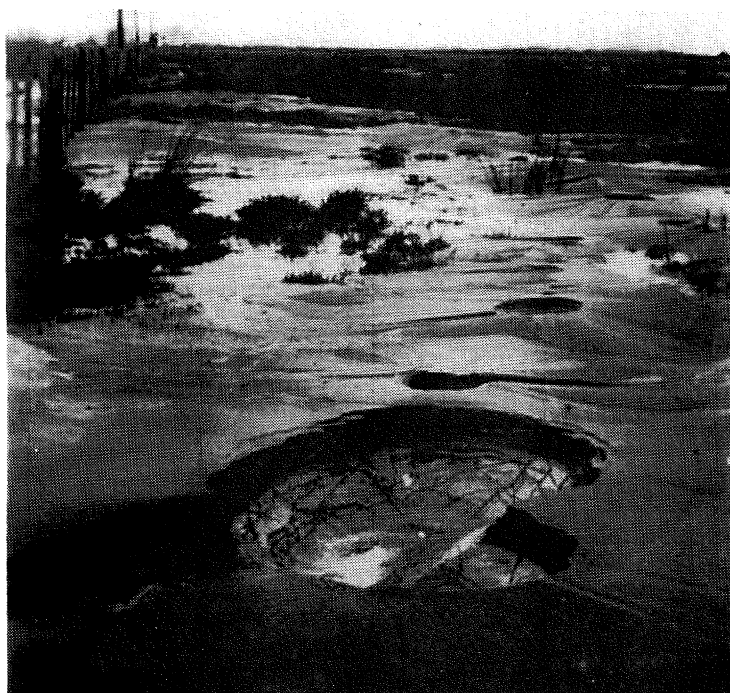
Figure 11: Sand boils at Paiake, near the Manawatu River, caused by the 1942 June 24 Wairarapa earthquake. Note patches in the background that also appear to be affected.

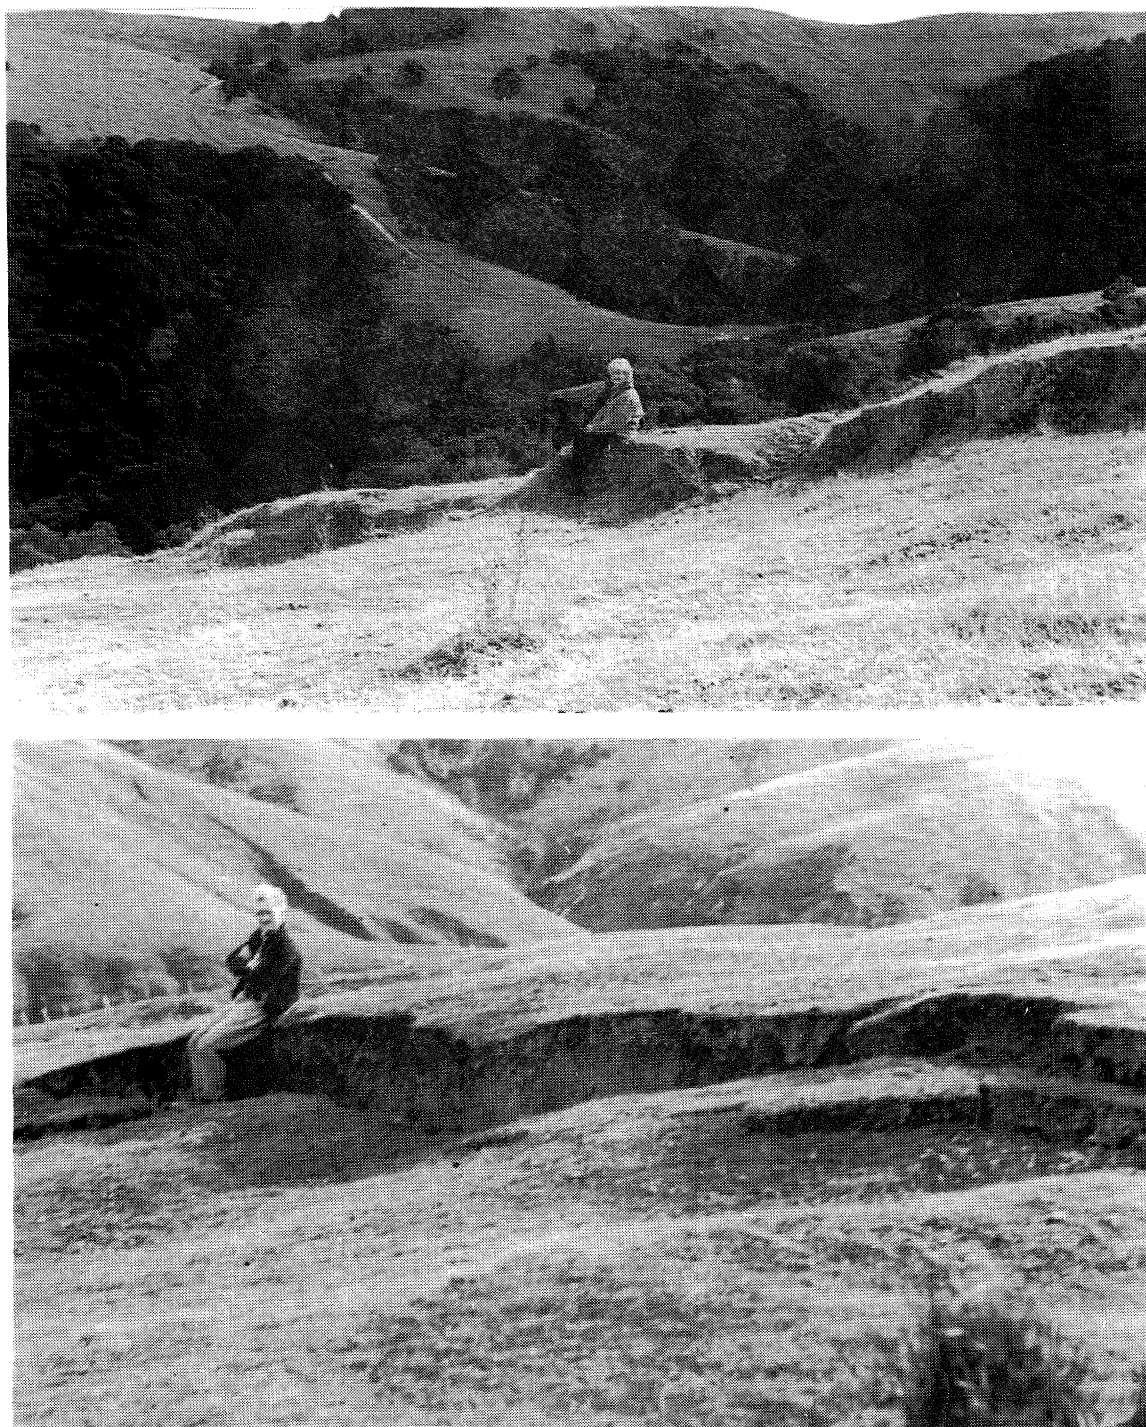
doubt triggered by the strong ground shaking generated from the 1942 earthquake. Ongley [6] describes the maximum vertical displacement across the freshly formed scarp as approximately 3 feet, and notes that the freshly formed scarp comprises only a part of a larger scarp of about 10 feet. Ongley proposed that the larger scarp height was the result of additional, older, fault

movements. The authors agree with Ongley that the larger scarp height documents repeated, older, movement, but the authors ascribe the movement not to tectonic fault rupture, but rather to landslide failure.

Figure 12: Photographs of the scarp near Tauweru (Landslide 1 in Figure 10) that Ongley attributed to surface fault rupture, now recognised as the western side of the head scarp of a large landslide. The upper photograph was taken in June 1999 at approximately the same location as Ongley's [6] Figure 4 shown below.

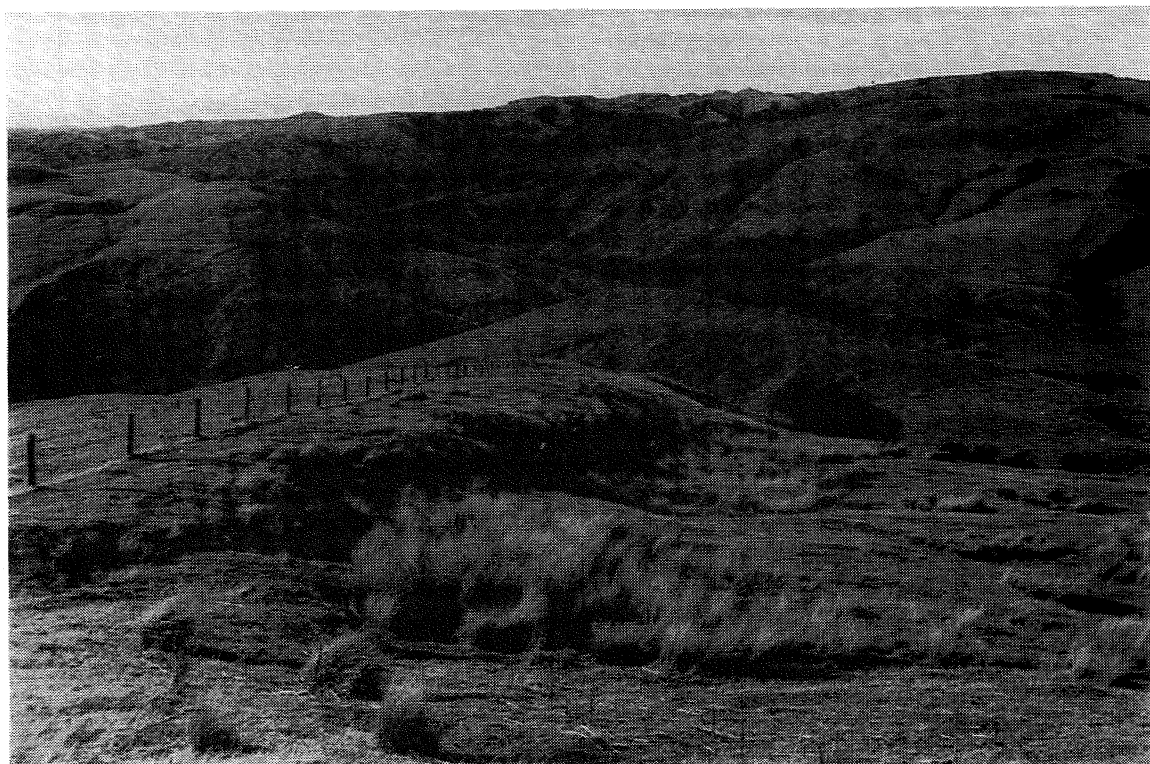
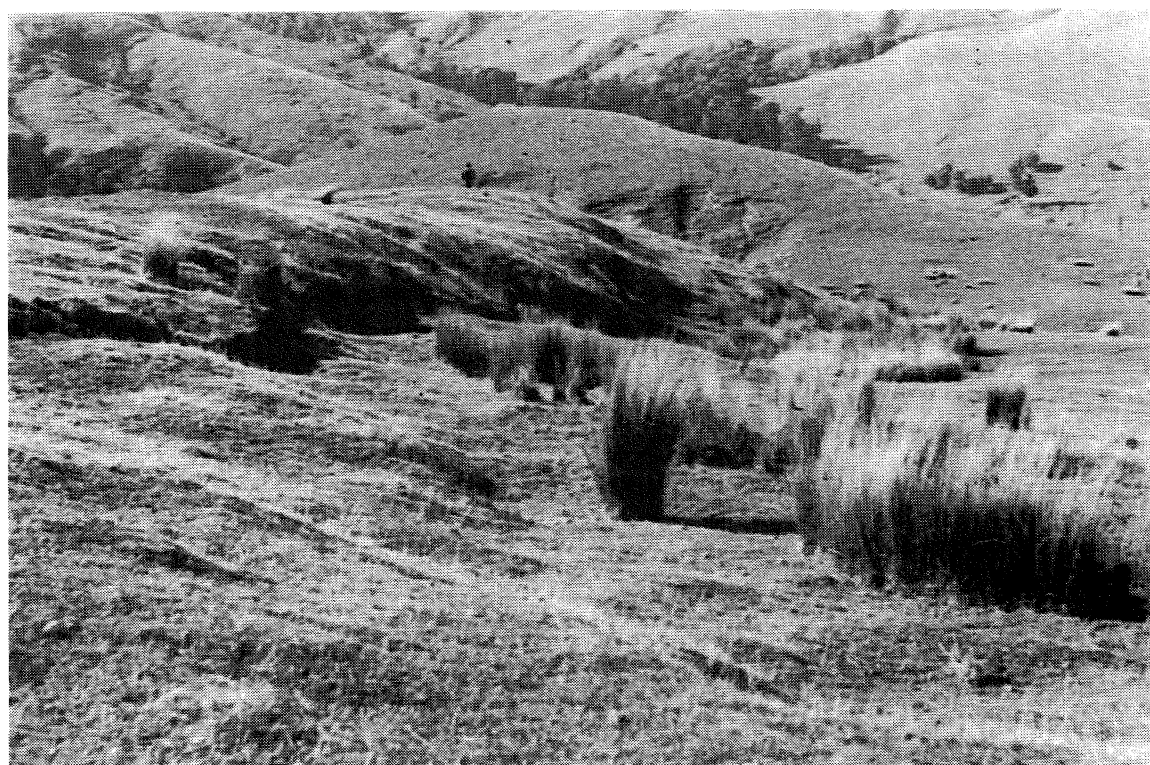
Figure 13. Photographs of the scarp near Tauweru that Ongley attributed to surface fault rupture, now recognised as the eastern side of the head scarp of a large landslide. The upper photograph was taken in June 1999 at approximately the same location as Ongley's [6] Figure 6 shown below.

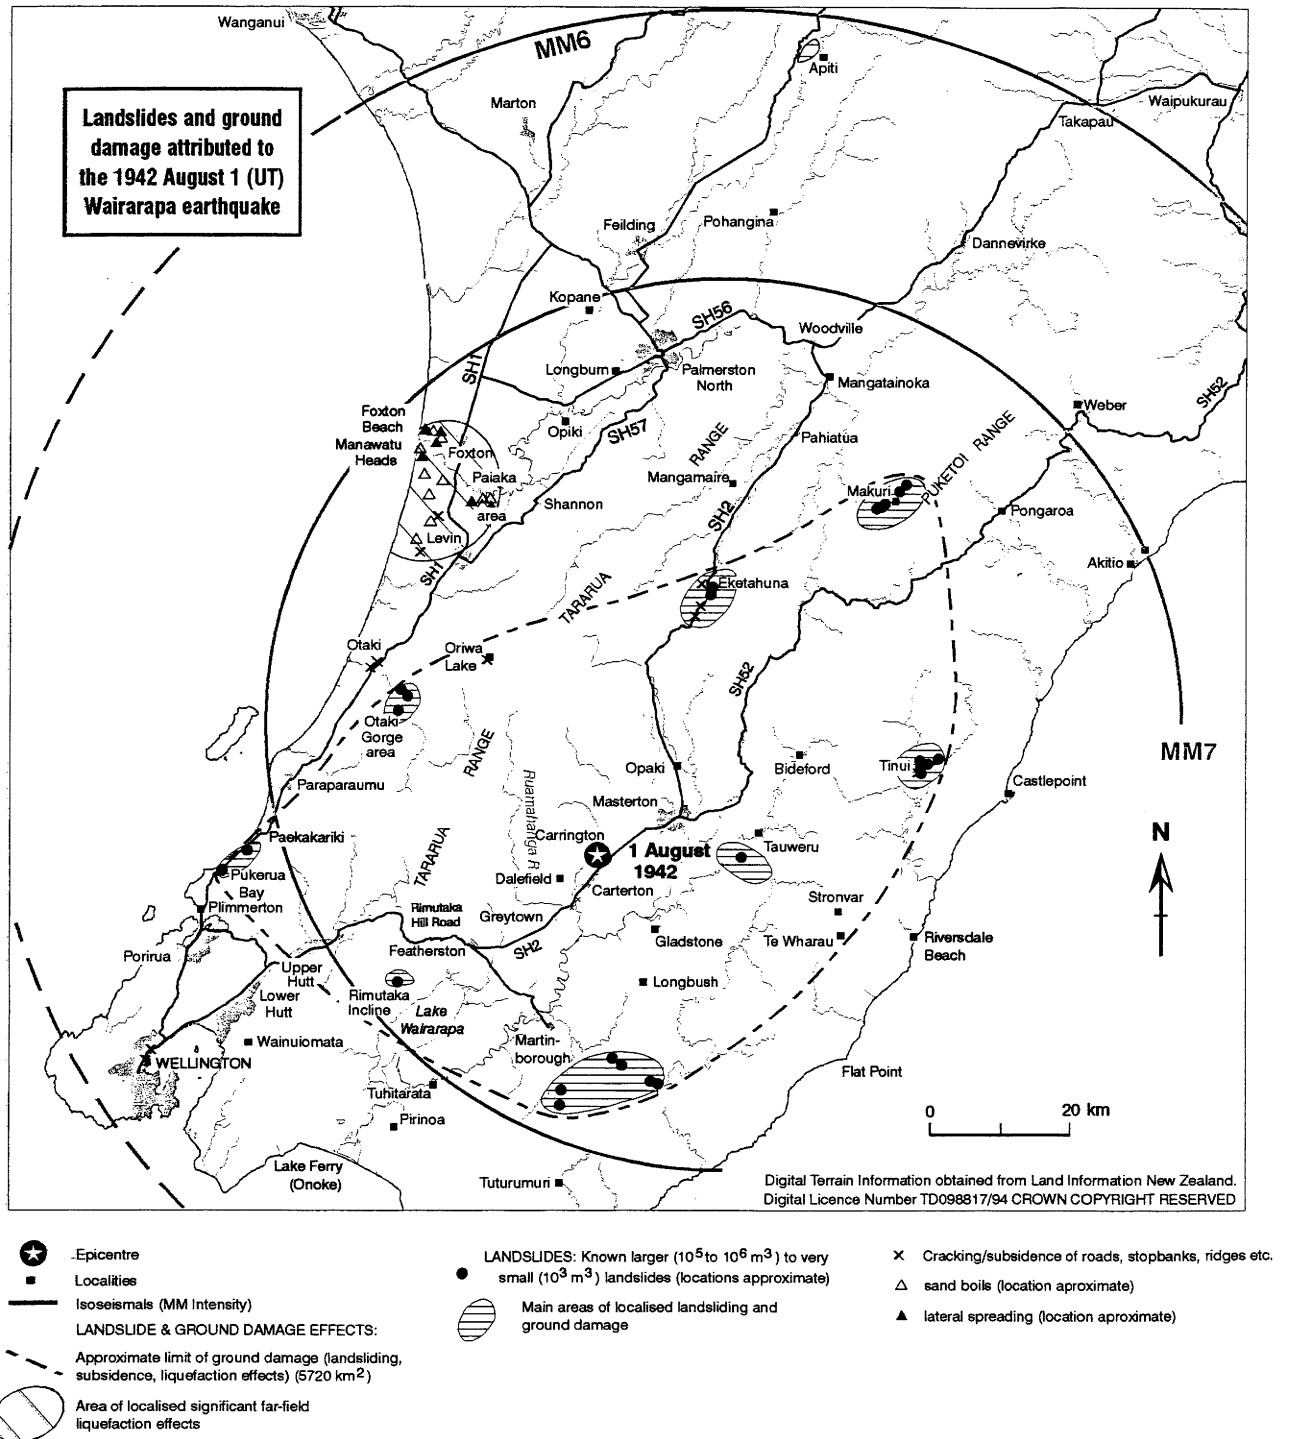
There was only moderate landslide damage in the Wairarapa, and minor subsidence of bridge approaches. The most intensive damage occurred in the Martinborough area, with all roads to the coast again blocked by slips, cracks, and subsidence. Slips again blocked the Stronvar road southeast of Masterton. In the north, slips fell on to the road south of Eketahuna, where there was also road cracking and subsidence. Again, there were numerous slips in Makuri Gorge. A slip occurred on the Rimutaka Incline between Cross Creek and the summit, and small landslides were reported in the Otaki Gorge area. The Paekakariki Hill road was closed by a "big slip" while at Pukerua Bay there was a "slight fall of earth" near the railway line. On the railway line south of Plimmerton there was no further trouble from the June slip area at Goat Point. There was little landsliding in Wellington City with only minor, very small regolith slides and falling rocks reported in a few places.

Soil liquefaction effects were also evident during this earthquake, particularly in the far field. Significant localised liquefaction effects were again reported in the Foxton to Levin area (Figure 14). Sand fountaining occurred along the river front at Foxton Beach, and bridge approaches in the area subsided. In the swampy ground in the Horowhenua area, power poles were tilted over, probably by liquefaction-induced ground failure. On the Paiaka Road to the Manawatu River (west of Shannon) widespread "sand geysers" again occurred over about 5 acres (2 ha), with sand piled up 400-500 mm and spread out over 2-4 m from some vents. Similar effects also occurred in about the same location during the June earthquake, although possibly more widespread. The widespread liquefaction effects in the Foxton-Horowhenua area indicate local shaking bordering on MM8 in an otherwise MM7 area, emphasising the high susceptibility of ground in the area to soil liquefaction and hence, microzone effects.

Figure 14: Geographic distribution of landslides and ground damage attributed to the August 1 1942 Wairarapa earthquake. Isoseismal lines are from Figure 4.

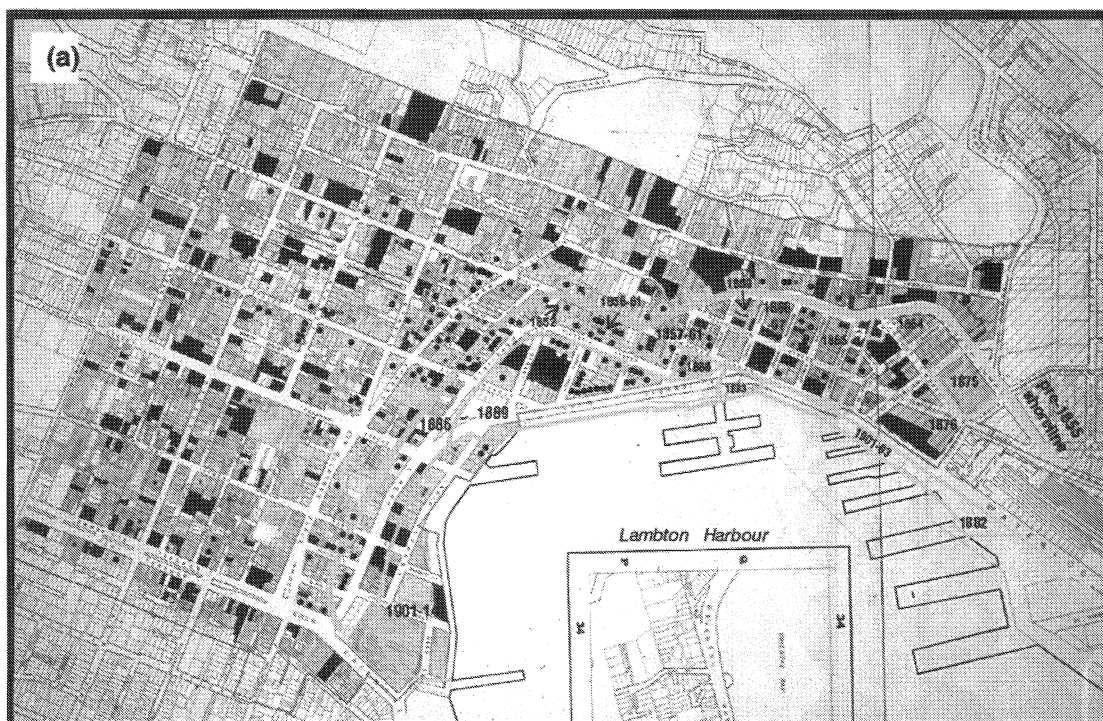
Figure 15. (a) Map (of unknown origin) of damage to commercial structures in the Wellington CBD. Black circles show damaged structures. Structures are separated into three categories: pre-1914 (red), 1914-1934 (blue), and post 1934 (black). Non-commercial structures are shown on map but are not classified as to damage
