LESSONS FOR STEEL STRUCTURES FROM THE 2009 EARTHQUAKE DAMAGE IN PADANG

Clark W. K. Hyland¹ and Sugeng Wijanto²

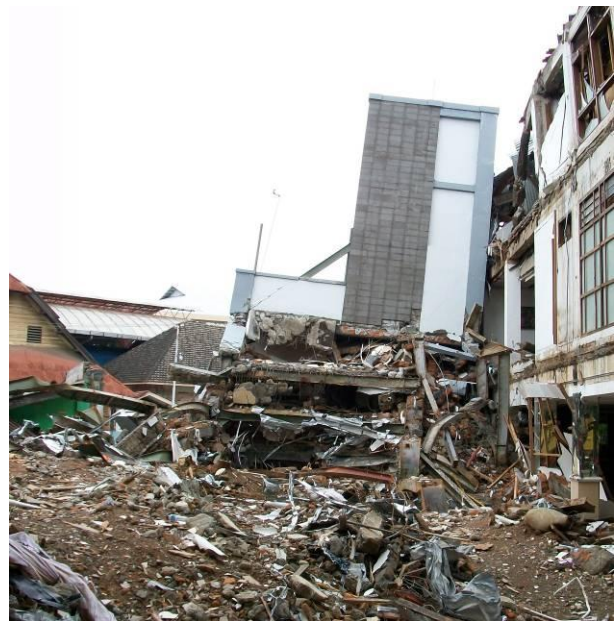
Figure 2: Collapsed 5 level two-way steel MRF addition to hotel.

The collapse of a recently built five storey single bay width addition to an existing hotel, involved a two way steel moment resisting frame (Figure 2). The five storey addition totally collapsed under bending failure about the weak axis of what appear to have been concrete encased I-section columns. Brick infill panels are likely to have been incorporated with window openings into the outer wall line. The two way moment connections at the columns appeared to have maintained integrity, so it appears that the frame had not been able to cope with large displacements in the weak axis MRF.

In New Zealand two-way MRF are avoided for seismic purposes. The preference being to use designated one-way MRF in each direction to provide the necessary stiffness and strength. Such an approach also avoids the issue of concurrent actions at columns in two-way MRF. Secondary $p-\delta$ moment

6. The design for weak-axis bending of two way moment resisting steel frames requires careful attention to secondary effects and should be avoided where possible.

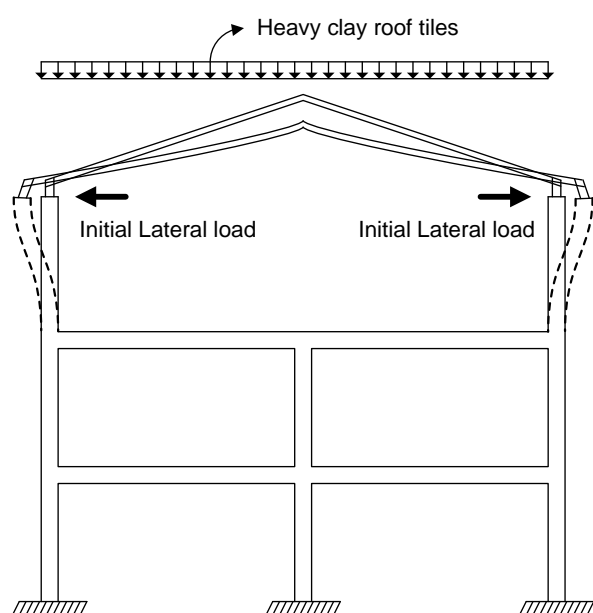
Figure 3: Reinforced concrete columns spread through shake-down of heavy tiled pitched steel roof.

A particular case of this behaviour was found in Pariaman where the upper level reinforced concrete columns supporting a simply supported pitched portal roof with heavy tile roofing, had spread outwards at opposing wall faces (Figure 3). If the pitched rafter had been tied then there would have not been any lateral dead load thrust at the column heads to cause the non-self centring behaviour. This would have been architecturally unappealing. The alternative would have been to design the cantilevered columns to act elastically in

response to the seismic “parts and portions” actions loads combined with the dead load lateral thrusts imposed by the rafter.

7. Non-self centring structural elements need to be identified at design stage and designed to minimise inelastic behaviour during ultimate limit state earthquakes.

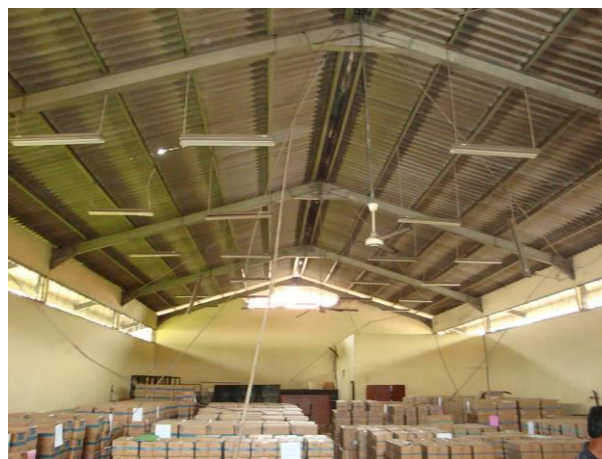
Figure 4: Collapsed roof level rod bracing in warehouse.

Diagonal rod roof bracing collapsed in a portal framed warehouse with high masonry walls. The rod bracing had broken free from the rafters after failure of the weld connecting the rod bracing plate to the rafter (Figure 4). The weld appeared to be a site weld, raising the issue of how to ensure site welding quality when performed at height. From a design perspective the weld should never be the weakest link in a primary structural member such as a roof bracing rod. The preferred hierarchy of failure is that ductile elongation of the rod itself protects against connection failure at the rod ends. The rod connection therefore needs to be able to cope with the over-strength demand of the rod.

8. Diagonal bracing rods should be designed to avoid failure within couplings. Consideration should also be given to the dynamic response of the roof level bracing system to heavy wall induced lateral loads.

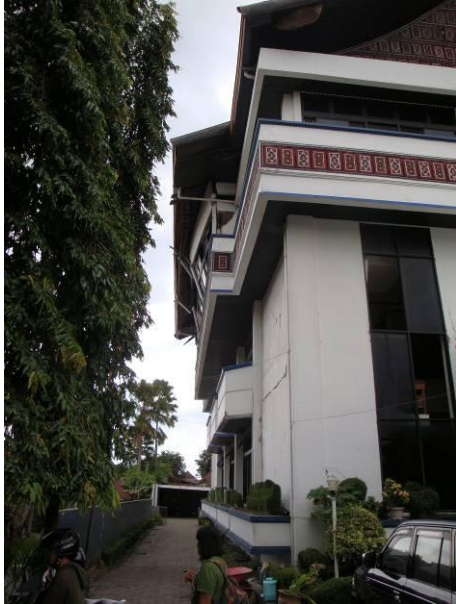
Figure 5: Wall panel detached from roof steelwork above drive way.

Concrete masonry panels around the top storey of a three storey office building detached from the roof steelwork in a number of locations around the perimeter of the building (Figure). The panels were found to be in danger of falling onto the access-way below. It wasn't clear how the panels had been attached to the roof steelwork which was still in good condition.

9. Connections at the interface of steel work with concrete and masonry sub-trades needs to be carefully monitored to ensure intended design performance is achieved.

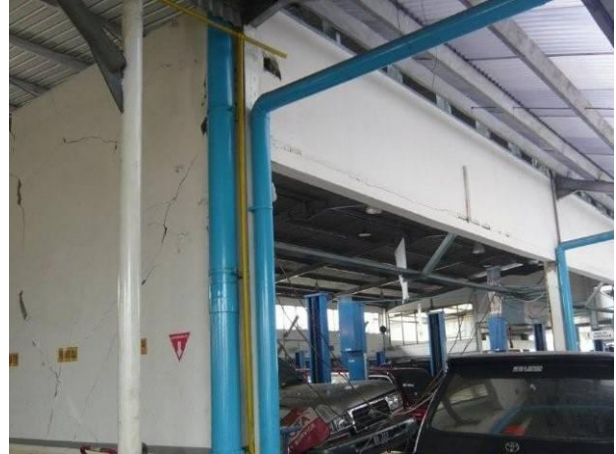
Brickwork supported on steel lintel beams broke free under face loading over exit ways in many cases and could have been a cause of serious injury of those escaping the buildings (Figure). These instances reinforced the requirement in New Zealand to tie back free standing brick veneers against face loading damage.

Figure 6: Brick infill panel on steel lintel typical of the type that collapsed under earthquake face loading.

10. Unreinforced masonry without lateral tiebacks should be avoided on lintels over egress ways.
11. A guide for typical structural repair methods would be a useful tool for post-earthquake use, to quickly identify appropriate repair strategies and allow initial repair cost budgets to be developed.
