BUILDING SAFETY EVALUATION FOLLOWING THE 30 SEPTEMBER 2009 PADANG EARTHQUAKE, INDONESIA

SUMMARY

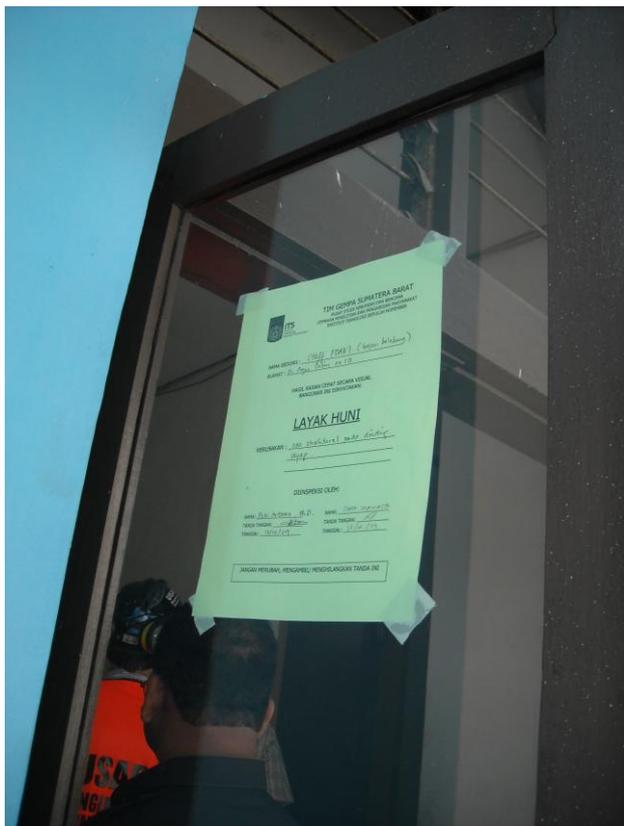
Figure 2: Example of a Rapid Assessment placard placed by local engineers.

Local agencies had posted some placards of their own in the days following the earthquake—an example is shown in Figure 2. These had not been consistently applied across the areas of greatest damage (understandable given the sheer scale of the damage), and contained only limited information. The NZ Engineering Team developed draft placards, adapted from the New Zealand version and translated into Indonesian. However neither of the Public Works agencies supported the NZ Engineering Team posting placards, despite our encouragement to do this in order to define safe and unsafe areas more clearly in some marginal structures. Their reasons included the lack of regulatory backing and the uncertainty that they believed these additional placards would create amongst the public. We also acknowledged that we would only be posting placards on some structures, and that this
