GEOTECHNICAL RECONNAISSANCE OF THE 2010 DARFIELD (CANTERBURY) EARTHQUAKE

Editors: **Misko Cubrinovski¹, Russell A. Green²**

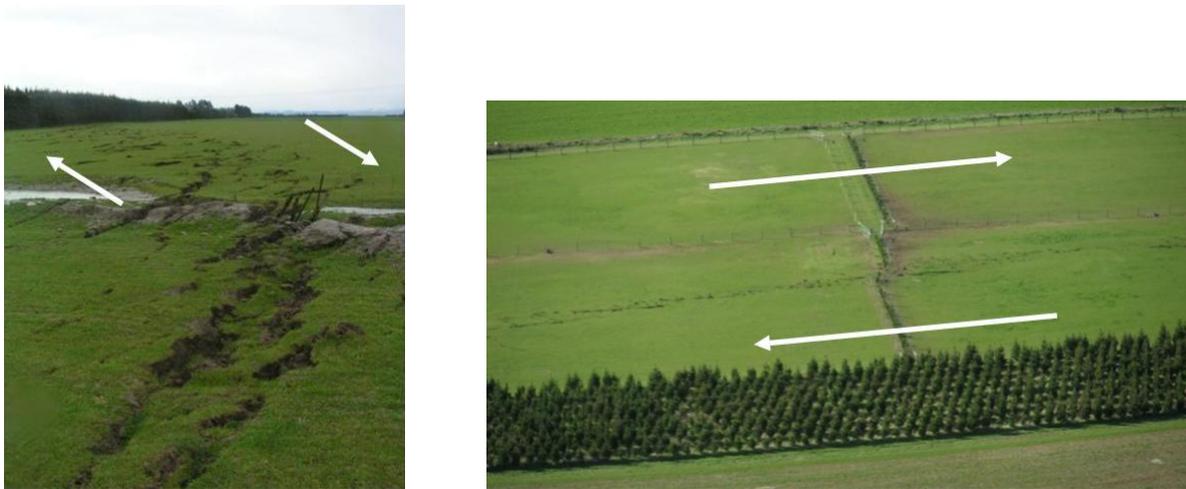
Figure 2.3: Photographs of surface fault rupture on the Greendale fault. (Left photo: <http://daveslandslideblog.blogspot.com/2010/09/images-of-darfield-canterbury.html>).

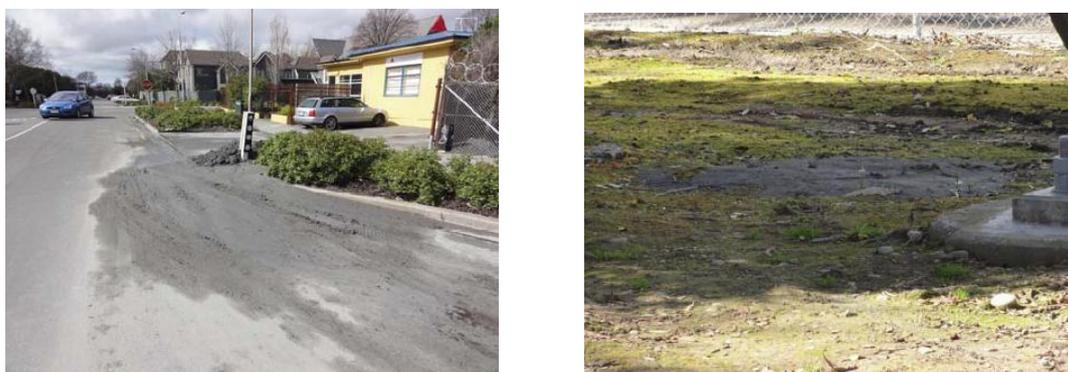
(a) Evidence of liquefaction at Peterborough St - Madras St (CBD); (b) Sand boil in the foundation soils of a transmission tower (sub-station northeast of Greers Rd - Ruddenklau Ln, Bishopdale).

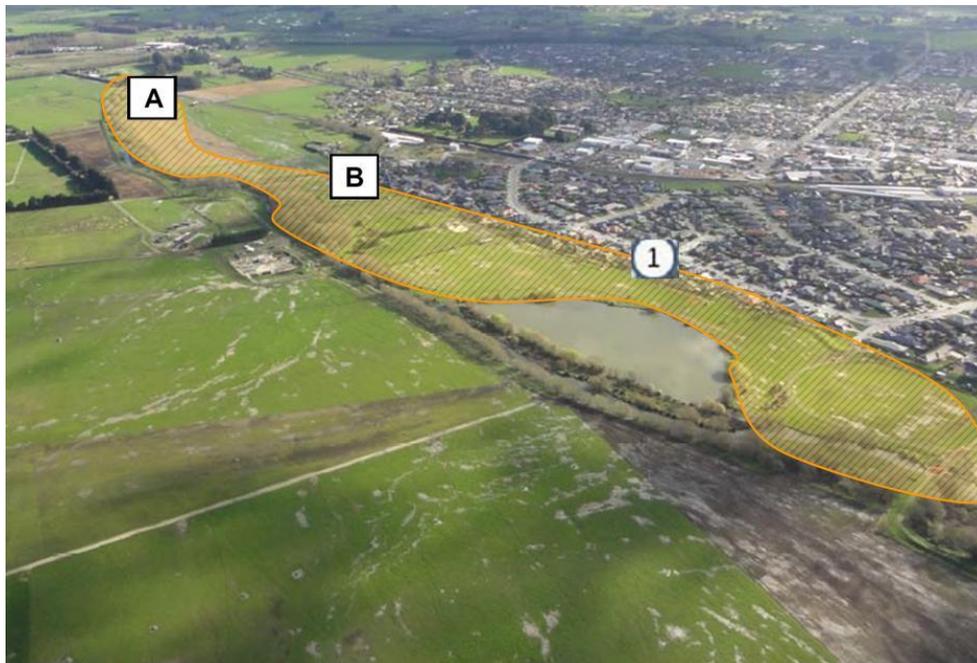
(a) Sand boils and area affected by lateral spreading around Courtenay Lake (from a helicopter flyover on Friday September 10).

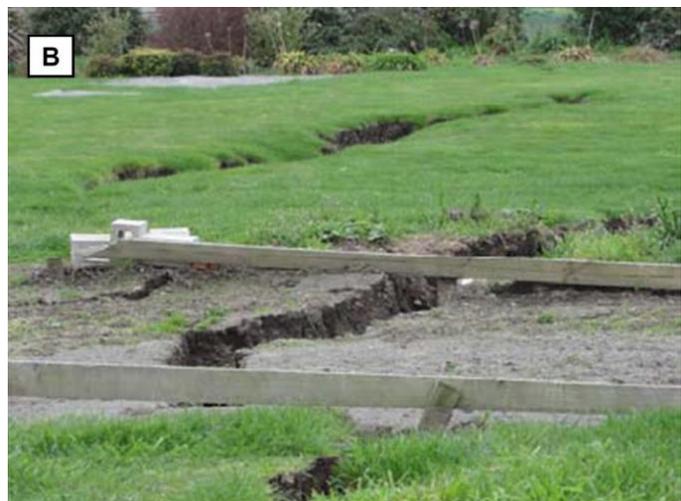
(b) Large lateral spread cracks in farm land (at B: 43.3941389°S, 172.659750°E).

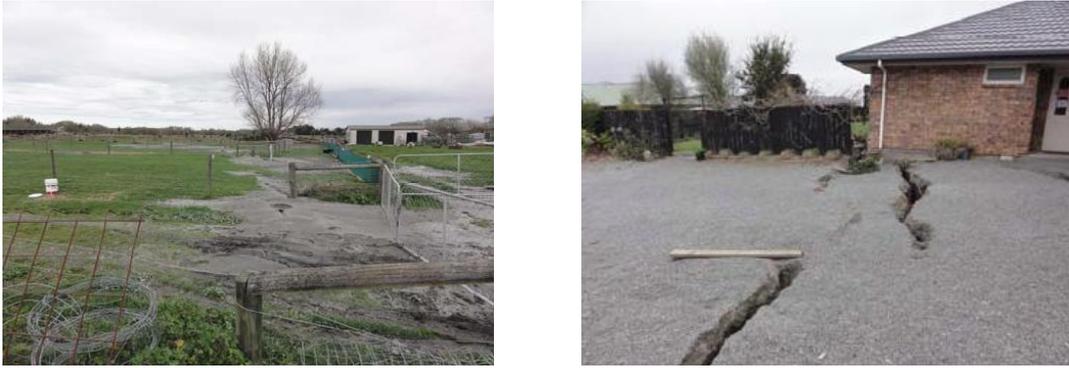
(a) Sand boils and lateral spread cracks.

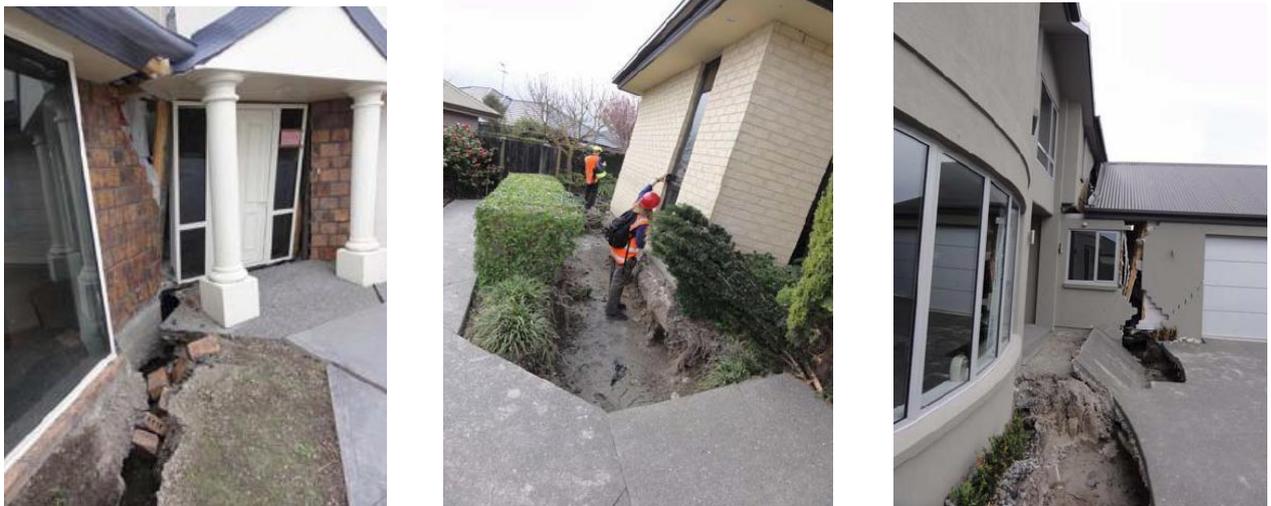
(b) Effects of lateral spreading in residential area.

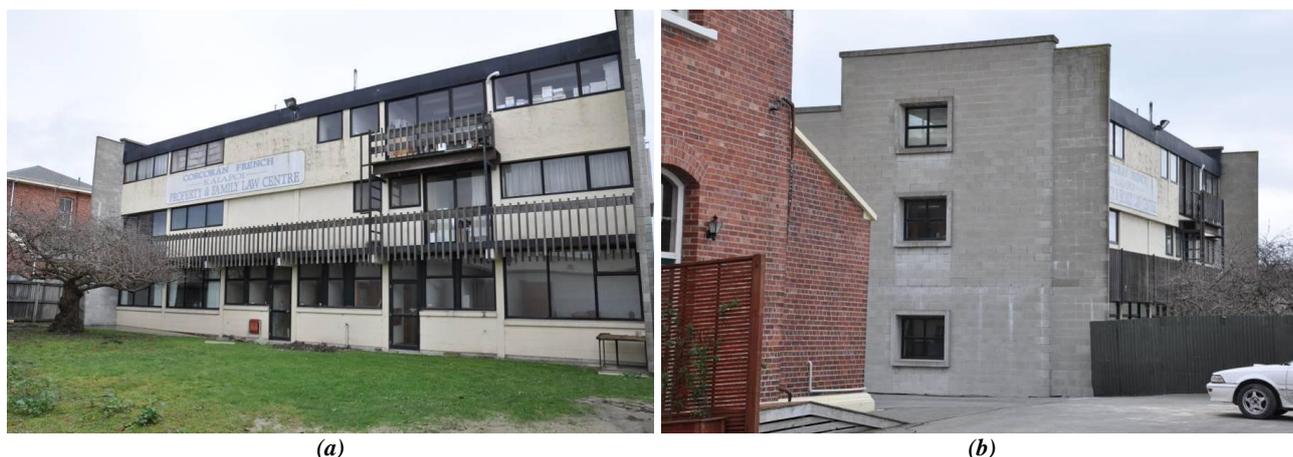
Figure 5.7: *Property and Family Law Offices in Kaiapoi business district. (Williams St.) (a) View looking northwest (at long axis end) of building and (b) view looking northeast showing shear wall ends of short axis of building.*

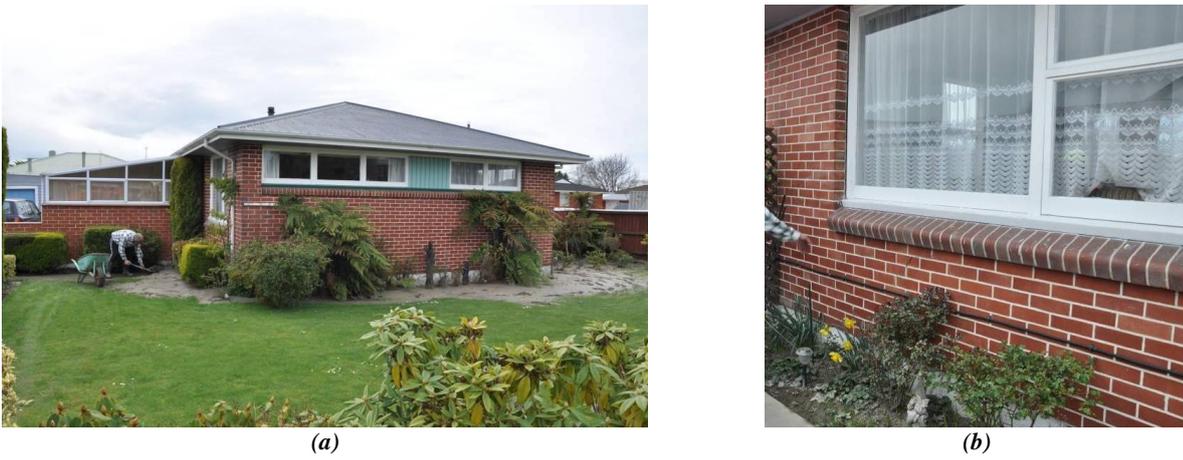
Figure 5.15: Residence along Charles Street. (a) Ejecta surrounding home and (b) owner points out shear cracking and gapping developed between window and brick due to structures movement.

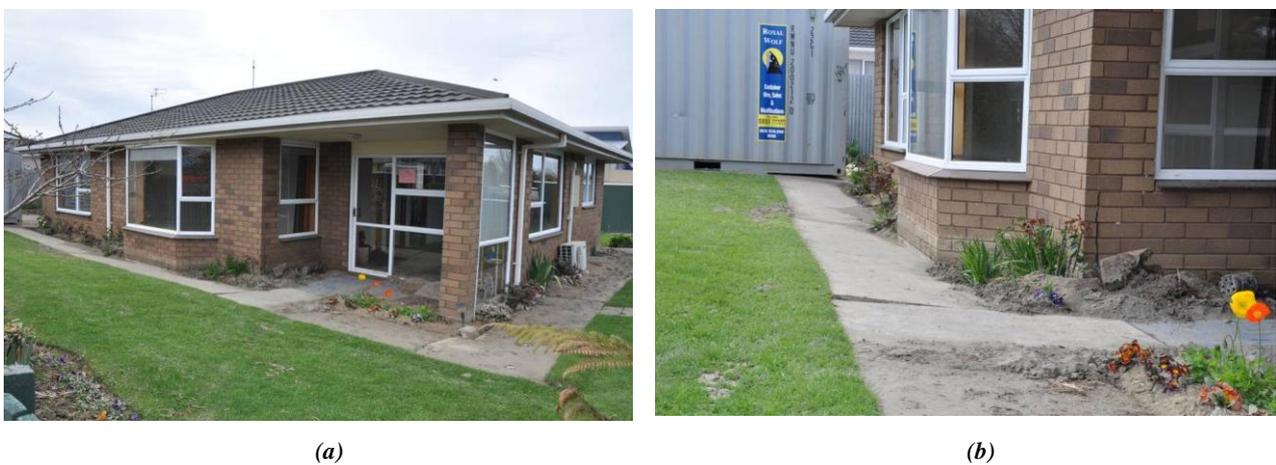
Figure 5.17: Red tagged residence on Charles Street. (a) View looking east and (b) north end of house, view looking North-East.

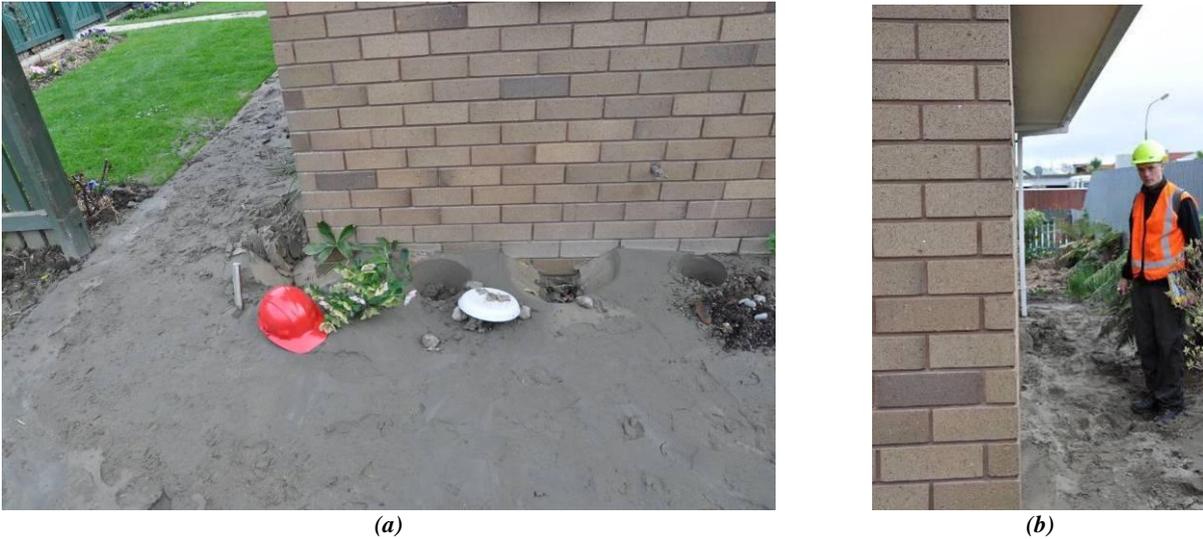
Figure 5.18: Red tagged residence on Charles Street. Extensive surrounding ejecta at perimeter of home.

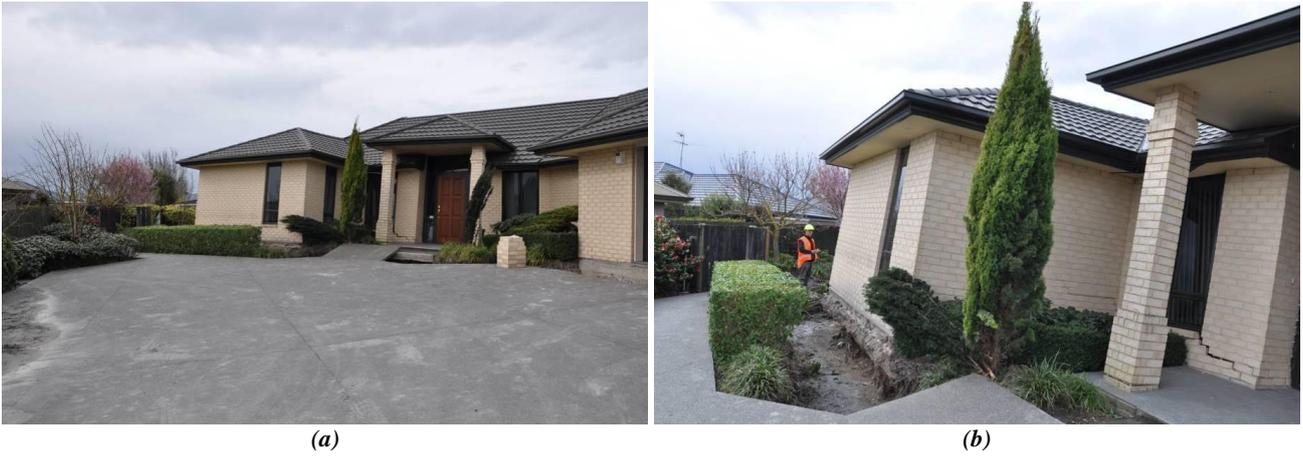
Figure 5.21: *Damage to a residence at Courtenay Drive in the South Kaiapoi residential community (front of home articulating excessive tilt and separation of foundation from surrounding hardscape).*

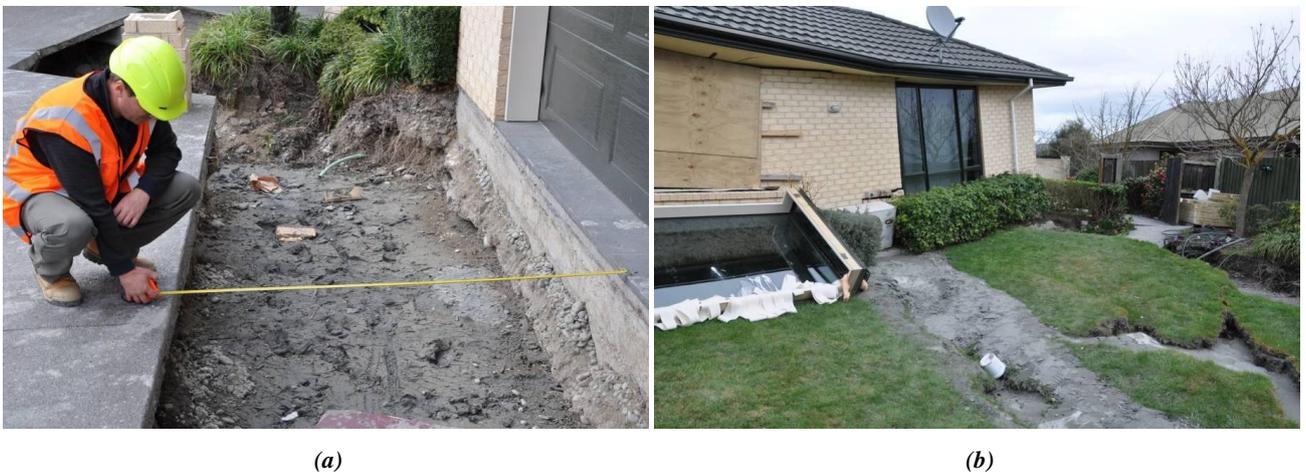
Figure 5.22: *Damage to a residence at Courtenay Drive in the South Kaiapoi residential community (a) front of home (1.5 m separation between garage and approach slab) and (b) back of home.*

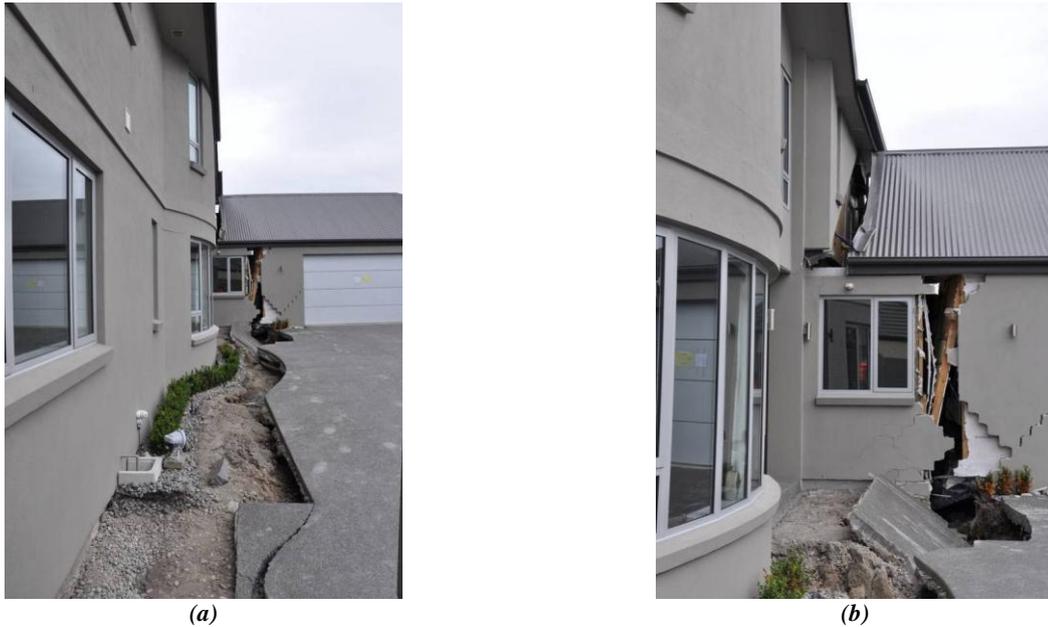
Figure 5.24: *Damage to a residence along Courtenay Drive in the South Kaipoi residential community. Front entry articulates extensive damage as large ground spreading subtends into the superstructure.*

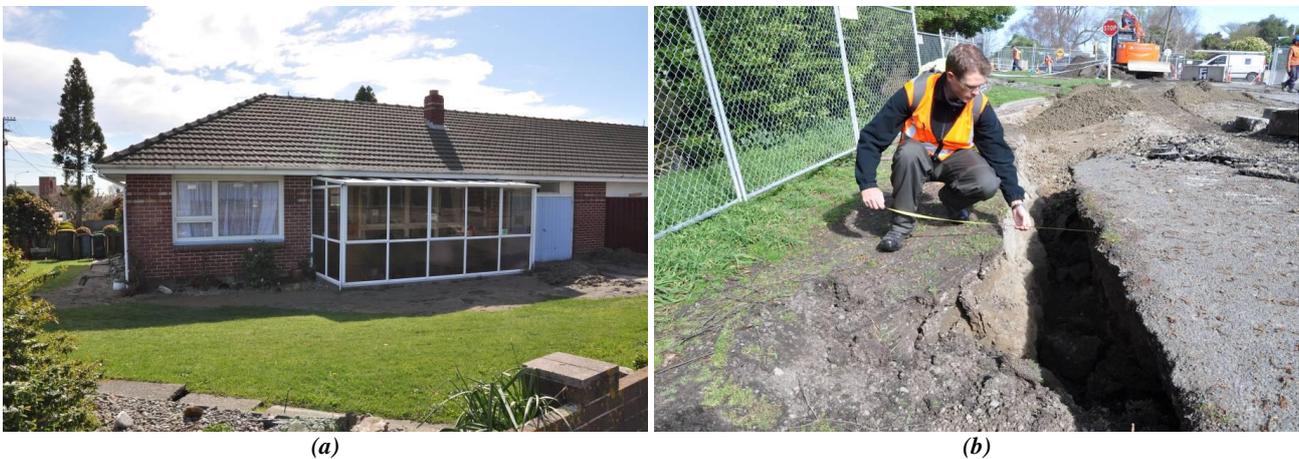
Figure 5.25: *(a) Rigid body rotation of a residence in Dallington (Locksley Avenue) due to liquefaction and (b) lateral spread features directly fronting the home. Surveys of ground features at this location are associated with T7 (refer to Figure 5.27).*

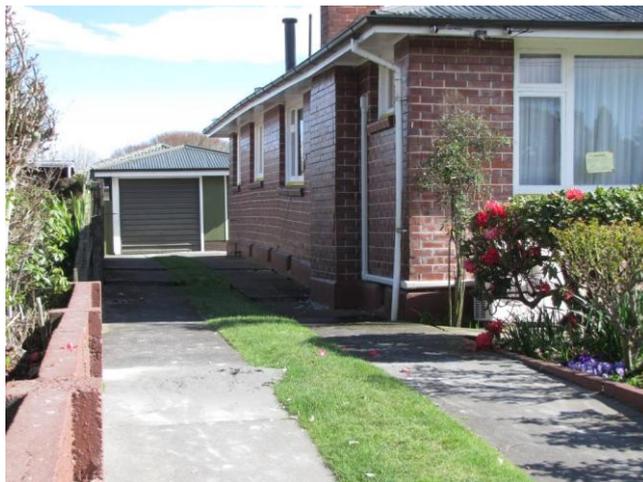
Figure 5.26: Residence affected by lateral spreading along the driveway which has induced differential settlement between the front and rear of the house. (Note that this is not a slab-on-ground house, rather an older style of construction with a concrete perimeter beam and the timber floor being supported on shallow foundations; Locksley Ave).

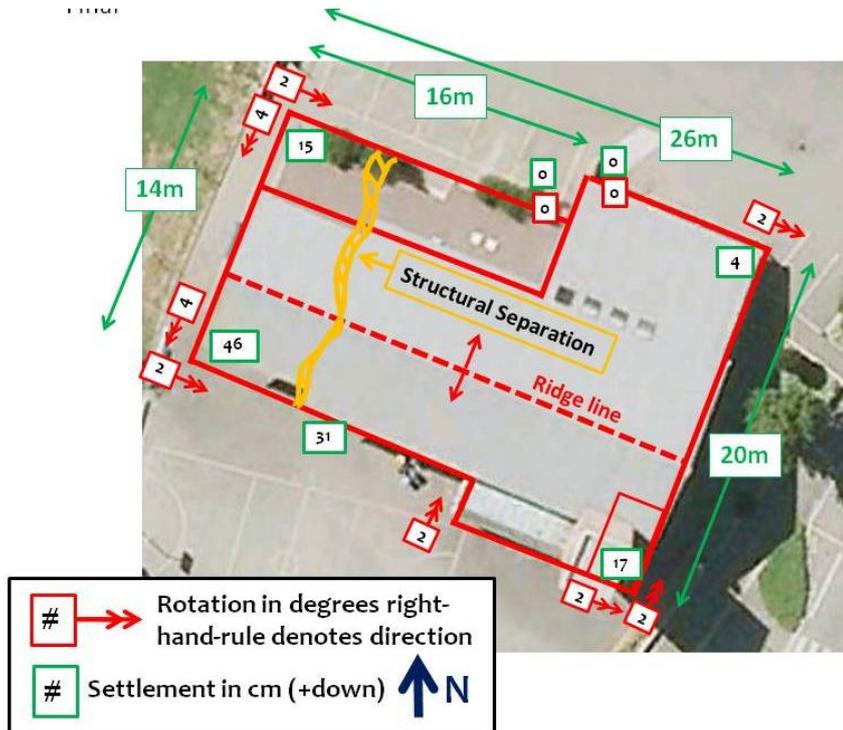
The geotechnical reconnaissance team performed a detailed survey at St Paul's Church (Gayhurst Rd, Dallington) which suffered damage due to liquefaction in the foundation soils (Chapter 5). Figure 4.5 shows a complex pattern of ground distortion including large cracks and vertical offsets around the building. Extensive sand boils covered the paved area around the building, backyard lawn, and around the perimeter of the building and its foundations. The building suffered large differential settlements and severe structural damage.

Figure 5.29: St. Paul’s church damage map – survey conducted 12 September 2010; Global dimensions approximate (extracted from Google Earth image), deformation obtained directly in the field.

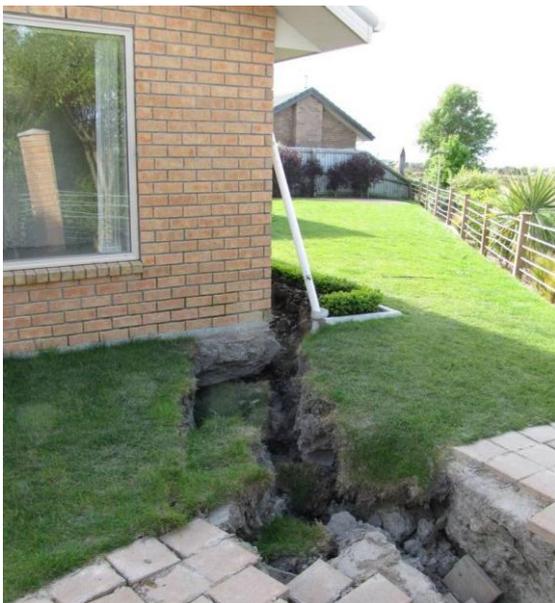
Figure 5.38: Lateral spreading compromising ground support beneath the concrete slab-on-grade house foundation. (Kokopu Street).

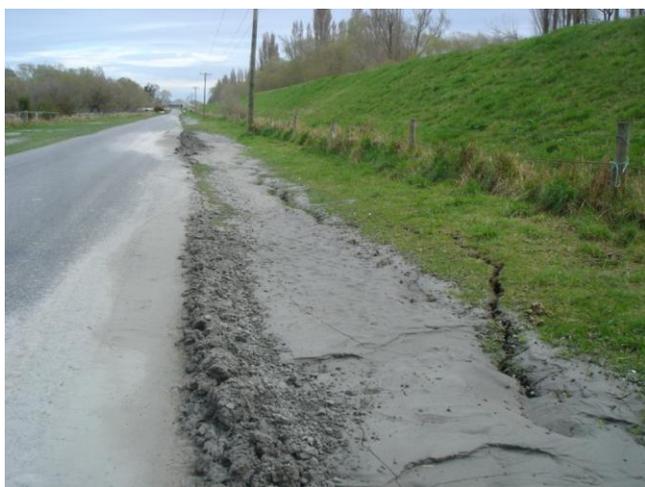
Figure 6.5: *Photo 2: Crack running along base of stopbank on Coutts Island Rd (landside) and liquefaction ejecta. (43.424466°S, 172.629907°E).*

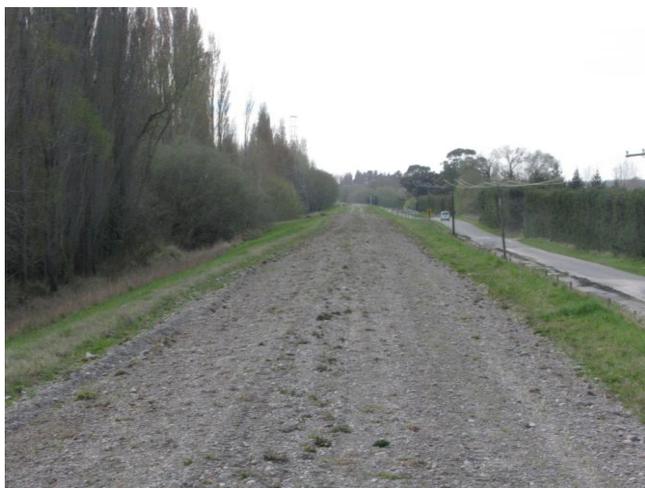
Figure 6.7: *Photo 4: Road on top of stopbank that had recently been regraded, presumably after the earthquake to fill in longitudinal cracks formed during the earthquake. Liquefaction was observed along the base of both sides of the stopbank along this stretch. (43.423943°S, 172.631045°E).*

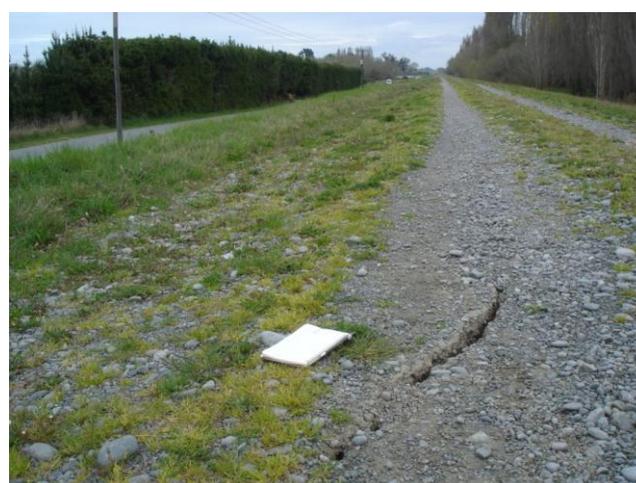
Figure 6.8: *Photo 5: ~20 mm wide crack running lengthwise along the top of the stopbank on Coutts Island Rd. This crack was at the edge of the ~0.5 km stretch of the stopbank where significant liquefaction was observed. Photo taken looking southwest (43.423440°S, 172.632349°E).*

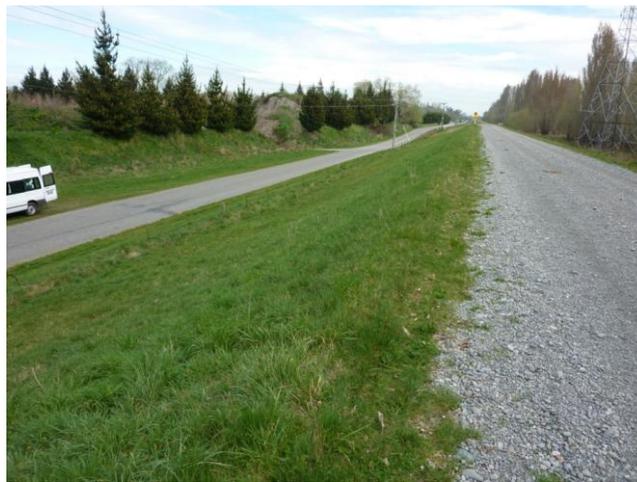
Figure 6.9: Photo 6: Stretch of stopbank without evidence of liquefaction. In the distance, a small rise can be seen in the road. This rise is the start of the ~0.5 km stretch where liquefaction was observed along the base of the stopbank. (43.4225°S, 172.6350°E).

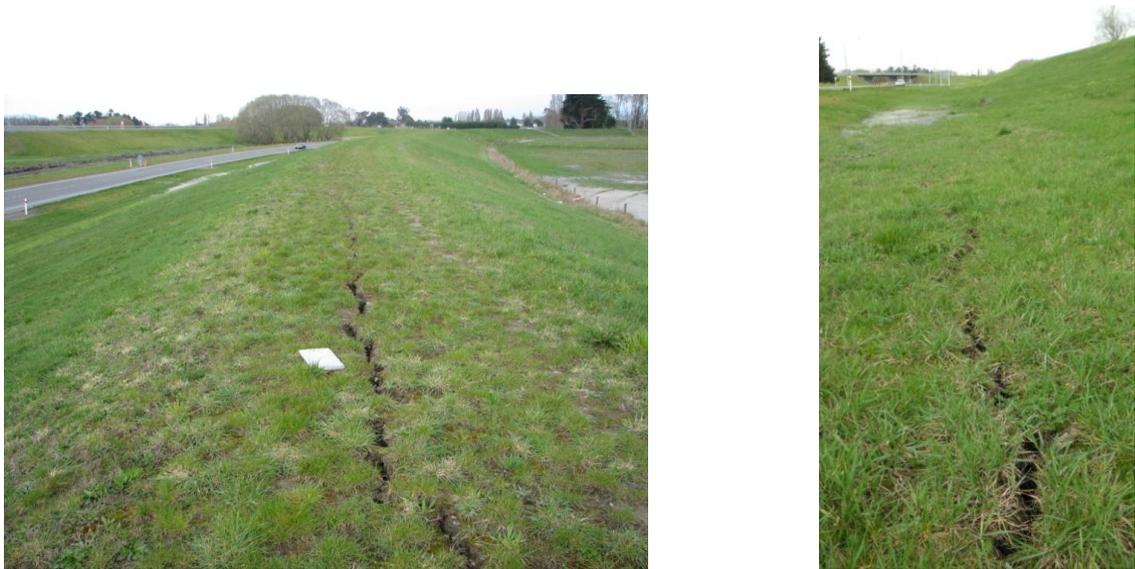
Figure 6.15: Photos 9 and 10: ~50 mm wide longitudinal cracks running along the crest (left) and base (right) of a secondary stopbank for the Waimakariri River. Photo taken looking southwest; SH1 on left of stopbank (43.430108°S, 172.643434°E).

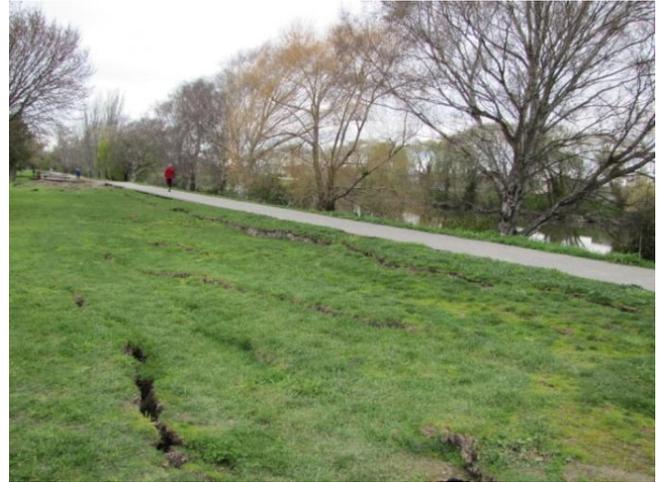
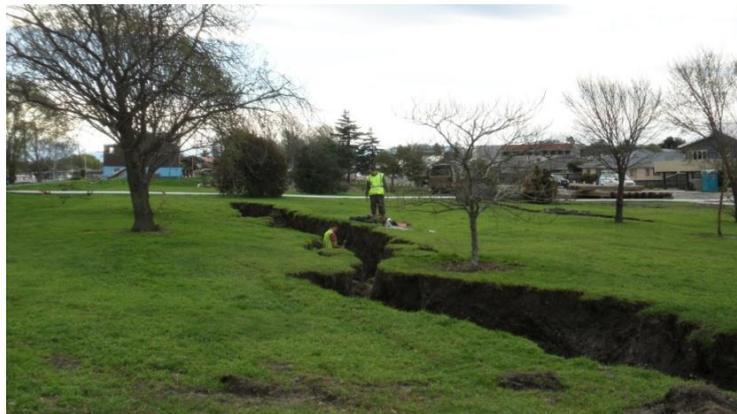
Figure 6.18: Photos 16-18: Lateral spread cracks along landside of the stopbank on the north side of the Kaiapoi River. The locations of these photographs are denoted in Figure 6.2. (43.384484°S, 172.660653°E).

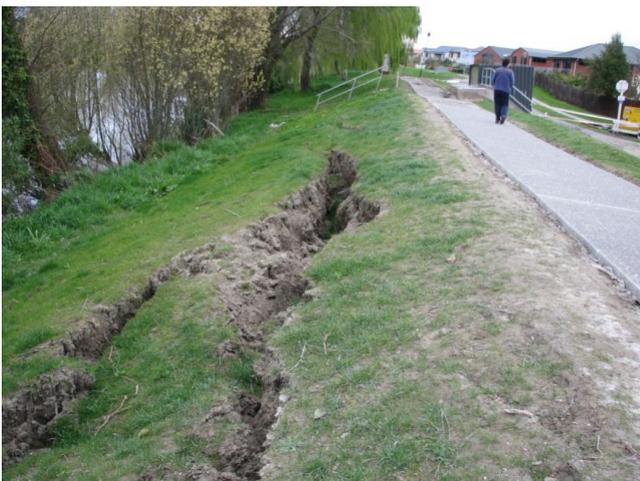
Figure 6.23: *Photo 25: Lateral spread cracks along riverside stopbank on the south side of the Kaiapoi River. The location of this photograph is denoted in Figure 6.2. (43.385254°S, 172.660131°E).*

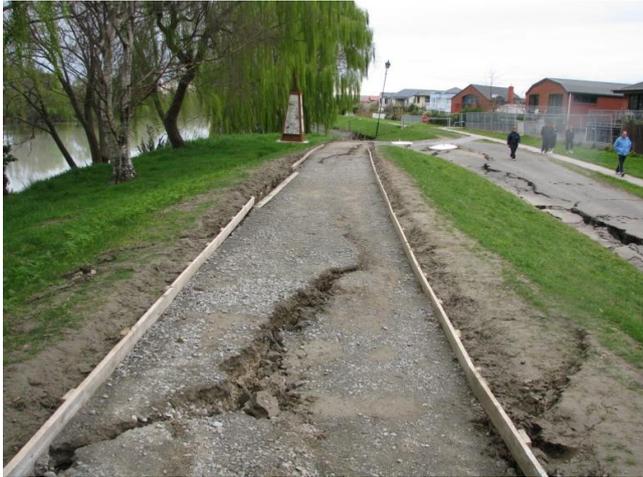
Figure 6.25: *Photo 27: Lateral spread cracks along the top of the stopbank on the south side of the Kaiapoi River. The location of this photograph is denoted in Figure 6.2. (43.385693°S, 172.660688°E).*

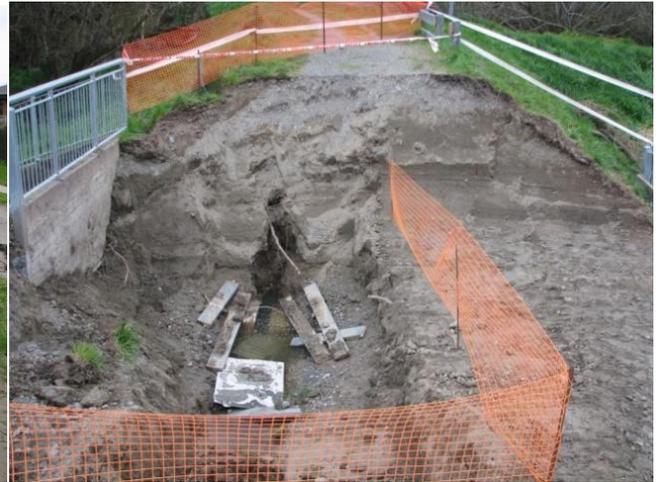
Figure 6.26: *Photo 28: Failed drainage conduits running underneath the stopbank on the south side of the Kaiapoi River. The location of this photograph is denoted in Figure 6.2. (43.388679°S, 172.666203°E).*

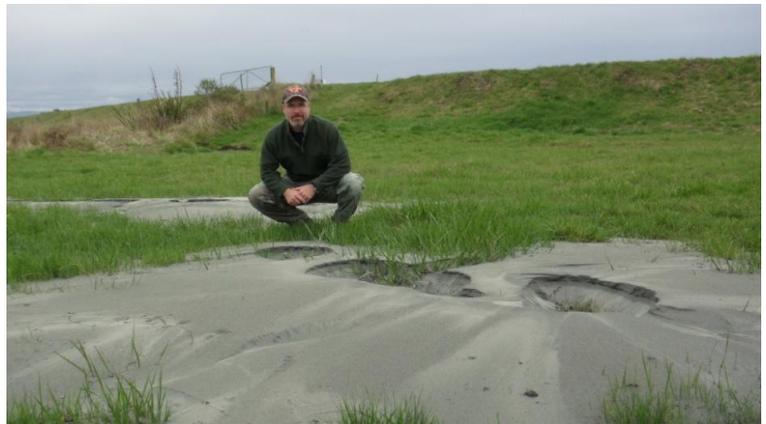
Figure 6.28: *Liquefaction and lateral spread features on or near stopbanks located about 100 to 200 m west of the Kaiapoi Sewage Treatment Plant. (upper left: 43.389175°S, 172.683235°E; upper right: 43.389701°S, 172.683390°E; bottom left: 43.389519°S, 172.682203°E; bottom right: 43.389432°S, 172.6682060°E).*

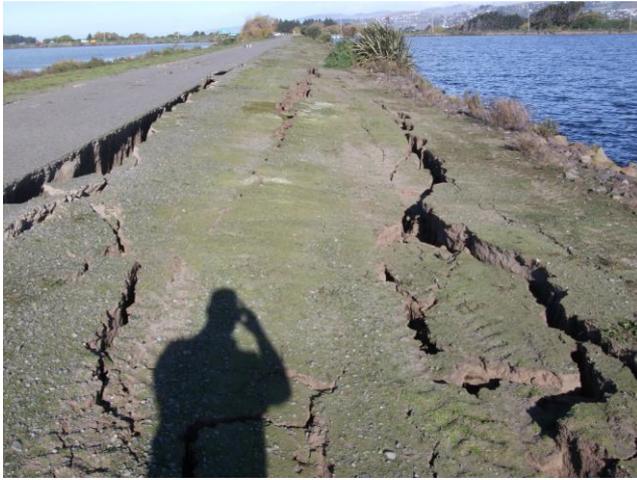
Figure 6.31: Lateral spread cracks running parallel to Dyers Road adjacent to Pond 2A. (-43.531393°, 172.712473°).

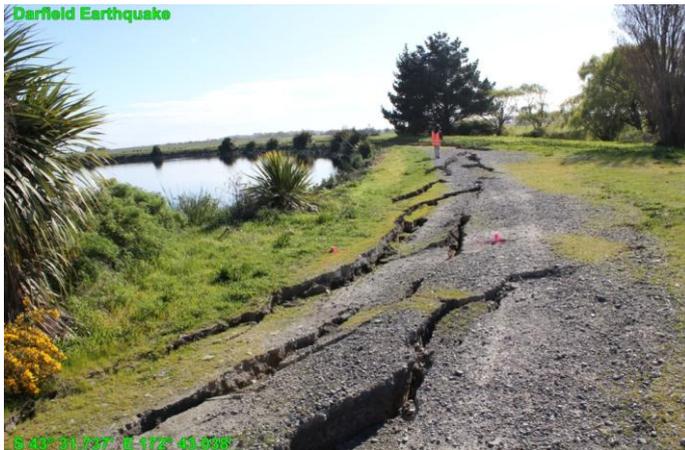
Figure 6.33: Lateral spread cracks at the eastern end of Pond 2B. The sink hole in the foreground of the photo on the right formed over the top of two outlet pipelines. (-43.52895°, 172.717300°).

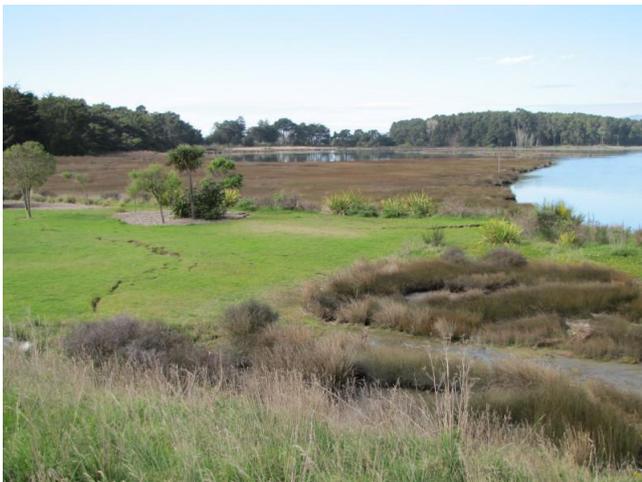
Figure 7.3: *Lateral spreading of east banks adjacent to the Bridge Street Bridge.*

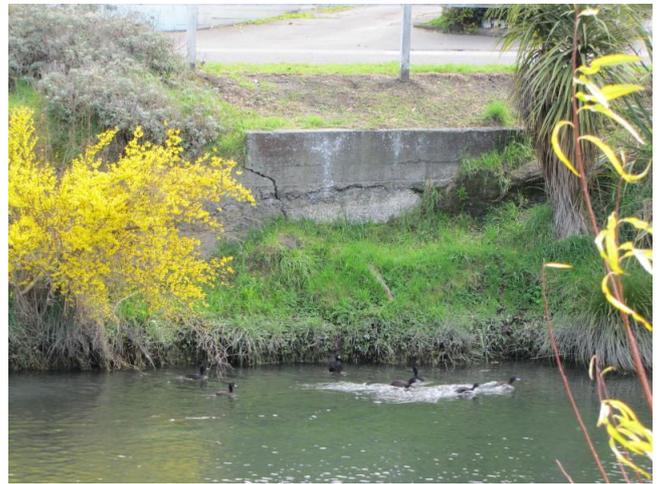
Figure 7.15: *Cracking of retaining wall, north bank of the Avon River.*

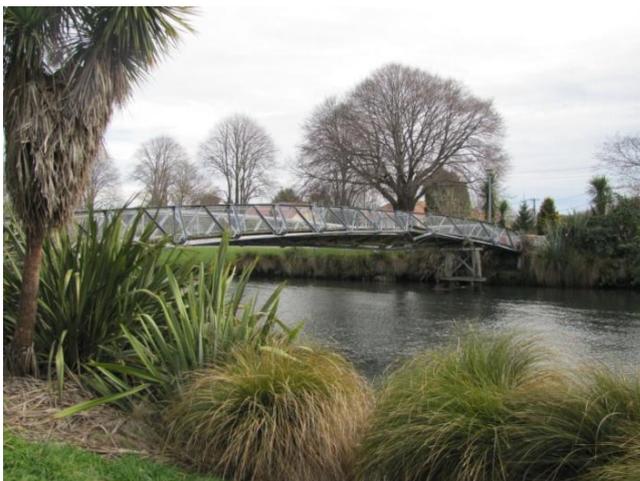
(a) *Buckled span.*

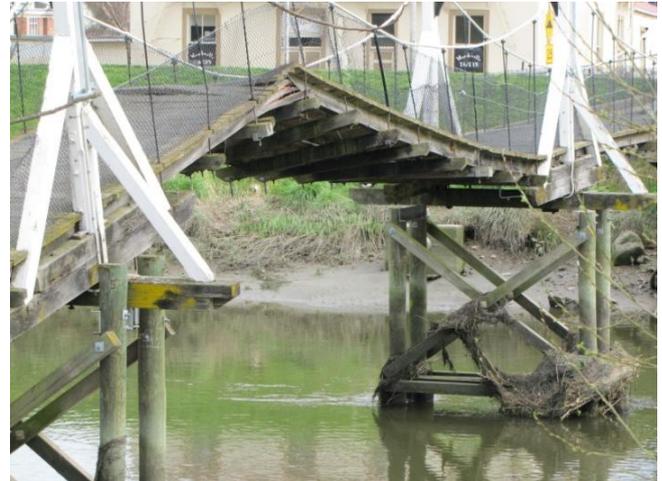
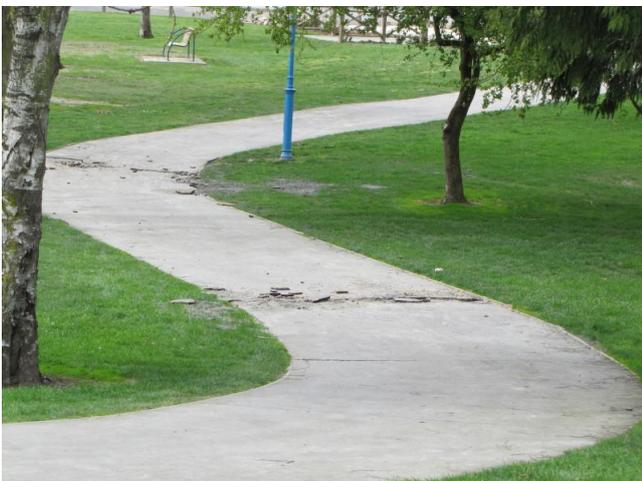
Figure 7.20: Cracking of sidewalk and evidence of liquefaction in Trousselot Park.

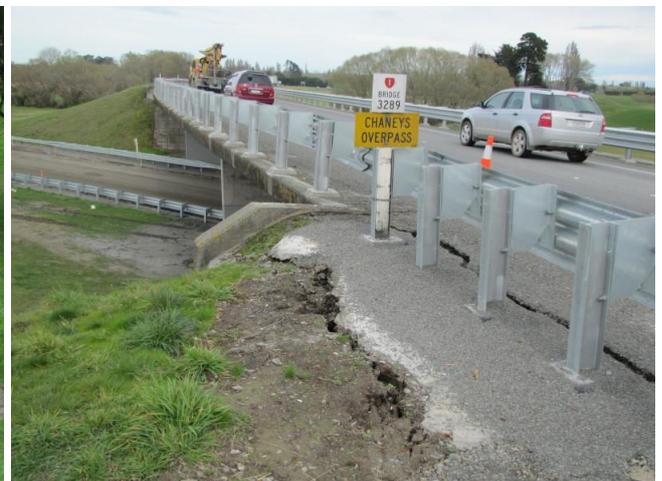
Figure 7.21: Incipient lateral spreading at Chaney's Overpass north abutment.

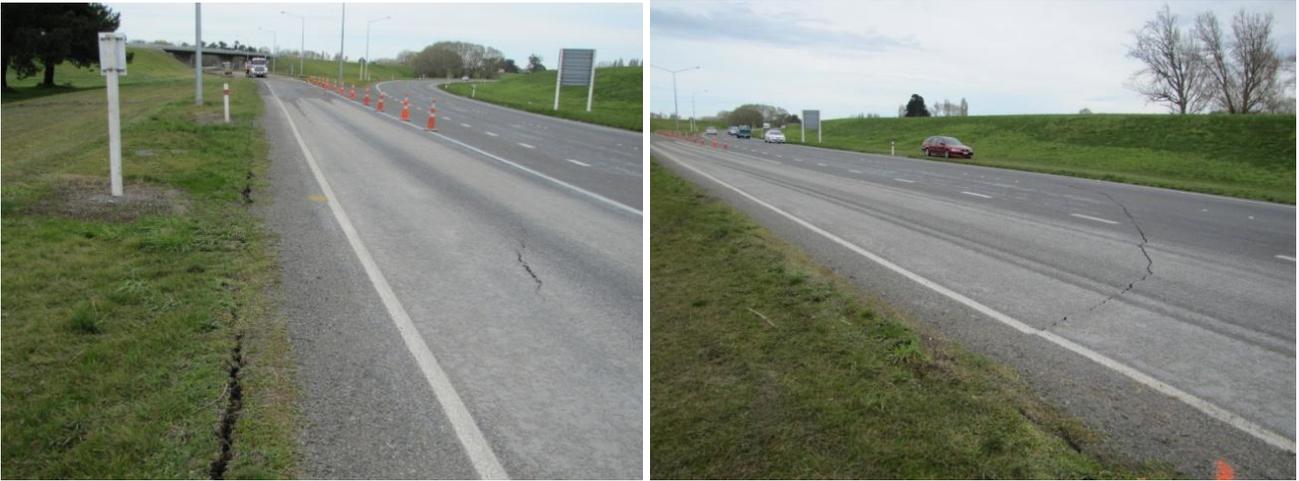
Figure 7.26: Cracking in and along roadway adjacent to Chaney's Overpass.

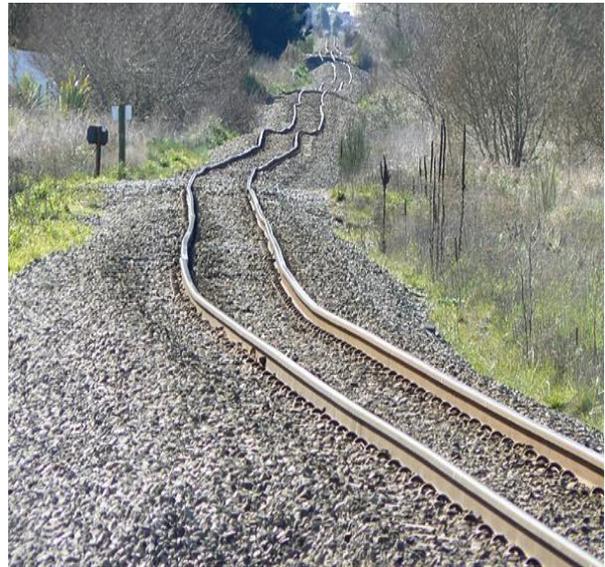
Figure 7.36: Damage to rail line at Woodford Glen (photo by L. Matthews and J. Overend).
