INTERBUILDING POUNDING DAMAGE OBSERVED IN THE 2010 DARFIELD EARTHQUAKE

SUMMARY

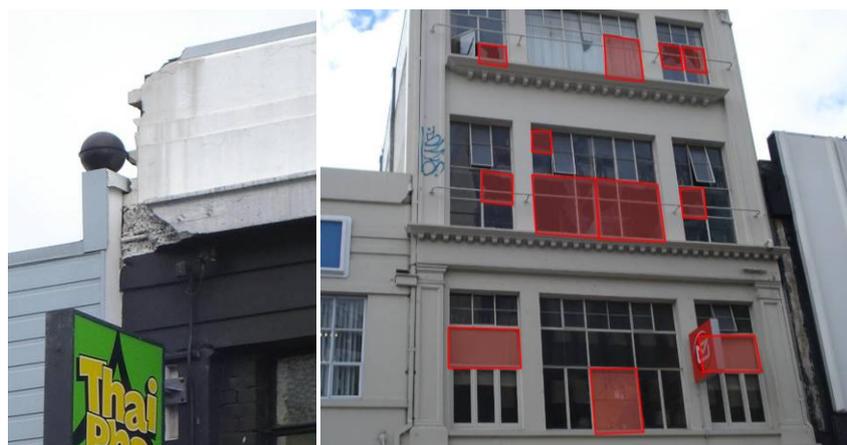
Figure 1: *Minor pounding damage. Left: Spalled concrete at building interface. Right: Glazing damage (highlighted) predominately located at the third floor, which coincides with the roof of the adjacent buildings. Cracks are also present at the top of the left hand building.*

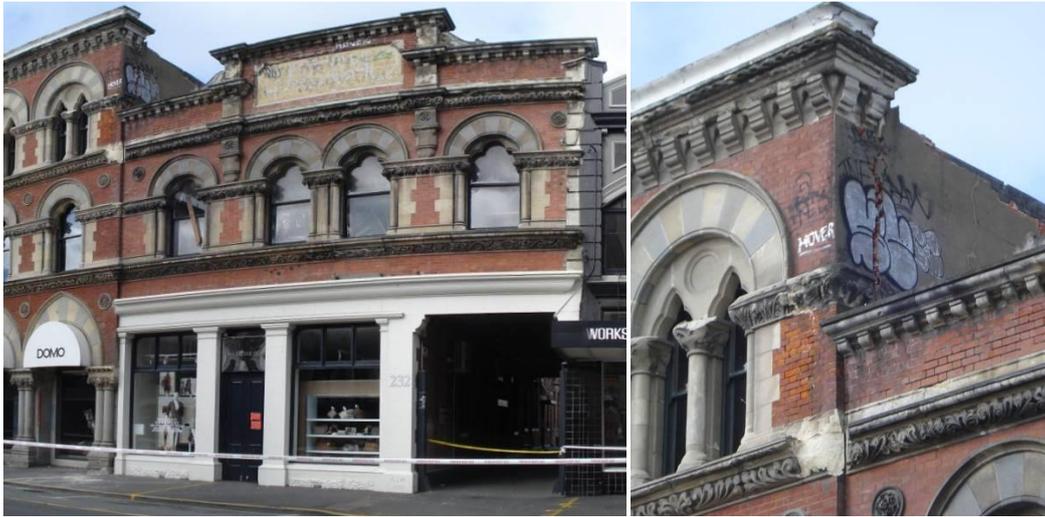
Figure 2: *Loss of decorative cladding, and damage to masonry wall partly due to pounding. Right: Magnification of damage at the left building interface.*

The observed damage was typically attributable to both pounding and URM construction. The central building in Figure 2 suffered damage from both adjacent buildings, including loss of decorative cladding on the left face. The damage to the masonry wall of the taller building is primarily attributable to the URM construction but pounding is likely to be a significant secondary factor. Parapet collapse also occurred along the length of this wall.

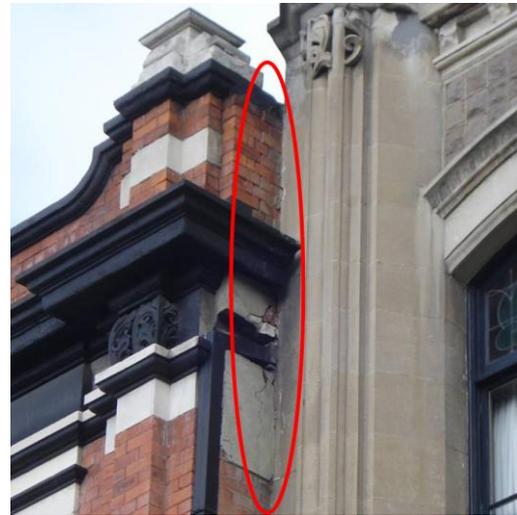
Adjacent buildings where one building has a façade setback suffered noticeable local pounding damage at the exposed corners (Figure 3). This configuration had not been previously identified as critical for pounding. Pounding damage of this type may be particularly severe if timber diaphragms are present in the protruding structure since they will provide little lateral support to the affected wall.

Figure 3: *Damage to wall resulting from adjacent facade setback*

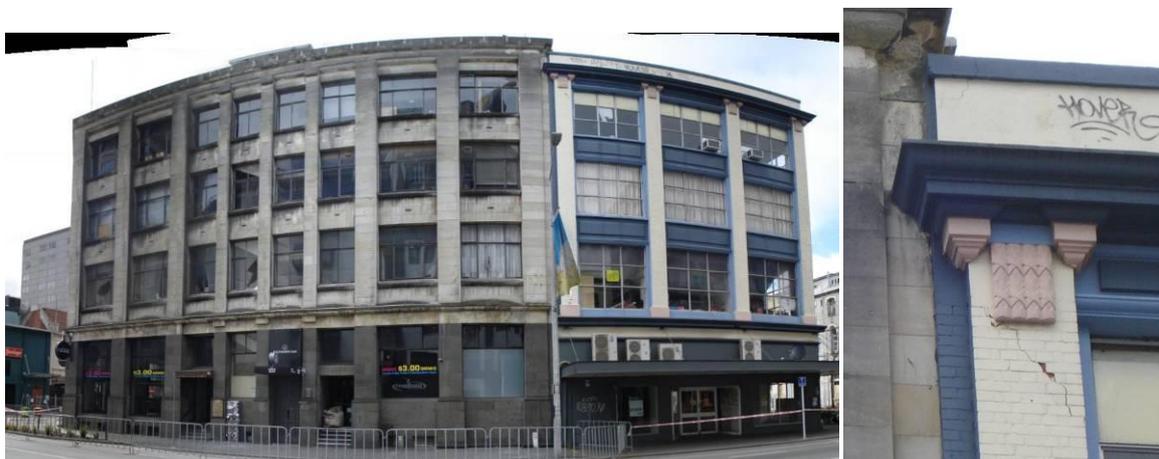
Buildings with observed pounding damage were typically two to four storeys tall. This is likely to be due to the large number of URM structures built within this storey range (Figure 4). Some image distortion is present in the left image in Figure 4, due to the combination of multiple photos.

Figure 4: *Pounding damage between two four storey structures Left: perspective image of building configuration. Right: Magnification of damage to top of right structure.*

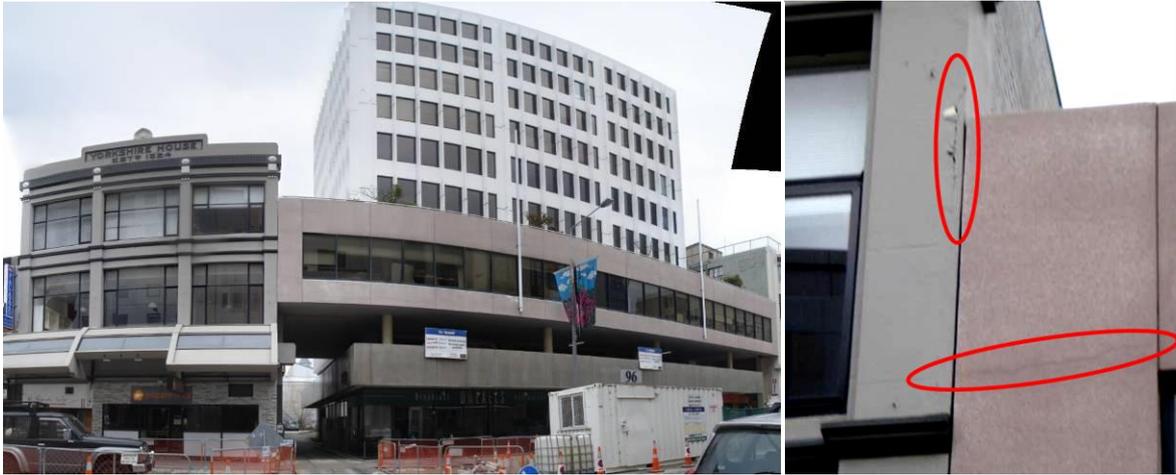
Figure 5: *Minor damage resulting from pounding buildings of greatly differing heights. Left: perspective image of building configuration. Right: Magnification of damage at the building interface.*

Adjacent buildings with greatly differing total heights displayed surprisingly little damage. Figure 5 shows the most severe damage observed between buildings differing by three or more storeys. While the level of damage is low, the location of this damage is critical. Both buildings have suffered damage to their vertical structural elements and not their horizontal elements. Since lateral loading is generally not considered at this location in any structure, and special detailing for inelastic behaviour due to such loading is unlikely to be present, this could potentially lead to brittle collapse in a larger event.

3. **Buildings with significantly differing total heights.** Only one case was observed where pounding damage was attributed total building height difference (Figure 5). As previously stated, this damage is minor.

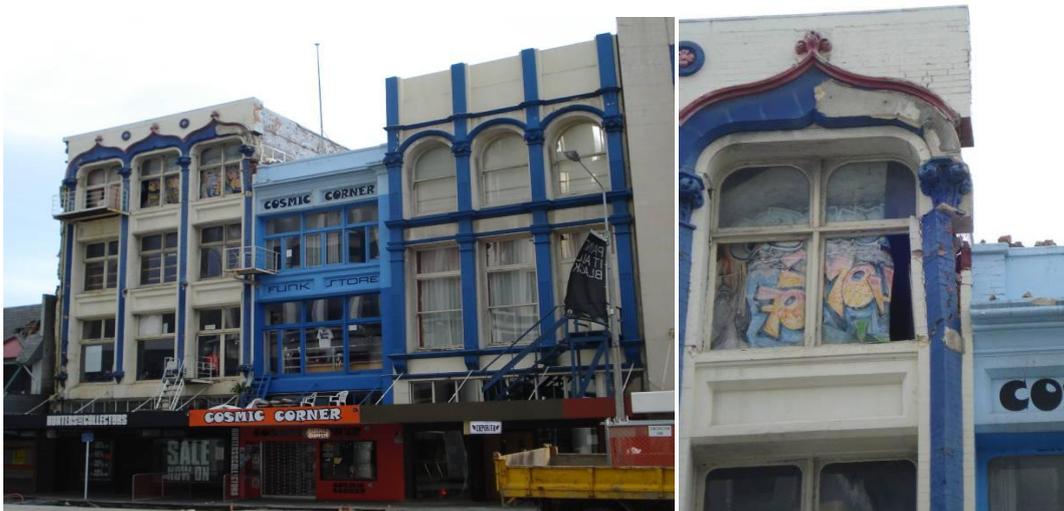
The most pronounced pounding damage observed within the CBD was located on High St (Figure 6). Pounding occurred between two URM buildings of three and four storeys, respectively. No building separation was present. While the damage was severe, it was also relatively localised. Two factors have significantly contributed to the local failure: The brittle nature of the unreinforced masonry, and the position of the relatively strong window lintel. The location of the lintel immediately above the parapet of the adjacent building, and the relative strength of the lintel has created a highly brittle configuration. As a result, the top of the damaged masonry has

displaced approximately 70 mm. Broken brick units have fallen into the resulting gap between the two buildings, which is likely to have contributed to this displacement. The lintel has also been damaged to a lesser extent. Other damage was also noted in the left hand building including partial failure of the wall not affected by pounding. However, this damage is attributed primarily to the building's URM construction.

Figure 6: *Top floor pounding. Pounding damage has been amplified by the relatively strong window lintel, localising the damage to the masonry below the lintel. Minor damage is present in the adjacent building's parapet. Left: Building configuration. Right: Magnification of damage.*

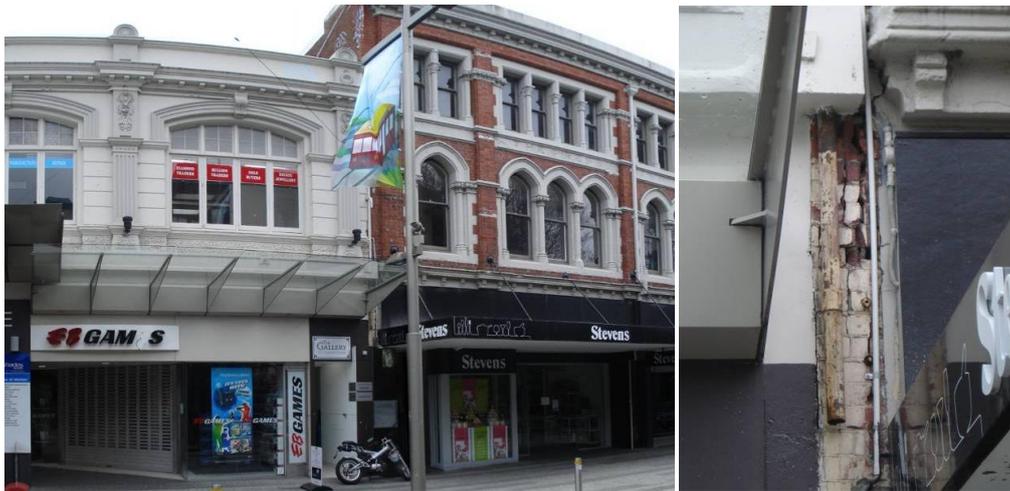
Less severe but still notable damage also occurred on Cashel St (Figure 7). Figure 7 shows the central two of four consecutive buildings with zero separation. Damage was confined to the interface between the two buildings. However significant masonry crushing is noted at the first floor. Some of the noted damage may be a result of the momentum transfer from the external buildings. No damage was observed at the top of the second floor. No other buildings in the CBD were observed to have this form of masonry crushing.

Figure 7: Local crushing of brick between buildings. Left: Building configuration. Right: Magnification of damage between buildings at the first floor.

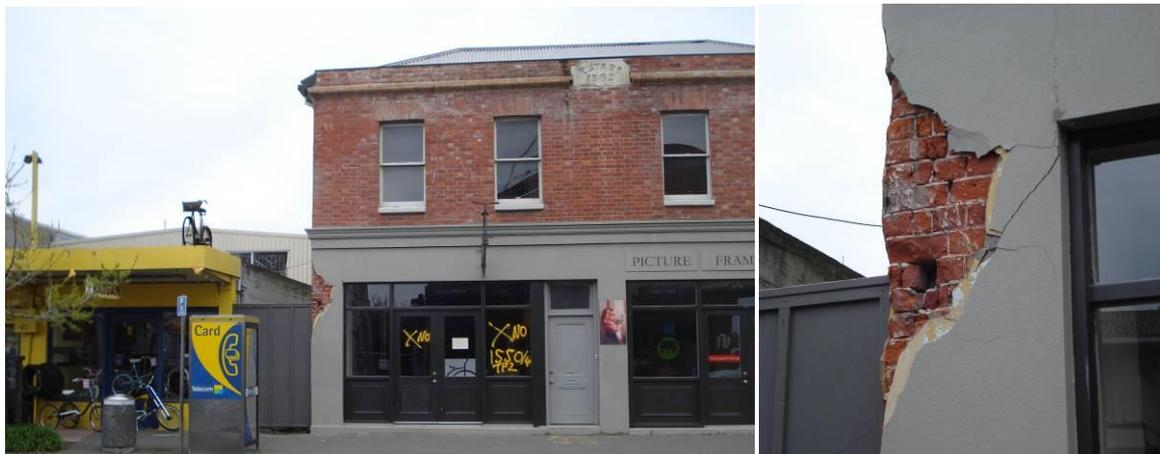
Pounding damage was not restricted to Christchurch CBD, two notable examples located further afield are presented in Figure 8 and Figure 9. These buildings were observed in the eight days following the CBD survey, while undertaking other research. Figure 8 displays the local damage caused by a

single fence in Woolston. The adjacent building to the left suffered no apparent damage. Figure 8 illustrates how a seemingly trivial addition to a building may have serious repercussions for the structural system. Figure 9 is also attributed to pounding, although the photo was taken after some demolition work was performed. The damage to the right structure has been amplified by the roof height of the left structure, which has acted as a localised hammer on the failed wall. Significant damage has resulted to both the first and second floor. Other damage is also found throughout the building, which is attributable to the URM construction. While major cracking was observed in the other external walls, none collapsed. Pounding is considered to have significantly contributed to the illustrated failure.

Figure 8: Pounding damage resulting from adjacent fence.

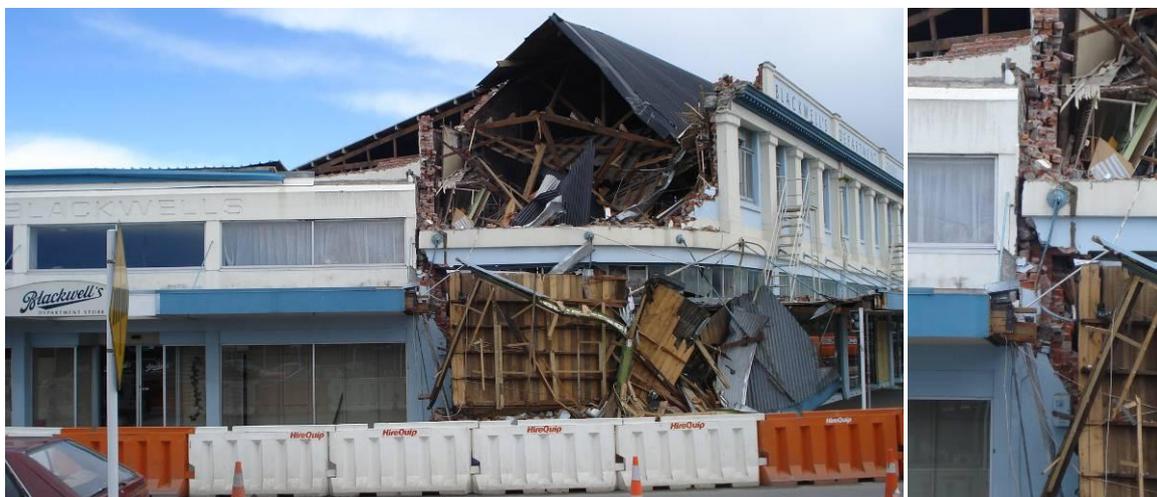
Figure 9: Damaged masonry structure in Kaiapoi. Right: Magnification of damaged building interface.
