# DAMAGE TO STEEL STORAGE RACKS IN INDUSTRIAL BUILDINGS IN THE DARFIELD EARTHQUAKE

Jeff Crosier<sup>1</sup>, Mark Hannah<sup>2</sup> and David Mukai<sup>3</sup>

## SUMMARY

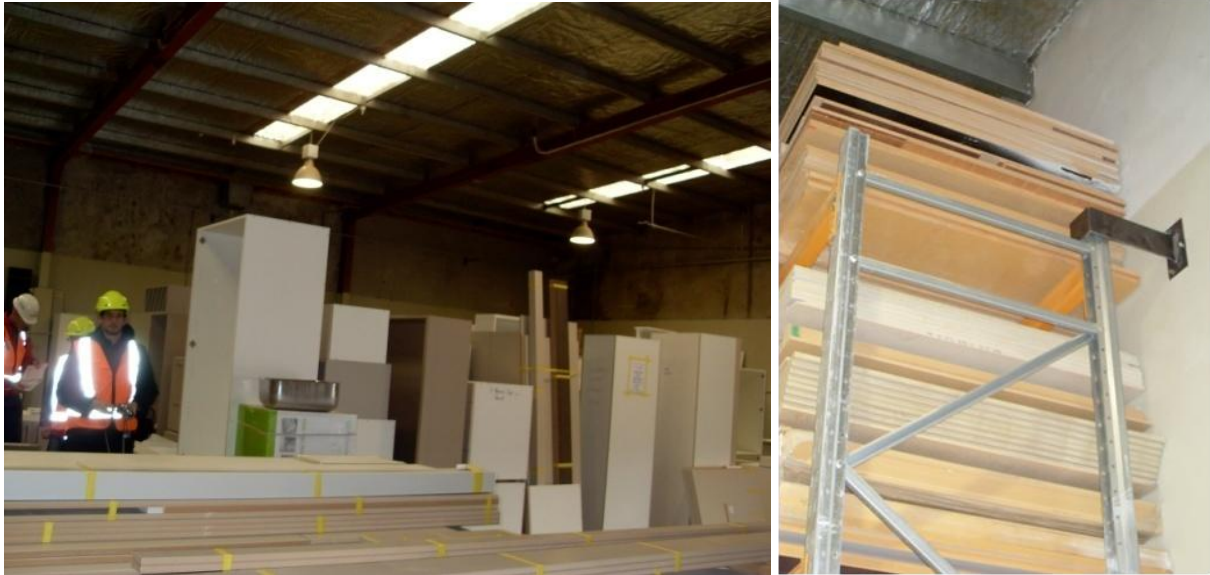
A kitchen cabinet manufacturer used commercially available rack systems tied back to walls (Figure 2), to store particle board. The racks and the contents were undamaged. The buildings at this site, 20 to 25 years old, showed no damage.

**Figure 2:** Undamaged stock and storage rack bolted to wall in Kitchen cabinet manufacture site. Source: D. Mukai.

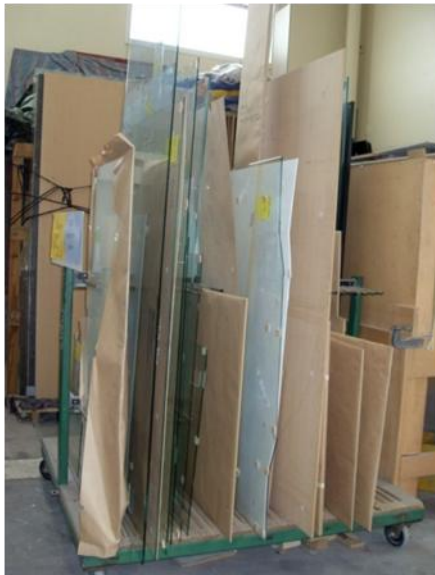
A glass workshop with four-year-old buildings stored large sheets of glass in vertical storage units (Figure 3). Some of the storage units were on wheels and others were fixed to the ground. In general, glass sheets stored longitudinally in the east-west direction had less damage than those stored in the north-south direction.

**Figure 3:** Undamaged glass plates stored vertically on racks with wheels at the glass workshop building. Plates stored in the East-West direction. Photo credit: D. Mukai.

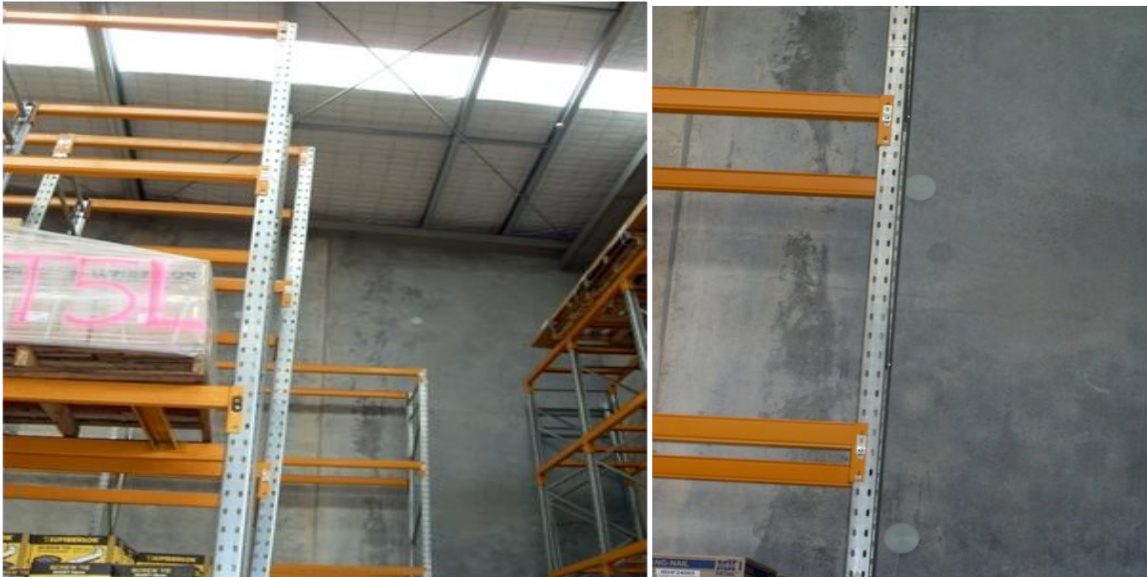
An engineered wood products manufacturer had one storage rack that had a permanent drift (Figure 4). This rack stored various fasteners and the total load on the top two shelves was 13,400 kg. This system is a commercially available system. Both the building (which exhibited no damage) and the racks

were 2.5 years old. Interestingly, this company had their own engineers analyze the storage racks prior to purchase and required the supplier to increase the stiffness of the rack. Using approximate dimensions of cross section and member lengths and the loading of the top two shelves, the first-mode period is estimated to be 0.4 seconds.

*Figure 4: Rack at wood products site with permanent drift. Note relative distances to plugs on wall. Photo credit: D. Mukai.*

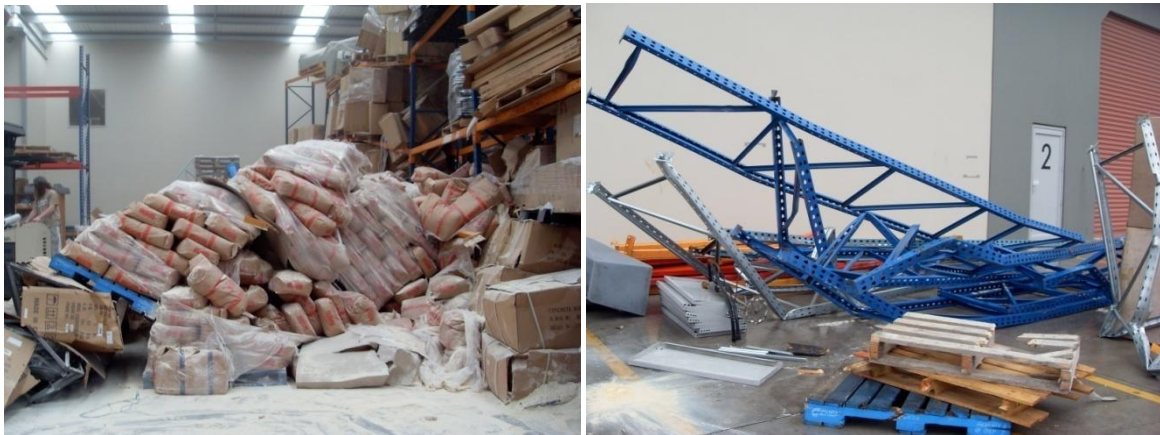
Three other sites fared even worse. A miscellaneous storage provider used light gauge commercially available racks. The heaviest loaded racks (Figure 5) carried pallets of 40 x 25 kg bags of flour (1,000 kg per pallet). These racks completely collapsed (Figure 5). A metal fabricator and supplier had two rows of racks collapse or overturn (Figure 6a). The down-aisle collapse caused the shelf to vertical member connection to fracture (Figure 6b). The buildings at this site, 35, 8, and 5 years old, showed no damage. The racks that collapsed (there were several others that suffered no damage) were heavily loaded with threaded bars, nuts, and bolts. Also, all the racks that failed were anchored. Other non-anchored racks walked, rather than overturned. A final site that was visited with severe rack damage was a milk distribution centre. Because the failed racks were in danger of collapsing into a high-voltage transformer, we were not allowed inside the facility. These racks were commercially available systems complete with cross-bracing and tension wires, both which failed. Complete collapse was only prevented by the racks catching on a low overhead girder. The racks were heavily loaded with cases of ultra-high-temperature pasteurized (UHT) milk.

*Figure 5: Damage inside miscellaneous storage provider site. Each pallet contained forty 25kg bags of flour. Photo credit: M. Hannah.*

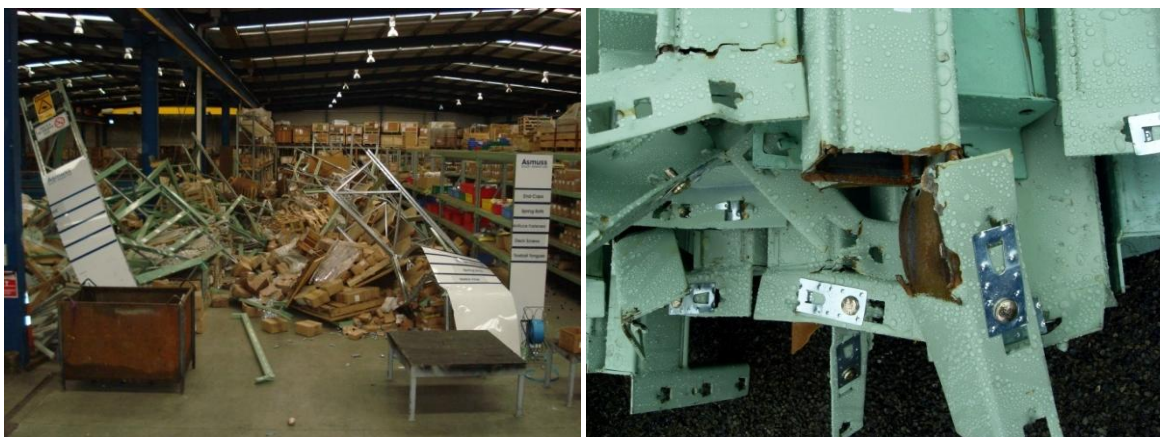
*Figure 6: (a) Collapsed racks at metal fabricator and supplier site and (b) fractured connectors from the collapsed racks. Photo credit: N. Crannitch.*
