DAMAGE TO POTABLE WATER RESERVOIRS IN THE DARFIELD EARTHQUAKE

Robert A. Davey¹

SUMMARY

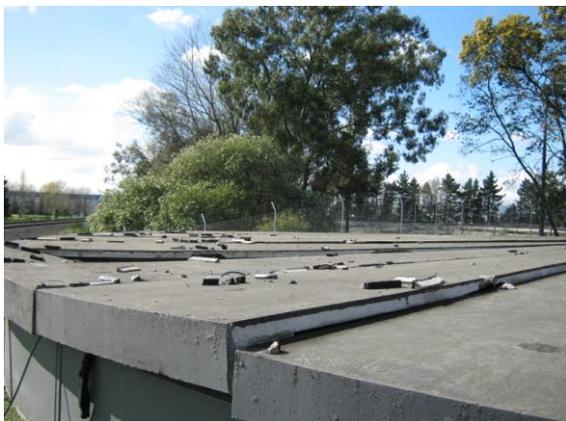
The other tank suffered partial collapse of the roof caused by buoyancy forces from the earthquake-generated convective (“sloshing”) wave causing the slabs to be lifted off the supporting walls and fractured when they impacted down again (Figure 4).

Figure 4: Reservoir roof damaged by convective wave.

Severe damage to the roof of one concrete tank does highlight the importance of avoiding or allowing for uplift pressures from the sloshing wave in the roof design.

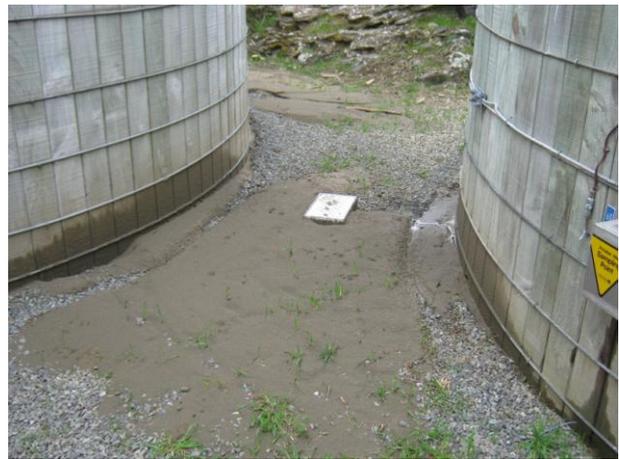
Timber tanks are typically not anchored to their foundations and the system relies upon base-isolation with the tank wall sliding on the foundation to control the forces in the structure to a level that the timber stave walls can support by inter-stave friction. Figure 5 shows two tanks that have exhibited base-isolation response, however the wall displacements have apparently caused the liners to rupture and the reservoirs to leak.

Figure 5: Timber tanks with ruptured liners.

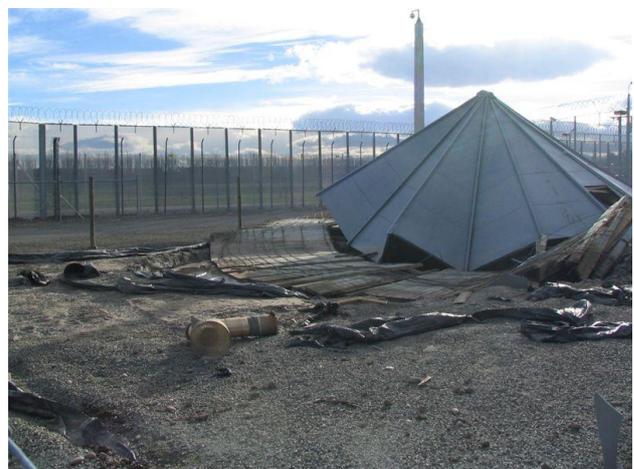
Two of the Council tanks leaked following the earthquake, while one remained functional. The Paparua tank collapsed.

Figure 6: Collapsed timber tank.

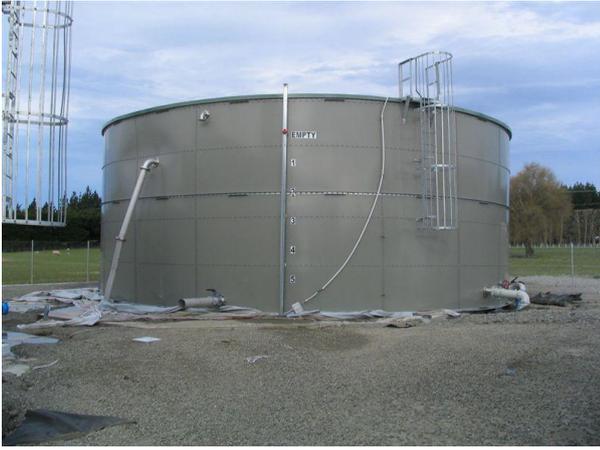
Six tanks were inspected, four of which failed at the anchor bolts. The four damaged tanks are located in Paparua. The undamaged tanks are located in Rakaia which is a similar distance from the earthquake epicentre as Paparua. The Rakaia tanks are smaller than those at Paparua but have a greater number of and larger anchor bolts explaining why they did not fail.

Figure 7: Damaged bolted steel tank.

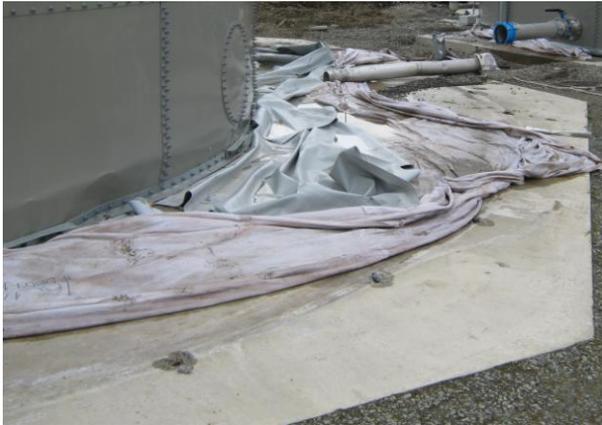
Figure 8: Fractured anchor bolts.
