LANDSLIDES CAUSED BY THE 22 FEBRUARY 2011 CHRISTCHURCH EARTHQUAKE AND MANAGEMENT OF LANDSLIDE RISK IN THE IMMEDIATE AFTERMATH

ABSTRACT

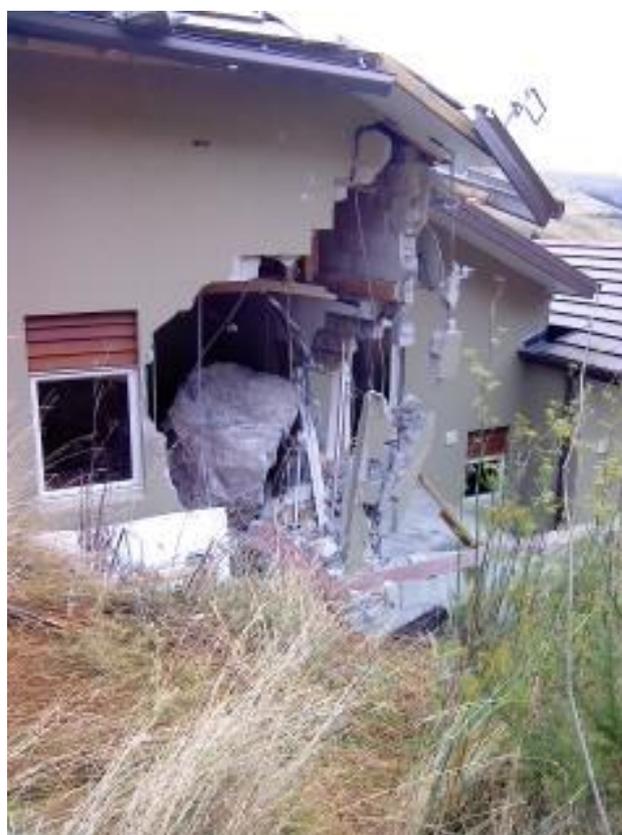
Unfortunately for the residents of the Port Hills, many homes are located on lower slopes or on valley floors adjacent to the valley walls and were damaged or destroyed by displaced boulders (Fig 3, Fig 5a). No-one was killed by these rock-falls,

Figure 3: Boulder damage to a house in Morgans Valley, Christchurch following the 22 February 2011 earthquake.

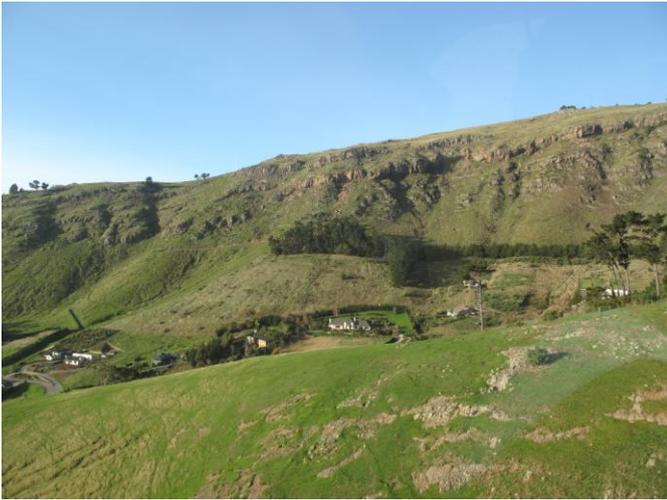
Figure 4: *The source area for the boulders that fell and rolled in the upper part of the Heathcote Valley (Morgans Valley) (Figure 3) is the lava outcrops immediately below the skyline crest. Note the large distances to the houses, some hit by boulders, on the valley floor.*

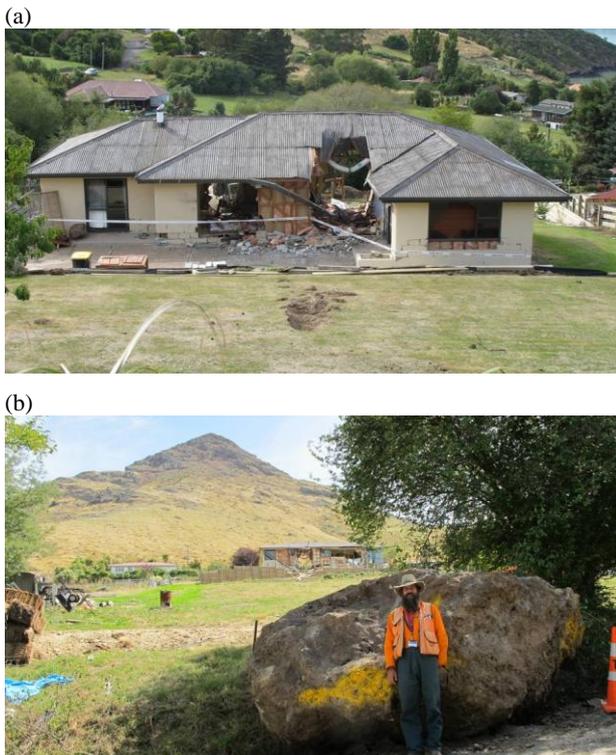
Figure 5: *(a) Rolling boulder damage to a house in Rapaki. The house was struck by four separate boulders, one of which smashed right through the house. Note the boulder bounce impact crater in front of the house. (b) The final resting place of the large boulder (~15 m³) that smashed right through the house in (a) above. The source area for the boulders was the bluffs near the summit of the peak visible above the house.*

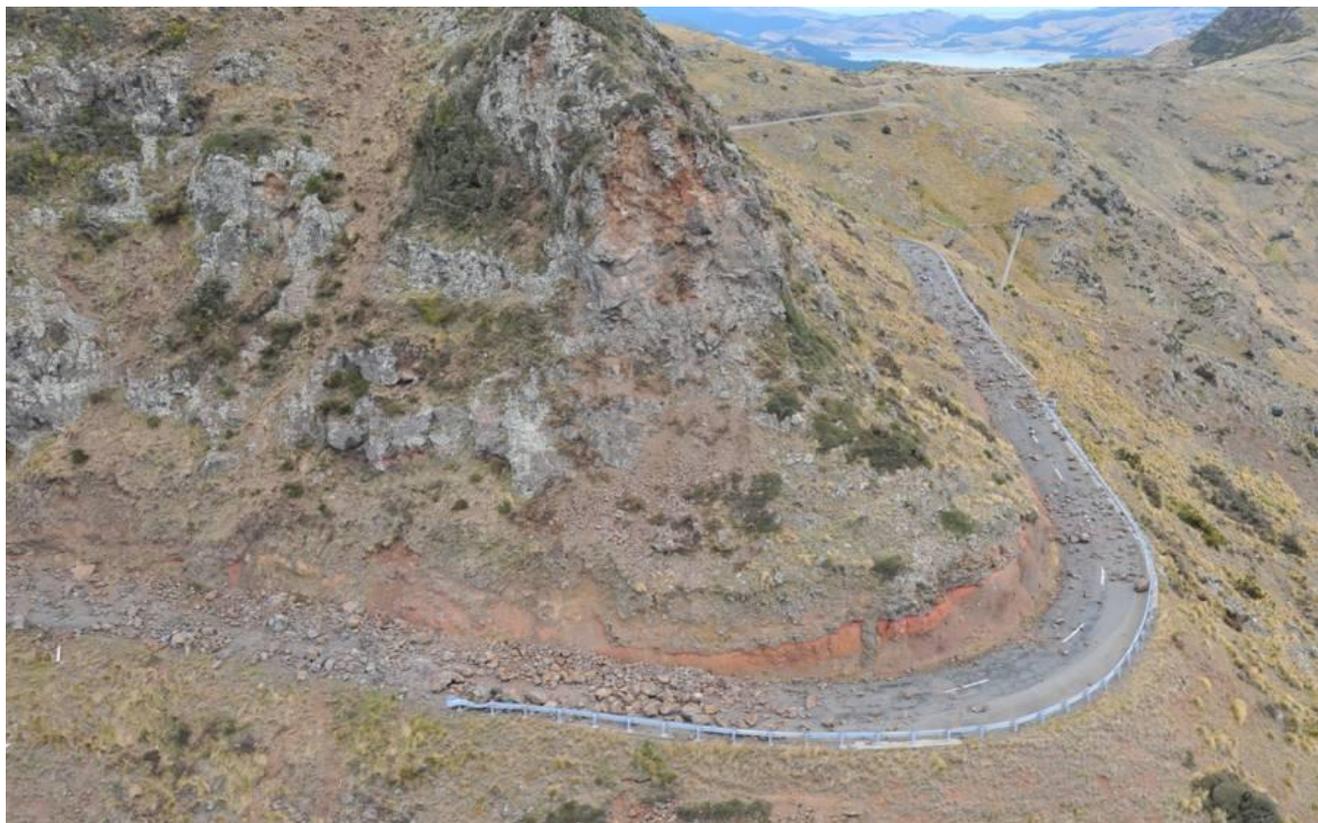
Figure 6: *Rock-falls from the steep bluffs below Mt Cavendish blocked the Summit Road. The Summit Road and Armo barrier acted as a partial catch-bench for rock-fall debris. The size distribution and angularity of the rocks on the Summit Road reflects the more closely jointed nature of the source area compared to the lava flow above the Heathcote Valley (Figs 3 and 4).*

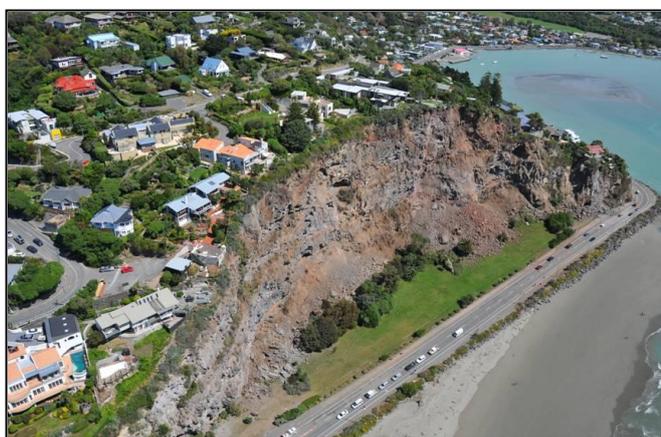
Urban areas affected by the cliff collapses include the cliff face at Peacocks Gallop between Sumner and Moncks Bay (Fig 7), the cliff behind the Sumner Returned Services Association (RSA) (the collapse extended a few tens of metres either side of the RSA building), the cliff at Whitewash Head in Scarborough (Fig 8) and the cliff face behind Redcliffs which extended several hundred metres (Figs 9 and 10). The steep bluffs and escarpments behind Lyttelton also collapsed in several places, with debris accumulating at the toe of the bluffs.

Figure 7a: *Cliff collapse at Peacocks Gallop between Sumner and Moncks Bay. This photo shows the extent of the fresh debris on the talus apron after cliff collapse at this site following the 22 February 2011 earthquake.*

of at least one property. The cliff collapse hazard below the cliff at Peacocks Gallop saw the construction of a bund of ballasted containers to provide route security in the event of another aftershock. A similar ballasted container bund was also put in place along Wakefield Avenue in Sumner to provide route security.

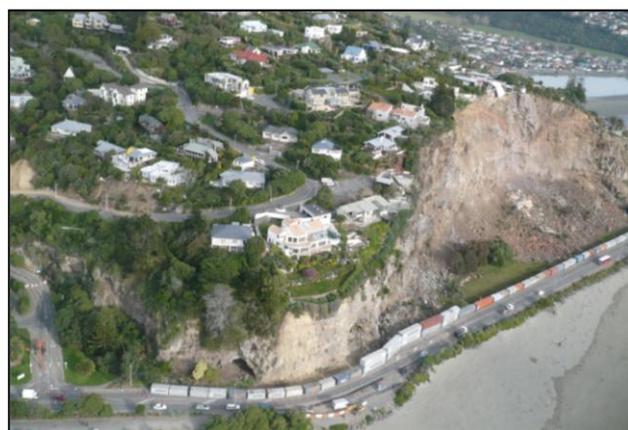
Figure 7b: *Additional cliff collapse at Peacocks Gallop following the 13 June 2011 earthquake. The debris accumulation at the western end of the cliff was much greater following the 13 June event which resulted in at least 15 metres of cliff-top retreat, undermining at least one house. Risk mitigation measures put in place after the 22 February earthquake (house evacuations for the properties at the top of the cliff and the rock-fall barrier of ballasted containers at the toe of the cliff) meant there was little disruption to recovery activities because of the additional collapse at this site on 13 June.*

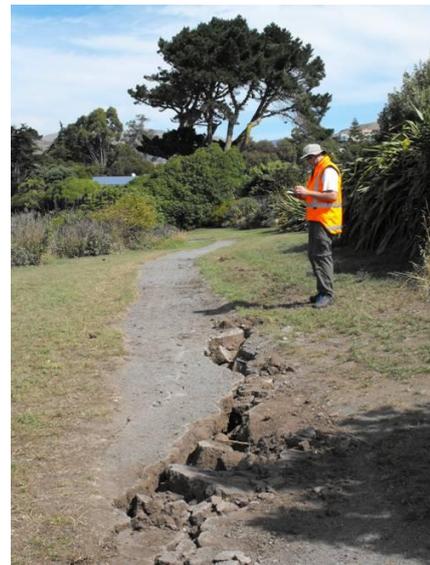
Figure 8a: Ground cracking on the cliff top at Whitewash Head, Scarborough after the 22 February 2011 earthquake. This crack is visible in front of the blue-roofed house in the upper left of Figure 8b.

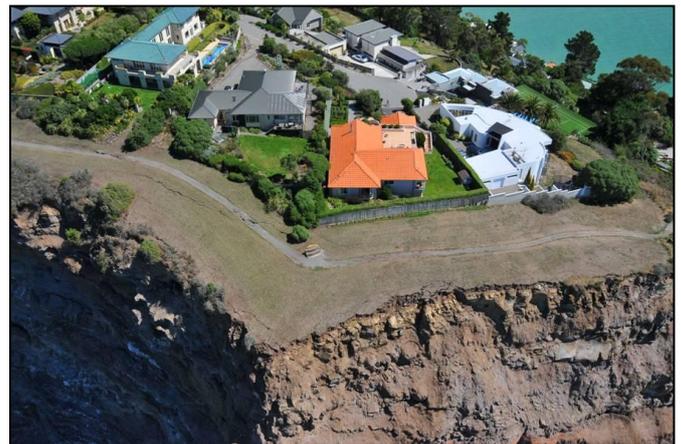
Figure 8b: Cliff-top homes at Whitewash Head, Scarborough are buffered from the cliff edge by the Sumner-Taylor's Mistake walkway. After the 22 February 2011 earthquake incipient cracking developed in the walkway zone. As a result residents evacuated homes bordering the walkway reserve.

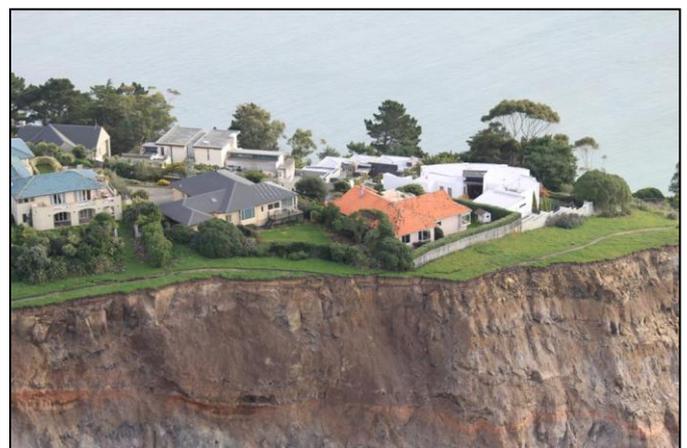
Figure 8c: The cliff-top at Whitewash Head, Scarborough following the 13 June 2011 earthquake. The cliff top has collapsed along the line of the incipient crack visible in Figure 8b above.

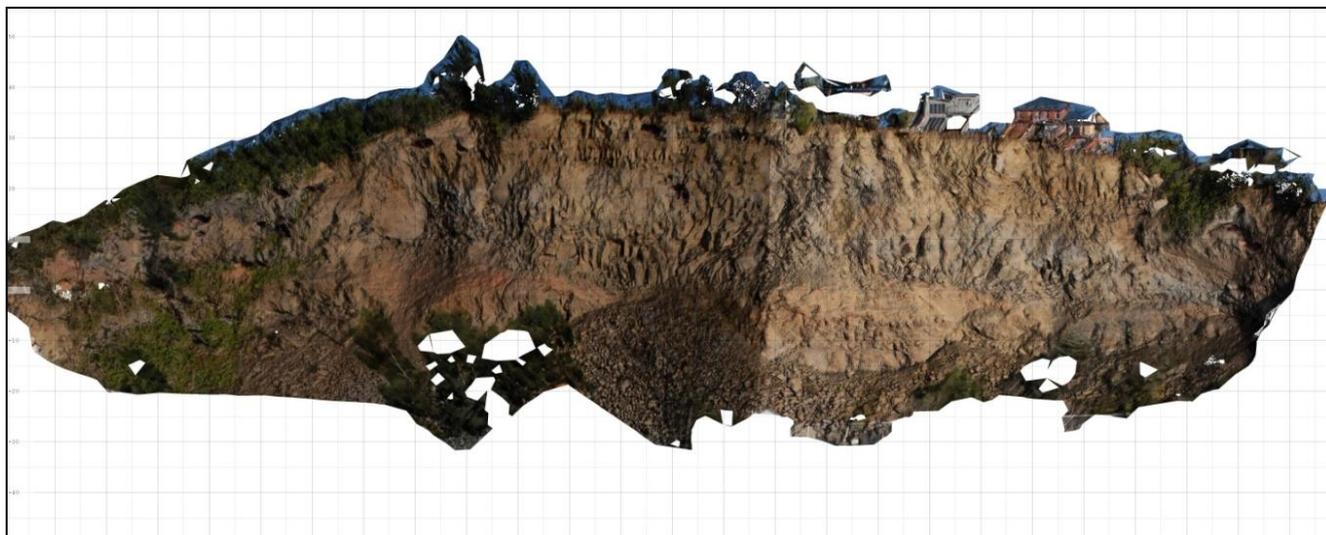
Figure 9a: A true colour image of the cliff behind Redcliffs captured using a terrestrial laser scanner. This image was taken after the 13 June 2011 earthquake.

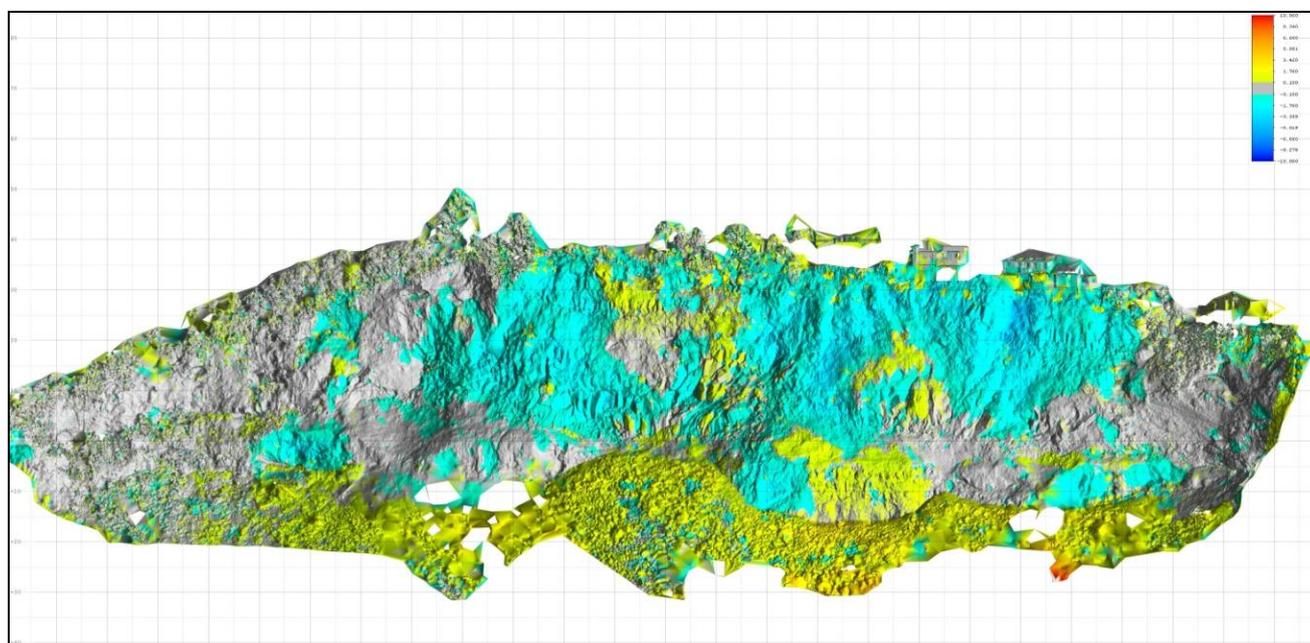
Figure 9b: A differencing image of the cliff behind Redcliffs created by comparing terrestrial LIDAR images from before and after the 13 June 2011 earthquake. Blue represents areas where material has fallen from the cliff face, while yellow and red show areas where material has accumulated.

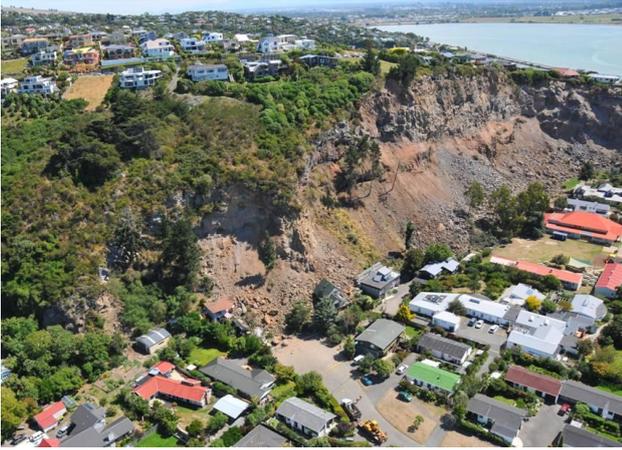
Figure 10: *The cliff behind Redcliffs taken shortly after the 22 February 2011 earthquake. In the bottom centre is the cul-de-sac at the end of Raekura Place. Two of the five rock-fall fatalities occurred here.*

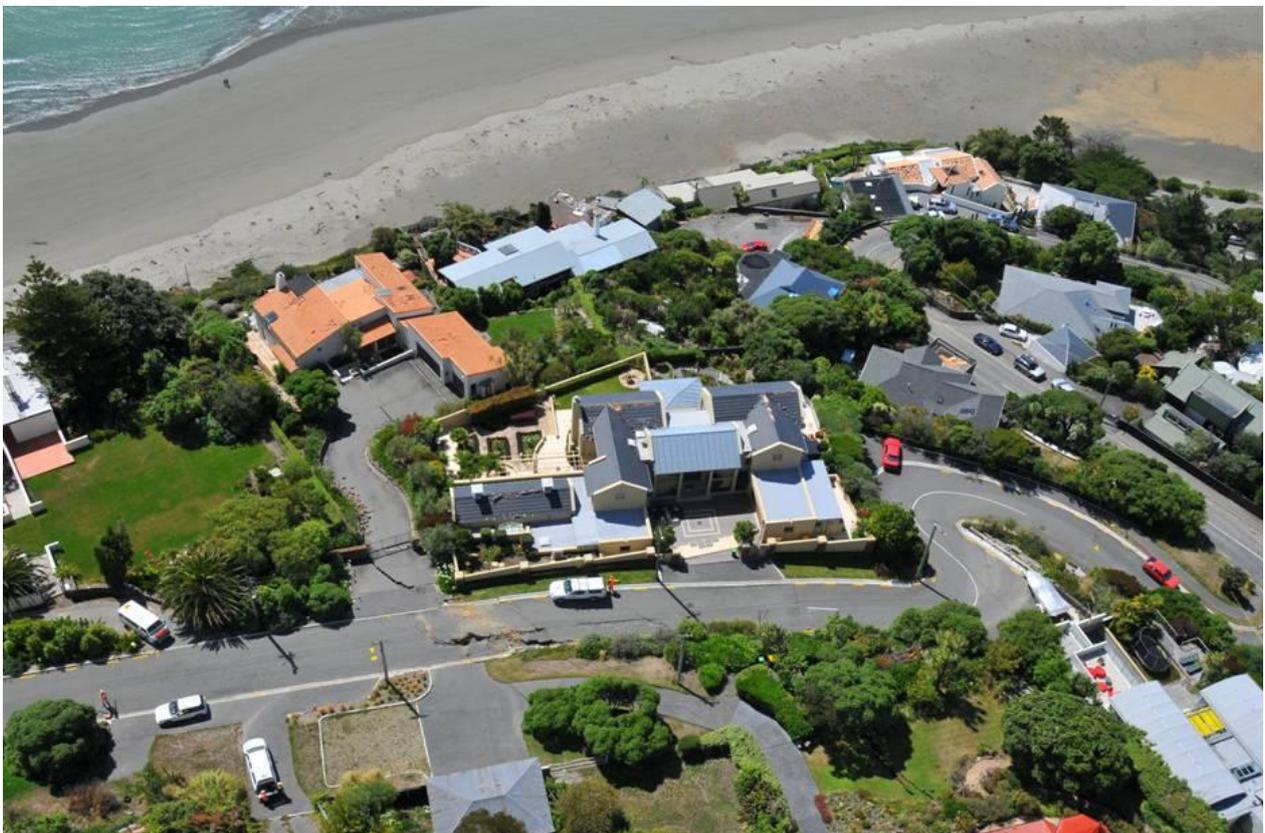
Figure 11: *An aerial view of the Kinsey Terrace landslide on Clifton Hill. A large tension crack is visible across Kinsey Terrace in the foreground. The crack extends towards the left hand side of the orange tile-roofed house on the northern side of the road and towards the red roof just visible in the lower right of the photo.*

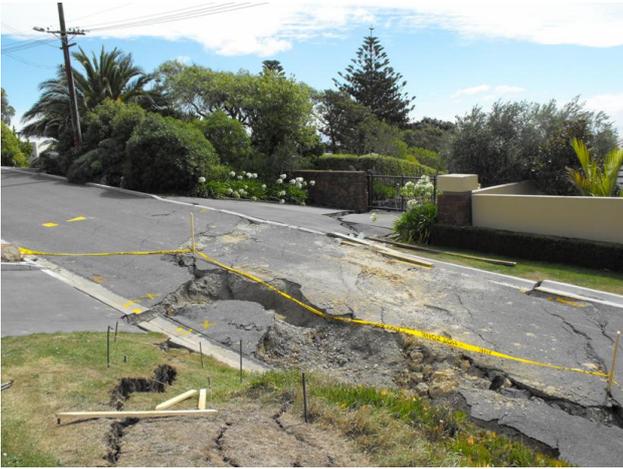
Figure 12: *The tension crack of the Kinsey Terrace landslide crossing Kinsey Terrace. Note the initial crack monitoring consisting of two 10 mm diameter steel pins and builder's string installed 36 hours after the earthquake.*

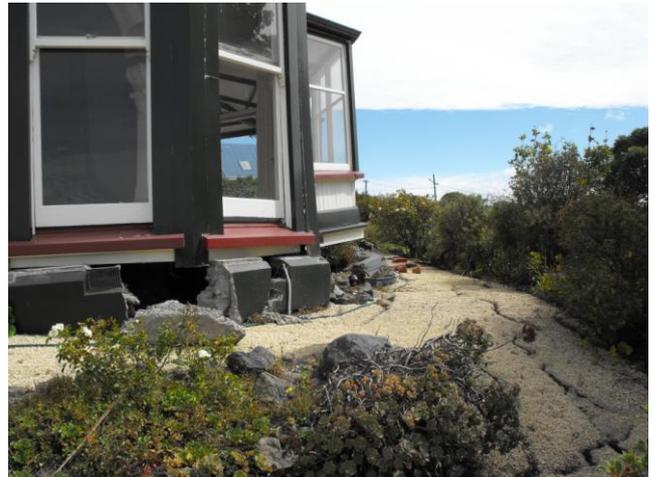
Figure 15: *Foundation damage to the red-roofed house partially visible in Fig 11 (lower right) was caused by tension cracks.*

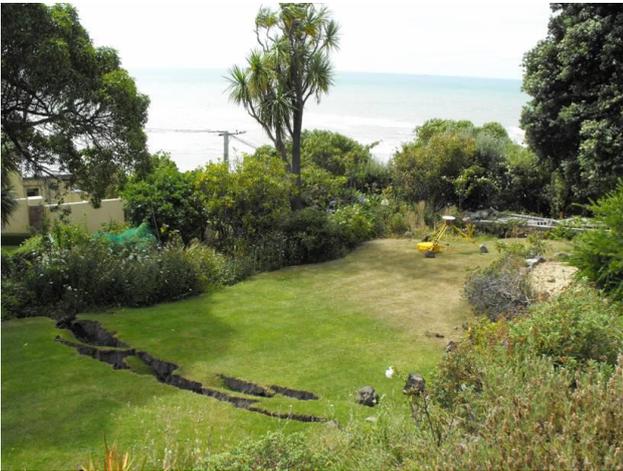
Figure 13: *Tension crack and temporary continuous-GPS installation on the Kinsey Terrace landslide.*

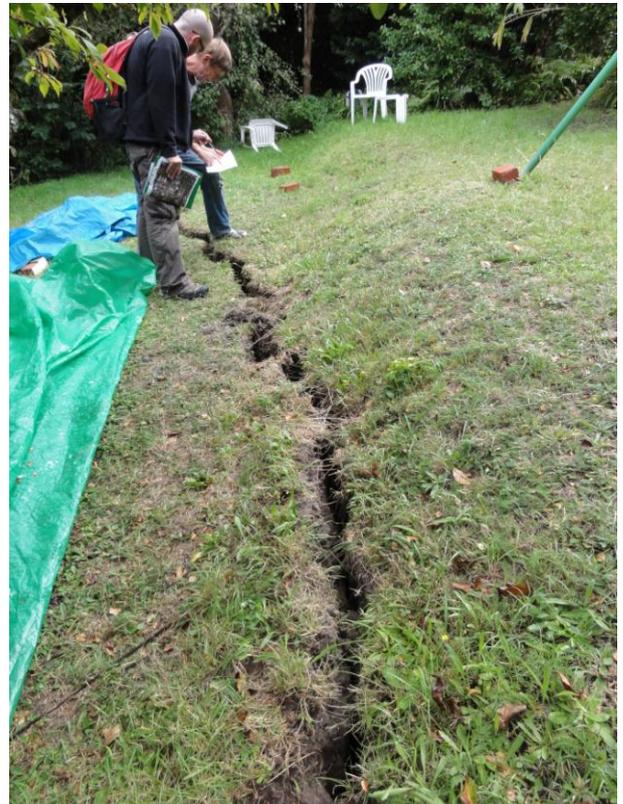
Figure 16: *Tension crack at the head of the Vernon Terrace landslide in Hillsborough on possible pre-historic head-scarp.*

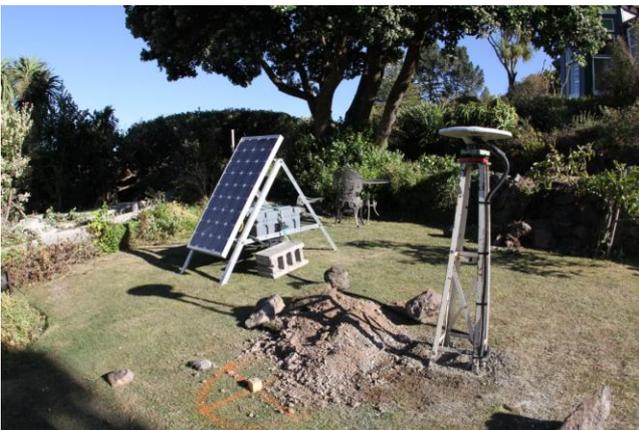
Figure 14: *Permanent continuous-GPS installation on the Kinsey Terrace landslide at the same site as the temporary continuous-GPS in Figure 13.*

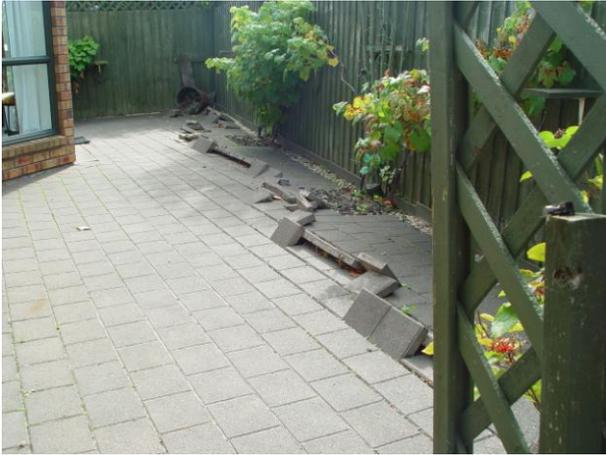
Figure 17: *Compressional ridge of the toe of the Vernon Terrace landslide in Hillsborough.*

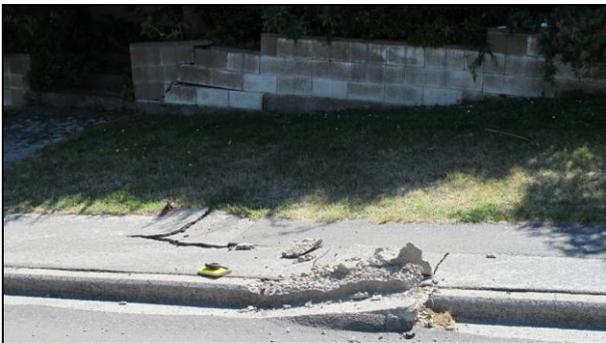
Figure 18: *Compressional cracking of curb and channel at the toe of the Vernon Terrace landslide in Hillsborough.*

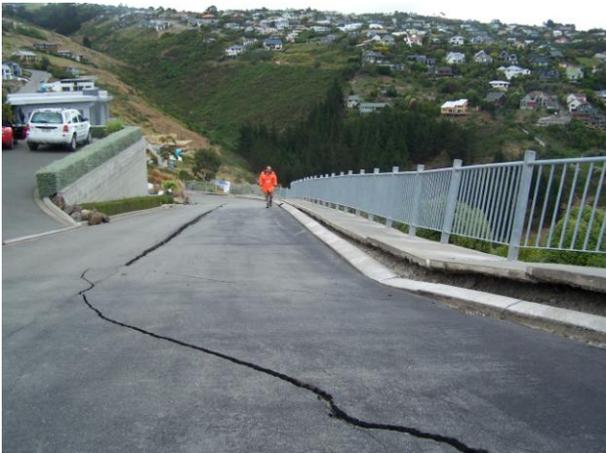
Figure 19: *Gabion and geogrid retaining wall failure in the Redcliffs area.*

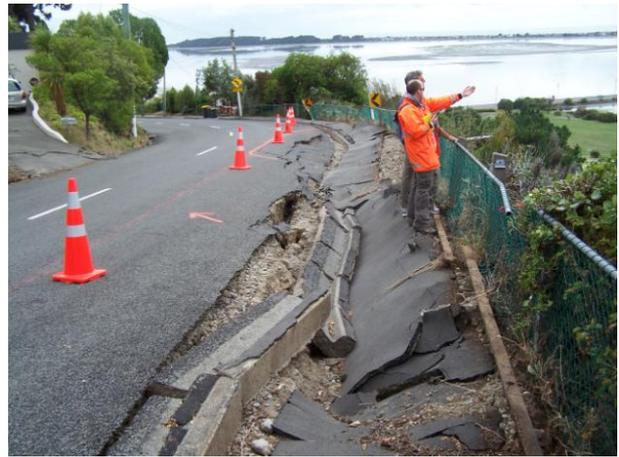
Figure 20: *Concrete crib retaining wall failure, Mt Pleasant Road, Mt Pleasant. The retaining wall has not collapsed but has bulged outward allowing the fill behind the retaining wall to settle destroying the curb and channel and footpath.*

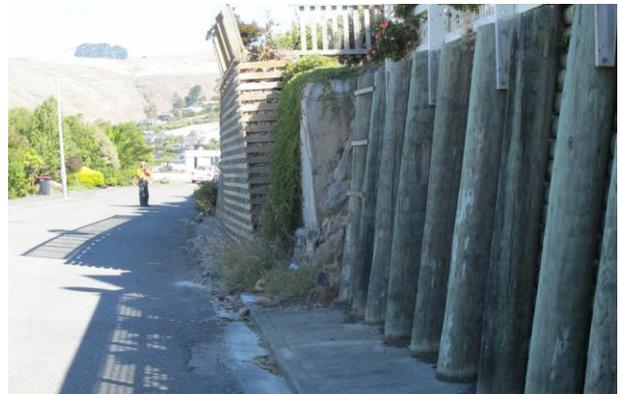
Figure 21: *These retaining walls in Glendever Terrace, Redcliffs showed contrasting behaviour. The anchored pole retaining wall in the foreground performed well. The bulging timber crib retaining wall next to it performed poorly in the 22 February 2011 earthquake and was cordoned off. It subsequently failed catastrophically in the 13 June 2011 aftershock.*

Although these failures were widespread, the damage they caused was often very limited in extent as the fills were small (< 100 m³) and damage was confined to one or two properties or half the outside lane on the road network (Figs 19 and 20). The same applies to retaining wall and stonework failures. Older lava block stonework facings in front of loess cuts in Lyttelton suffered badly with numerous collapses. Elsewhere crib walls (both timber and concrete) performed poorly while anchored pole walls performed well (Fig 21).

The widespread distribution of these types of failures and the limited damage they caused meant they were not perceived to be a life-safety risk in the immediate aftermath of the earthquake. Where unstable areas were encountered, for example a badly deformed retaining wall in Glendever Terrace above Redcliffs (Fig 21), they were cordoned off to

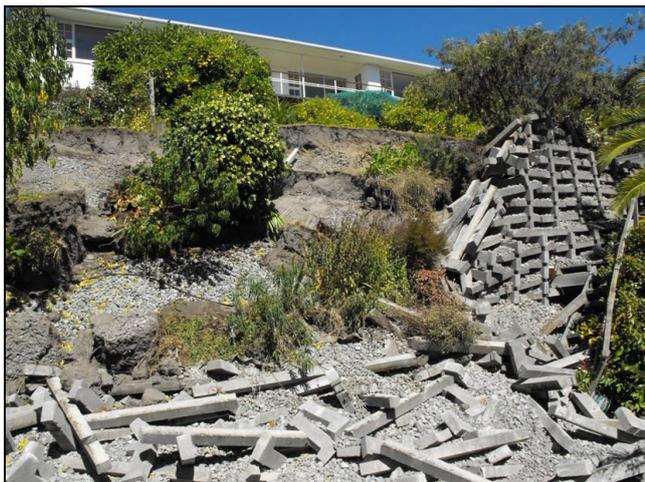
The fourth type of ground failure observed after the 22 February 2011 earthquake was widespread but minor failures of retaining walls and the settlement of poorly compacted fills. These failures were usually small (< 100 m³) but ranged from incipient cracking of a few millimetres (Fig 19) to extensive deformation of retaining walls (Figs 20 and 21) through to catastrophic collapse of retaining walls (Fig 22).

Figure 22: Collapse of concrete crib retaining wall in Soleares Ave., Mt Pleasant.
