# STEEL STRUCTURES DAMAGE FROM THE CHRISTCHURCH EARTHQUAKE SERIES OF 2010 and 2011

**Charles Clifton<sup>1</sup>, Michel Bruneau<sup>2</sup>, Greg MacRae<sup>3</sup>,  
Roberto Leon<sup>4</sup> and Alistair Fussell<sup>5</sup>**

## SUMMARY

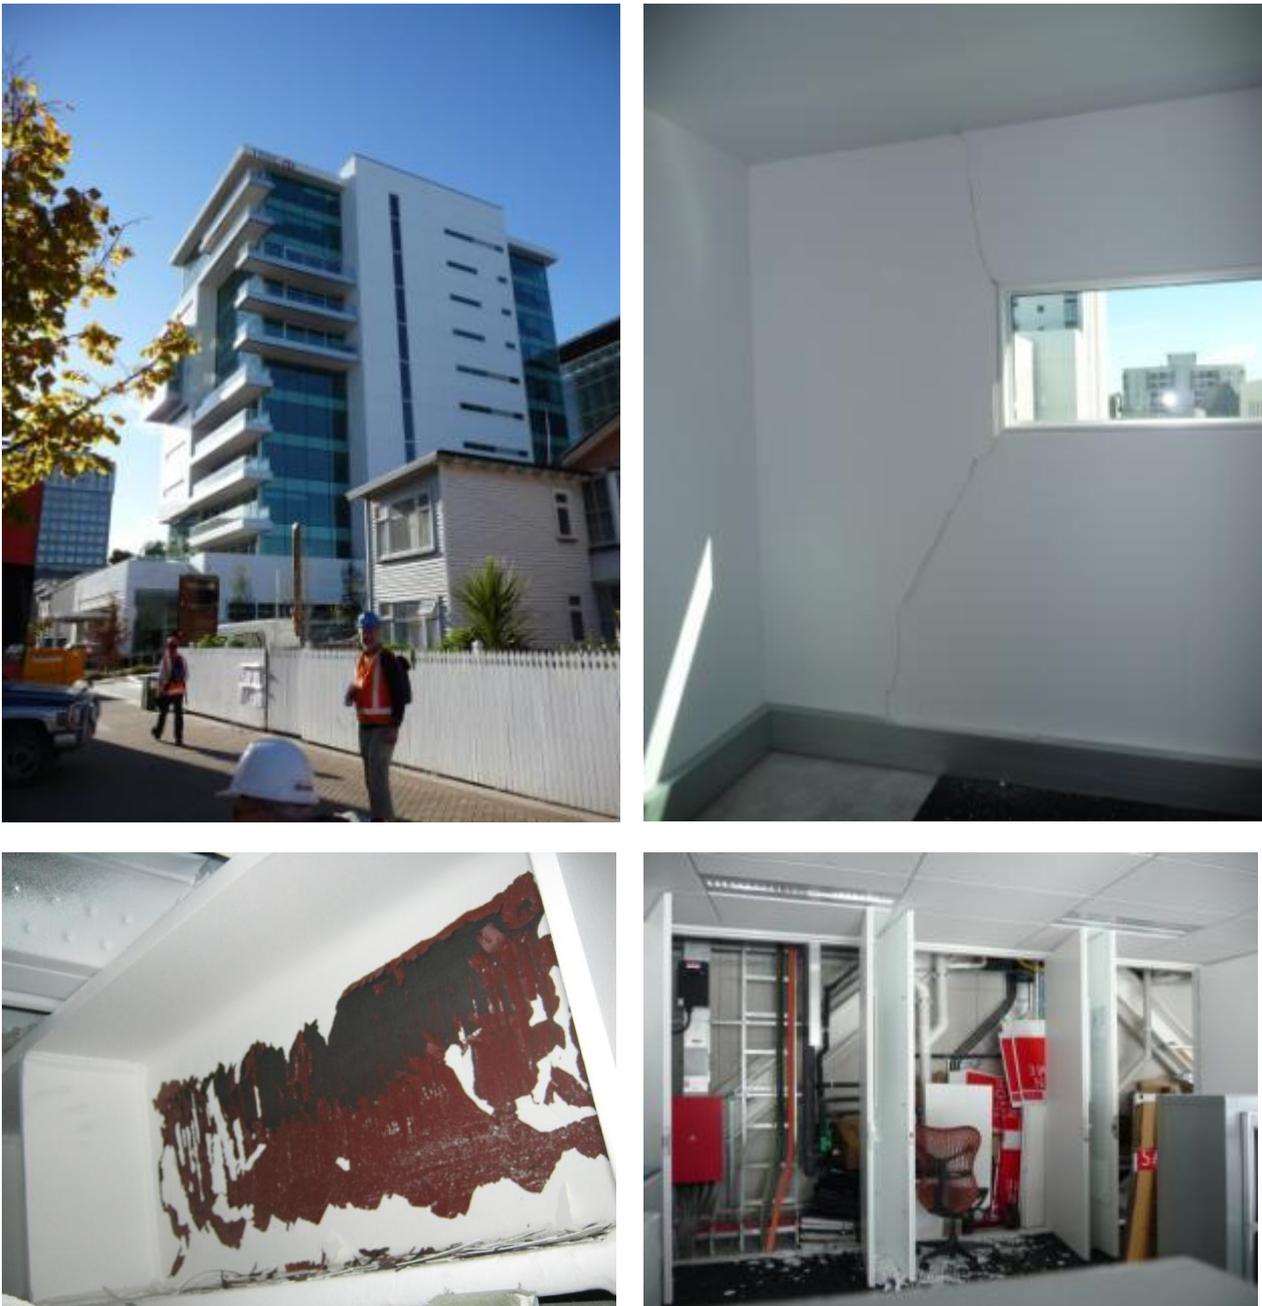
The Club Tower Building (Figure 3a) has eccentrically braced frames located on three sides of an elevator core eccentrically located closer to the west side of the building and a ductile moment resisting frame (DMRF) along the east façade. The steel frame is supported on a concrete pedestal from the basement to the 1st storey, and foundations consist of a 1.6 m thick raft slab. Only the EBFs on the east side of that core could be visually inspected without removal of the architectural finishes (Figure 3d), however more detailed investigation was made of the South side active links through removal of ceiling tiles to ascertain the most significantly yielded braces. Figure 3c shows a link at level 3 on the South side which has the greatest observed inelastic demand. Estimates of the peak inelastic demand in that brace were made by two independent means. First was through assessment of the visible state of the metal in the yielded web of the active link and secondly through an estimate of the peak interstorey drift. Both methods gave a peak shear strain of between 3% and 4%. The links were free of visible residual distortions. Assessment of damage accumulation in the steel at a peak shear strain of 4% over an estimated two complete cycles of loading using the damage criterion developed by (Seal, 2009) and the change in transition temperature based on the work of Hyland *et al* (2004) and Hyland and Fergusson (2006) showed that the yielded active links have sufficiently robust metallurgical properties to be left in place. This had to be made by assessment as material could not be taken from the yielded links for direct testing, which would have then required active link replacement. Previously reported slab cracking (Bruneau *et al.* 2010) could not be detected as the concrete floor slab was covered by floor carpeting, except at one location at the fixed end of a segment of the floor cantilevering on one side of the building (a feature present only over two storeys for architectural effect). Crack widths after February 22, 2011 appeared similar to what had been

observed after September 4, 2010, being localised only. Substantial shear cracking of the gypsum plaster board (sheetrock) finish on the exterior wall of that cantilevering part of the floor was also observed (Figure 3b); only hairline cracking of gypsum plaster board finishes was observed elsewhere throughout the building, supporting post-earthquake survey measurements showing that the building has a post-earthquake residual drift of only 0.1%. One non-structural masonry block wall installed for sound proofing purposes adjacent to mechanical units on the pedestal roof suffered minor shear cracking, where it had been placed hard up against a cantilevering floor beam.

Given the magnitude of the earthquake excitations, with demands above the ULS design level, substantial yielding of the EBF links would have been expected. EBFs designed in compliance with the NZS 3404 (SNZ, 1997/2001/2007) provisions are typically sized considering a ductility factor ( $\mu$ , equivalent to  $R_u$  in US practice) of up to 4, corresponding to a level of link deformations that would correspond to significant shear distortions of the links. Yet, yielding was below that determined necessary in subsequent detailed assessment to require structural replacement of the EBF active links. Beyond the usual factors contributing to overstrength in steel frames (e.g. expected yield strength exceeding nominal values, modelling assumptions, etc.), a number of additional factors can explain the behaviour in this particular case, including the strength of the composite floor slab action (neglected in design), mobilization of the solid non-structural wall concrete cladding adjacent to the staircase, elastic stiffness of the gravity frame especially the columns and the relatively short duration of the February earthquake excitation.

**Figure 3:** *Club Tower: From top down and left to right: (a) Global view; (b) cracking of partition in cantilevering portion of story; (c) paint flaking of partially hidden EBF link; (d) global view of EBF braces obstructed by various utility runs. [Photos by M. Bruneau and C Clifton].*

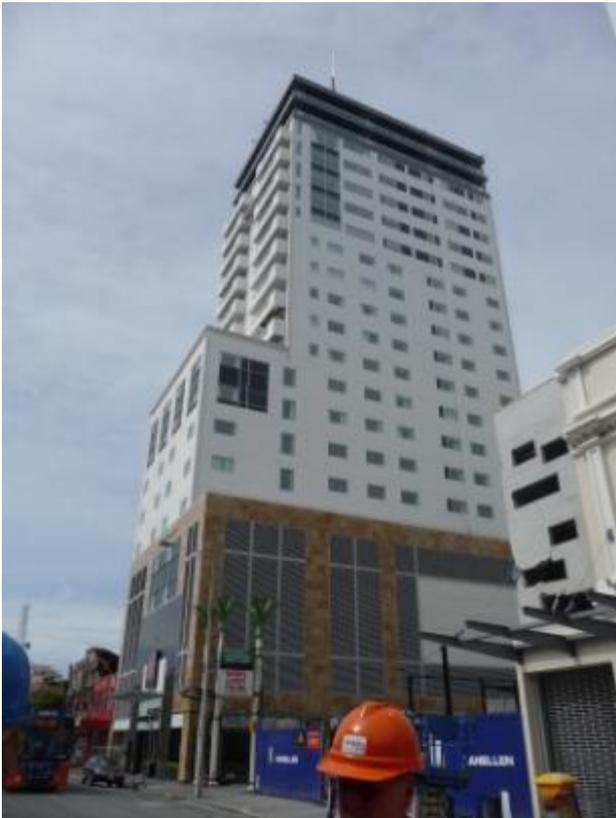
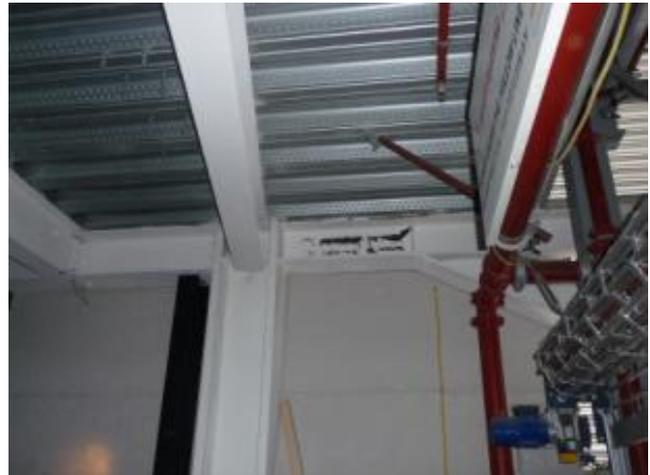
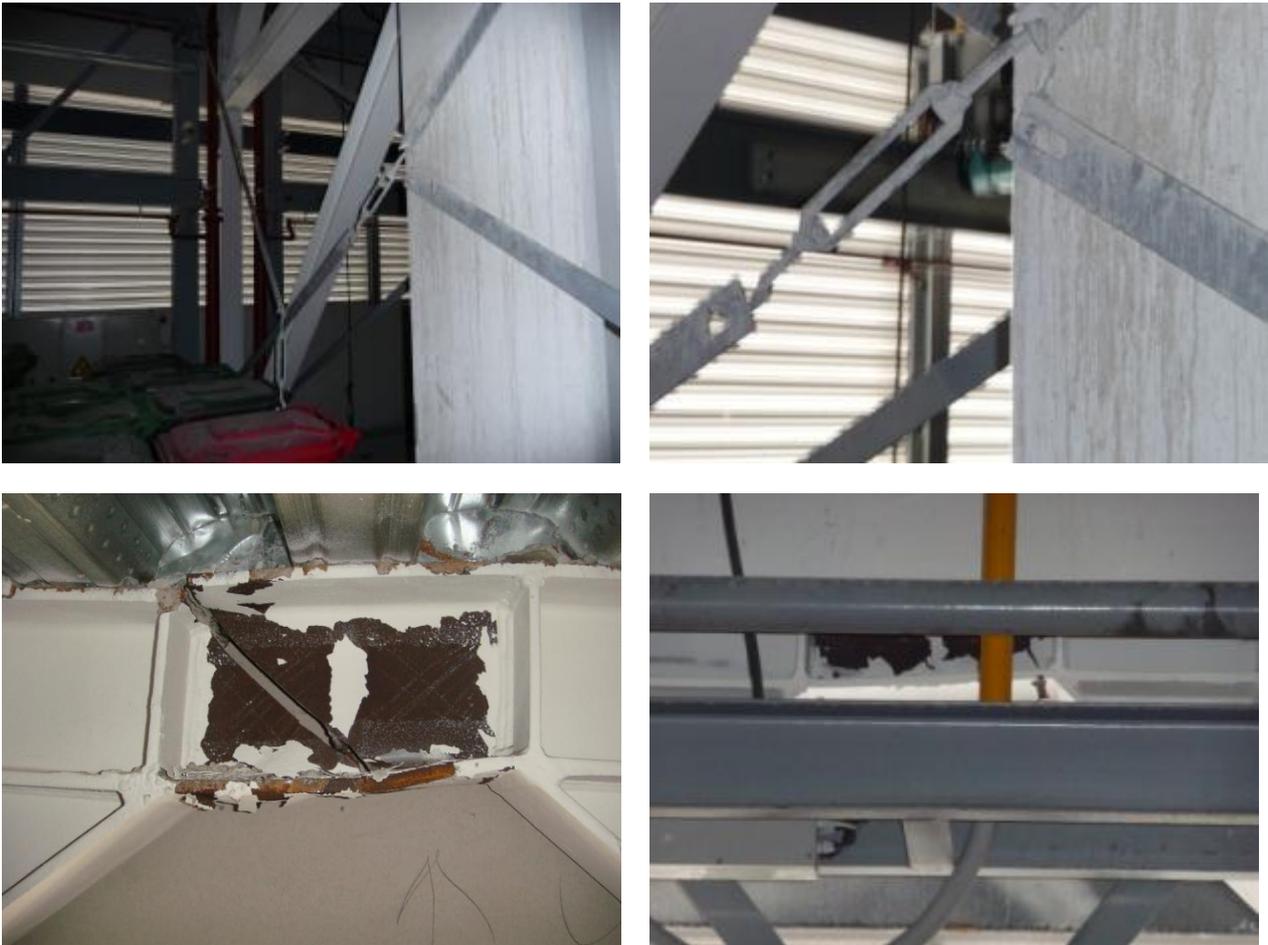
these levels housed a mechanical multilevel parking elevator system. The separate bracing system of that mechanical device consisted of flat plates connected with turnbuckles and hooks. Some of those details failed as the bars un-hooked when returning into compression after tension yielding excursions that elongated the braces. The EBFs at intermediate locations (on the NW frame) were not integral with the floor slab and so did not benefit from the strength increase provided by that integral action throughout the rest of the building. A range of views for this structure are given in Figure 4.

Paint flaking and residual link shear deformations were observed in the EBF links at those levels. Design of the EBFs in that building was governed by the need to limit drift, with a

corresponding resulting design ductility factor ( $\mu$ ) of 1.5 (even though up to 4.0 is permitted for EBF systems, as mentioned earlier). This is typical of EBFs in tall buildings in New Zealand's moderate to low seismic zones; Christchurch is moderate in accordance with the earthquake loadings standard, NZS 1170.5 and a more typical design ductility factor range for such buildings is 2 to 3. When the initial internal inspections were undertaken, there was an absence of significant damage to architectural and other non-structural finishings except at level 6 where a few of the hotel room doors along the corridor could not be closed, suggesting greater residual deformations at that level. This level was the first in which a detailed evaluation was undertaken. One fractured EBF active link was discovered (Figure 4e) in the top level (underside of Level 6) of the EBF system at the North-Western corner of the building. The frame sits behind the louvre system nearest the camera in Figure 4a. This link had undergone at least one full cycle of web panel yielding prior to a fracture propagating from one top corner across the active link region and resulting in significant residual deformation. Temporary strap cross-bracing was welded to the active link frame to provide lateral load resistance while a repair strategy was implemented, which comprised cutting out the damaged link, welding on an endplate system to each collector beam/brace face and replacing with a site bolted endplate active link. The replacement was scheduled for early October 2011 and is the only repair to the structural frame required for this building. A detailed evaluation was undertaken of all active links in the adjacent storeys and throughout the building, with the frequency of inspection reduced as no further examples requiring replacement were

found. This inspection required removal of architectural finishes.

This type of failure has not been reported in either EBFs tested in the laboratory or from damage reports from other earthquakes; the reasons for this link fracture are not currently clear and it is to be the subject of a detailed metallurgical and structural evaluation once removed.

**Figure 4:** Pacific Tower From top down and left to right: (a) (previous page) Global view; (b) (previous page) Flaked paint on EBF active link; (c) and (d) Multi-story mechanical garage stacker failed braces; (e) Fractured EBF active link in top level of EBF system in front face of atrium; (f) Residual shear deformations of EBF link in car stacker tower. [Photos by M. Bruneau and C Clifton].

As with the Club Tower, some repair of dry-wall cracking and realignment of lift shaft guide rails is the only other work required and the intention is to have this completed in time for the building to be fully opened when public access is restored into this area. It is also worth noting that this may be the only one of the six high-rise buildings in Christchurch that will be returned to service and is certainly the one requiring least structural and non-structural repair.

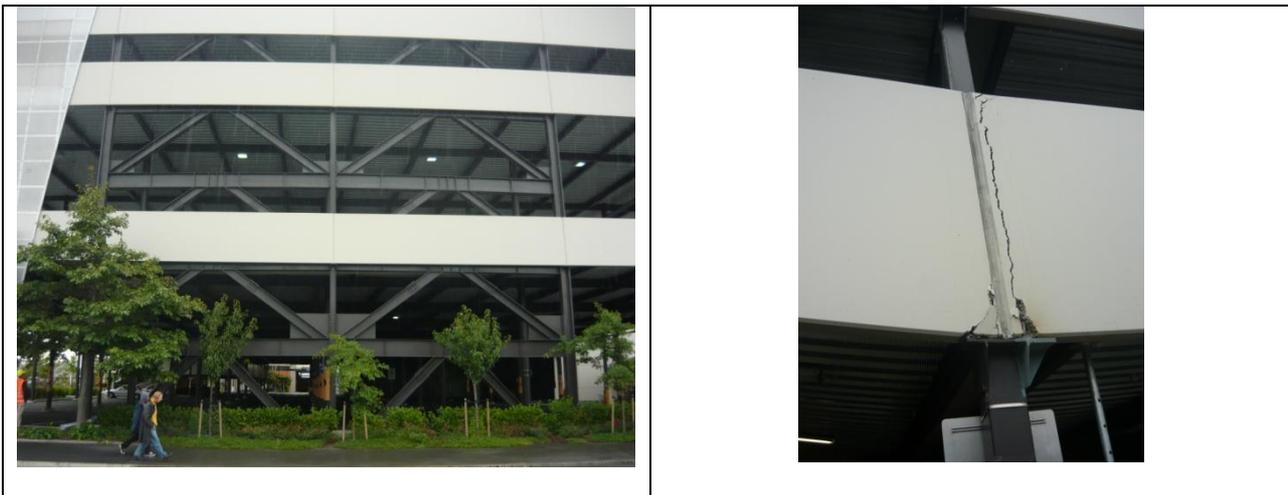
**Figure 5:** Shopping mall on Dilworth St and Clarence St, Christchurch From left to right; (a) View from the East, (b) Fracture of Precast Spandrel Beams on South side. [Photos by G. MacRae].

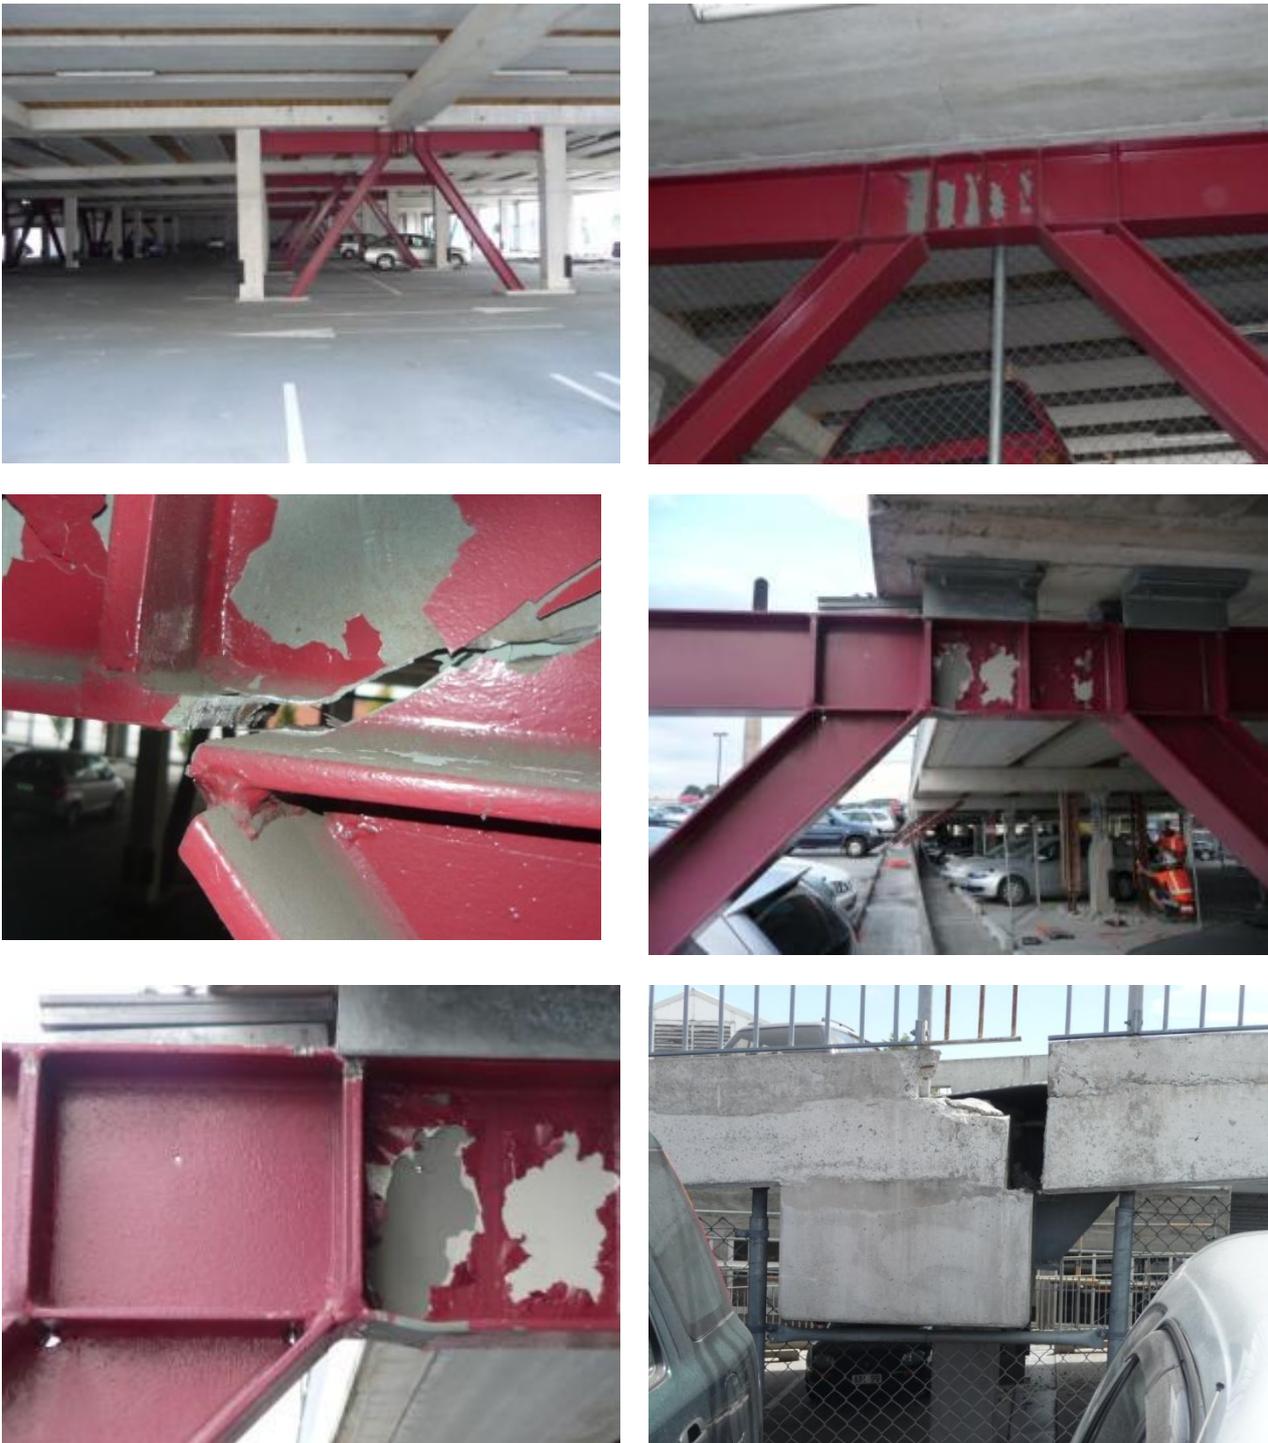
The EBFs in a hospital parking garage closer to the epicentre (Bruneau et al. 2010) also performed well, although some link fractures were observed in two braced bays (Figure 6). Note that at least six EBF frames were used at each level in each of the buildings' principal directions, and that this significant redundancy contributed to maintain satisfactory seismic performance of the building in spite of those significant failures. Residual drifts of the parking structure or damage to the gravity load carrying system were not visually noticeable, which suggests that these fractures would have not have been discovered if hidden by non-structural finishes.

Note that this parking structure was also designed to accommodate two additional floors. Yet, some of the links at the first storey showed paint flaking as evidence of inelastic deformations. Evidence of soil liquefaction was also observed over parts of the slab on grade. Depending on the foundation type, liquefied soils can act as a sort of base isolation or as a method to lengthen the period. This generally results in a lower ground acceleration experienced by the structures with lower structural demands. As such, it is possible that this parking garage was not subjected to ground motions as severe as those shown in Figure 1, in spite of being only 1.5 kms away from station CCCC in Figure 2. However, because these EBFs were not drift dominated they were designed for the maximum  $\mu = 4$  ductility demand. Also these active links were added as finished components into the largely precast concrete structure and so were not tied into the floor slab with shear studs as they were for the taller buildings previously discussed. This meant that they did not have the same strength enhancement due to resistance to out of plane deformation of the floor slab as the taller buildings had.

The fractures, as shown in close-up in Figure 6(c), were of particular concern as these were the first fractures recorded in EBFs worldwide (the Pacific Tower fracture as mentioned above was discovered later). Further puzzlement was added by the fact that the fracture plane, shown in Figure 6(c), indicated a ductile overload failure rather than a brittle fracture. However, the likely explanation lies in the offset of the brace flange from the stiffener. This offset is shown in Figure 6(c) and means that, when the brace was loaded in tension, the axial tension force in the brace fed into the active

link/collector beam panel zone through a flexible beam flange rather than directly into the stiffener. This meant that the junction between the unstiffened beam flange and the beam web was severely overloaded, leading to fracture between these two surfaces and this fracture spread across the beam flange and through the web. Evidence in support of this is from the following:

- where the flanges of the brace line up with the stiffeners, as in the right hand side of the active link shown in Figure 6(b) or the panel zone shown in Figure 6(e), there was no damage to this panel zone region.
- the damage to the panel zone region is directly proportional to the eccentricity between the brace flange and the active link end stiffener.

Also, the ramp at the top level, built in anticipation of future additional storeys, suffered damage as the only EBF on the upper segment of the ramp was located at the east end of that ramp, inducing torsional response and shear failure of the columns in moment-frame action at the west end of the ramp – these shear failures had not been repaired by the time of the aftershock and exhibited more significant damage (temporary lateral bracing were installed to prevent further sway motions). Steel angles, originally added at the expansion joint to meet the design requirement for support length of the hollow-core slab prevented unseating of the ramp. The EBF link at the ramp level itself exhibited substantial inelastic distortions.

The lateral bracing of the active links in the building shown in Figure 6 was only in the form of a confining angle each side of the top flange, as shown in Figure 6(d) and 6(e). No lateral movement or twisting of the ends of the active links was observed, indicating that the lateral restraint provisions had been adequate in practice, despite only being applied to the top flange and for EBFs not integral with the slab above, also being non-compliant with NZS 3404.

**Figure 6:** *Parking garage on St Asaph St and Antigua St, Christchurch From top down and left to right: ; (a) Redundancy provided by multiple EBF bays; (b) Evidence of EBF link yielding; (c) Fractured link at lower level EBF; (d) Evidence of inelastic deformations at top level EBF; (e) Close-up view of same; (f) Displacement at expansion joint, top ramp. [Photos by M. Bruneau and C Clifton].*

As of mid 2011, the fractured active links have been cut out and are being replaced to bring the building back into service in advance of when public access is restored to this area.

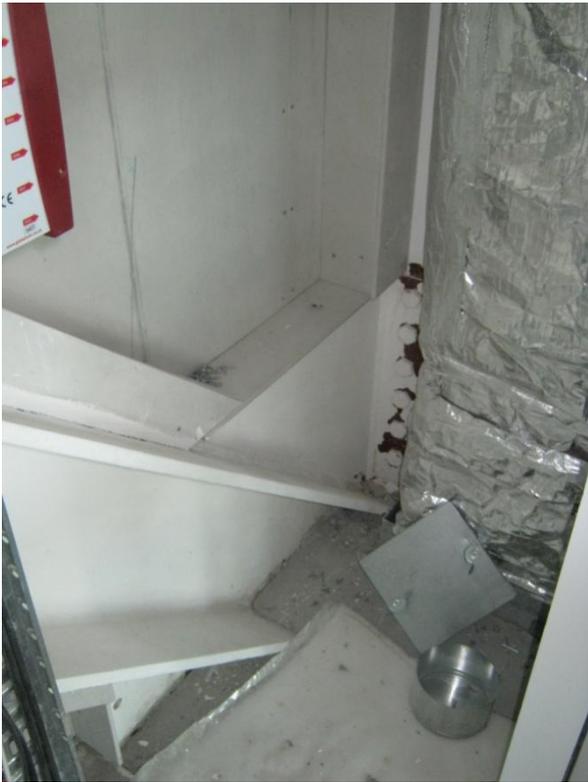
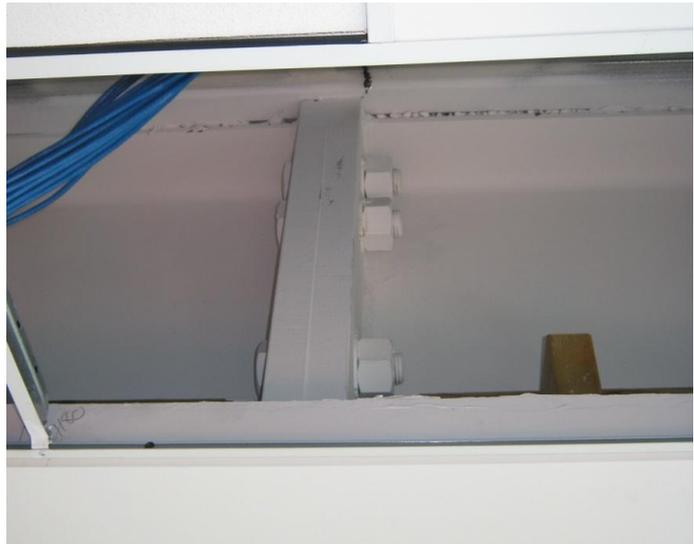
**Figure 7:** Connections in Club Tower Building, Christchurch From left to right: ; (a) Brace/beam/column connection showing out-of-plane yielding in endplate but no inelastic demand in gusset plate; (b) Flush moment endplate splice connection. [Photos by G C Clifton].

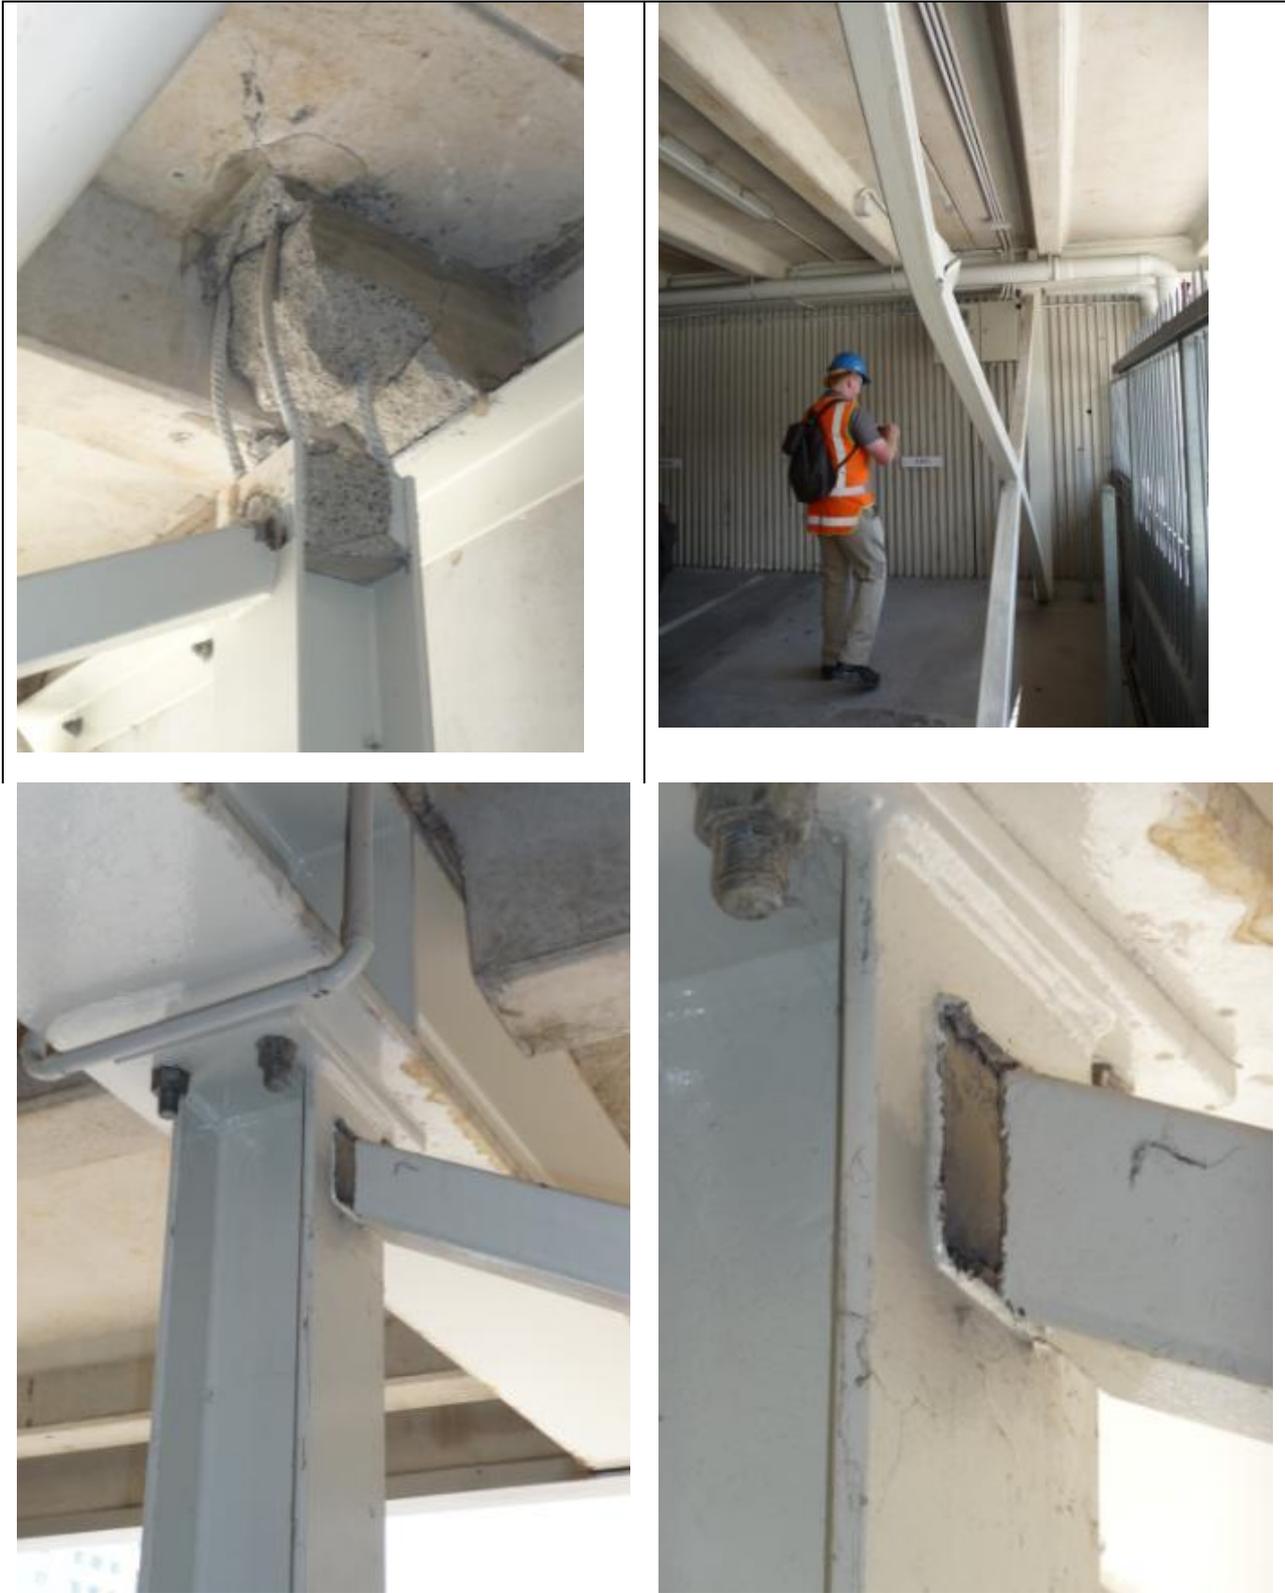
A single suspended level parking garage with concentrically braced frame (CBF) was found to have performed poorly (Figure 8). The garage had solid pre-cast panel walls on three sides, and two individual CBF bays along the fourth side (one bay on each side of the garage door). While the columns of the westernmost CBF tied to a steel beam at their top, the easternmost CBF was not similarly aligned with a steel beam. A non-ductile reinforced concrete extension

framing into a concrete beam at the top performed poorly. The other brace of that frame failed at the welds under tension loads; these welds did not appear to be designed to develop the tension capacity of the brace according to the capacity design principles of NZS 3404. The westernmost CBF performed better, without fractures and with proper attachment to the supported floor at both columns, with visible post-earthquake residual buckling as a consequence of brace elongation.

**Figure 8:** *Low-rise CBF parking garage From top down and left to right: : (a) Poor column connection detail; (b) Buckled brace; (c) and (d) Fractured non-ductile brace-to-column connection. [Photos by M. Bruneau].*

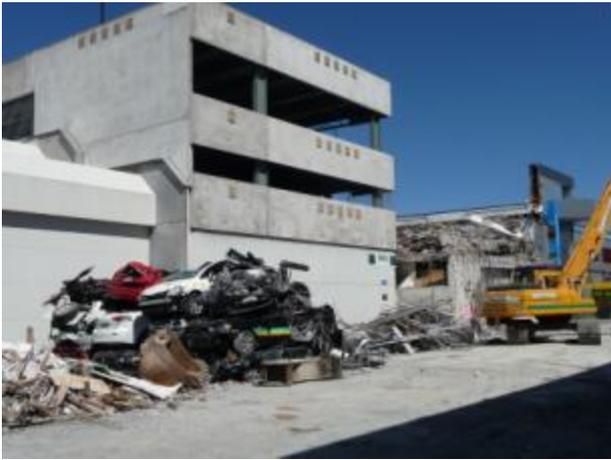
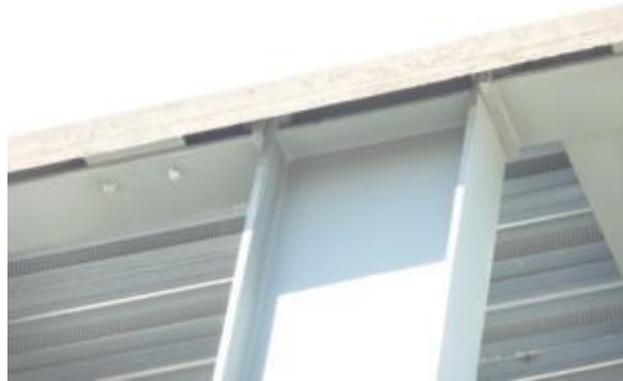
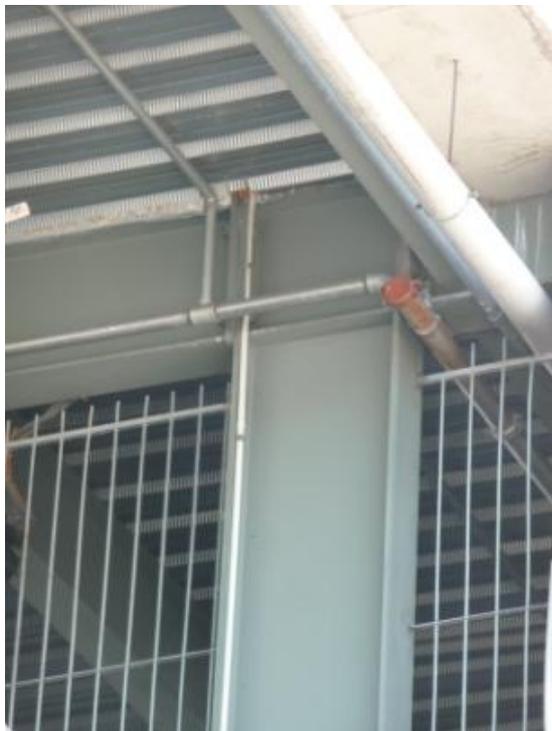
**Figure 9:** Low-rise MRF parking garage From top down and left to right:: (a) Global view; (b) and (c) Typical moment connections. [Photos by M. Bruneau].

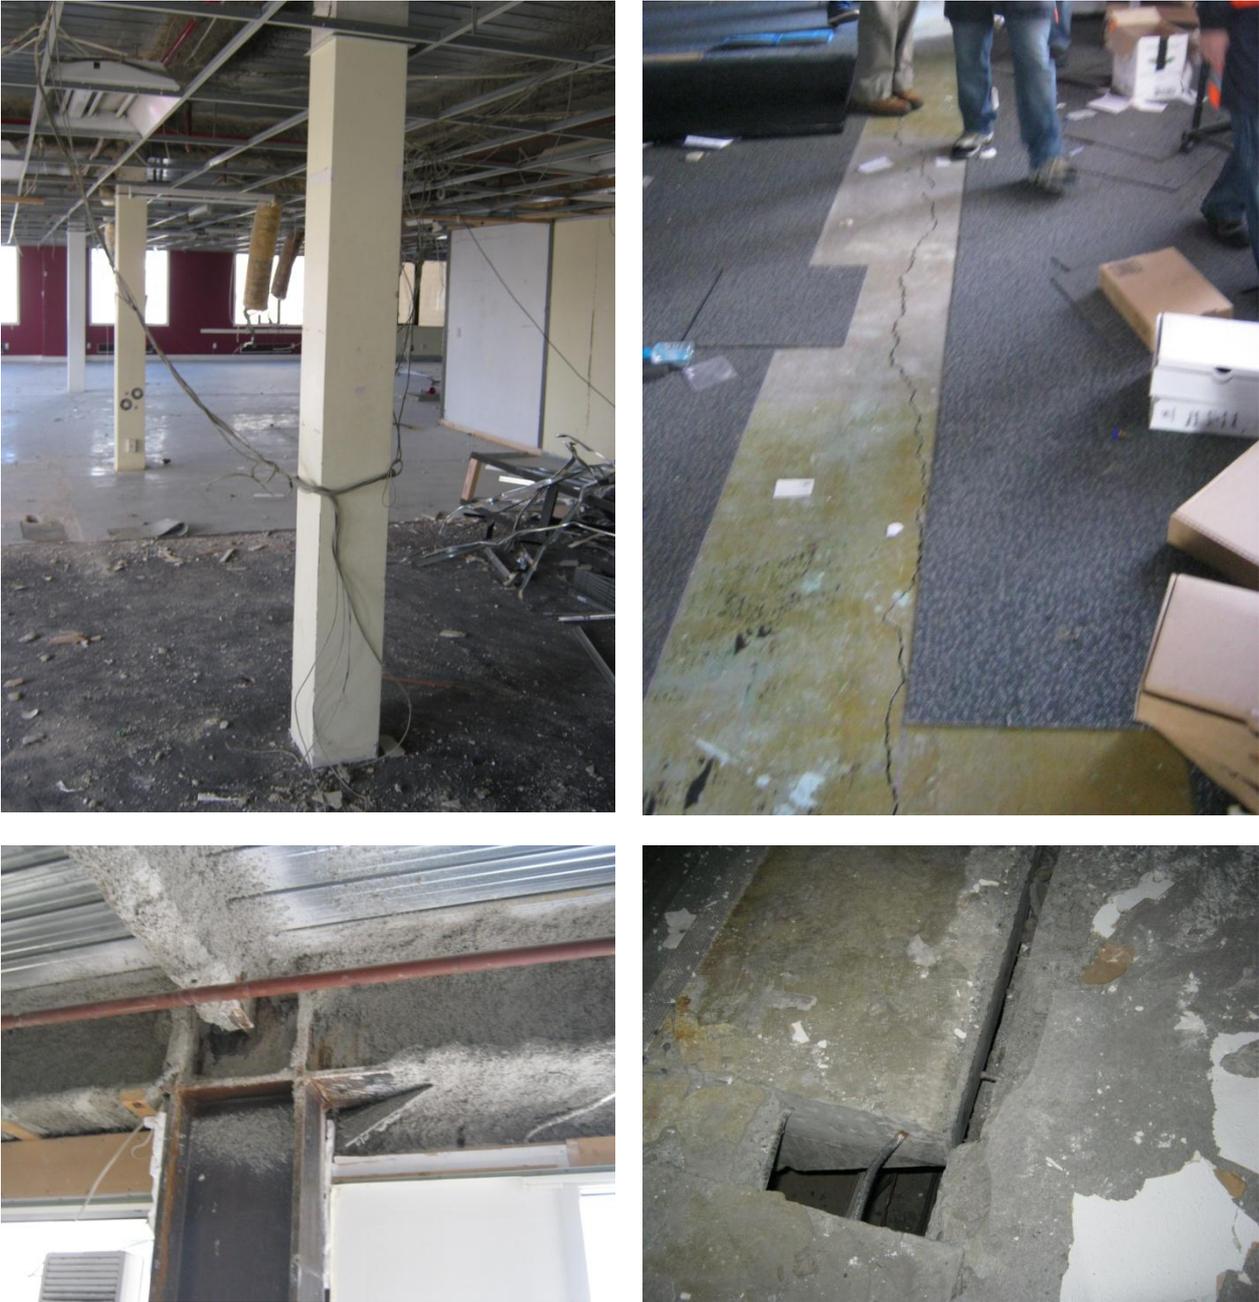
inside and out. The structure comprises a perimeter moment resisting frame along all 4 sides, with a non-structural stair and services core and composite floor. Inspection of the steel frame and floor showed no visible damage, however the perimeter frame had sunk a noticeable amount in relation to the core (Figure 10b) and had acted as pinned base, causing significant interstorey drift which has subsequently significantly damaged stairs (Figure 10d) and non-structural components. The extent of ground movement around the building was considerable and it is likely that significant foundation movement has occurred. The question of what to do with this building will rest on what has happened below ground.

**Figure 10:** Seven storey PMRF building From top down and left to right:: (a) Internal view of partially stripped floor; (b) Crack in ground floor slab where perimeter (to the right of the crack) has moved downwards relative to the core; (c) Typical beam to column connection with fire protection partially removed for inspection; (d) Gap opening in stair at landing due to lateral movement (stairs had independent structural support). [Photos by C Clifton].

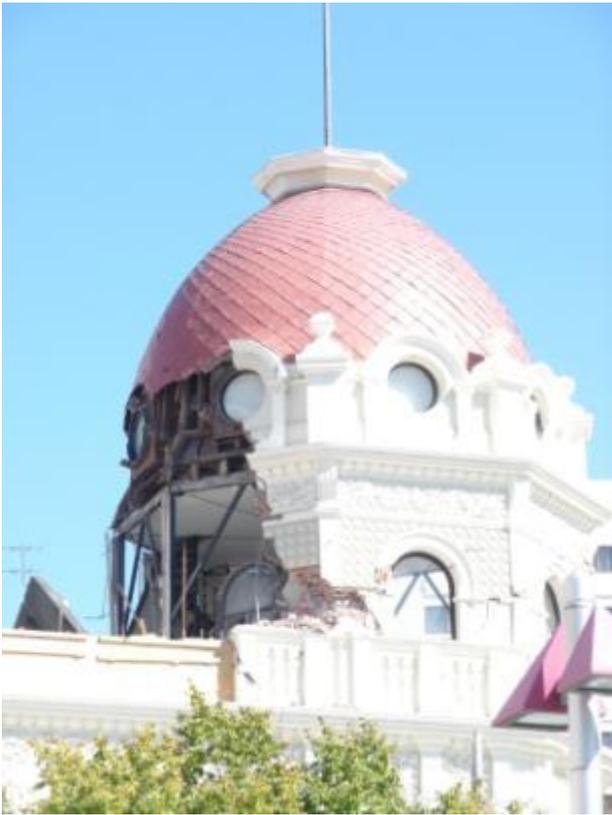
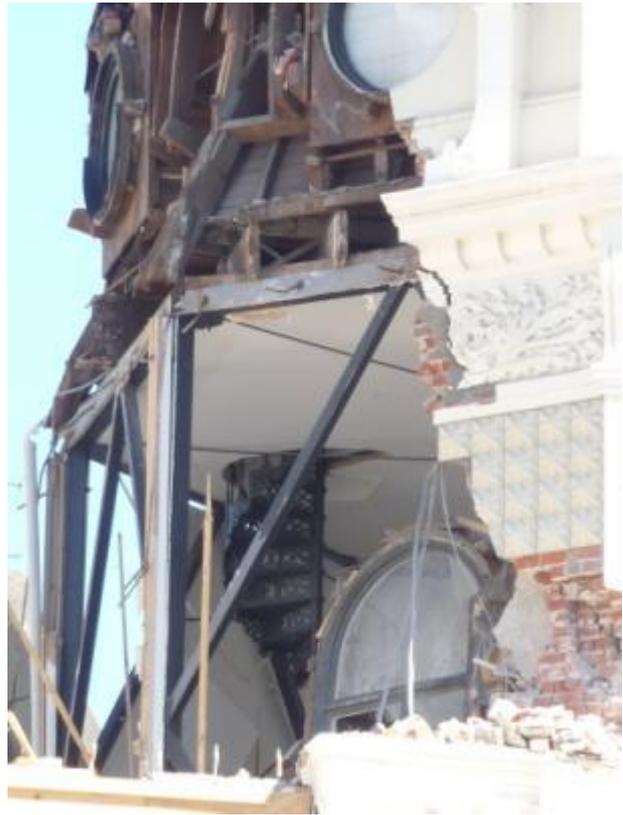
Partial out-of-plane failure around the dome at the top of the Regent Theatre Building revealed that a braced steel frame had been used there (Figure 11). Although subsequent inspection will be required to verify the integrity of the connections, it appeared to be in good condition from a distance. The building was built before 1910 and the scene

was reminiscent of pictures of similar buildings following the 1906 San Francisco earthquake. However, the CBFs appeared to be welded construction (to be verified) which means they are likely to be newer than the rest of the building and had been added in a subsequent retrofit.

**Figure 11: Braced dome at top of Regent on Worchester Building From left to right : (a) Global view; (b) Close-up view. [Photos by M. Bruneau].**

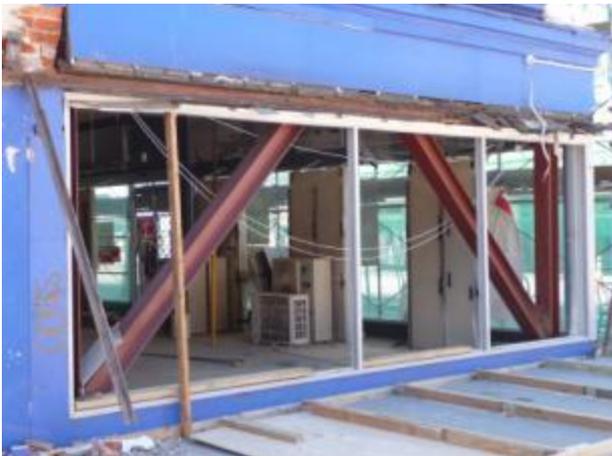
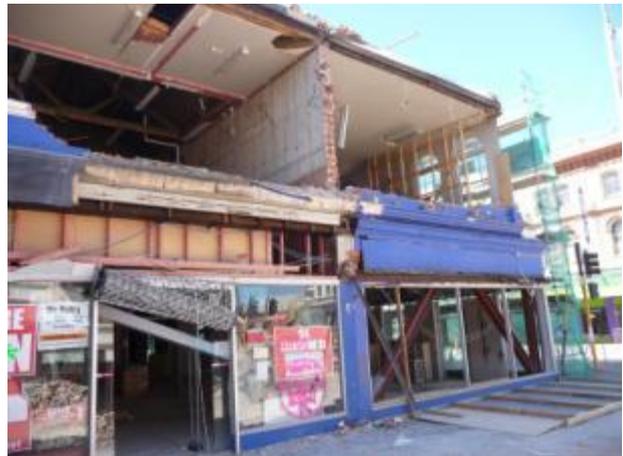
Steel braced frames were sometimes used to retrofit unreinforced masonry structures (e.g. Figure 12). Drift limits to prevent failure of the unreinforced masonry typically

govern design in those instances, which explain the significant member sizes of these frames proportional to the reactive mass, and their elastic response.

**Figure 12 : Braced frame as a retrofit to unreinforced masonry building From left to right : (a) Close-up view; (b) Global view. [Photos by M. Bruneau and C Clifton].**

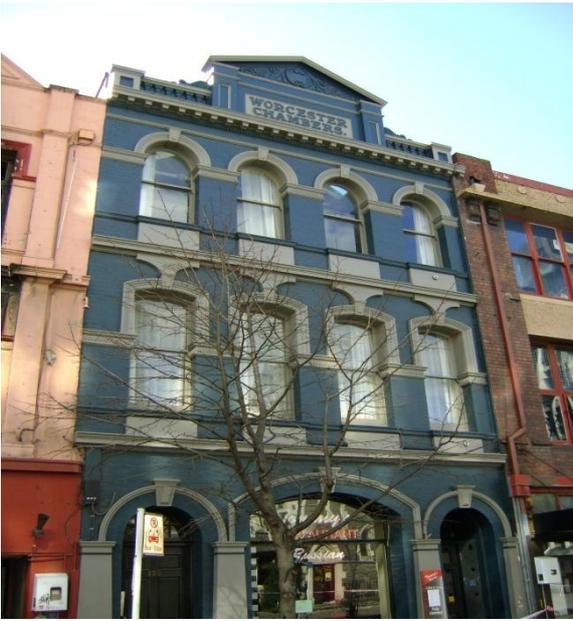
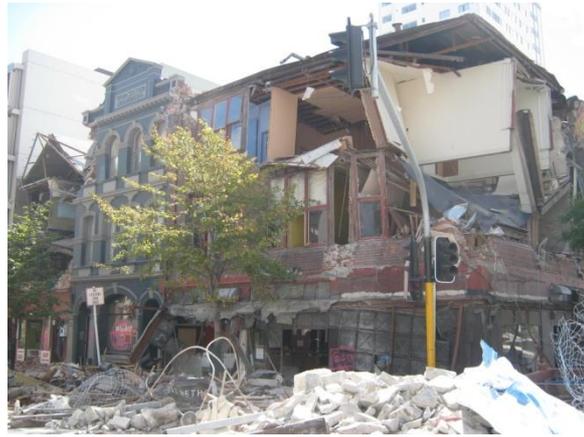
Buildings in the CBD that had been strengthened prior to the September 2010 earthquake typically suffered minimal to no damage in that event. They were not so fortunate in the much stronger February 2011 event. Figure 13 shows one group of

three buildings, (a) following the September 2010 event and (b) following the February 2010 event (from a different vantage point). Note especially the strengthened building on the corner has collapsed.

**Figure 13:** Strengthened URM buildings From left to right: (a) is following the September 2010 event and (b) following the February 2011 event, taken from a slightly different view-point. [Photos by C Clifton].

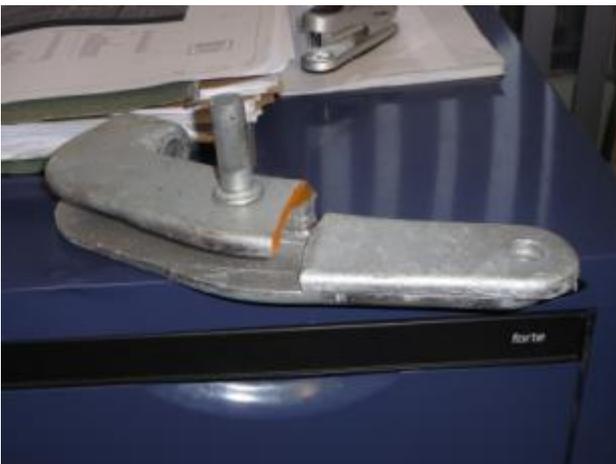
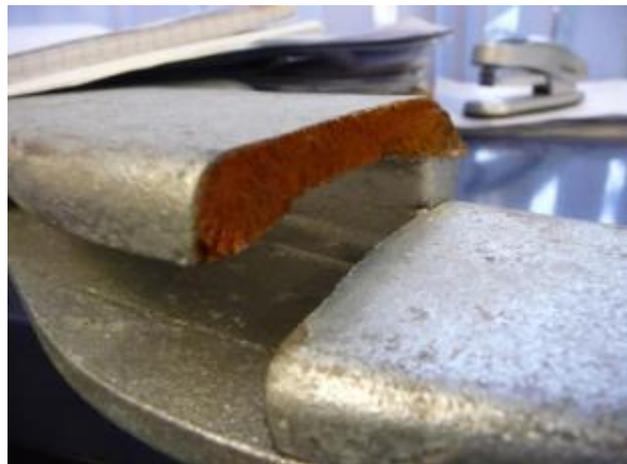
As was the case following the September 2010 Darfield earthquake, a proprietary system often used in these warehouses (sold as a kit) which used a particular banana end fitting, suffered some brittle failures of the cast-steel connectors (as shown in Figure 14). These occurred in a new warehouse when the fitting fell to the ground following the shearing of the pin retaining clip. Given that these connectors are rated for earthquake loading based on static tests conducted by the manufacturer, in light of the few fractures reported following the two earthquakes, some engineers have expressed concerns regarding their strength and potential brittleness. Performance of this and similar systems needs to be validated under a dynamic test regime more representative of their expected seismic demands, particularly simulating the impact forces applied when previously-buckled braces re-tighten during earthquake excitations.

**Figure 14:** Example of fractured banana end of proprietary brace connector in the roof plane of a long span steel portal frame building From left to right: (a) Global view; (b) Close-up view. [Photos by M. Bruneau].

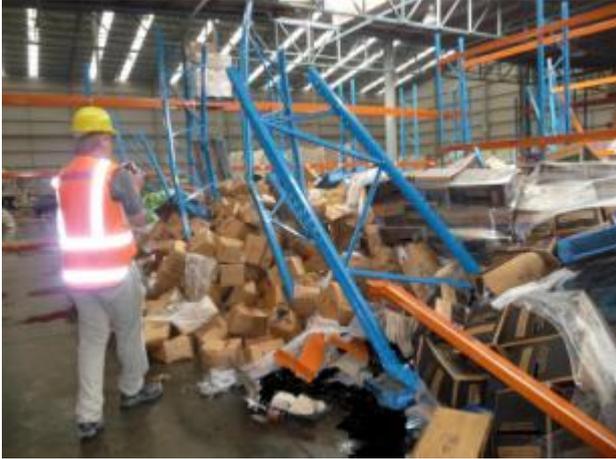
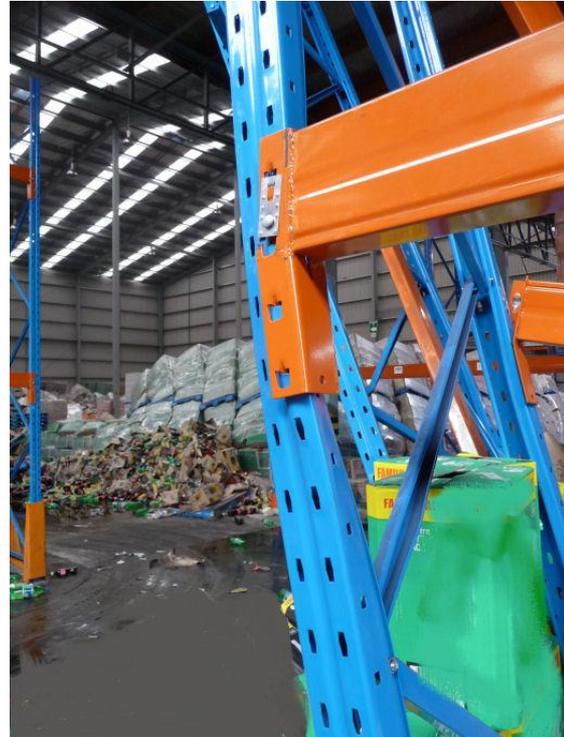
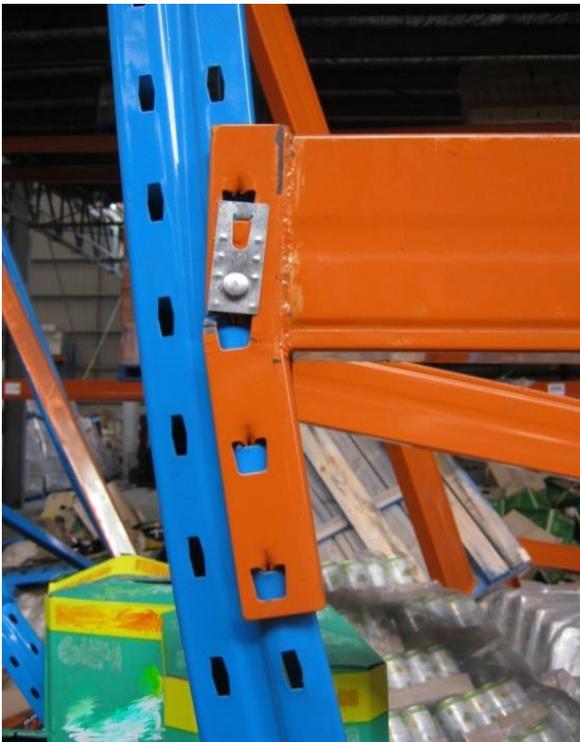
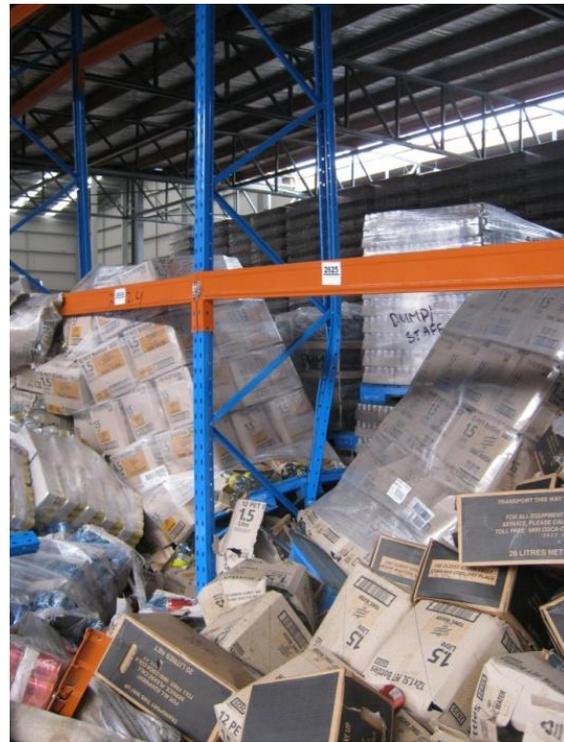
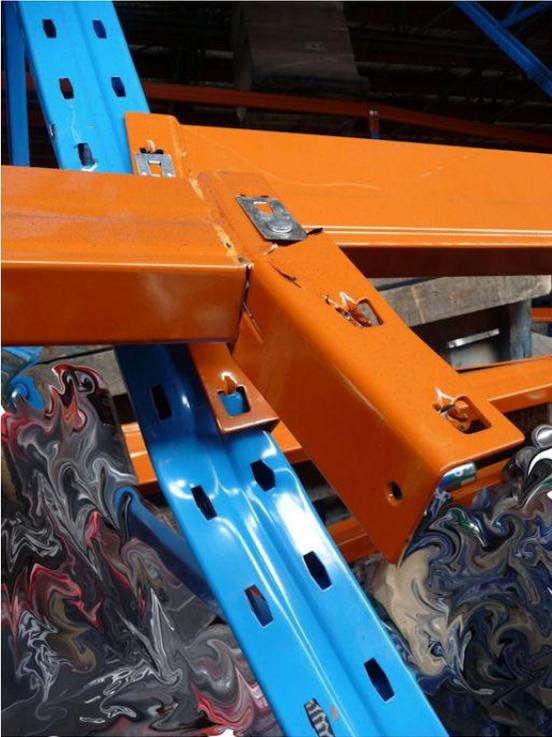
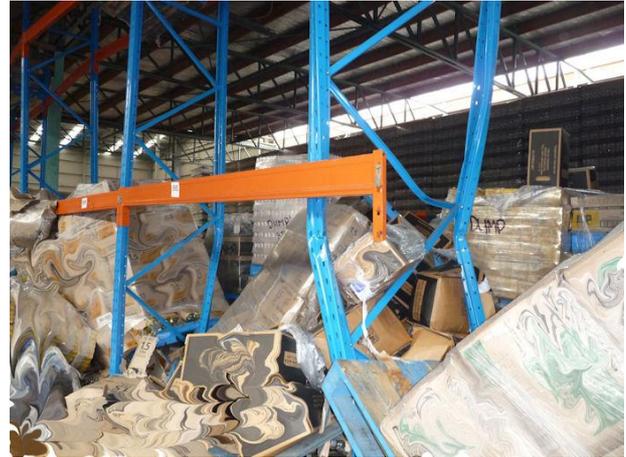
Extensive failure of steel storage racks was observed in industrial facilities, in some cases in spite of additional measures taken following the September earthquake. For example, one facility owner who had racks stacked 6 pallet-levels high that collapsed during the September 2010 earthquake, purchased new racks “designed to resist Magnitude 7 earthquakes of the type expected in [the most active seismic zone of] Wellington” and re-structured his operations to limit stacking to three levels. In spite of those measures, all racks experienced total collapse, as shown in

Figure 15. While racks that failed in the transverse direction could have been pushed due to “spilling” of the pallets and piling up of the products into the aisles, this was not a factor in the longitudinal rack failures that exhibited a combination of overloaded and fractured beam to column connections, and column local buckling. It appeared that the semi-rigid beam to column connections in the longitudinal direction were too weak for the intensity of shaking and design gravity loads. See also (Uma and Beattie, 2011).

*Figure 15: Example of collapsed industrial storage racks.*

*Figure 15 (continued): Example of collapsed industrial storage racks. [Photos by M. Bruneau and G. C. Clifton].*
