# STEEL STRUCTURES DAMAGE FROM THE CHRISTCHURCH EARTHQUAKE SERIES OF 2010 and 2011

**Charles Clifton<sup>1</sup>, Michel Bruneau<sup>2</sup>, Greg MacRae<sup>3</sup>,  
Roberto Leon<sup>4</sup> and Alistair Fussell<sup>5</sup>**

## SUMMARY

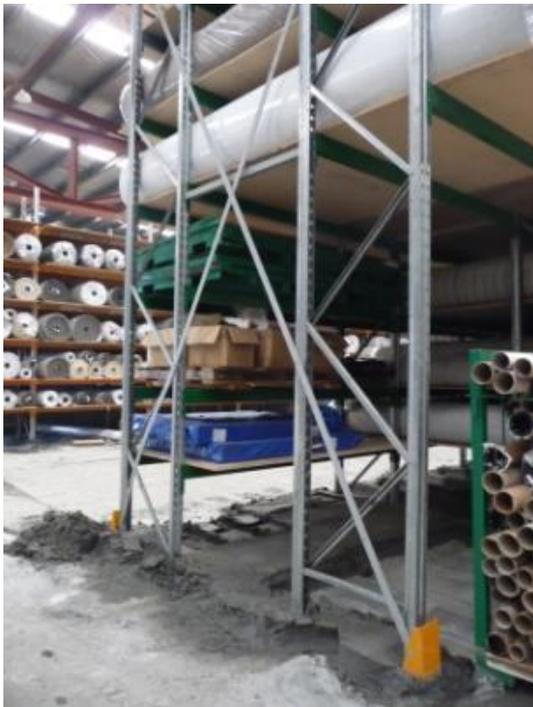
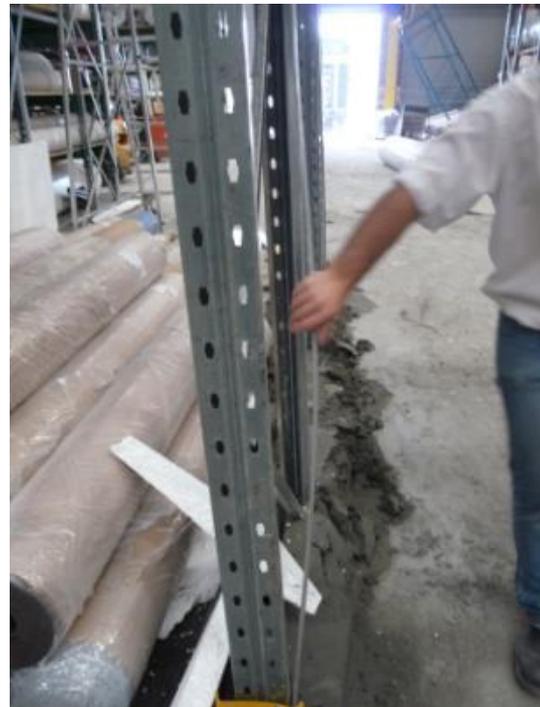
*Figure 16: Industrial storage racks that survived, with evidence of soil liquefaction From left to right; (a) Global view; (b) Close –up of buckled brace. [Photos by M. Bruneau].*

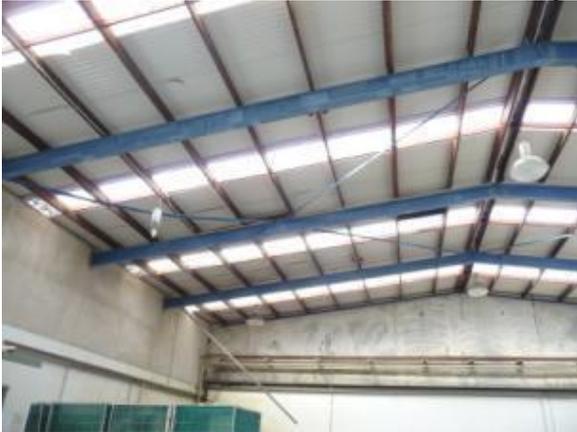
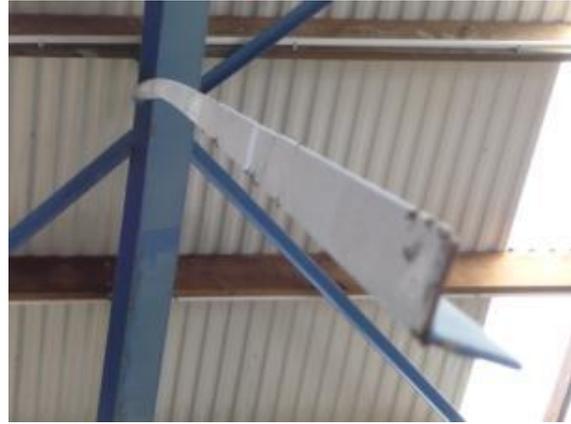
Multiple examples of tilt-up panel movements due to ground liquefaction were observed, sometimes leading to fracture of non-ductile braces unable to accommodate the imposed

**Figure 17: Industrial facility roof bracing** From left to right ; (a) Global view, showing buckled brace and fractured brace; (b) Close –up view of fractures weld of tension brace. [Photos by M. Bruneau].

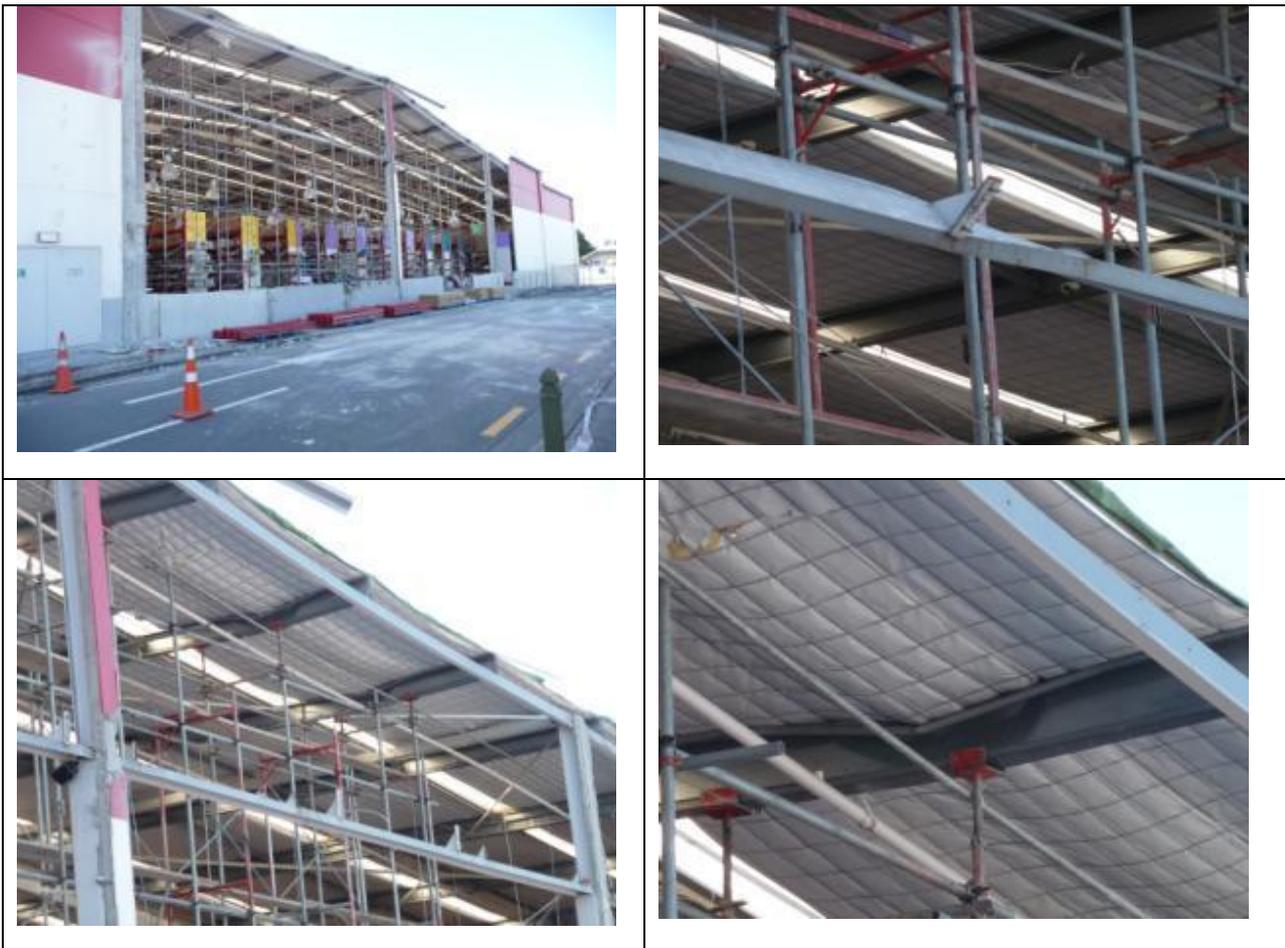
Anchorage of tilt-up walls to steel structures also failed in a few instances. Figure 18 shows roof beams buckled in compression by the inward movement of the tilt-up panels, and failure of the anchors due to their outward movement (i.e. away from the building). Given that this happened in modern construction, and because tilt-up walls of greater slenderness have progressively been implemented in New Zealand, a

**Figure 18 : Failure of tilt-up panel connections** From top down and left to right: (a) Global view; (b) Close –up view of fractures connection; (c) Global view of buckled beams; (d) Local view of one such beam. [Photos by M. Bruneau].

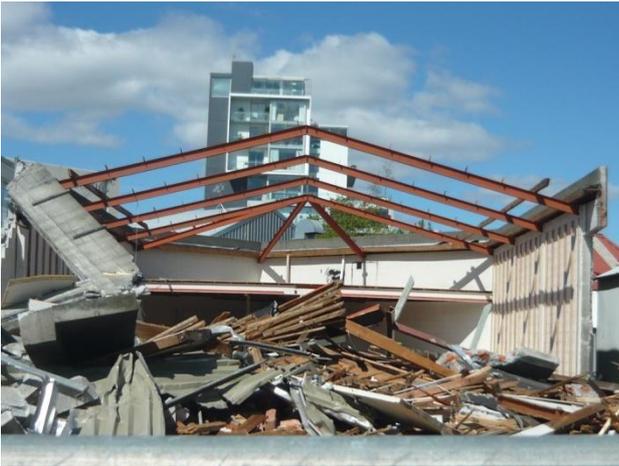
Figure 19 shows the steel structure standing when the roofing has collapsed. This shows very good performance of the steel members, but poor performance of the roofing/connections.

**Figure 19: Failure of roof and walls in older industrial facility on Salisbury Street. [Photo by G MacRae].**

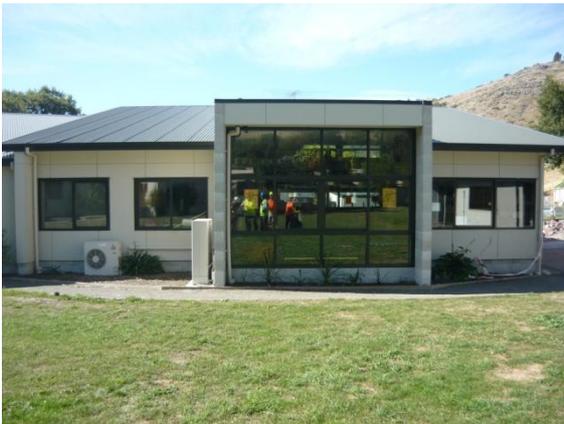
**(a) Overall View from the South.**

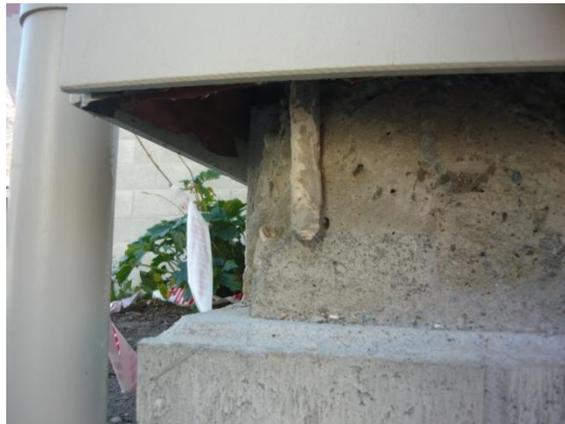
wall was leaning to the east at the southern end, and to the west at the northern end. The concrete baseplate was blown out on the southeast side of the building as shown in Figure 20b.

**(b) Baseplate bolt at SE corner of the building.**

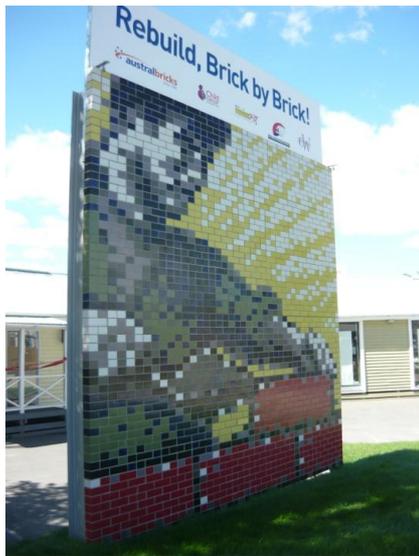
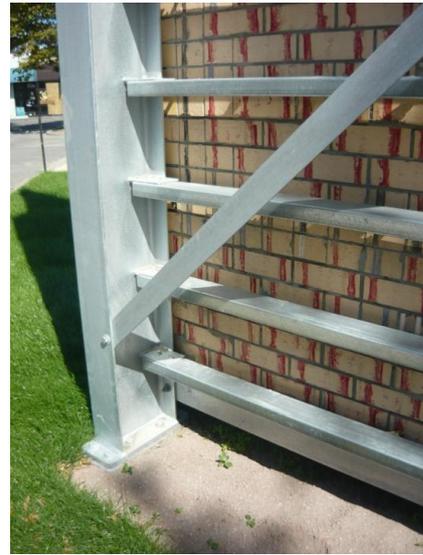
“Rebuild, Brick by Brick”. The wall suffered no damage during the subsequent earthquakes and the brick ties between the steel framing and the bricks showed no signs of distress.

**Figure 21: September 2010 Rebuilding Stand Consisting of Bricks Supported by Steel Frame. [Photos by G MacRae].**  
 (a) Overall View of Wall  
 (b) Back View of Wall

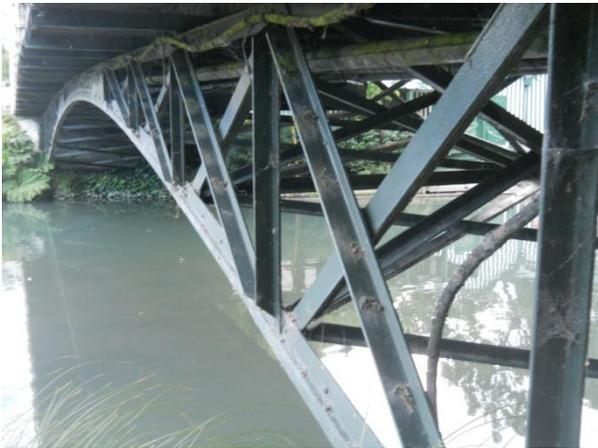
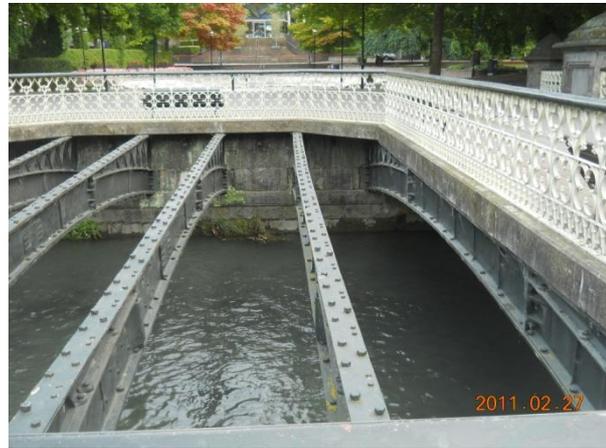
**Figure 22: Undamaged older steel pedestrian bridges on the Avon Rover near the CBD. [Photos by R: Leon].**

There are relatively few steel bridges in the Christchurch area. A pedestrian arch bridge at the Antigua Boatsheds and one at Victoria Square showed no visible damage (Figure 22).

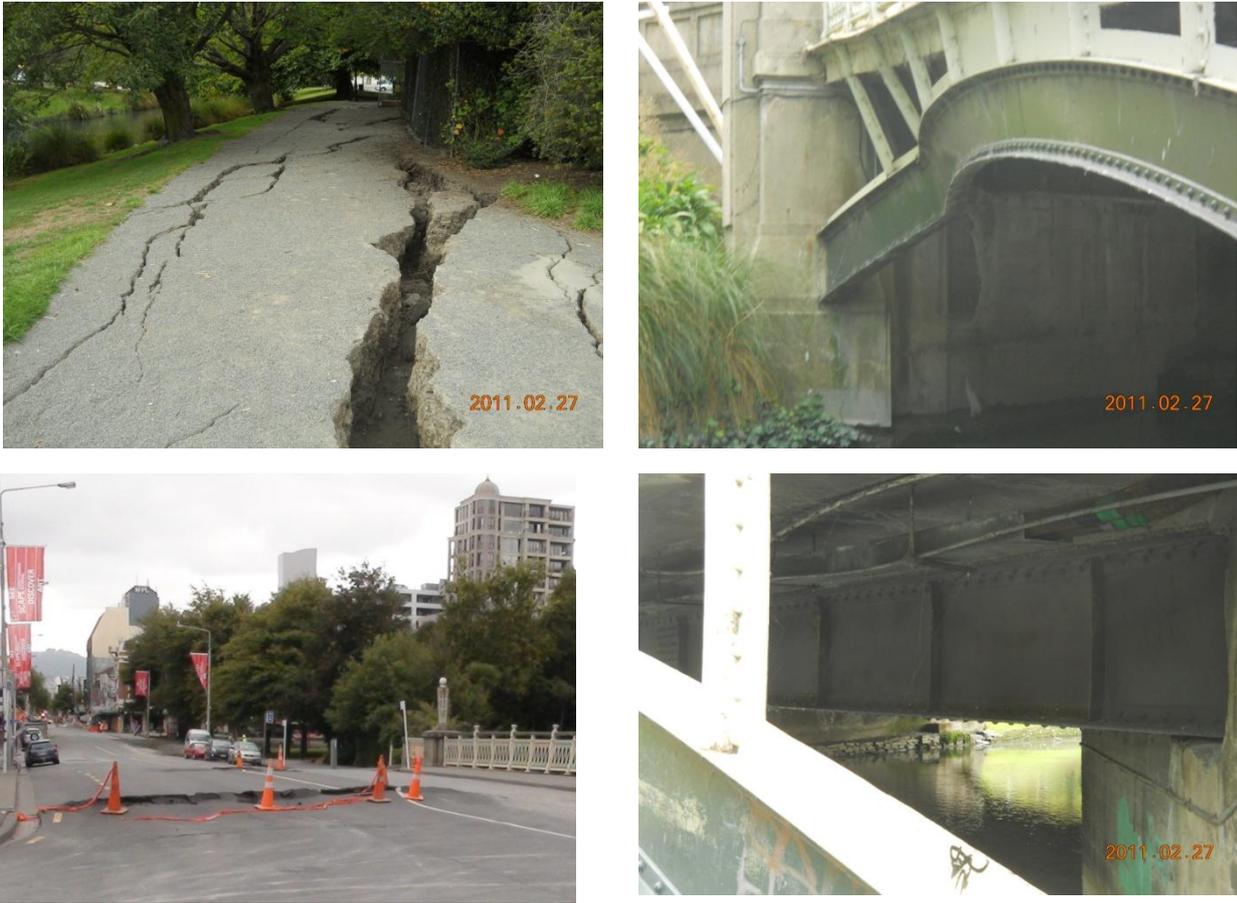
Figure 23: From top down and left to right: Colombo Street bridge (a) Slumping of riverbank close to bridge; (b) Buckling of fascia arches; (c) Slumping of abutments at end of bridge; (d) Undamaged straight riveted girders. [Photos by R Leon].

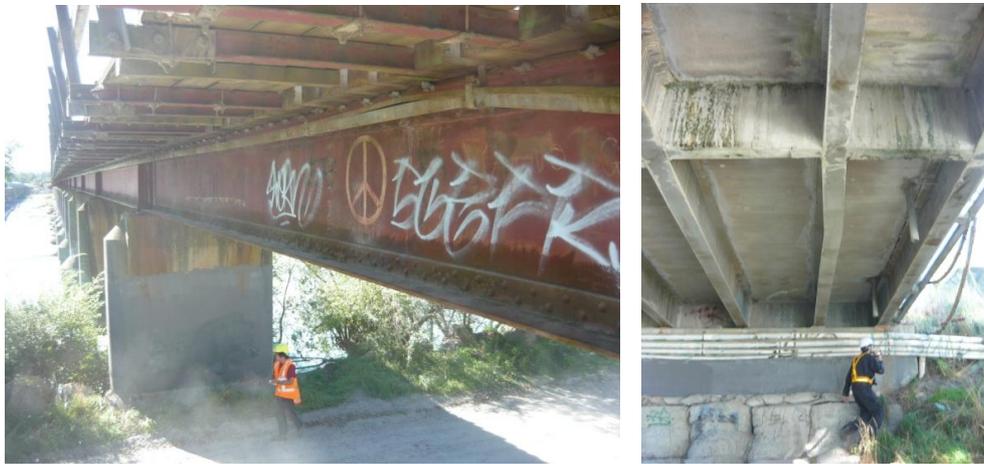
the pier had moved over 100 mm toward the river and back during this shake (Figure 24a). The old road bridge suffered some longitudinal buckling of the lower flange of one beam (Figure 24b) as well as some spalling of concrete on the west side of the abutment. The only major modern steel bridge at the Port of Lyttelton, a three-span continuous plate girder, had only minor damage at the abutment (Figure 25).

Figure 24: Waimakariri Bridges, South end (a) Old Rail Bridge, (b) Old road bridge. [Photos by G MacRae].

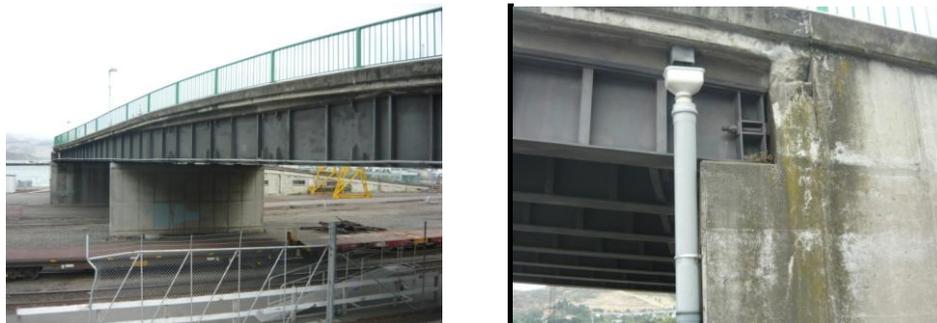
Figure 25: Lyttelton Port Bridge (a) Plate Girder (b) Abutment Spalling. [Photos by G MacRae].

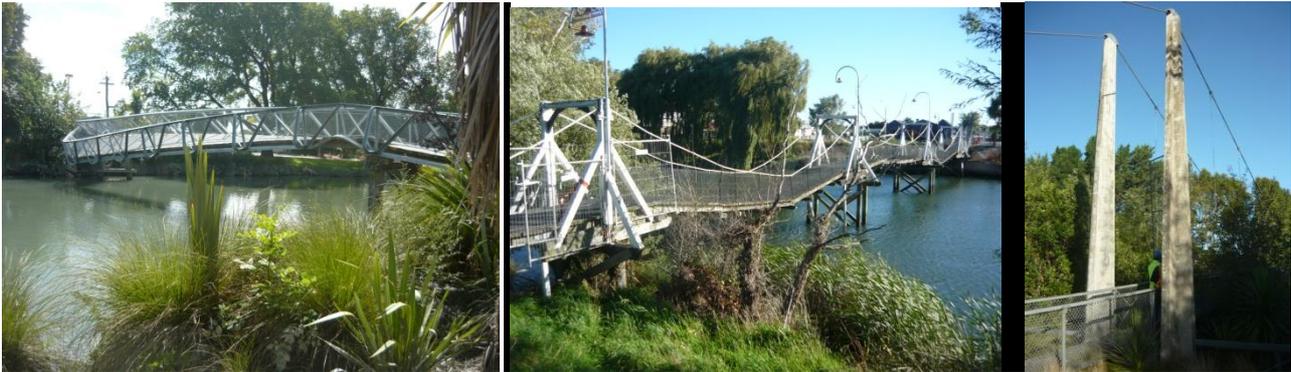
The footbridges shown in Figure 26 were damaged in the September 2010 earthquake and had not been repaired at the time of the February 22 event. Due to further lateral spreading

and slumping of abutments, they were even more damaged in this shaking.

**Figure 26: Footbridges; From top down and left to right: (a) Truss bridge over Avon River, (b) Suspension bridge with timber deck Over Kaiapoi river, (c) Suspension bridge at Groynes. [Photos by G MacRae].**
