# BUILDING AND BRIDGE POUNDING DAMAGE OBSERVED IN THE 2011 CHRISTCHURCH EARTHQUAKE

## SUMMARY

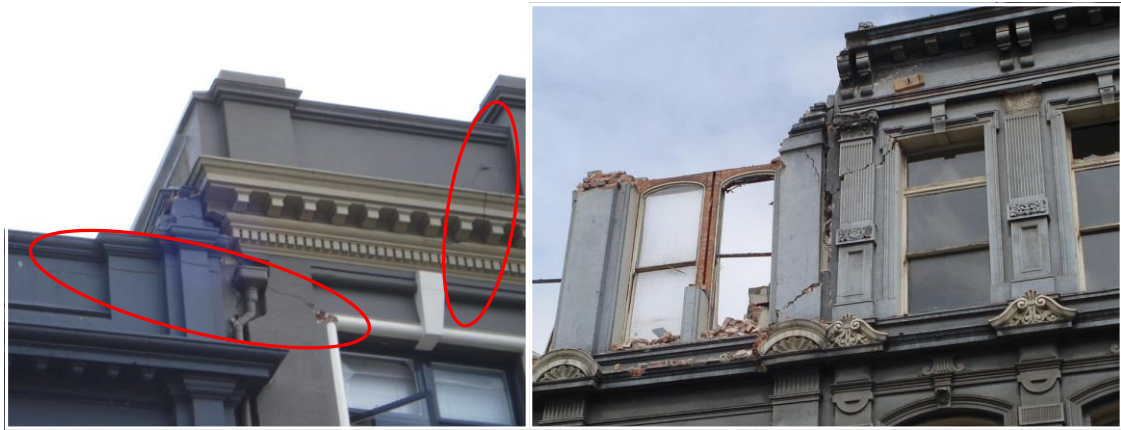
**Figure 1: Examples of URM pounding damage. Left: minor damage. Right: major damage partially caused by pounding.**

Pounding damage to URM buildings (for example, Figure 1) occurred sufficiently frequently to enable identification of common damage patterns (Figure 2). Masonry cracking typically extended from the topmost point of contact between two buildings to the nearest window arch or lintel in each building. Cracking frequently extended further from the window opening through to the top of the building’s parapet, although this parapet damage was not usually attributed to pounding. Multistorey buildings occasionally also presented damage at lower floors, although this damage was observed to be progressively less severe as the distance from the topmost point of contact increased. Cracking was also observed to concentrate in stiff lateral elements, such as wall sections with wide spacings between window penetrations (Figure 2a). Occasionally, local crushing of masonry units was observed at the point where two floors collided. When buildings of differing height collided, the floor immediately above the topmost point of contact also frequently suffered notable cracking. Figure 2b presents an idealised load path diagram, which also reflects the typically observed masonry damage distribution. In reality the damage ‘struts’ were not oriented at 45 degrees. This angle was instead governed by the building’s wall penetrations.

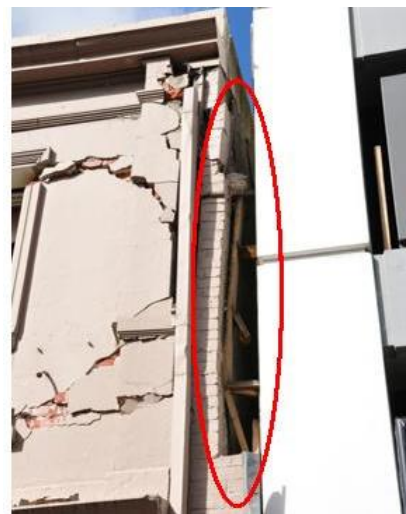
the URM building due to its weak, brittle properties). The primary source of pounding damage in modern buildings with separation was instead observed where building separations were infilled with cosmetic flashings (Figure 3). While flashings are intended to cover the gap between adjacent buildings, the detailing of some flashings created stiff and strong elements, which transferred significant force between the two buildings. In some instances the flashings caused failure of adjacent building elements, while in other instances the entire flashing detached from both buildings. Flashing detachment can cause a sizable amount of falling debris when the buildings have multiple storeys. Furthermore, this form of damage can be simply avoided by designing flashings to compress/crush and ensuring they are adequately anchored to one building only. Five instances of significant damage resulting from force transfer through building flashings were observed within the CBD.

**Figure 3: Building damage caused by framed flashing.**

- Modern buildings were primarily endangered by pounding when flashings between buildings were constructed with stiff and strong materials that allowed force transfer across building separations. This hazard can be mitigated by using compressible flashings attached to one building (but not both).

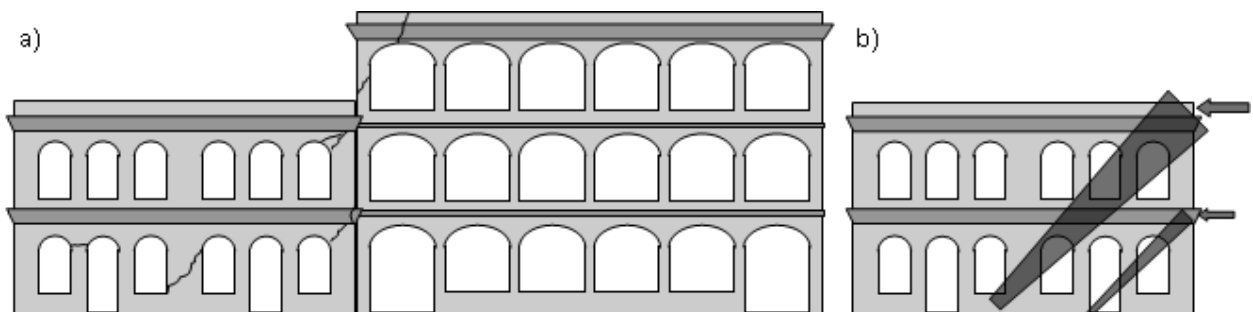
**Figure 2: Damage to URM buildings. a) Typical pounding damage. b) Idealized masonry strut damage. Arrows denote floor collision points of the adjacent building. Width of the shaded zone indicates approximate severity of damage. Figure reproduced from [4].**

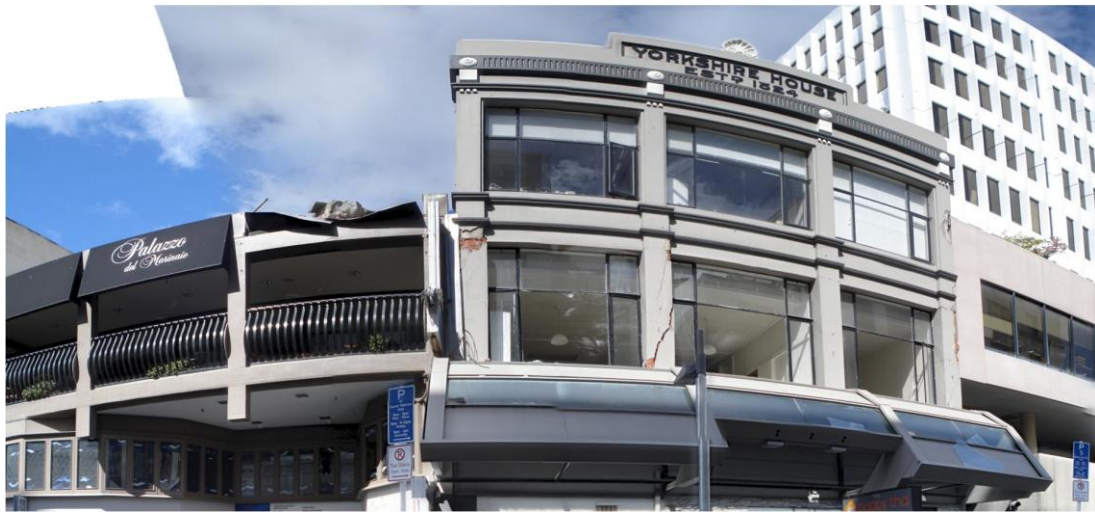
**Figure 5:** Pounding damage caused by buildings with greatly differing heights. Note image is distorted due to panoramic photography.

As was also observed in the Darfield earthquake, very little pounding damage was observed between buildings of greatly differing overall heights. This is again primarily attributed to the greater separations that generally surround taller buildings. However, Figure 5 presents one building configuration where extensive pounding damage did occur. Pounding between the central building and the taller rightmost building also occurred in the Darfield earthquake. The damage in the Darfield earthquake was minor, although it was noted that this damage occurred in the vertical elements of the primary gravity structure [3].

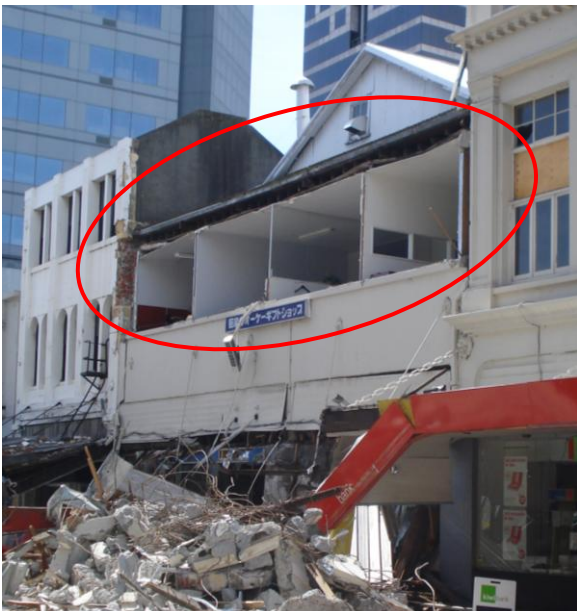
Three instances of buildings apparently being crushed from either side by adjacent buildings were also observed (Figure 4). This was evidenced by façade collapse and localised crushing damage at the points of contact with adjacent buildings. It is noted that some engineers have expressed some doubt to the first author that the adjacent buildings contributed to this failure. However, an alternative explanation for the observed damage at the contact points has thus far not been presented. If pounding did contribute to these collapses, it is a particularly dangerous consequence for any pedestrians in the vicinity when an earthquake occurs, in addition to potentially compromising the building's overall stability. The illustrated example's façade was constructed of reinforced concrete, which typically performed very well elsewhere in the CBD. This further highlights the potential danger of this type of damage.

**Figure 4:** Façade loss attributed to building crushing.

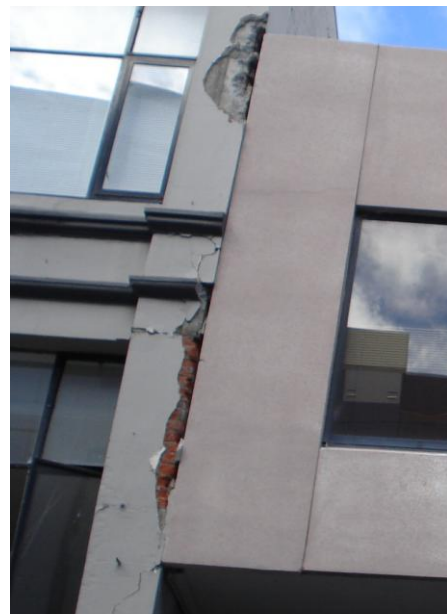
**Figure 6:** Damage between central and rightmost building.

The Christchurch earthquake significantly increased the damage in the central building, and also caused damage at the boundary with the leftmost building. At the right interface of the central building the observed damage is predominantly spalling (Figure 6), although cracking also extended below the contact interface. The damage at the left interface is more severe. The masonry column of the central building has been offset approximately 30 mm due to collision with the left building. It is considered that the central building was crushed by the surrounding buildings, primarily due to the greatly differing earthquake response of the taller rightmost building.

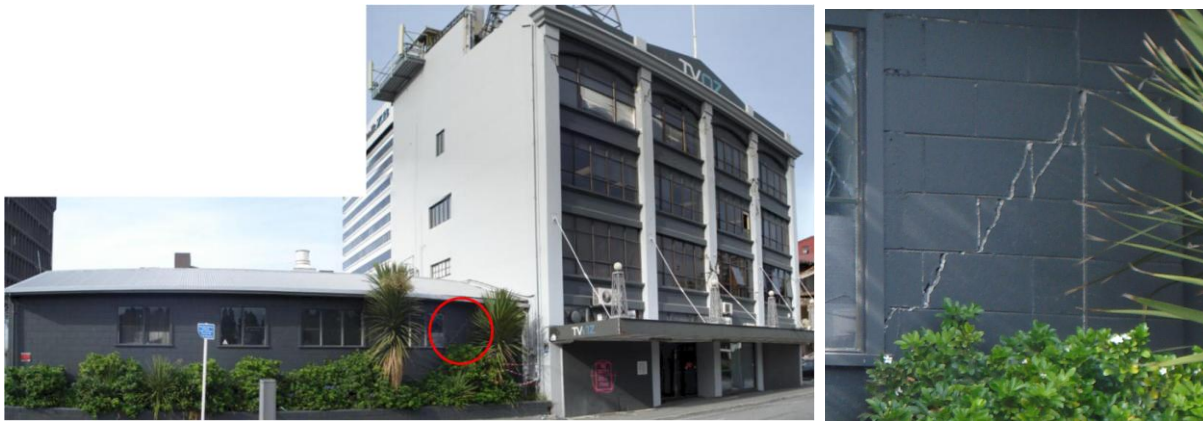
**Figure 7: Pounding between 1 storey and 4 storey buildings. Damage to four storey building not attributed to pounding.**

The range of buildings affected by pounding sometimes extended to buildings where pounding would not normally be anticipated. One single storey building was observed to suffer substantial pounding damage as a result of contact with a neighbouring four storey building (Figure 7). The neighbouring four storey building was substantially damaged during the Christchurch earthquake, however this damage is not attributed to pounding. As a result of this damage, the lateral stiffness of the neighbouring building reduced, causing greater building deflection. It is considered that this effect has increased building damage, although its significance is unknown. Approximately 10 mm building separation was observed between these buildings.

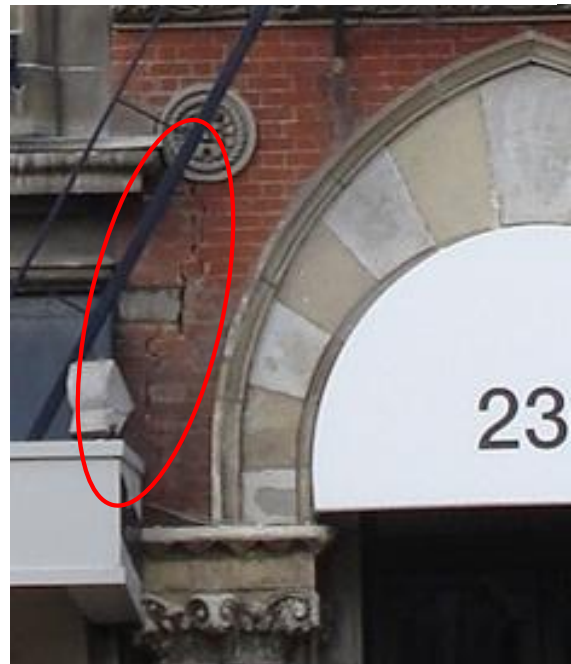
**Figure 9: Masonry damage after the Darfield earthquake.**

The second building configuration suffering collapse was also documented after the Darfield earthquake, as shown in Figure 9 (see also Figure 2 in [3]). Figure 10 displays the damage following the Christchurch earthquake. Figure 9 is located at the first floor between the left and central buildings, and is quite possibly the initiation point of the global collapse.

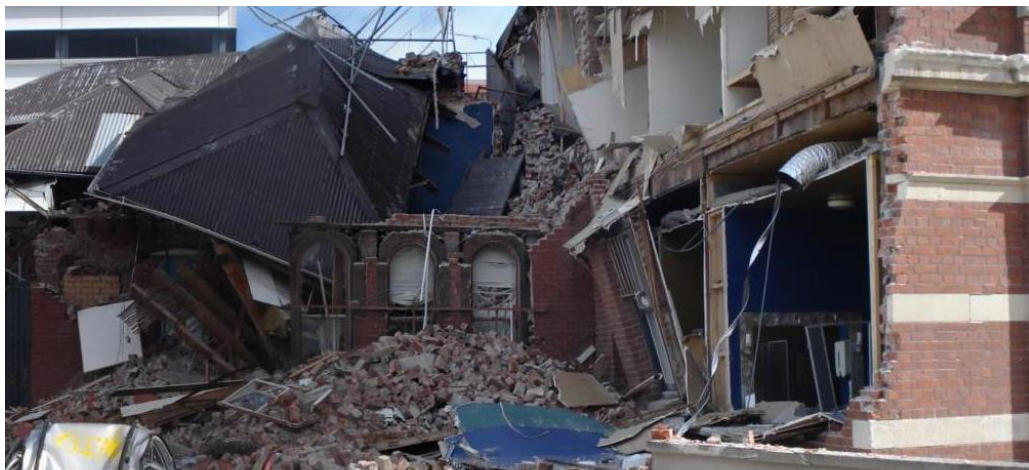
Two building collapses within the CBD are partially attributed to pounding. Both these cases involve URM buildings that were constructed circa 1900. Figure 8 illustrates the damage caused to a two storey URM building that sustained pounding during the Christchurch earthquake (shown on the left). Significant damage has also been sustained by the adjacent right building. These buildings were externally surveyed after the Darfield earthquake and were found to be separated by approximately 50 mm at ground level, but were in contact at roof level. It was concluded that the two storey building had begun to lean, although whether this was due to the Darfield earthquake could not be determined. As these buildings were in contact, pounding undoubtedly occurred during the Christchurch earthquake. However, the primary cause of collapse is attributed to the URM construction. Whether pounding appreciably contributed to this collapse is very difficult to determine, due to the level of destruction that has occurred.

**Figure 8: Two storey building collapse involving pounding. Primary cause of collapse is attributed to URM construction.**

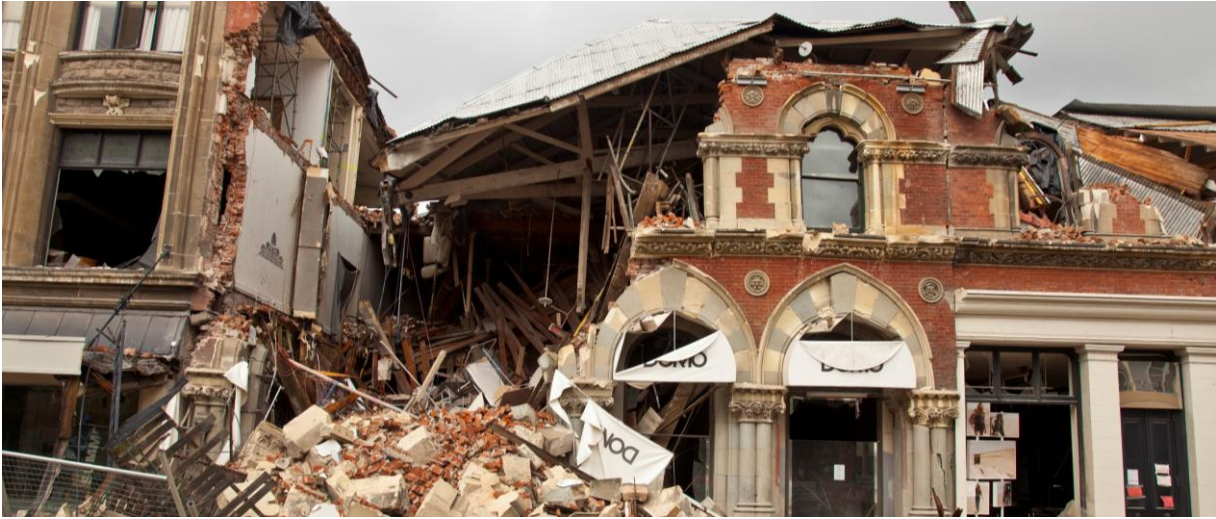
**Figure 10: Building collapse involving building pounding. Primary cause of collapse is attributed to URM construction. (Photo courtesy of Colin Monteath, Hedgehog House.)**

The damage shown in Figure 10 indicates that the central and leftmost buildings were likely to be constructed with a shared party wall. This can be observed where wall sections remain standing at the building interface. At the second level, a 100 mm thick brick wall appears to have supported both buildings. This evidence is also supported by the interior finishings that can be observed on the ‘exterior’ of this wall. Nevertheless, localised damage consistent with pounding is present between the central and rightmost buildings. Once again it is difficult to discern the level of influence pounding has had on the presented collapse. The primary cause of collapse is attributed to the URM construction. However, it is credible that the severity of this damage would have been greatly reduced if adjacent buildings had not been present.

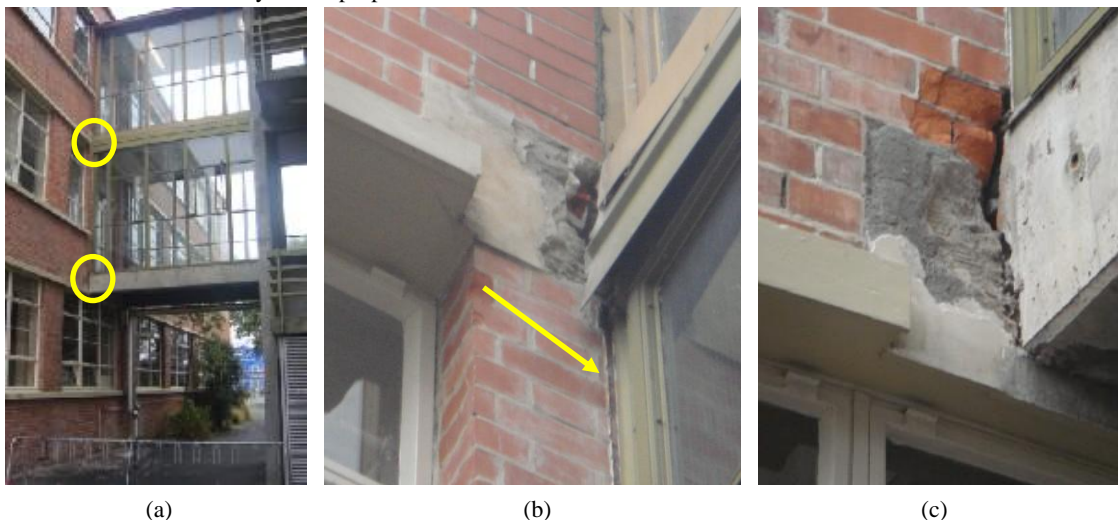
**Figure 11: Pounding damage to buildings at the Christchurch Polytechnic Institute of Technology. (a) Adjacent buildings with pedestrian bridges; (b) upper and (c) lower pounding locations.**

Pounding between adjacent buildings can be avoided if a sufficient gap exists. In some cases, however, although the adjacent buildings are well separated, pounding can still take place. This is the case when the buildings are linked by pedestrian bridges as the buildings at the Christchurch Polytechnic Institute of Technology along the Madras Street in Figure 11(a) show. The upper and lower pounding locations are indicated by the circles. The damage due to pounding of the upper floor of the pedestrian bridge is displayed in Figure 11(b). The residual opening relative movement can also be clearly seen indicated by the arrow. Figure 11(c) shows the damage to the unreinforced masonry wall due to pounding of the lower RC floor of the pedestrian bridge. In the case considered both adjacent buildings have different fundamental periods owing to their dissimilar building configuration, and thus different oscillation pattern are to be expected. Previous studies on pounding responses between buildings linked by pedestrian bridges in near-source earthquakes have shown that neglecting of soil-foundation-structure interaction can underestimate pounding potential and also the induced vibrations in the buildings [6].

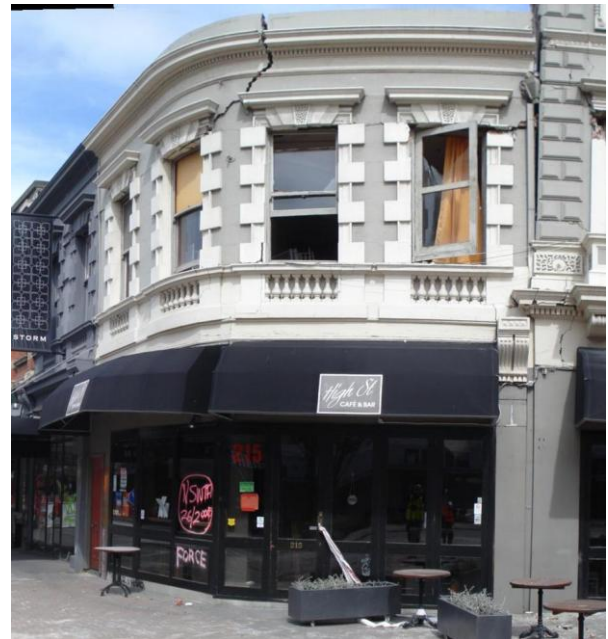
5. **Building subject to torsional actions arising from pounding.** Torsional pounding interaction was found to be particularly difficult to identify from external inspection. Only one possible case of torsional pounding interaction was observed in the CBD (Figure 14).

Figure 12 Possible torsional building pounding due to irregular plan layout.

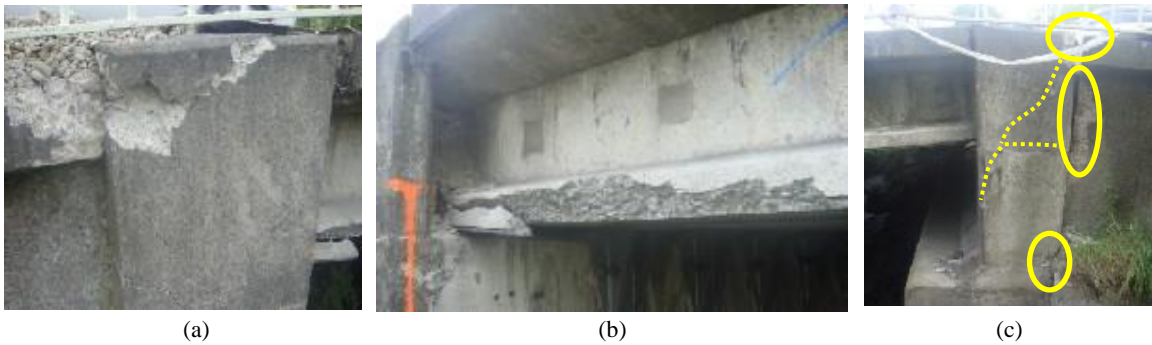
**Figure 13:** *Fitzgerald Avenue Bridge. Pounding damage (a) at the abutment; (b) to the immediate adjacent girder and (c) to the other abutment.*

Although the Christchurch earthquake did not cause spectacular damage to bridge structures due to their relative movement, i.e. bridge collapses due to pounding and unseating of the bridge deck such as observed in the 1995 Kobe earthquake in Japan [9], the 1999 Chi-Chi earthquake in Taiwan [10] or the 2010 Maule earthquake in Chile [11], the very short but strong pulses still caused pounding damage to a number of bridge structures in Christchurch and surroundings. Figure 13(a) shows the pounding damage to the abutment of the Fitzgerald Avenue Bridge. The damage to the immediate adjacent girder can be seen in Figure 13(b). The pounding caused a spall of the edge of the girder. Damage to the other abutment in Figure 13(c) occurred even along the entire height of the abutment wall as indicated by the circles. The cracks of the wall are indicated by the dotted lines. It should be noted that lateral spreading of the ground surface due to soil liquefaction occurred in the surroundings. This spatial variation of the ground movements might have amplified the relative movement between the two bridge structures and contributed to the poundings.

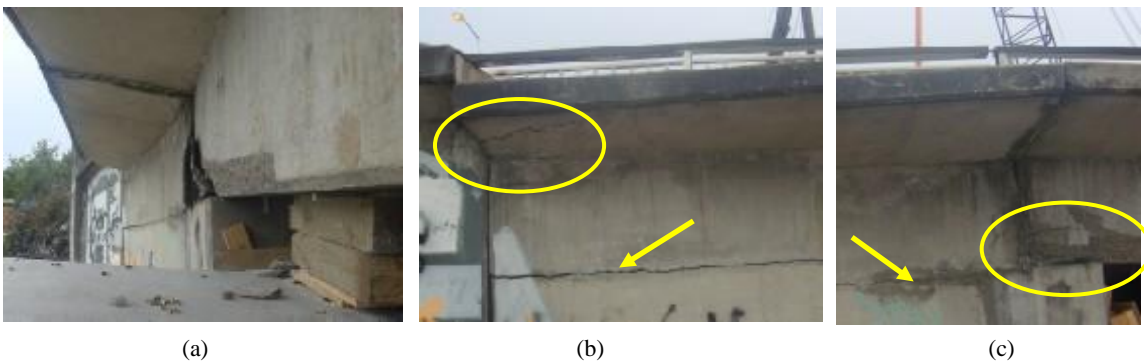
In Figure 14 the significant damage to the Ferrymead Bridge can be observed. The bridge is very valuable since each day approximately 30,000 vehicles were using the bridge that links Christchurch and Lyttelton. Severe soil liquefaction has been observed in the area, and thus behaviour similar to the Fitzgerald Avenue Bridge was expected. Figure 14(a) shows pounding induced spalling at the edge of the girder of the Ferrymead Bridge, which is similar to that observed at Fitzgerald Avenue Bridge (Figure 13(a)). The effect of the unequal soil settlement might also have amplified the closing relative movement as one can observe in Figure 14(b). The damage due to pounding to the upper deck is indicated by the circle. The closing relative movement caused a large horizontal crack at the interface between the upper deck and the supporting abutment as indicated by the arrow. Direct damage at the pounding location can be seen in Figure 14(c) (marked by a circle). The horizontal crack in the abutment due

to the pounding is indicated by the arrow.

**Figure 14:** *Ferrymead Bridge. Pounding damage (a) to girder; (b) at abutment and (c) at girder-abutment location.*
