# CHRISTCHURCH CITY COUNCIL LIFELINES – PERFORMANCE OF CONCRETE POTABLE WATER RESERVOIRS IN THE FEBRUARY 2011 CHRISTCHURCH EARTHQUAKE

Ian Billings<sup>1</sup> and Nicholas Charman<sup>1</sup>

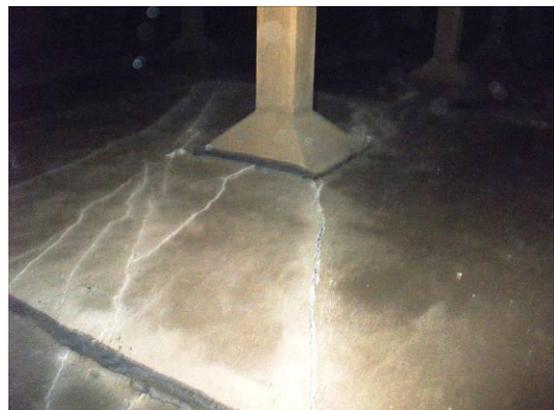
The main structural damage was cracking of the individual base-slabs with cracks of up to 35 mm width measured and movement of slabs both horizontally and vertically by up to 50 mm. This cracking had a distinctive pattern extending diagonally across the reservoir. A similar pattern of cracking was also observed in the roof and movement/slippage of up to 20 mm along construction joints measured. Discrete localised cracking was observed in the walls and the central, low height, dividing wall was severely damaged at one location consistent with the base-slab diagonal cracking pattern. The adjoining pump station was also significantly damaged plus the main 600 diameter inlet / outlet pipe. Refer figures 2 and 3.

Figure 2: Huntsbury No.1 Reservoir – base-slab cracking.

Extensive geotechnical investigation, including GPR surveying and inclined boreholes, indicated the likely presence of an underlying shear zone in the underlying rock extending diagonally across the reservoir footprint. This shear zone was considered the main reason for the observed pattern of structural damage. Following completion of a site viability report and detailed risk assessments of various concepts, the impact of the shear zone was assessed as being too high a risk for long term reliability of any structure constructed over it. Two significantly smaller reservoirs have therefore been proposed which will be constructed in the corners of the current reservoir footprint. The first replacement reservoir is currently under construction and due for completion in December 2011. The final configuration of the second replacement reservoir is still being assessed with construction completion anticipated around mid-2012. The estimated storage volume at the completion of reconstruction is about 12,000 m<sup>3</sup>, providing only approximately one-third of the reservoir's original capacity.

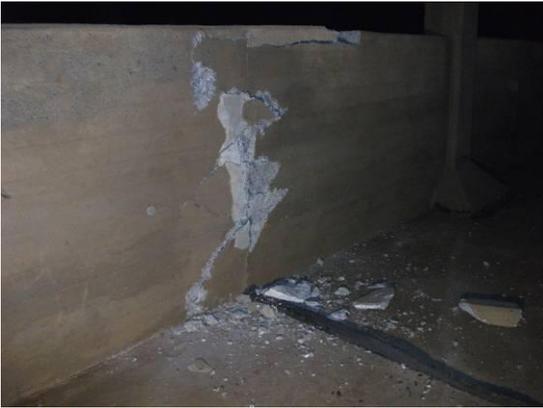
**Figure 3:** *Huntsbury No.1 Reservoir – dividing wall failure.*

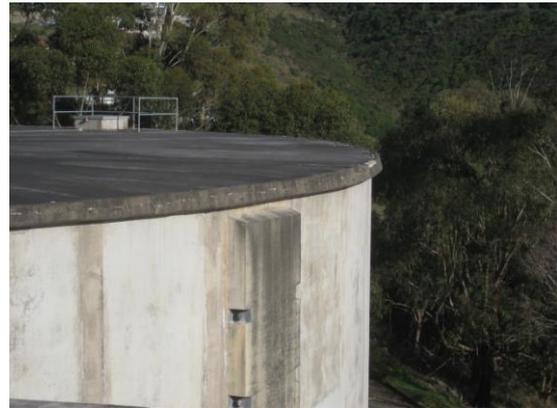
Damage noted to Reservoir No.1 is very similar to No.2 but its roof is more severely damaged due to extensive failure of roof-wall connections, and water appears to be leaking through the circumferential post-tensioning tendons.

**Figure 4:** *McCormacks Bay No.1 Reservoir – significant roof damage.*

The detailed seismic assessment identified vulnerabilities with the roof-wall connection, the wall to base connection, the wall circumferentially and a potential deficiency in resistance to sliding. The damage observed is generally consistent with the seismic assessment.

Repair and retrofit requirements are extensive and costly including; construction of a full base-slab overlay and internal ring beam to tie the wall in to the base-slab and to provide a direct seismic shear transfer mechanism, a ring beam around the top of the wall tied to the roof (No.2 reservoir) and bandaging of all wall vertical construction joints full height. Reservoir No.1 repairs are still being developed at the time of writing but expected to be similar, with the impact of water leaking through the tendons still to be assessed.

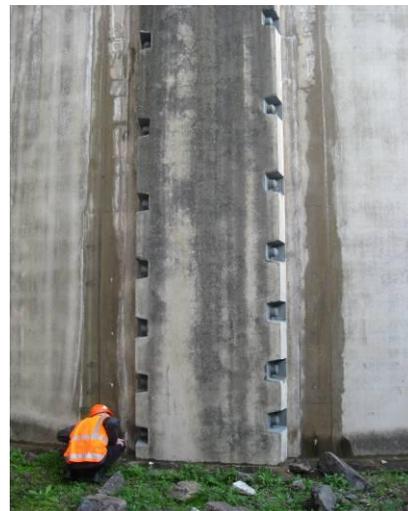
**Figure 5:** *McCormacks Bay No.1 Reservoir – leaking vertical construction joints.*

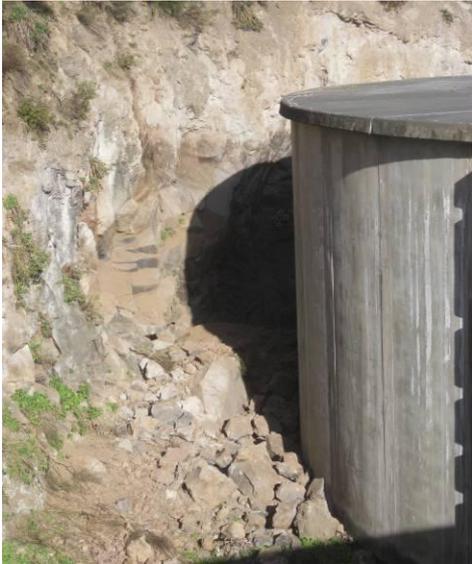
**Figure 6:** *McCormacks Bay No.1 Reservoir – rock fall behind reservoir.*

The McCormacks Bay site requires extensive, and costly, stabilisation. The access road to the reservoirs has significant cracking, settlement (up to 500 mm) and slumping towards the slope below the reservoirs. The stacked basalt block gravity wall supporting this road partially collapsed resulting in rockfall hazards to the road and residents below. Emergency temporary rockfall fences were installed to mitigate short term rockfall risks. A permanent piled replacement retaining wall is currently proposed along the edge of the road. The construction platform for the reservoirs was cut into rock and there is a near vertical face (up to around 21 m high) behind the reservoirs. The large ground accelerations that were experienced at the site on 22 February and 13 June led to significant loosening and dislodgement of material from the rock face. Rock and material has piled up behind the reservoirs and some rocks may have impacted the reservoir wall. It is currently proposed that reinforced steel mesh and a grid of rock anchors and soil nails be installed over the full extent of the cut face.

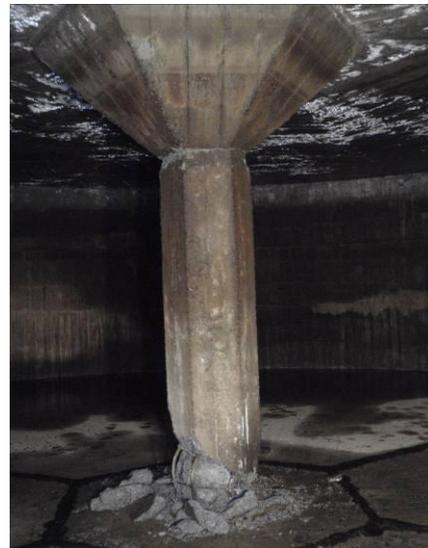
Damage noted includes failure of the internal column, sagging of the roof and shearing of the roof overhang at the roof-wall joint.

The roof has an overhanging nib with only a small overlap with the top of the reservoir wall. Under horizontal earthquake loading the roof has impacted the top of the wall and resulted in the overhanging nib shearing off. Excessive translation of the roof has subsequently occurred and resulted in the column failing due to only limited shear and flexural capacity. Refer to figures 7 and 8.

**Figure 7:** *Clifton 3 – internal column failure.*

Repair and retrofit includes break-out and reconstruction of the damaged top and bottom of the column, jacking of the roof vertically and fitting of a reinforced concrete ring beam at the top of the wall to restrain the roof against lateral movement. A kerb is also being constructed at the base of the column to provide additional restraint. Minor repairs to floor sealants and wall cracking are also required.

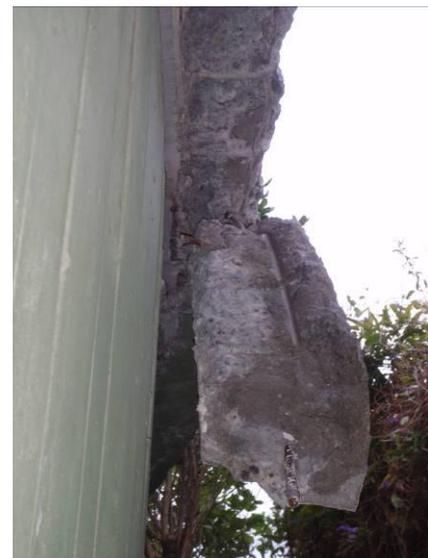
**Figure 8:** *Clifton 3 – failure of roof overhanging nib (repaired nib shown).*

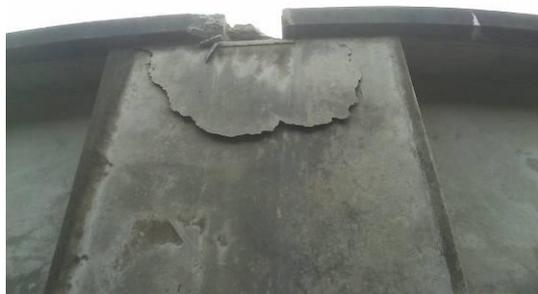
The roof comprises precast roof beams that are slotted into the reservoir wall and pilasters. Under horizontal earthquake loading the roof beams have impacted the wall and resulted in major cracking and damage to the top of the wall. At pilaster locations, the beams have punched off the wall concrete at the ends of the beams. The excessive roof movement has also resulted in damage to the top of the internal column. Refer figures 9 and 10.

**Figure 9:** *Upper Balmoral Reservoir –concrete shear failure at pilaster locations due to roof beam (concealed) impact.*

The detailed seismic assessment identified vulnerabilities in the roof-wall connections, the internal column and the wall to base connection.

Repair and retrofit includes break-out and reconstruction of the damaged top of the column, and fitting of a reinforced concrete ring beam at the top of the wall (tied to the roof beams). An internal ring beam is to be constructed to tie the wall into the base-slab and to provide a direct seismic shear transfer mechanism.

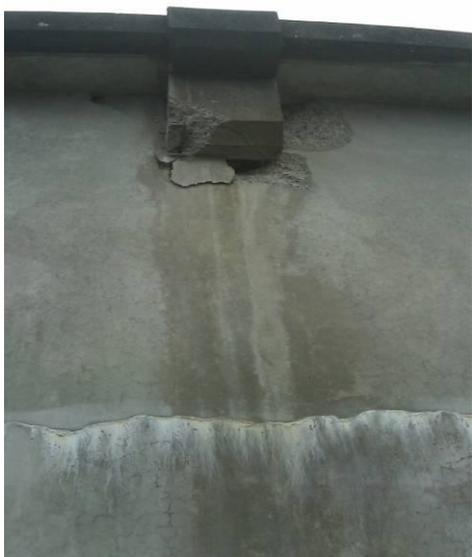
**Figure 10:** *Upper Balmoral Reservoir – concrete damage at roof beam wall support.*
