# GROUND MOTIONS AND DAMAGE OBSERVATIONS IN THE MARLBOROUGH REGION FROM THE 2013 LAKE GRASSMERE EARTHQUAKE

Gareth J. Morris<sup>1</sup>, Brendon A. Bradley<sup>1</sup>, Adam Walker<sup>2</sup> and Trevor Matuschka<sup>3</sup>

## SUMMARY

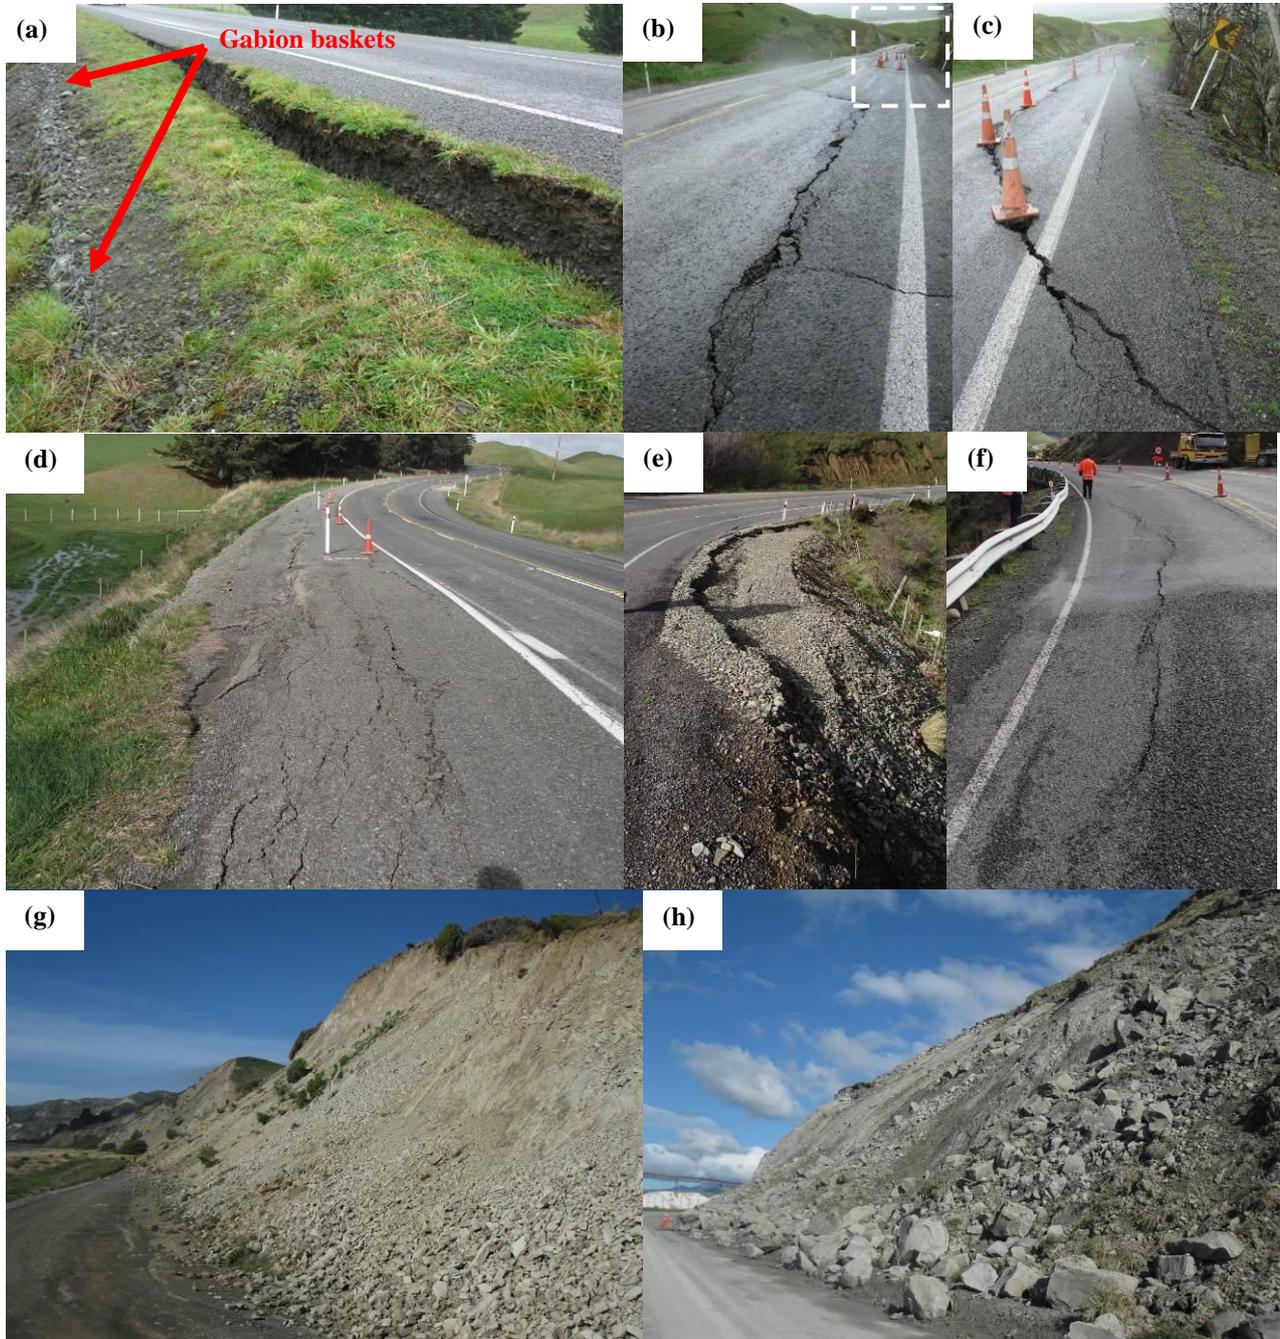
Figure 3(a) shows an example of slopes adjacent to the road shoulder that are restrained by gabion baskets. Following the 16 August event large cracks were observed at the interface between poorly compacted materials on the slopes themselves

and adjacent to competent material beneath the pavement. In general crack widths of approximately 50 mm were observed at sections with steep slopes and cambered corners with large depth of fill and near the embankments of bridges and culverts. The largest observed pavement cracks were approximately 150 mm in width as shown in Figure 3(c). Vertical settlements on SH1 generally ranged between 250-300 mm, with the largest observed settlement up to 500 mm at a Highway intersection within 1 kilometre of the earthquake source [W. Oldfield, pers. comm.].

**Figure 3:** (a)-(d) Damage to State Highway 1 indicates instability of engineered fill materials and shoulders; (e)-(f) similar damage on Weld Pass; (g)-(h) slips on local roads within 1 kilometres of the earthquake source (Photos (d-f) courtesy of NZTA).

Immediately following the 16 August event, earthworks were undertaken to clear fallen debris from the pavement to permit regular volumes of SH1 traffic. Filling and repaving was regularly required for settlements at bridge approaches to smooth over rough pavement cracks and vertical offsets as shown in Figure 5(a). No raw photographic observations were obtained for slips on SH1; however Figure 3(g) and (h) show slips on two local roads within 1 kilometre of the earthquake source.

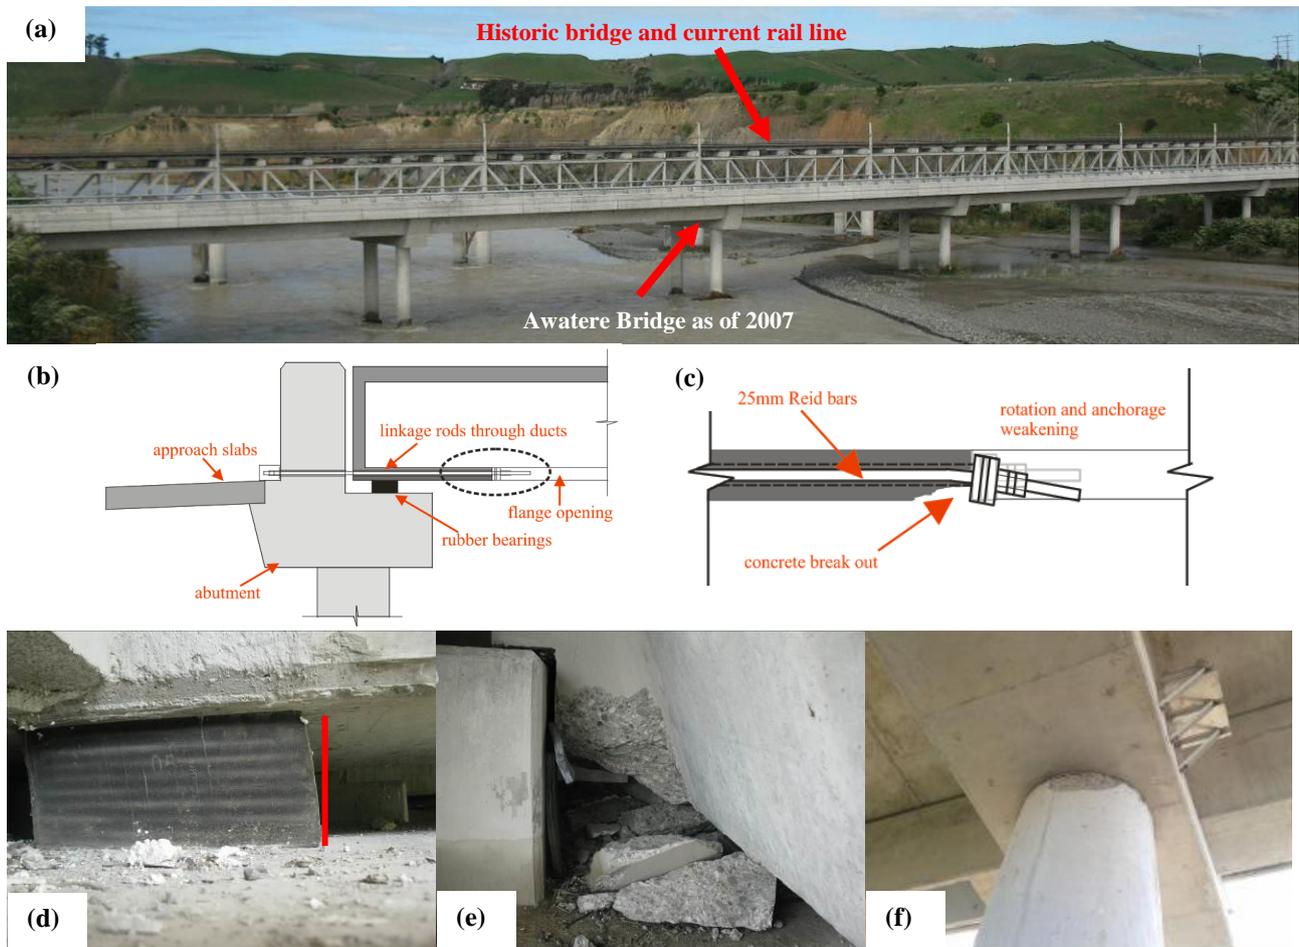
Inspections of the north abutment showed failure of the concrete adjacent to the anchorage of the linkage bars in the beam flange. Under large seismic demands the desired behaviour is for bar yielding, however beneath the ducts cast into the flange the area of concrete to resist the imposed bearing stresses is relatively small. Following the concrete break out the link bars were projected downward as indicated by Figure 4(c). Also at the north abutment, the outside corners of the U-beams sustained minor concrete crushing which is due to transverse displacements. The fill material at the north approach was estimated to have settled by approximately

As illustrated in the previous section on observed ground motions, the Awatere bridge was likely subjected to significantly stronger ground shaking during the 13 August event than that on 21 July. Figure 4(d) shows the rubber bearings between the U-beams and the south abutment indicating residual displacement in the south direction. A 30-40 mm offset was observed for the south abutment relative to the embankment and gabion walls had moved up to 30 mm away from both abutments towards the river. No further damage was observed to the linkage bars from that already seen after the 21 July event. Figure 4(f) illustrates concrete spalling at central piers which suggests significant transverse deflections [13]. On the carriageway itself, the north approach settlement was approximately 15 mm while 5 mm settlement was observed at the south approach. Minor hairline cracks were observed to the north and south abutments.

At the west side of the south abutment a series of lateral spreading cracks between 50-150 mm propagated approximately 30 m in the upstream direction. Cracks spread parallel to the Highway from the north abutment approximately 10 m on the north-west side. Given that the shaking in Seddon exceeded 500 year design levels for short to moderate vibration periods, the observed moderate embankment damage, which did not impact the bridge's functionality, and can be considered a good performance.

**Figure 4:** (a) The 275 m Awatere Bridge; (b) details of the abutment-diaphragm connection; (c) post- 21 July damage at north abutment. Post-16 August damage; (d) rubber bearings indicate residual longitudinal displacement; (e) spalling of cover concrete at edge of U-beam girders and; (f) spalling at central piers (last image courtesy of NZTA [13]).

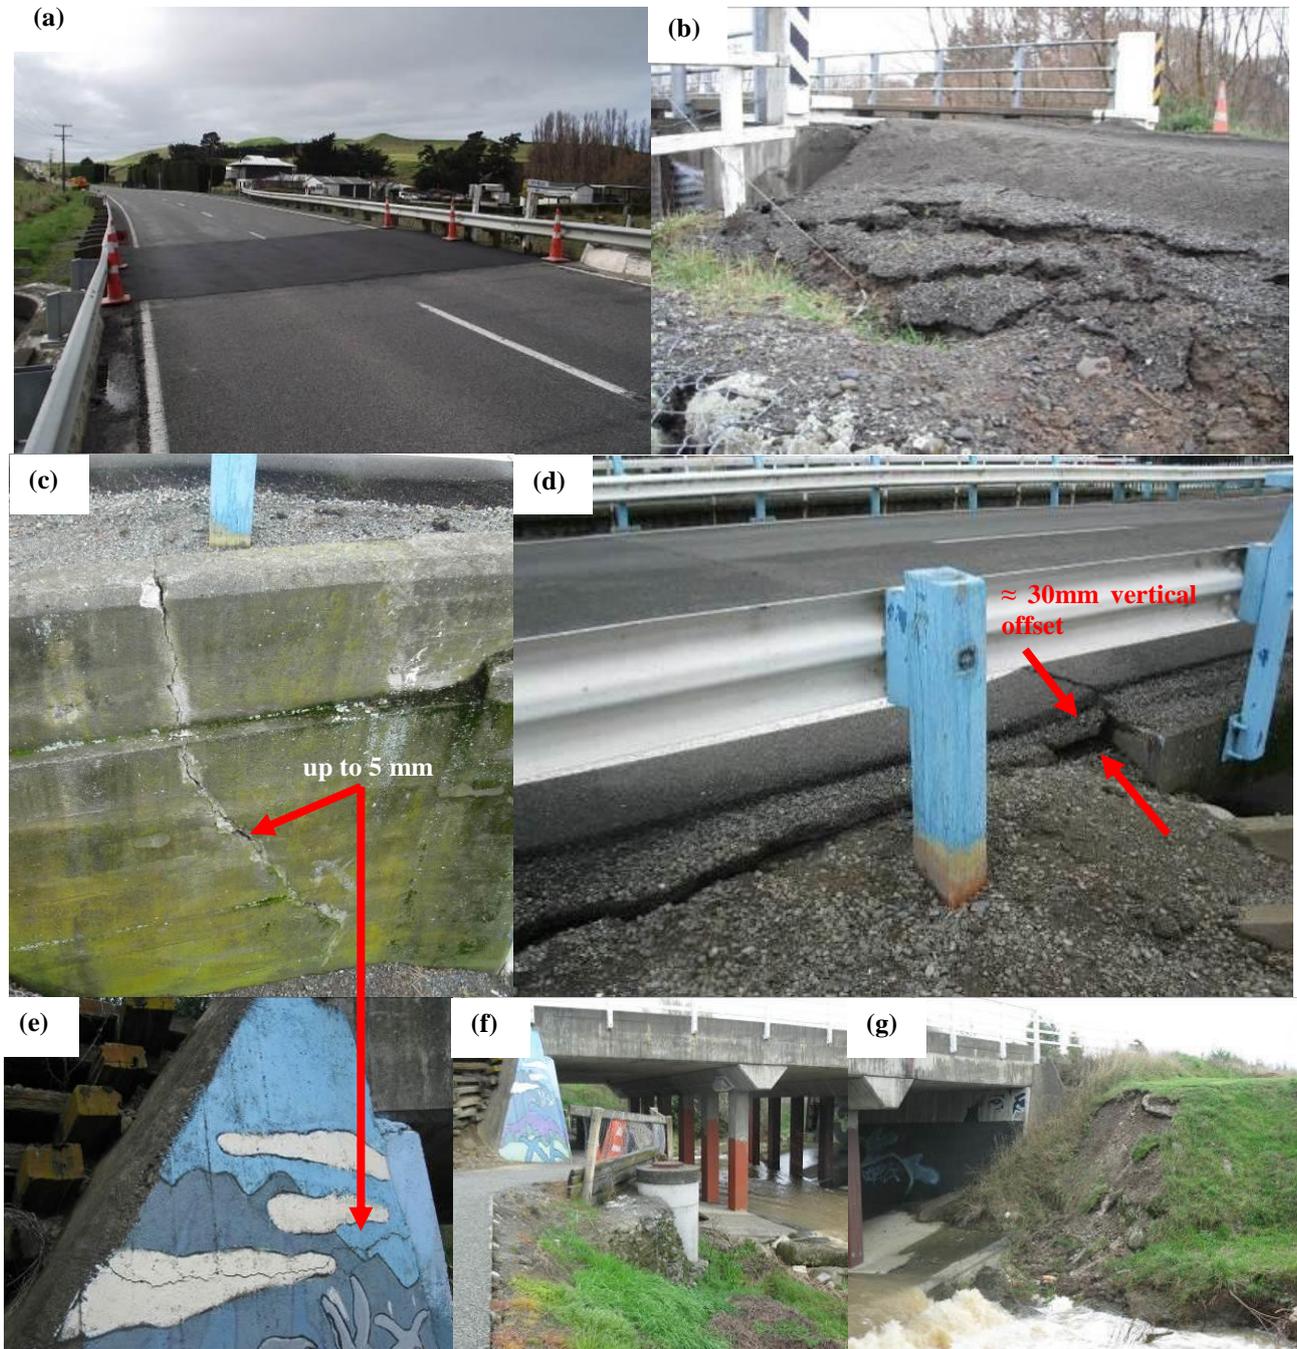
Lateral spreading and approach settlements were observed at several smaller bridges on SH1 and local roads. Figure 5(a) illustrates the resurfaced north approach at the Needles Creek Bridge (located North of Ward), which settled approximately 100 mm and required re-filling and re-surfacing. Figure 5(b) shows the largest reported [13] settlement of 400 mm at Merrifield's Bridge on Blind River Loop Road (within 5 kilometres of the fault plane).

Structural damage observed at other bridges included minor spalling at girder-pier supports and the spalling of relatively small volumes of concrete adjacent to bolts providing shear transfer. Figure 5(c) and (e) show cracks up to 5 mm to the abutment wing-walls on the State Highway 1 road and rail bridges over the Starborough Creek in Seddon. Repair work on the rail bridge abutments commenced within a few days after 16 August.

**Figure 5:** Approach settlements observed at: (a) 100 mm Needles Creek Bridge (rapid repair); (b) 400 mm Merrifields Bridge (courtesy of NZTA). Damage to road and rail bridges over the Starborough Creek on State Highway 1 included approach settlements, cracked abutment wingwalls and slope stability issues.

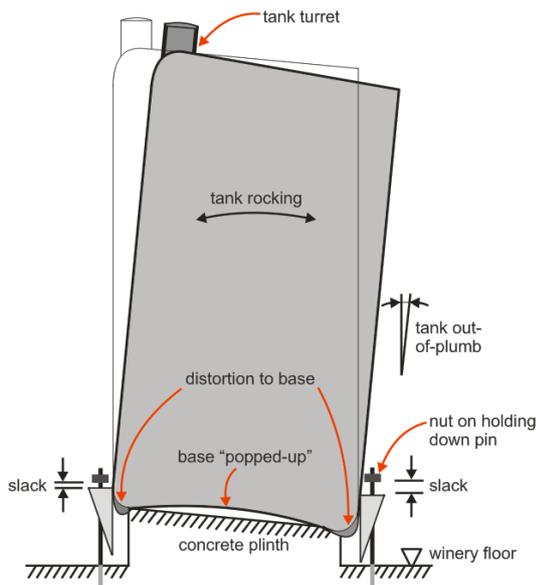
**Figure 6:** A characteristic damage state for plinth mounted tanks is tank settlement and “knuckle-squash” at the tank floor.

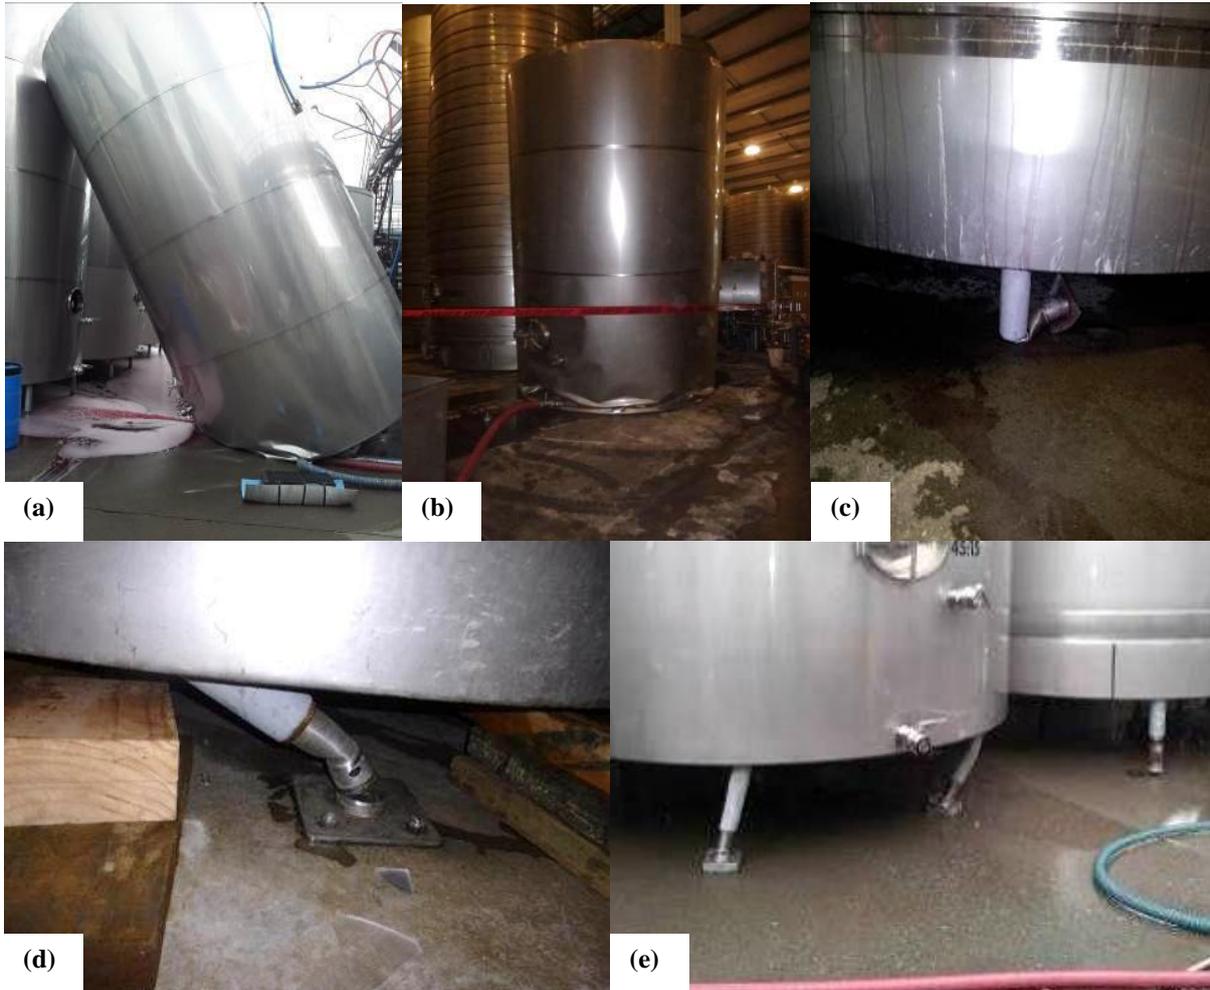
As far as the authors are aware, the worst observed damage during the 16 August event was two tanks that overturned due to the failure of supporting legs, with one tank falling and damaging the walls of another nearby tank as illustrated in Figure 7(a). Various damage states typically observed to the majority of this type of tank following the 16 August event included:

Damage to leg mounted tanks following buckling failure of tank legs

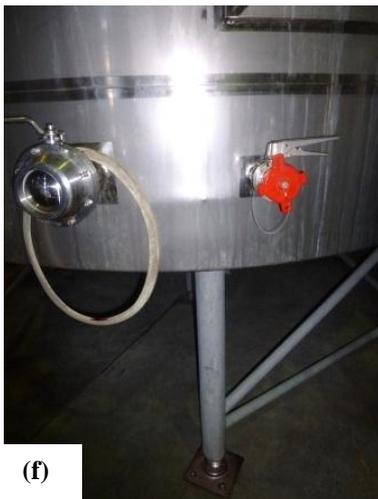
Skirt and base damage to red cellar leg mounted tank

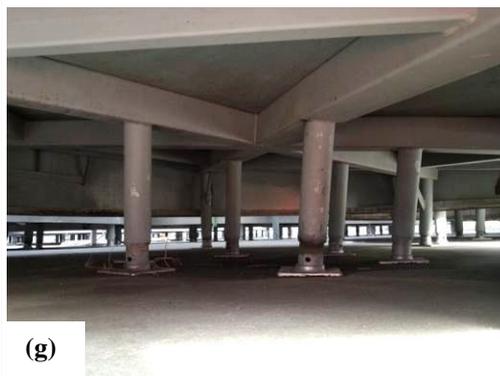
Bending of frame

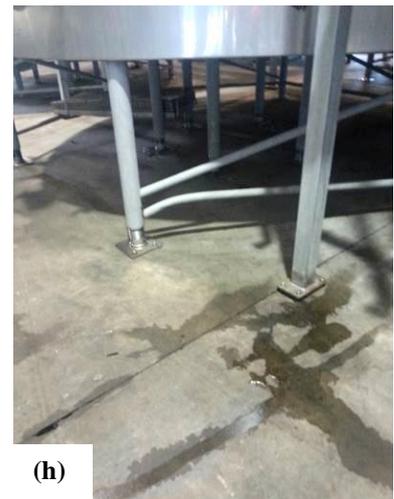
- Buckling of legs, braces or adjustable feet, as shown in Figure 7(c)-(e).
- Fracture of straps connecting base frame to tank.
- Distortion of tank floor where connection straps were damaged. In some instances the distortion was extensive enough to cause tearing of the tank floor which resulted in some loss of product.
- Yielding and deformation of the base frame at joints, in some instances leading to stress on the tank floor and the rotation of the joints of the circular hollow section (CHS) legs and rectangular hollow section (RHS) frame beams through localised bending of the RHS flange.
- Movement of tank on the slab or rotation of the baseplate around a single bolt.

Buckling of brace

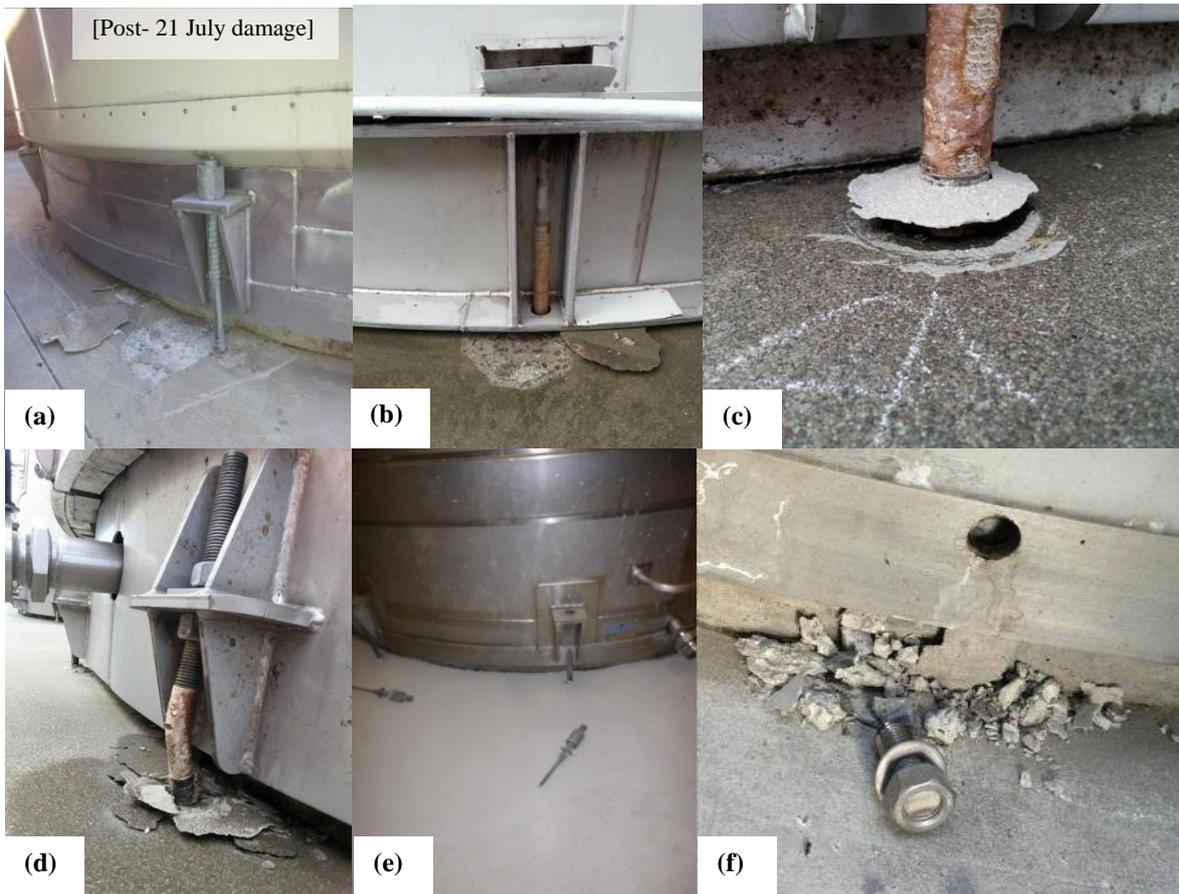
- Anchor failure in the form of anchor fracture, pullout through the epoxy, or concrete cone failure as shown in Figure 8(a)–(e).
- Lateral movement on the plinth, leading to bending of anchors, as shown in Figure 8(g).
- Settlement of tank around the plinth (illustrated in Figure 6) due to deformation of the tank floor across the gap between tank skirt and plinth. In rare instances tank deformation was sufficient to rupture

Some older tanks were simply fixed by a number of bolts drilled horizontally into the plinth around the perimeter of the skirt. Shear failure of the majority of bolts fixed into the plinth had occurred at some facilities as shown in Figure 8(f).

Anchorage failure by pullout, bolt tensile fracture and bolt shear failure

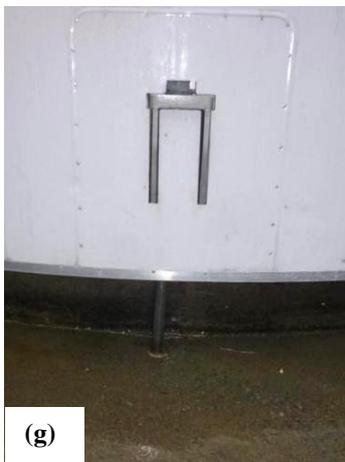
(g) Bending of anchor due to lateral tank movement relative to plinth

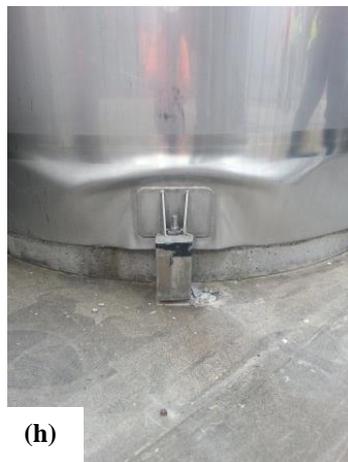
(h) Buckling of tank skirt

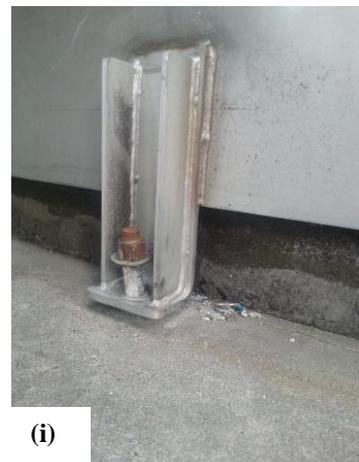
(i) Pullout failure on slab mounted anchor chair

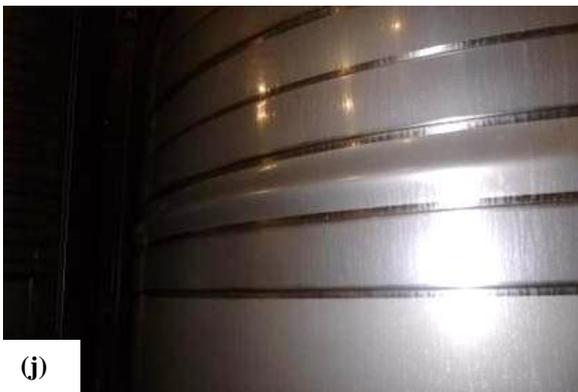
(j) Elephant's foot buckling of tank

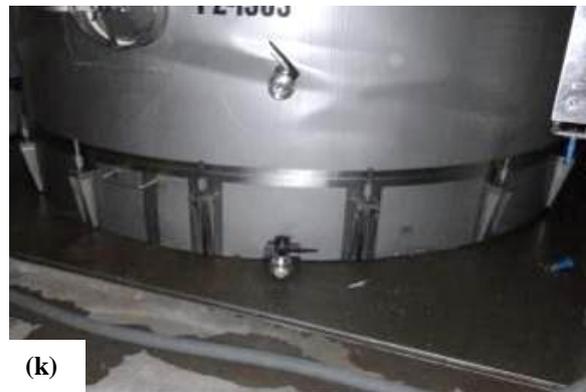
(k) Diamond shaped buckling

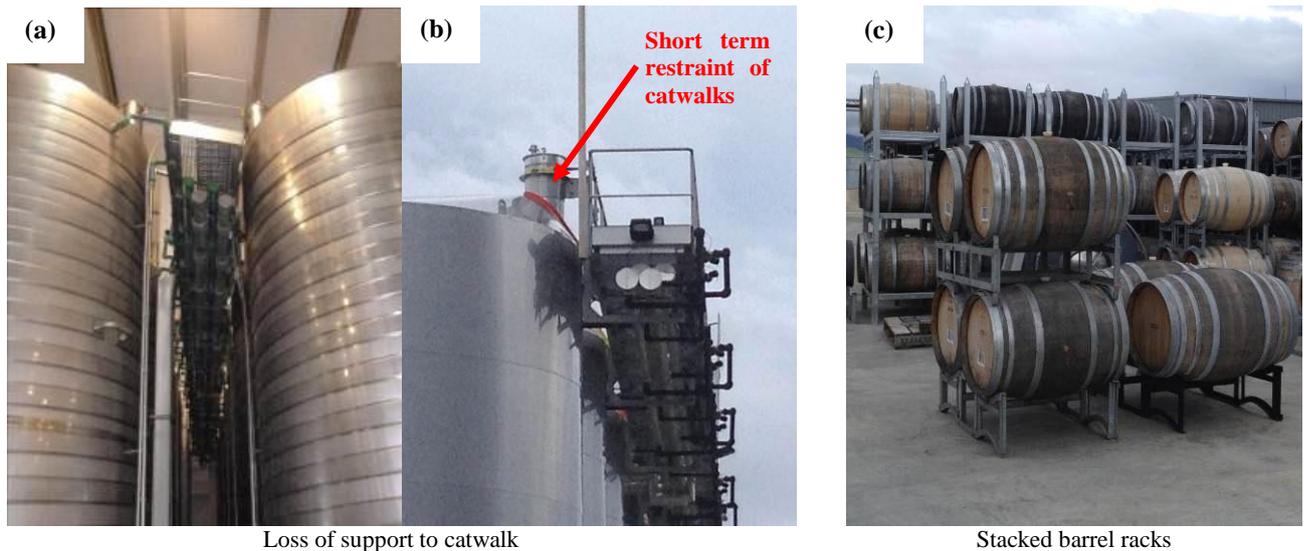
In the direction along a row of tanks, the cleat orientation is such that bending about the plate’s weak axis results in cleat flexibility. Some distortion of plates was observed, however, there was no evidence of connection failure due to displacement in this direction. Across two rows of tanks, in the orthogonal direction, the connections are often stiffer and some displacement induced failures have been observed where the tolerance of the slot has been used up and bolts have failed in shear. Other examples of catwalk damage included the distortion of box-type cleats that are welded to the tank wall.

**Figure 9:** (a) Catwalks were damaged at connections to tanks; (b) temporary catwalk restraint to tank turret; (c) stacked barrel racks.

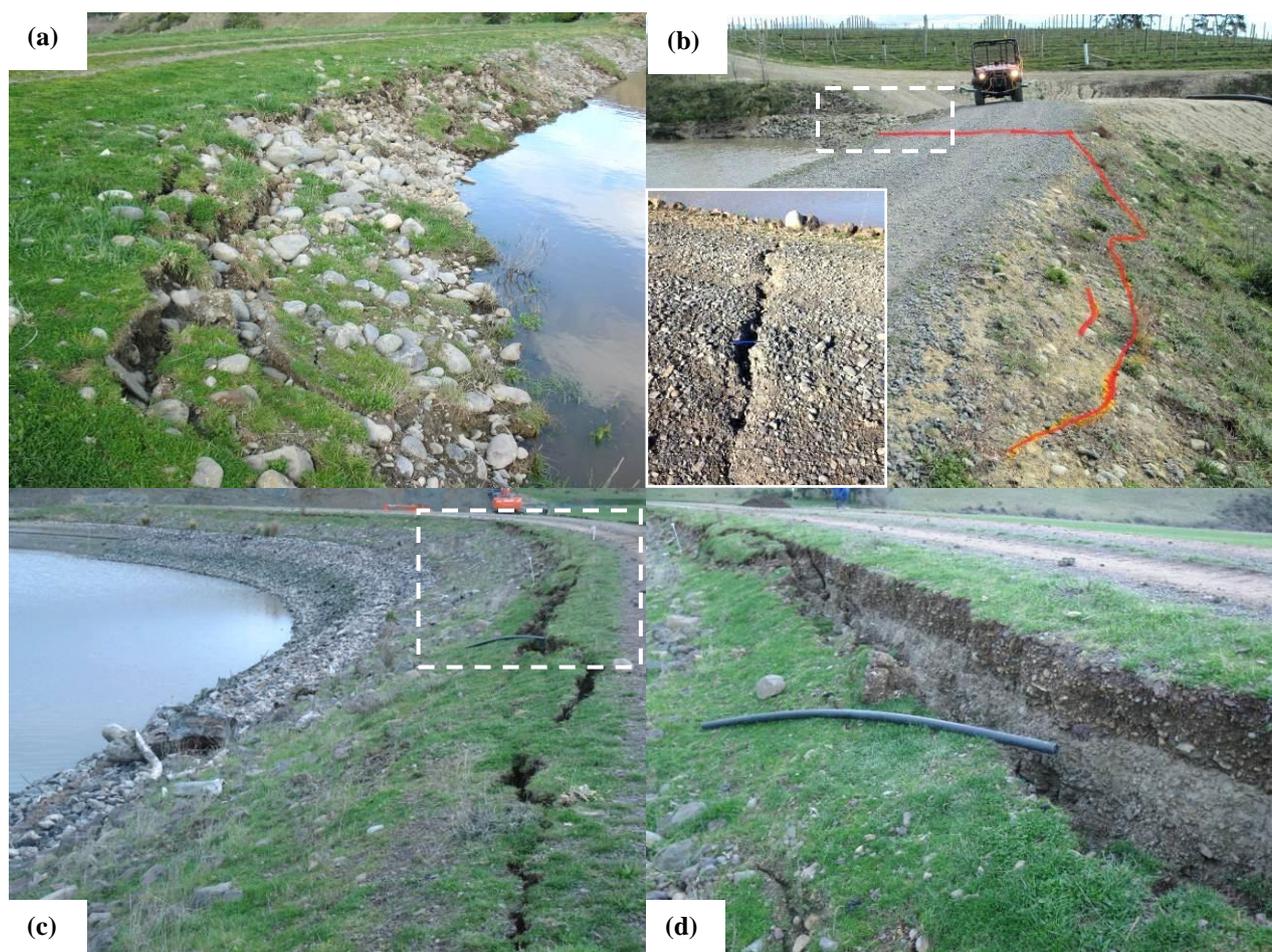
At Dam A damage was relatively minor and involved some movement of riprap on the upstream shoulder near the left abutment as shown in Figure 11(a). Riprap consisted of rounded river rock placed over a geotextile, so the frictional resistance between the riprap and geotextile was probably quite low. There was a small crack of limited length associated with backfill above the spillway outlet pipe.

Dam I also suffered some damage with evidence of some slumping of the upstream shoulder and some longitudinal and transverse cracks in the crest as shown in Figure 11(b). The water levels in Dams E, F and I have been lowered to allow post-earthquake inspection and assessment of repairs.

**Figure 11: Various damage observations to water storage dams: (a) movement of riprap on the upstream shoulder of Dam A; (b) longitudinal and transverse crack (inset) to the crest of Dam I; (c)-(d) extensive damage at Dam E included longitudinal cracking to the full crest length.**

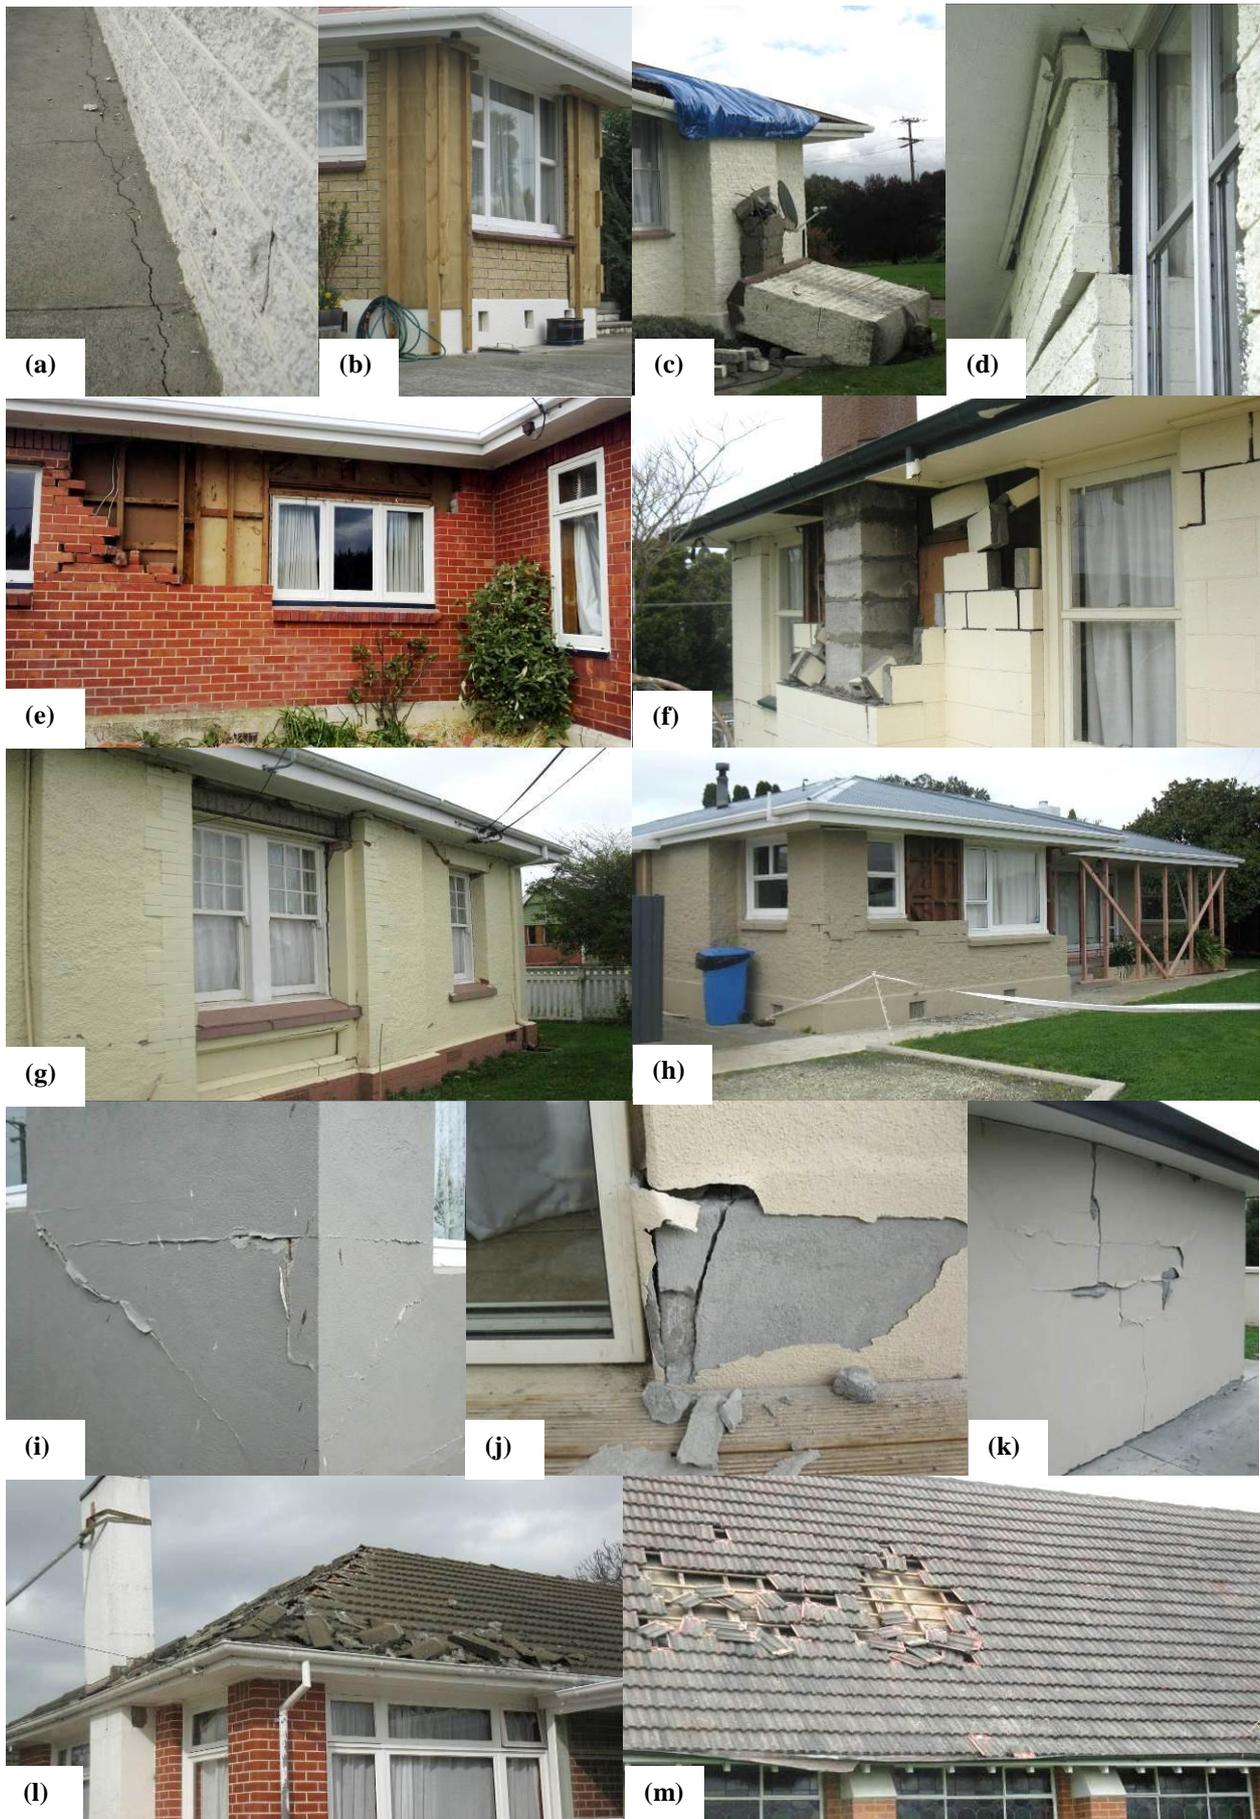
significant deformations due to liquefaction or lateral spreading). In Seddon, damage foundations was limited to minor perimeter cracking as shown in Figure 12(a). Some houses with timber piles were observed to displace relative to the ground.

**Figure 12: Various observations for residential buildings: (a) minor foundation cracking; (b) stabilisation of cladding after the 21 July event; (c) chimney collapse; (d)-(h) collapse of brick veneer at roof soffit, around chimneys, between openings; (i)-(k) cracking of plaster coating, and; (l)-(m) detachment and falling of roof tiles on churches and housing.**

The 16 August event generally resulted in chimneys either collapsing or being in a state of incipient collapse (Figure 12(c)) and these were rapidly deconstructed in many cases. Figure 12(d)-(h) highlights the poor performance observed for brick and masonry cladding that had partially detached from the timber framing.

Typically brick veneer collapsed nearest the roof soffit and regions between windows and door openings. Large separations from the timber framing resulted in the cladding having a very low out-of-plane stiffness which was vulnerable to further damage. The most extensive cladding damage occurred at corner elements.

Plaster coat finishing of modern houses provides external insulation and improved aesthetics, however, in many cases the coatings had partially detached from the brick veneer. Figure 12(i)-(j) shows that damage to plaster coating was generally localised to cracks at corners of windows and door openings, as well as at corner elements and near foundations. Figure 12(k) shows plaster coat damage due to out-of-plane movement of the brick veneer. Moderate damage was sustained to brick and plaster fences of relatively large mass and will require additional repair.

The performance of weatherboard claddings agreed with observations from recent earthquakes [20] and only minor relative slipping of boards was observed and resulted in exterior paint cracking. Several older houses and church buildings showed detachment and falling of roof tiles as illustrated in Figure 12(l) and (m).

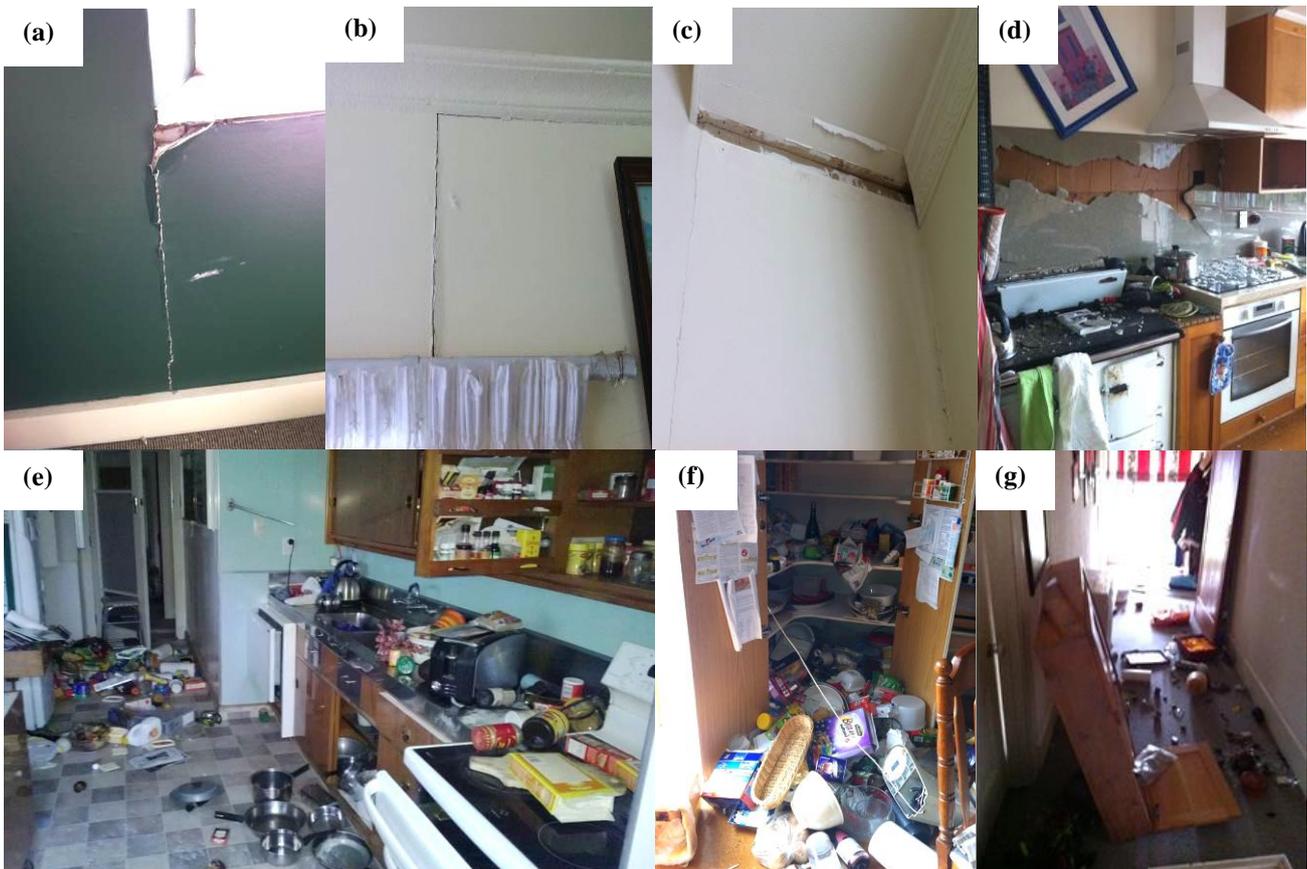
**Figure 13:** Various states of interior damage was observed: (a)-(b) wall linings; (c) detached scotia beading; (d) brittle failure of kitchen splash-backs; (e)-(g) widespread contents damage at houses located within 10 km from the fault source.

Moderate damage was observed to interior linings such as gypsum plasterboards. Observed cracking shown in Figure 13(a)-(c) were localised near window and door openings and damage to the edges of linings was indicated by paint cracking near ceilings, skirting boards, scotia beading and inside room corners. In some cases, deformations caused minor buckling of wall linings. Figure 13(d) illustrates brittle fracturing of kitchen splash-backs that were fastened to walls that suffered minor distortion. The seismic performance of various internal lining products (typically used in different construction eras) has previously been described in further detail elsewhere [20], [21]. Linings had separated from interior masonry (behind chimney flumes) which resulted in significant distortions in walls and ceilings. Figure 13(e)-(g) indicates the typical extent of contents damage to houses within 10 kilometres of the earthquake source.

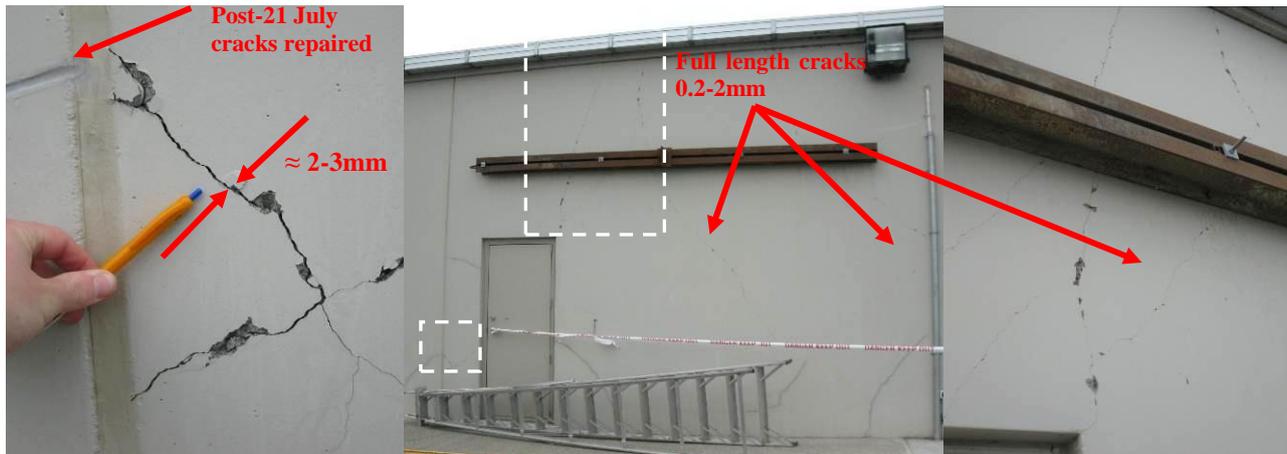
**Figure 14:** Precast concrete wall panels damaged following the 16 August earthquake. The panels had previously been repaired by epoxy injection of cracks following the 21 July earthquake.

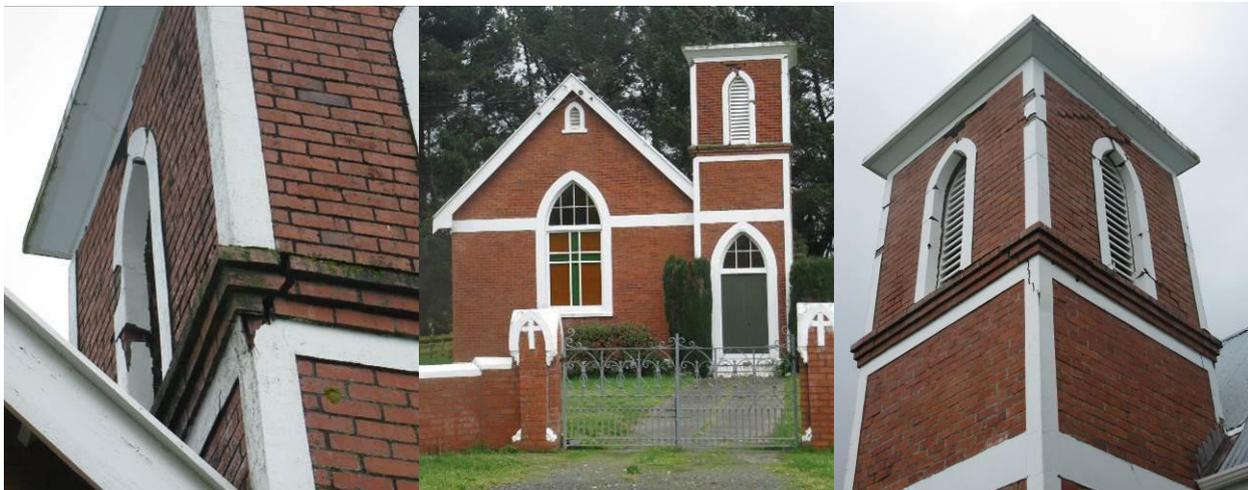
performance of unreinforced masonry (URM) buildings. Figure 15 shows the relatively short tower of an unreinforced masonry church located in Ward that sustained severe damage in both directions and was deemed vulnerable to collapsing in

future strong ground motions. Cracks through the brick and mortar were observed near window and door openings. There was no reported church damage after the 21 July event.

**Figure 15:** Severe damage to a church building in Ward following the 16 August 2013 earthquake event.

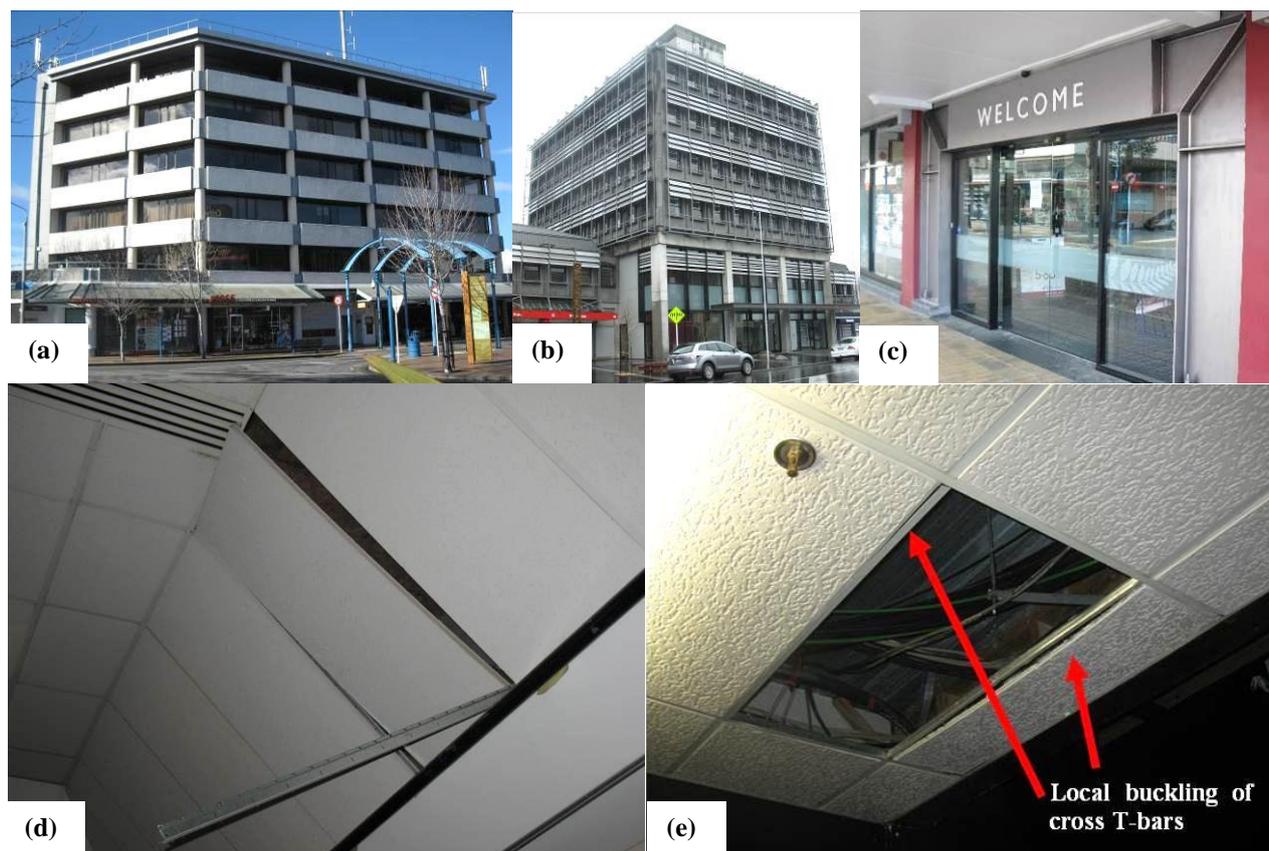
loads. Figure 16(d) and (e) shows minor damage sustained to two systems containing relatively large heavy ceiling tiles. To

**Figure 16:** The largest commercial buildings in the Blenheim CBD: (a) Porse House; (b) Rangitane house. (c) One of several two-storey buildings retrofitted earlier in 2013. Observed failure of ceiling system grid members due to: (d) rivet connection failures; (e) local buckling of grid members resulting in falling tiles.

prevent the connection failure in Figure 16(d), larger diameter or multiple rivets could be used.
