## THE M<sub>w</sub>7.8 2016 KAIKŌURA EARTHQUAKE: SURFACE FAULT RUPTURE AND SEISMIC HAZARD CONTEXT

### ABSTRACT

We provide a summary of the surface fault ruptures produced by the Mw7.8 14 November 2016 Kaikōura earthquake, including examples of damage to engineered structures, transportation networks and farming infrastructure produced by direct fault surface rupture displacement. We also provide an overview of the earthquake in the context of the earthquake source model and estimated ground motions from the current (2010) version of the National Seismic Hazard Model (NSHM) for New Zealand. A total of 21 faults ruptured along a c.180 km long zone during the earthquake, including some that were unknown prior to the event. The 2010 version of the NSHM had considered multi-fault ruptures in the Kaikōura area, but not to the degree observed in the earthquake. The number of faults involved a combination of known and unknown faults, a mix of complete and partial ruptures of the known faults, and the non-involvement of a major fault within the rupture zone (i.e. the Hope Fault) makes this rupture an unusually complex event by world standards. However, the strong ground motions of the ea

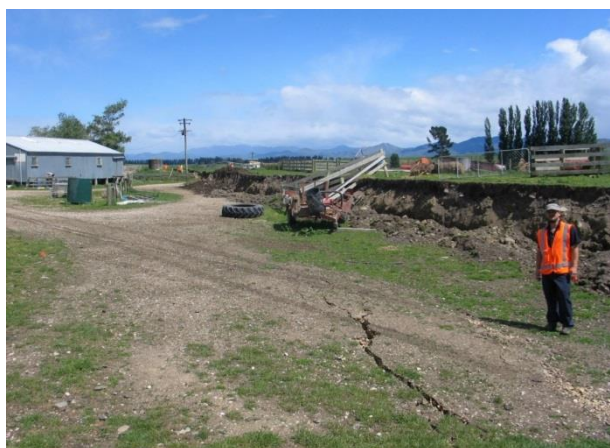
**Figure 3: Oblique dip slip-dextral fault scarp of The Humps Fault at Glenbourne Farm that caused displacement damage to concrete slabs, farm tracks and fencing (Lat 42.615°S, Lon 173.105°E; view west; photograph by Jarg Pettinga).**

| Fault | Engineered structures impacted by surface rupture | Figure in this paper |
|---|---|---|
| The Humps | Leslie Hills Road<br>Hossack Downs Road<br>Sherwood Road<br>Inland Kaikōura Road (SH70)<br>Chaffey's Road<br>The Gates Road<br>Irrigation lines<br>Farm accommodation<br>Stockyards<br>Fence lines<br>Woolsheds<br>Barns<br>Feed silos | <br><br><br><br><br><br><br><br><br>Figure 6<br>Figures 3, 4<br>Figures 3, 4<br>Figure 4<br><br>Figure 4 |

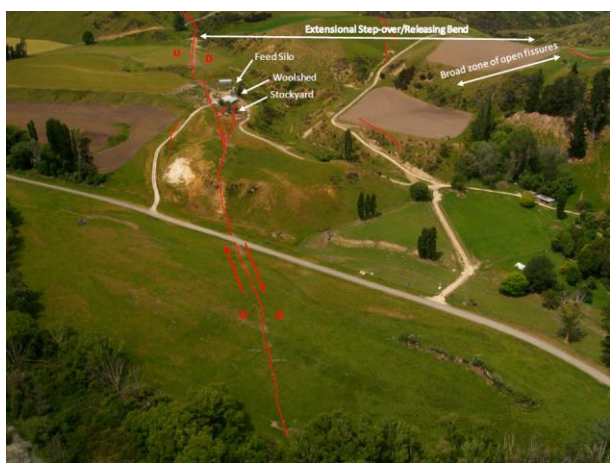
**Figure 4: Aerial view of The Humps Fault surface rupture (red lines) at Glenbourne Farm, showing the sense of movement (red arrows) and highlighting farm infrastructure damaged by the earthquake (Lat 42.615°S, Lon 173.105°E; view northeast; photo and annotation by Clark Fenton).**

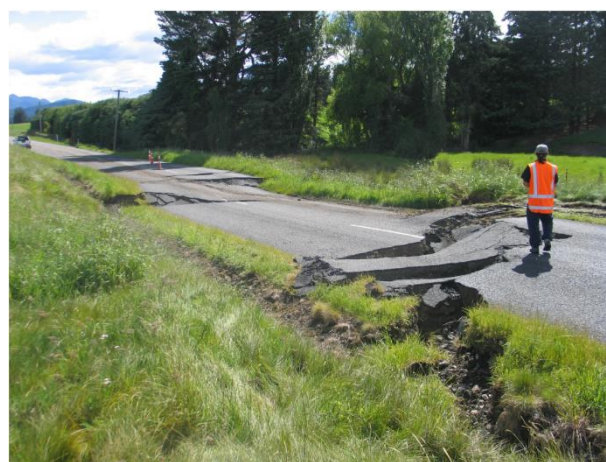
**Figure 5: Oblique transtensional rupture within The Humps Fault zone displacing State Highway 70 (the Inland Kaikōura Road; Lat 42.597°S, Lon 173.091°E; view towards the north; photograph by Jarg Pettinga).**

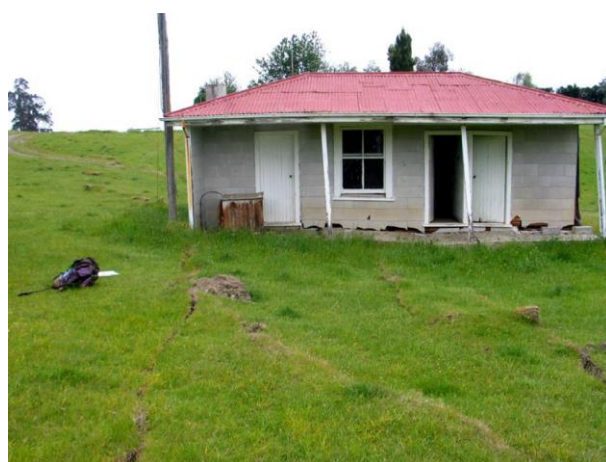
**Figure 6: The Humps Fault surface rupture through a farm worker's cottage at Hossack Downs (Lat 42.629°S, Lon 173.015°E; photograph by Jarg Pettinga).**

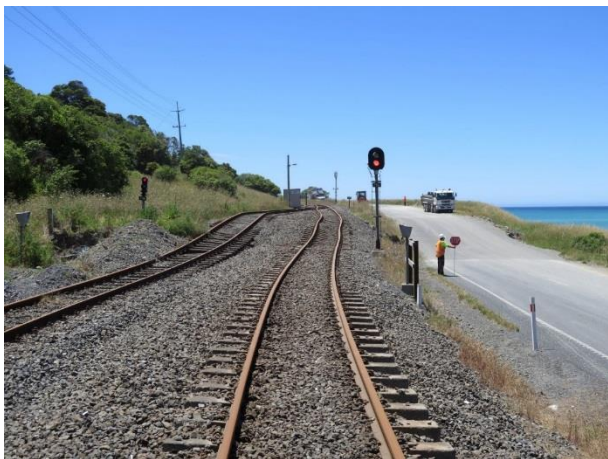
**Figure 7:** Dextral-reverse displacement of the SIMT and State Highway 1 across the Hundalee Fault at Oaro (Lat 42.504°S, Lon 173.510 °E). The displacement of the road was sharp, but smoothing and resurfacing was just being completed when the photo was taken. The SIMT offset was diffused through embankment ballast and the flexibility of the rails, and in this view has yet to undergo any repair or modification (photograph by Mark Stirling).

| Fault | Engineered structures impacted by surface rupture | Figure in this paper |
|---|---|---|
| Hundalee | State Highway 1<br>Birches Road<br>SIMT railway line<br>Deer fences | Figure 7<br><br><br>Figure 7 |

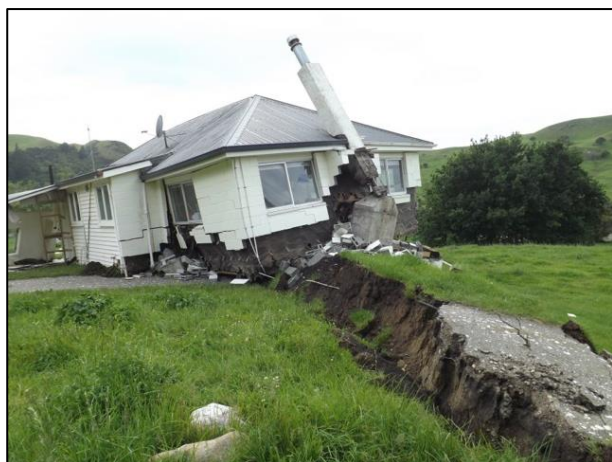
**Figure 8:** Direct fault surface rupture of c.8 m (dextral) through a farm worker's house across the Kekerengu Fault (Lat 41.978°S, Lon 178.998°E; view to the west; photograph by Tim Little).

| Fault | Engineered structures impacted by surface rupture | Figure in this paper |
|---|---|---|
| Kekerengu | State Highway 1<br>Kekerengu Valley Road<br>Wiffens Road<br>SIMT railway line<br>Main east coast fibre optic cable<br>Residential dwelling<br>Fence lines | Figure 9<br><br><br><br><br>Figures 8, 9 |

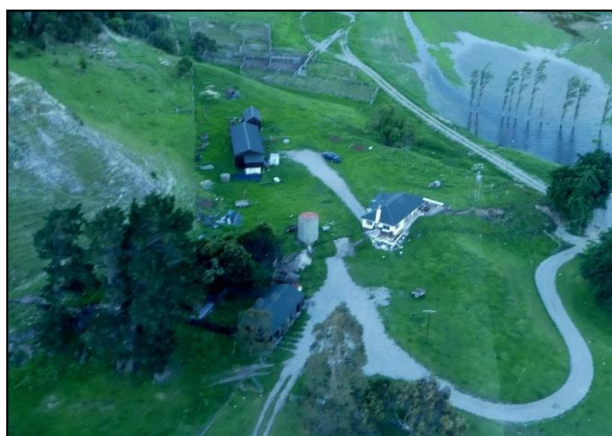
**Figure 9:** Aerial view of the area of the Kekerengu Fault rupture shown in Figure 8 (view to the north; photograph by Tim Little).

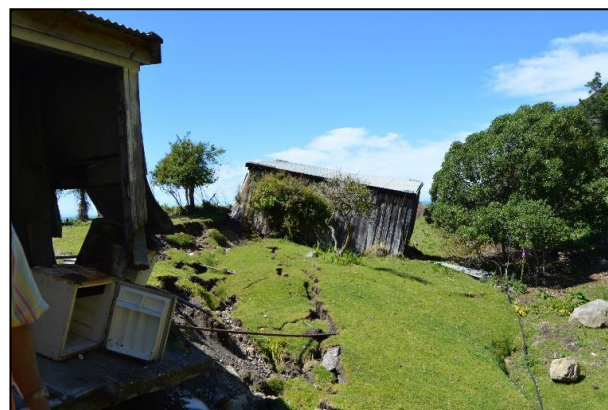
**Figure 10:** Rupture through farm buildings on a southwestern stand of the Papatea Fault near the coast (Lat 42.201°S, Lon 173.875°E; view to the south; photograph by Robert Zinke).

| Fault | Engineered structures impacted by surface rupture | Figure in this paper |
|---|---|---|
| Papatea | State Highway 1<br>Waipapa Road<br>Waiautoa Road<br>Clarence Valley Road and bridge<br>SIMT railway line<br>Main east coast fibre optic cable<br>Several residential dwellings<br>Fence lines | Figure 12<br><br><br><br><br>Figures 11, 12<br>Figure 11<br>Figure 10 |

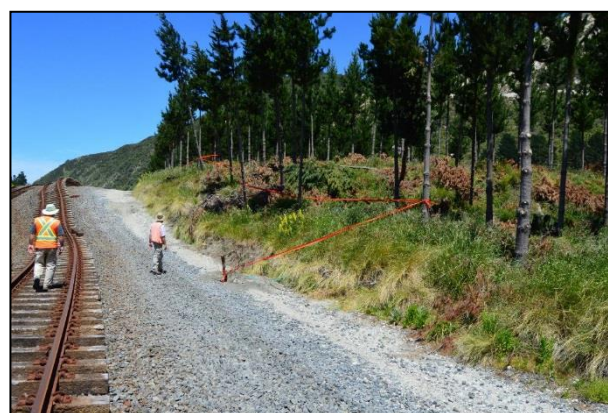
**Figure 11:** Surface fault rupture across a northeastern strand of the Papatea Fault near the coast deformed and distorted the SIMT line and severed the East Coast fibre optic cable at this location. Orange flagging marks the location where the fibre optic cable was cut by fault rupture and subsequently repaired (view to the southwest; photograph by Robert Zinke).

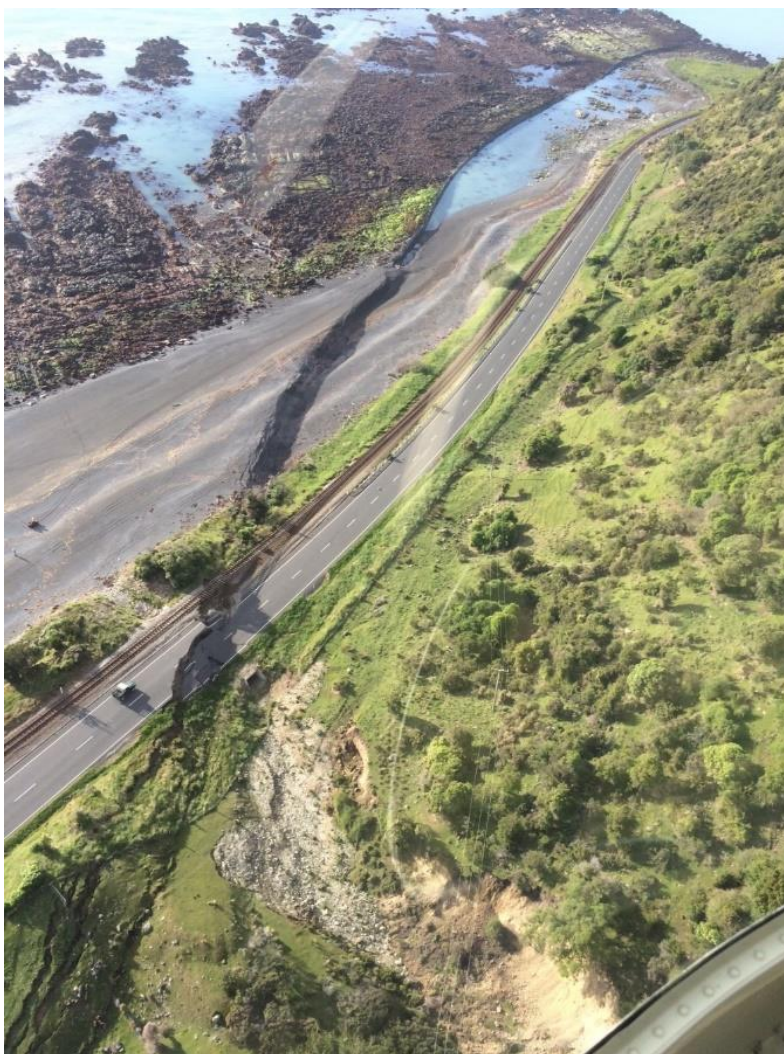
**Figure 12:** Aerial view of a southwestern strand of the Papatea Fault surface rupture across State Highway 1 and the SIMT line. This scene lies about 100 m south of that shown in Figure 10 and 900 m southwest of the Figure 11 view of the northeastern strand of the fault (view to the south; photograph from Chris Hayles).

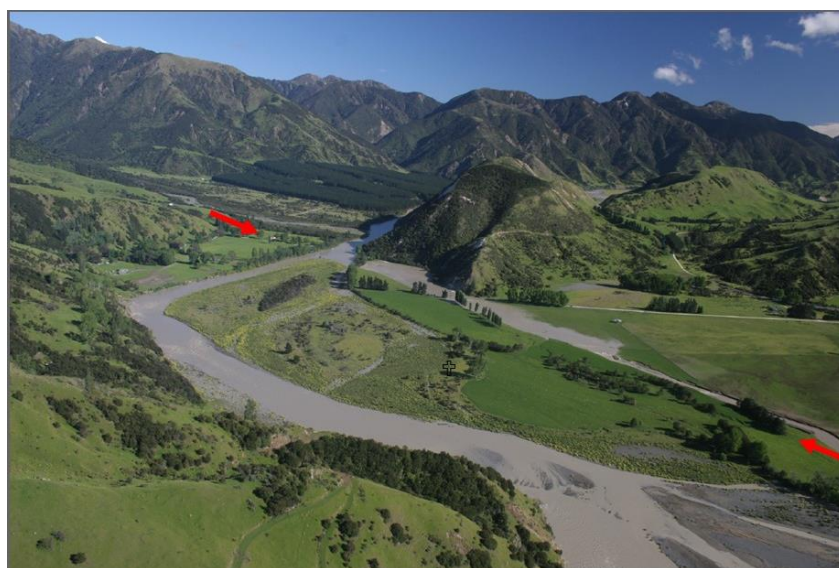
**Figure 13:** Avulsion of the Clarence River onto farmland as a result of displacement along the Papatea Fault (Lat 42.115°S, Lon 173.844°E). The obvious distributary of the river to left of centre has occurred as a result of oblique-sinistral slip and formation of a zone of echelon folding and faulting (west side up) between the arrows and across the river (view to the northwest; photograph by Julie Rowland).
