## DAMAGE TO NON-STRUCTURAL ELEMENTS IN THE 2016 KAIKŌURA EARTHQUAKE

Andrew Baird<sup>1</sup> and Helen Ferner<sup>2</sup>

### ABSTRACT

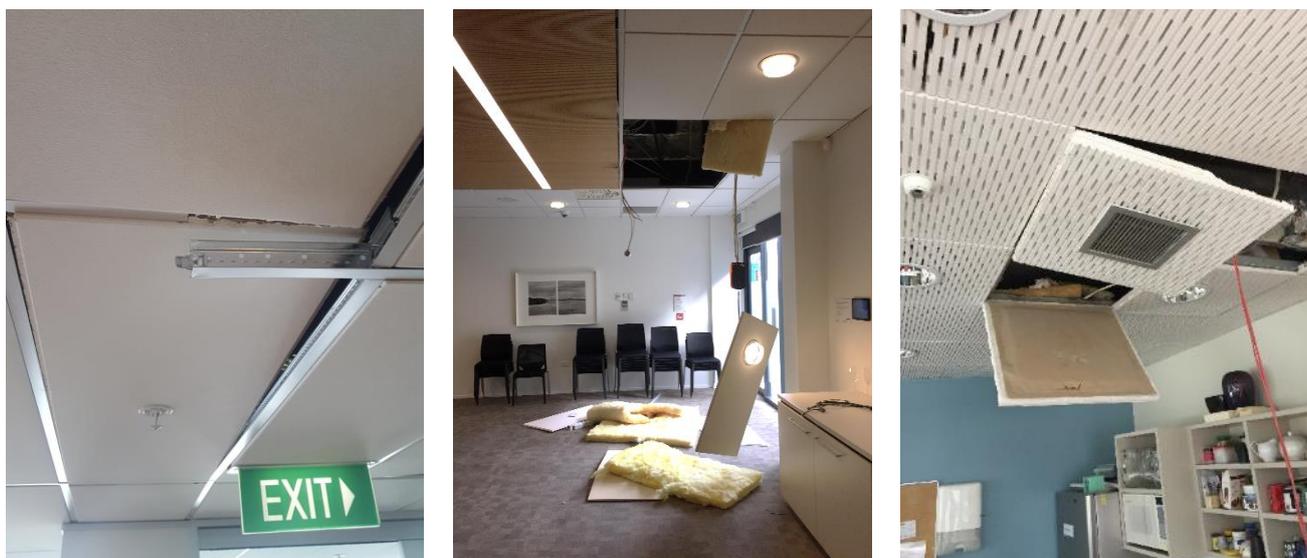
Figure 1: Damage to suspended ceilings: failed ceiling t-rail (left), fallen lightweight ceiling tiles (centre), fallen heavy plaster tiles (right).

Widespread damage to suspended ceilings in multiple buildings was observed. Refer to Figure 1 for examples of typical damage to suspended ceiling systems.

The observed damage included examples of failure due to overloading of the ceiling components, and damage which appeared to be the result of displacement incompatibilities between the ceiling and other components. Failure of several t-rails was observed which suggests that the inertial forces imposed on the component by the overall ceiling system exceeded the capacity of the t-rail leading to failures similar to that shown in Figure 1 (left). Such failures of the ceiling grid were predominantly observed for large, uninterrupted areas of suspended ceiling. This indicates that the seismic restraint of the ceiling was reliant on perimeter fixing of the grid to the structure, and the ceiling rails were inadequate for the area of ceiling they were being required to provide restraint to.

Both lightweight and heavy tiles were observed to have fallen in a number of instances. Although lightweight ceiling tiles, such as the mineral fibre tiles shown in in Figure 1 (centre), only weigh a couple of kilograms, some heavy tiles, such as the plaster tiles shown in Figure 1 (right), may weigh upwards of 10kg. The life safety risk of heavy tiles falling was clearly apparent to building occupants.

The observed damage points to the vulnerability of suspended ceiling systems in earthquakes. In particular where they are not braced against movement relative to other building elements and where the suspended ceiling grid members and connections have not been adequately designed for seismic loads. The extent, prevalence and type of damage observed indicated a widespread lack of consideration of seismic effects on suspended ceilings in commercial multi-storey office buildings. These observations align with a recently completed, but yet to be published, survey of Wellington and Auckland commercial offices which identified that ceiling seismic bracing is often absent from existing fit outs.

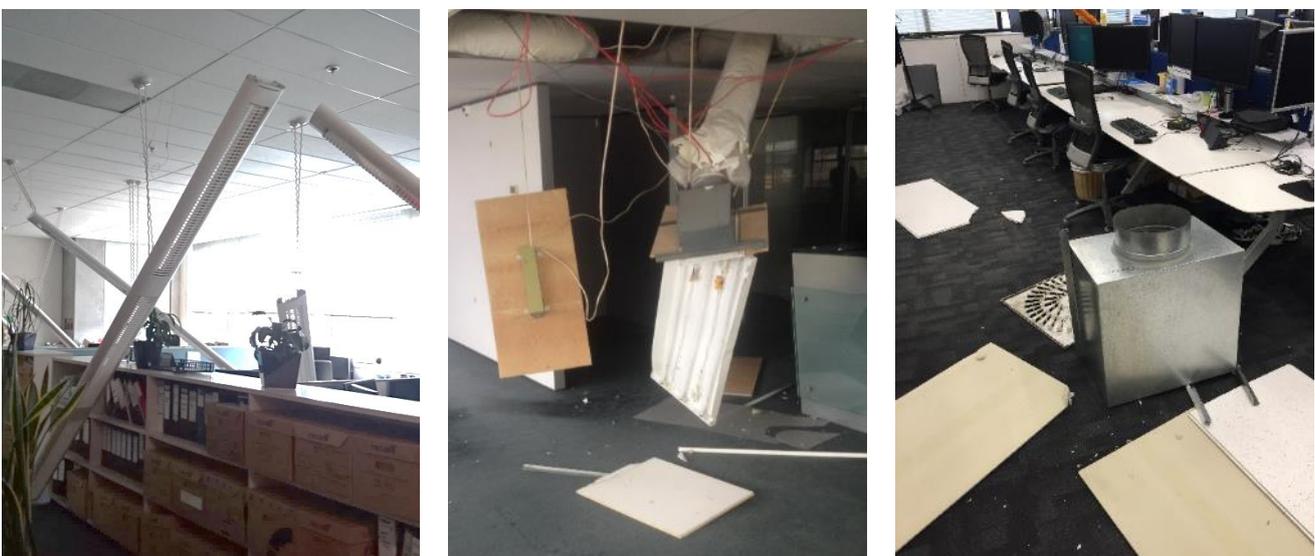
*Figure 2: Damage to suspended services: fallen suspended pendulum lighting (left), fallen diffuser fixed to ceiling grid (centre), fallen HVAC diffuser (right).*

Other examples include HVAC equipment and ducting located above ceilings where it was observed neither the ceilings and/or the HVAC equipment was braced, as shown in Figure 2 (centre and right). Damage appeared to have resulted from the relative displacement of the various services elements relative to the ceiling system leading to multiple instances of services components falling out of the ceiling. The life safety risk associated with the falling of services components including lights, diffusers, ducting, etc. was noted.

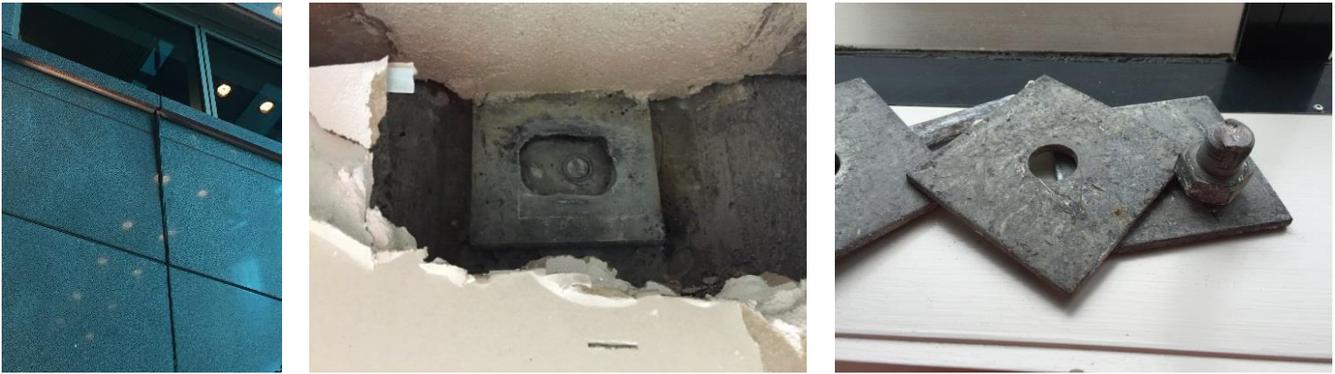
**Figure 3: Damage to precast concrete panels: ejected seals (left), top connection of precast panel with oversized hole for bolt (centre), sheared off bolts of precast panel connection with oversized washers (right).**

Damage to several precast concrete panels was visible from outside buildings on street level, however such damage was minor, consisting of hairline cracks in panels, panels being out-of-plumb, or torn or ejected sealant, such as that shown in Figure 3 (left).

Minor visible exterior damage was visible for the one known case of precast panel connection failure that occurred. The failure involved full-height panels on a six storey building. The panels were fixed to the structure with a rigid weld plate connection at the base. This plate was welded to an angle bracket that was cast into the floor slab. The top connection consisted of an angle cast into the soffit of the floor beam with an oversized hole in it. A bolt was fixed through the angle into a cast in TIM in the panel. A 6mm oversized washer on the bolt then allowed the bolt to (theoretically) move within the oversized hole, as shown in Figure 3 (centre).

Although it appeared the design had considered the requirement for relative deformation between the structure and panel with the oversized hole, it was apparent on inspection that no sliding of the bolts had occurred. The 6mm washers appeared to have been bent into the oversized hole, causing the connection to lock up. It is likely that the bolts were unable to slide due to being over-tightened. Experimental testing of slotted connections has also found that the connections are at risk of locking up if a thin washer is used [5].

With no ability to accommodate the inter-storey drift of the building, the washer sheared straight through the top connection bolts, as shown in Figure 3 (right). Of the 6 storeys of panels, only 3 bolts remained out of a total of 24. The panels did not fall from the building, due to the nominal

moment capacity provided by the base detail. Once discovered, the street below was cordoned off until a new connection was fitted.

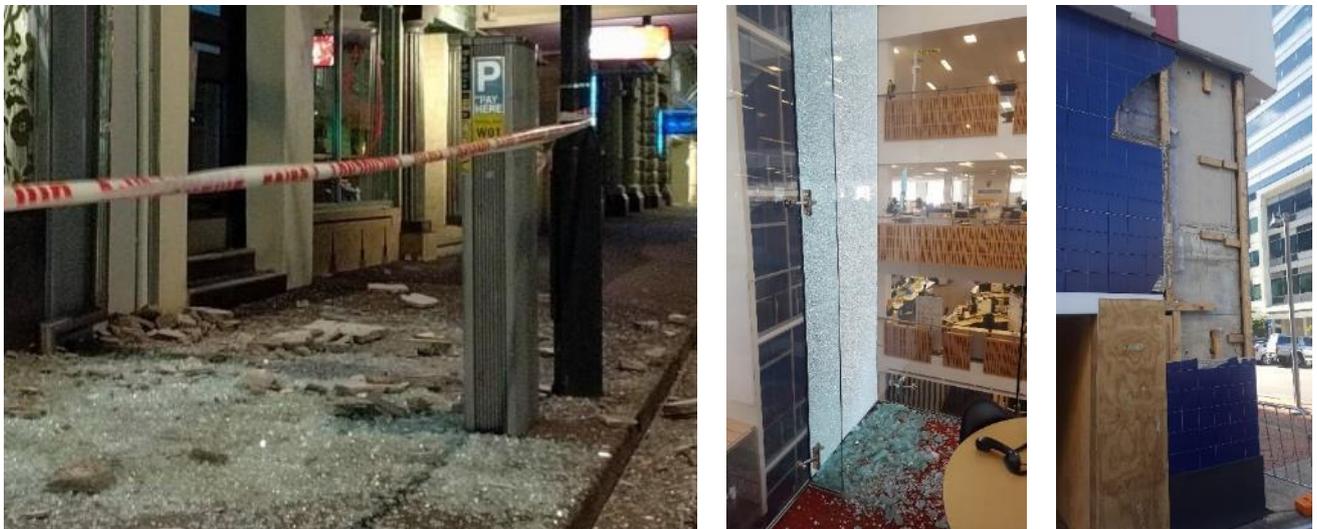
**Figure 4: Damage to exterior cladding and glazing: glass and debris on footpaths in Wellington CBD [7] (left), spider glazing failure (centre), tiled cladding failure (far right).**

Damage to exterior cladding and glazing was widely reported in the media immediately following the Kaikōura earthquake [7]. Such damage typically consists of glass and debris on footpaths below buildings, as shown in Figure 4 (left). Depending on the size of the glass shards, and the type of glass, (e.g. tempered glass vs non-tempered glass), such falling objects can present a life-safety risk to pedestrians outside buildings.

the stress concentrations in the glass result in the entire glass panels shattering, as shown in Figure 4 (centre). The amount of deformation a spider glazing system can accommodate is not large (1% drift is the limit of a typical system) and since the system does not have any redundancy like framed systems, large failures can occur. Similar damage was previously observed to frameless glazing systems in the 2010-11 Canterbury earthquakes, highlighting their vulnerability to earthquake induced deformations [5].

Several other instances of damage were observed to various cladding systems that appeared to be due to the system being unable to accommodate structural deformations, such as the tiled cladding shown in Figure 4 (right).

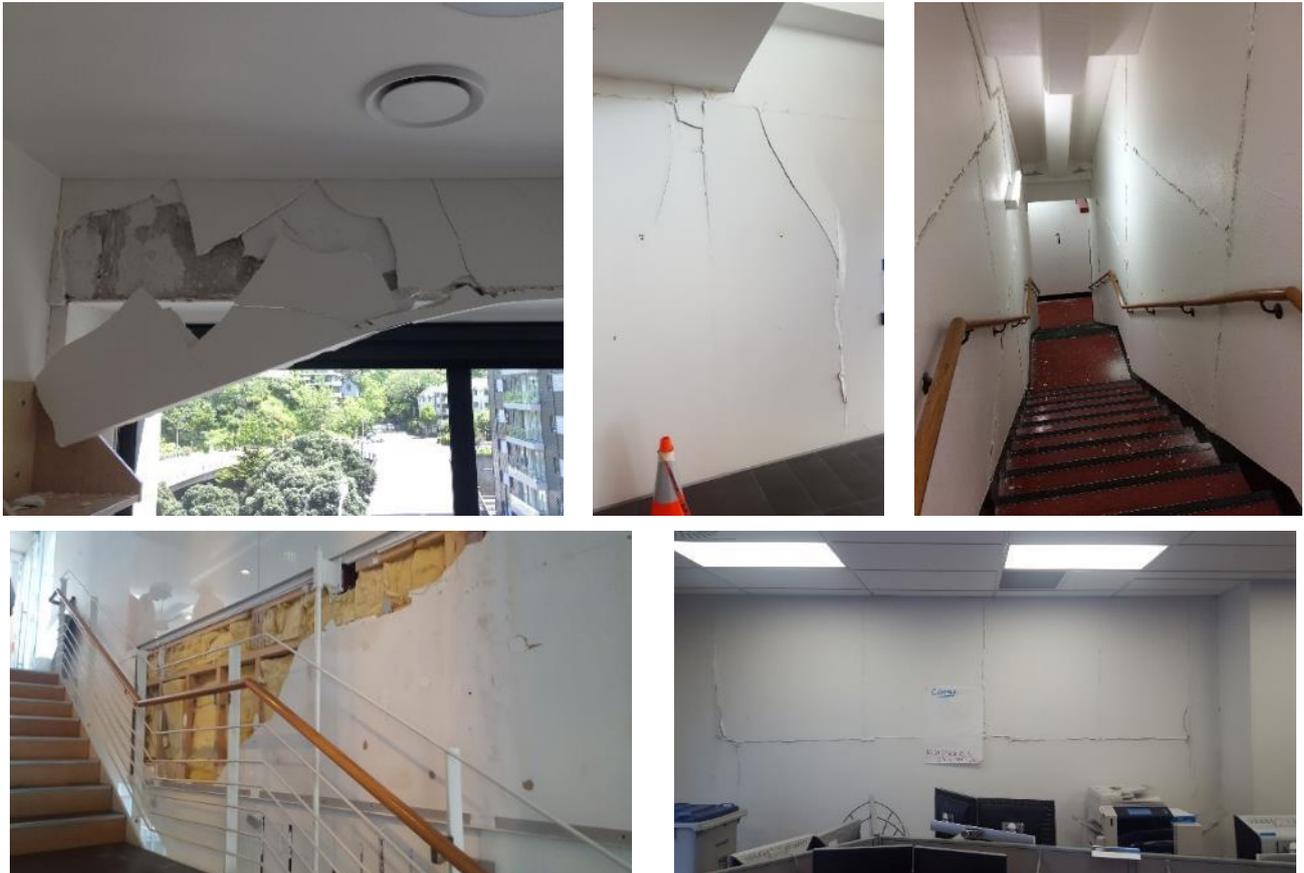
**Figure 5: Damage in internal linings: plasterboard debonding from structural beam (top left), cracked and delaminated plasterboard (top centre), cracked plasterboard lining of stairwell (top right), broken glass lining adjacent to stair (bottom left), typical movement induced cracking in plasterboard (bottom right).**

Where large partitions had no seismic separation, damage was typically located at the joints between individual panels of plasterboard, as shown in Figure 5 (top right and bottom right). In other locations earthquake induced movement had caused cracks through the panels, and these were typically observed to have been initiated at corners or other discontinuities, such as that shown in Figure 5 (top centre). A small number of instances were observed where the plasterboard had been glued directly to the structure, and the structural movements had caused the lining to de-bond and break away, or otherwise become dislodged, as shown in Figure 5 (top left).

The damage of many internal linings also demonstrated that structural movements are not always adequately understood by architects and there is a need for such movements to be better communicated. One example of this was damage to a glass lining adjacent to a stair, as shown in Figure 5 (bottom left).

The stair appeared to have been detailed to slide to accommodate inter-storey drift, as movement was evident at the base of the stair. However a large glass panel had been fixed to both the stair and the adjacent structure and consequently, as the stair moved relative to the structure during the earthquake the glass had been heavily damaged.

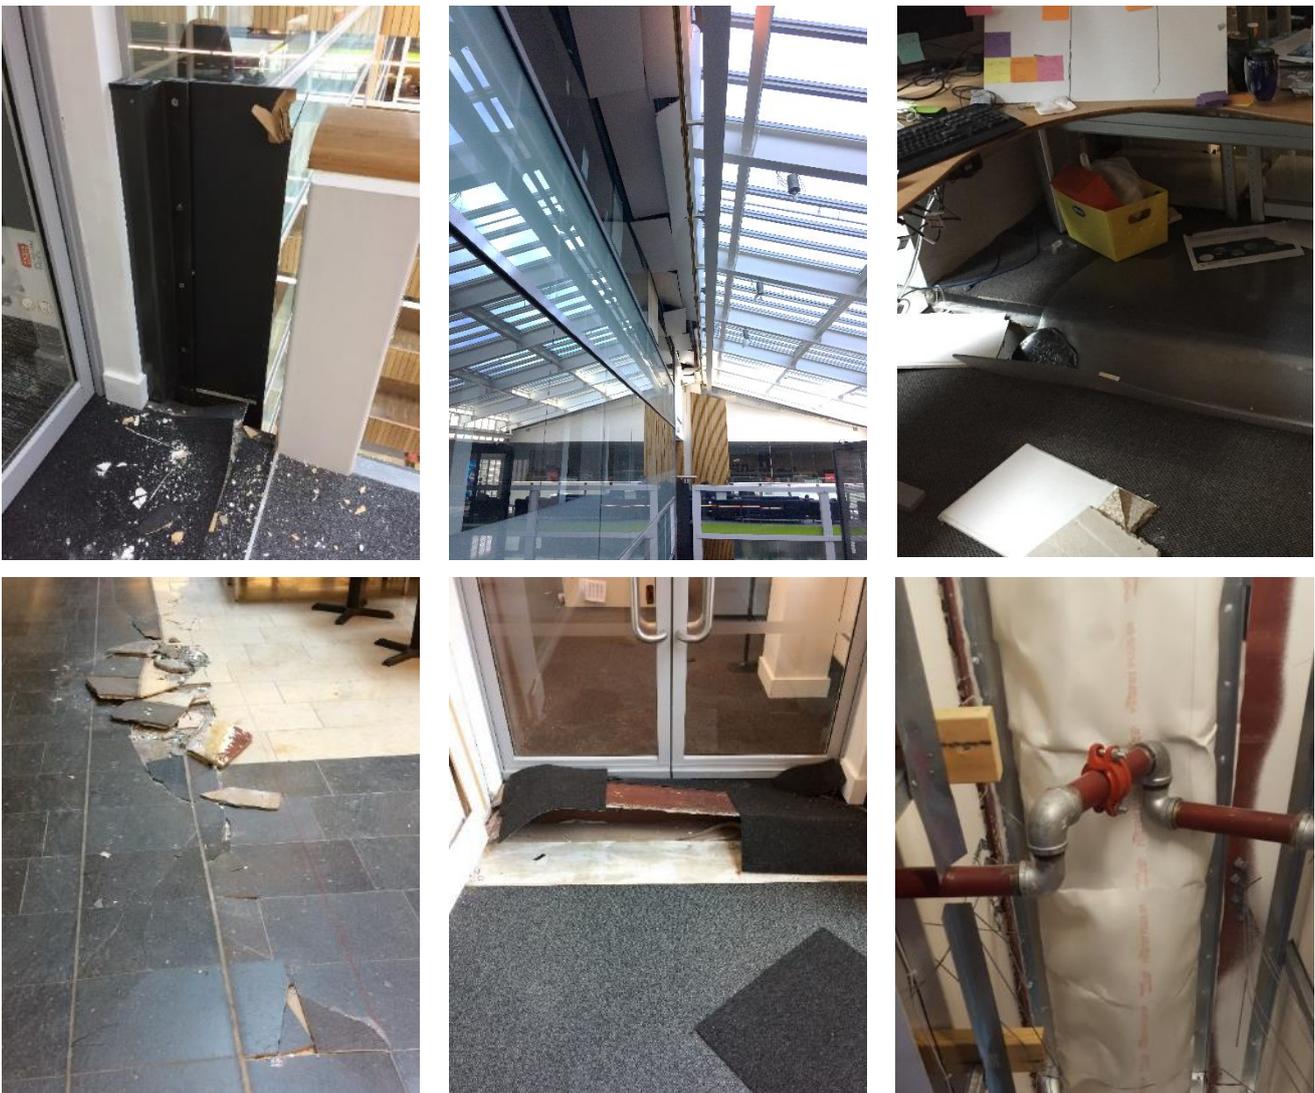
**Figure 6: Damage at seismic gaps: timber boards enclosing atrium bridge at seismic gap (top left), dislodged ceiling tiles at seismic gap (top centre), seismic gap underneath desk (top right), tile damage at seismic gap (bottom left), bent seismic gap cover plate (bottom centre), undamaged sprinkler pipe and fire seal at seismic gap (bottom right).**

One building complex inspected comprised several individual structures interconnected on various levels at a central multilevel atrium with bridges and seismic gaps between each structure. From a structural point of view, all of the seismic gaps were observed to have performed as intended as it was evident that significant amounts of relative movement between buildings had occurred. No ledge failures were observed or loss of structural support at any of the seismic gaps. Inspection indicated that while the structure had been designed to allow relative movement of the different structures at the seismic gaps this consideration had not extended to the architectural finishes. Damage to the architectural elements, such as balustrades, floor coverings, and architectural panel was extensive, as shown in Figure 6.

Fire sprinkler pipes were observed to cross one of the seismic gaps as shown in Figure 6 (bottom right). The pipe arrangement indicates the installer had some idea that a movement joint was required for the sprinkler main. It is however noted that the installed joint does not meet the requirements for a groove mechanical joint in NZS4541:2013 or the alternative flexible V loop type system [8]. Even so, no

failure of the pipe at this junction was observed.

Observations from this building suggest that perhaps more attention is needed when considering architectural finishes at seismic joints. This is particularly relevant to finishes which if damaged could cause a life safety risk to building occupants below or as they exited a building immediately following an earthquake.

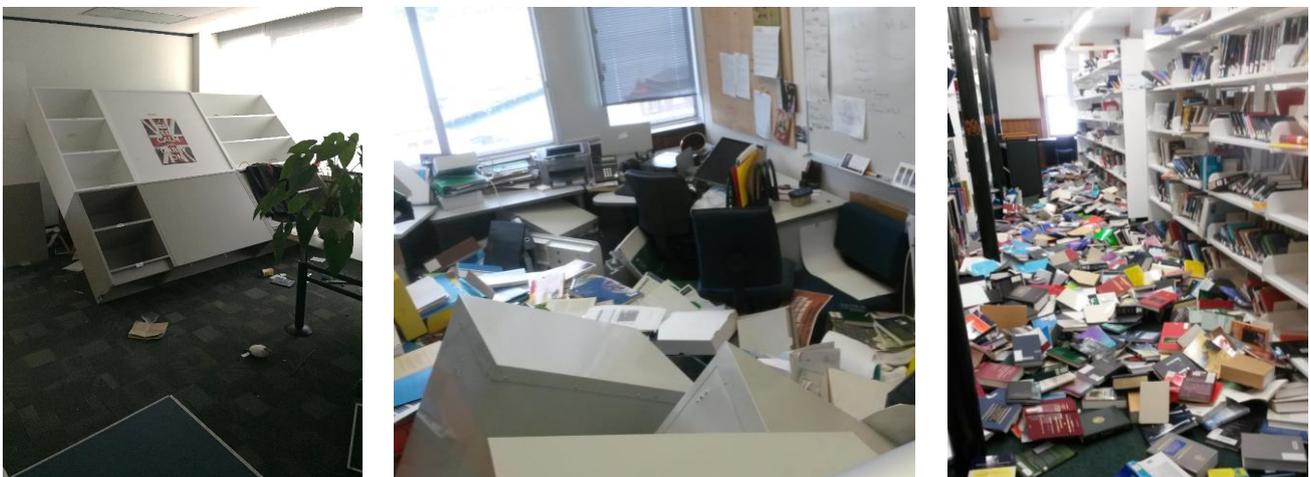
Widespread damage to contents was noted in the commercial buildings included in the post-earthquake reconnaissance. Figure 7 illustrates typical examples of contents damage, such as overturned book cases and storage. Contents spilling from drawers and cupboards or falling from desk tops and other surfaces within the offices was widely observed. Damage to contents in retail shops and supermarkets was also reported [9]. This indicates the retail industry may not have learnt the lessons from the experience in the Canterbury earthquakes, e.g. protecting contents using catches, wires, etc.

Figure 7: Damage of building contents: toppled bookcase (left), toppled office furniture (centre), books spilt from bookcases (right).

While relatively easily repaired and cleaned up post-earthquake, the extent and types of furniture which fell suggests a potential for injury to people within the building during an earthquake. The significant contribution building contents made to injury numbers has been noted in recent New Zealand earthquakes [9]. This suggests that building tenants should consider the restraint of building contents as part of fit out works. For example fixing cupboards and bookcases to floors and / or walls and including positive catches on cupboard doors or drawers to restrain the contents from falling out.
