PERFORMANCE OF WINERY FACILITIES DURING THE 14 NOVEMBER 2016 KAIKŌURA EARTHQUAKE

Dmytro Dizhur¹, Gye Simkin², Marta Giaretton³,
Giuseppe Loporcaro⁴, Alessandro Palermo⁵ and Jason Ingham⁶

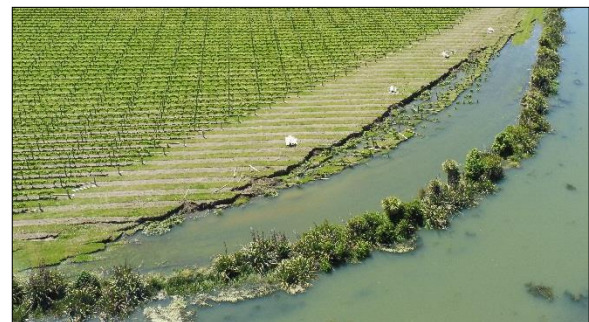
Significant land damage to vineyards was sporadically observed. However, cases of lateral spreading and ground deformations near river banks were evident (see Figure 2a). For example, the Burkhart Estate will have to re-plant approximately half a hectare of grapes due to earthquake induced land damage to a relatively small area near the Opaoa River, affecting approximately 30 of the vineyard rows (see Figure 2b). Liquefaction was observed throughout the Marlborough region, but with limited affects to vineyards (see Figure 2b for example). Further details of liquefaction and general observations of land damage following the 2016 Kaikōura earthquake presented in greater detail by Stringer et al. [18].

(a) Lateral spreading and sand ejecta damage to vineyards along the Lower Opaoa river (Marlborough District Council 2016)

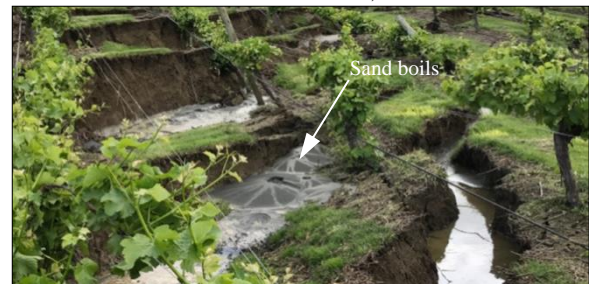
(b) Land at Burkhart Estate vineyard shifted north (credit Trevor Burkhart)

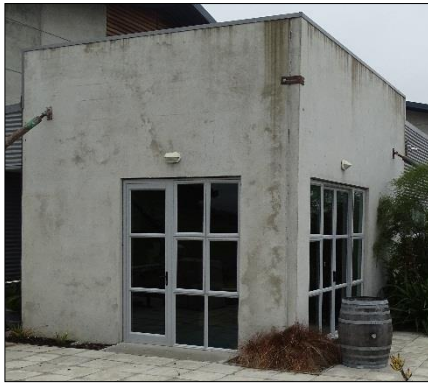
(a) Precast panels exhibiting movement that required temporary propping

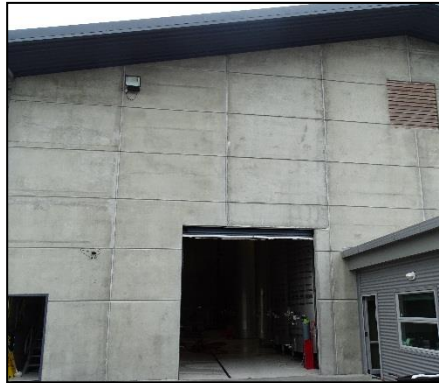
(b) Concrete panels performed well, minor observed cracking at the base

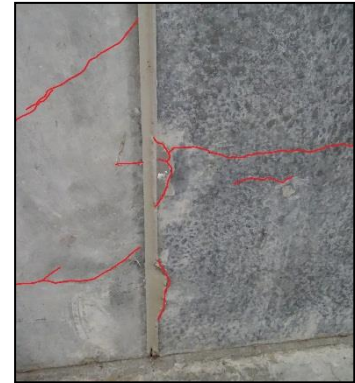
(c) Cracking observed near wall base and at panel joints

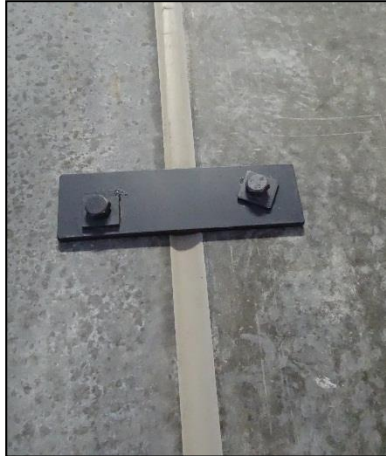
(d) No damage or residual movement observed at concrete panel joints

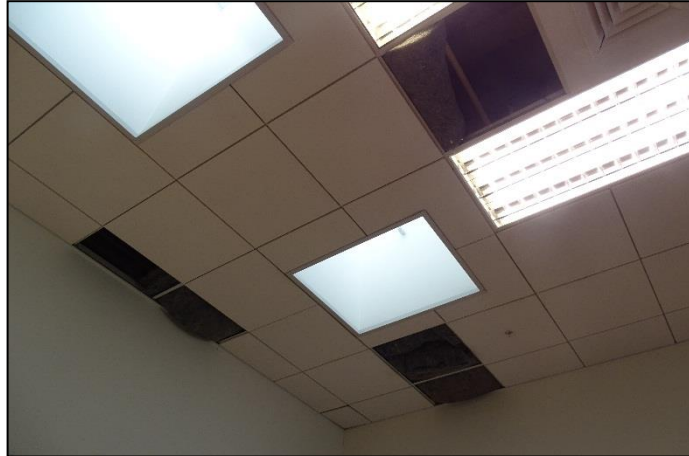
(e) Non-structural damage of ceiling panels in office spaces

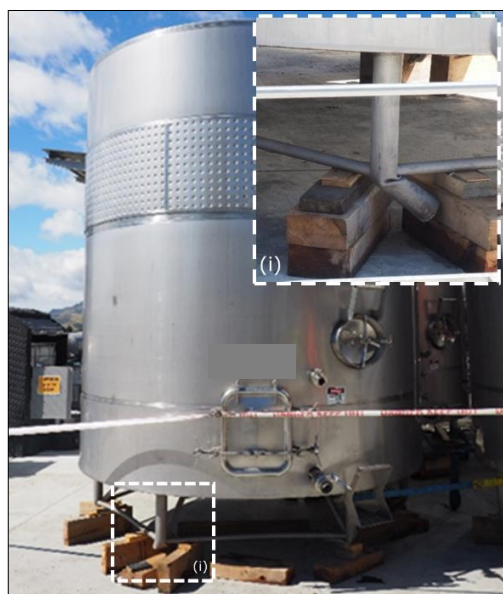
- Legged tanks with tall bases typically had braced legs. The braces were often connected to the legs 200-300 mm above ground with the unbraced portion of the leg commonly failing in bending (see Figure 4a).

(a) Bending of tank legs below brace, with tank temporarily supported on timber blocks (0.13g hPGA)

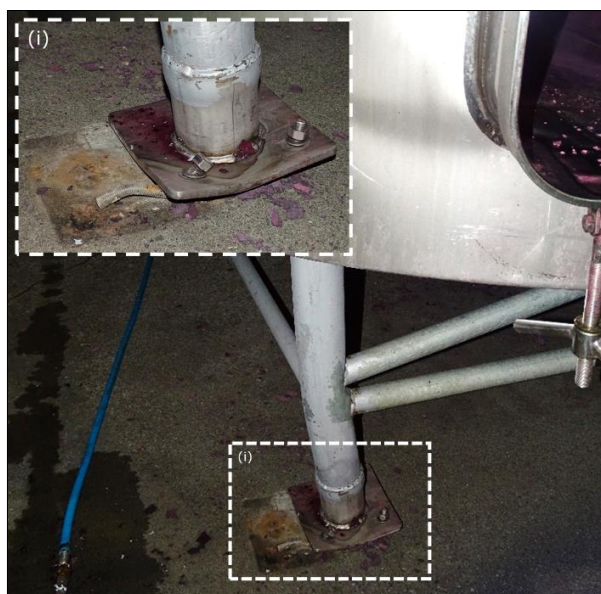
- Pull-out of adhesive anchoring systems used to secure tank base plates was widely observed (see Figure 4b). It was evident that fixing of base plates reduced the horizontal translation of the tanks but dramatically increased the forces in the tank legs.

(b) Significant movement and uplift of legged base plate with bending of the leg member below bracing (0.20g hPGA)

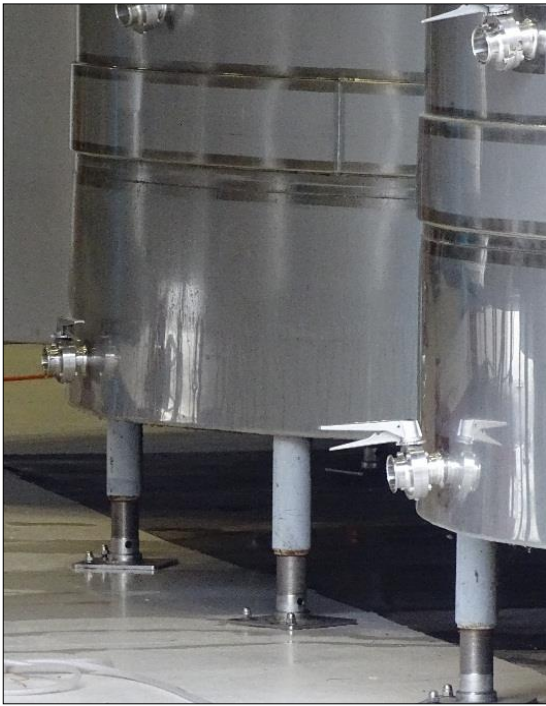
- Local buckling of adjustable threaded leg sections at the point of cross-section reduction (see Figure 5a) or where the thread engagement length was insufficient, resulting in an inadequate bending moment transfer mechanism (see Figure 5c-e).

(a) Slender adjustable legs prone to buckling at the point of cross-section reduction (0.20g hPGA)

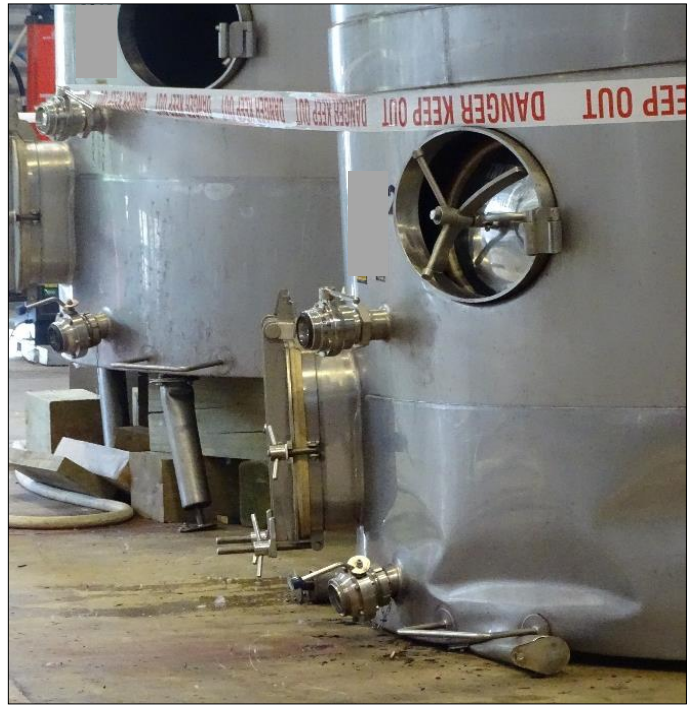
- Failure at the top of the leg in unbraced frames, (1) within the supporting beam, or (2) fracture of the weld connecting the leg and beam at the maximum moment locations. The weld connecting the leg and beam is often poorly detailed (see Figure 5b).

(b) Collapse of tanks due to buckling of slender and understrength support legs (0.13g hPGA)

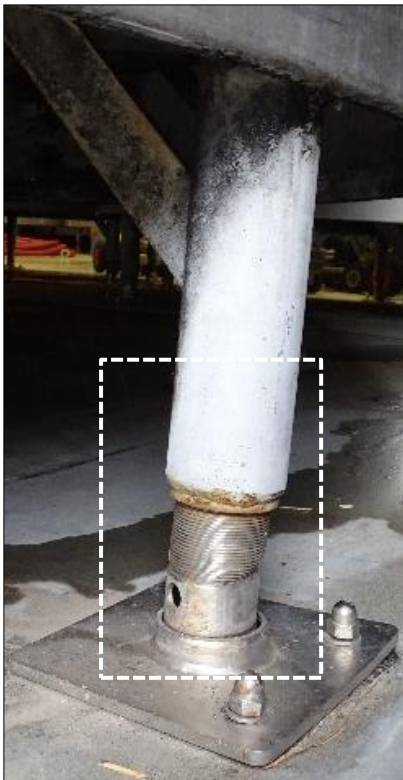
(c) Buckling of adjustable portion of the leg support and bending of base plate (0.20g hPGA)

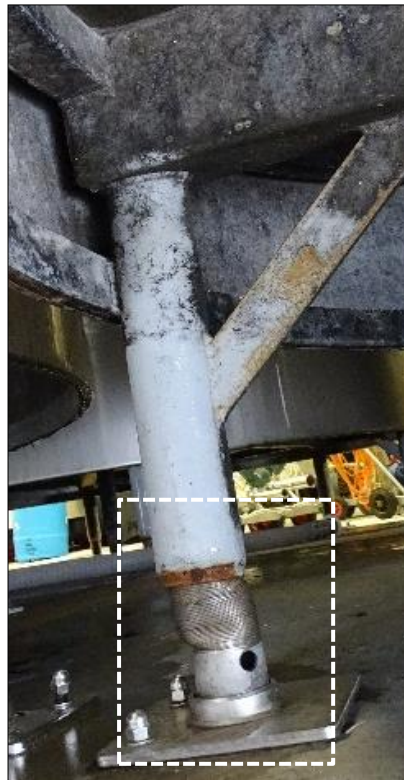
(d) Buckling of adjustable leg support portion (0.20g hPGA)

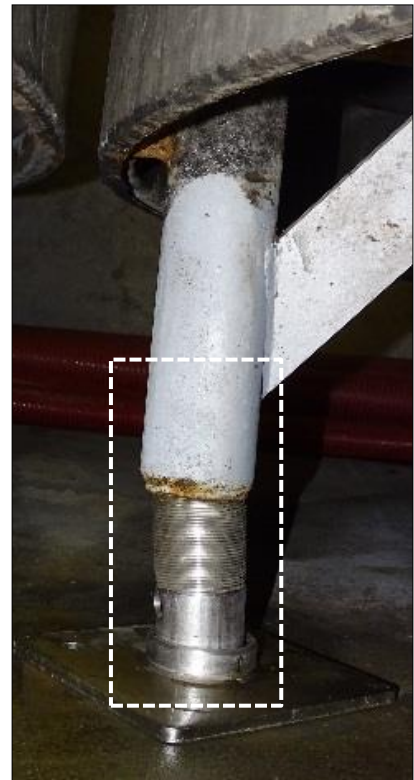
(e) Buckling of adjustable portion of the leg support below brace (0.20g hPGA)

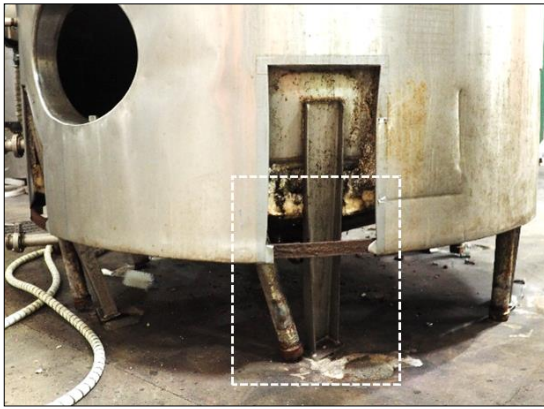
- Inadequate strengthening of tank legs (see Figure 6a).
- In cases where the legs were adequately strengthened, buckling and damage to tank skirts occurred (see Figure 6b).
- Well braced legged tanks with braces connected to the bottom-most part of the leg generally had no damage to legs or tanks (see Figure 7a,c,d).
- Tanks with stiff squat legs that were not secured to the concrete slabs generally performed well, with only minor evidence of sliding on the concrete slab (see Figure 7b) or minor damage due to pounding with adjacent tanks.

(a) Additional legs added following the 2013 earthquakes (see white dotted box). Torsional rotation observed with near collapse of the tank (0.14g hPGA)

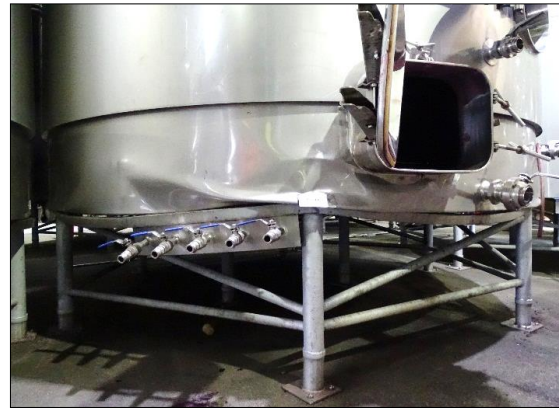
(b) Strong braced legs fixed to concrete slab resulted in good performance of the legged system but lead to buckling and damage to the tank above (0.23g hPGA)

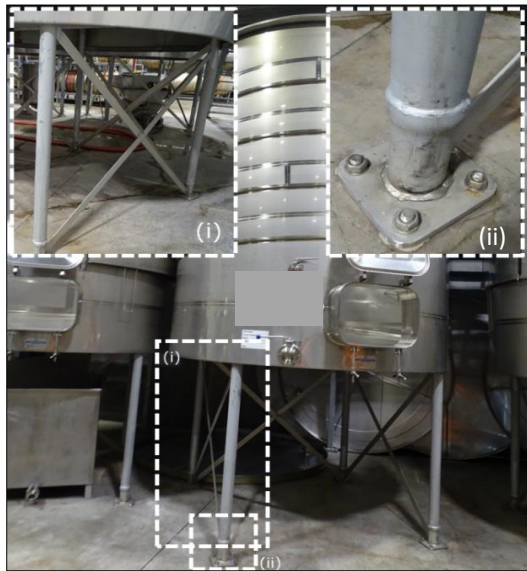
(a) No damage to legs or tanks observed (0.20g hPGA), (i) braces connected near base plate, (ii) base plate well connected to concrete

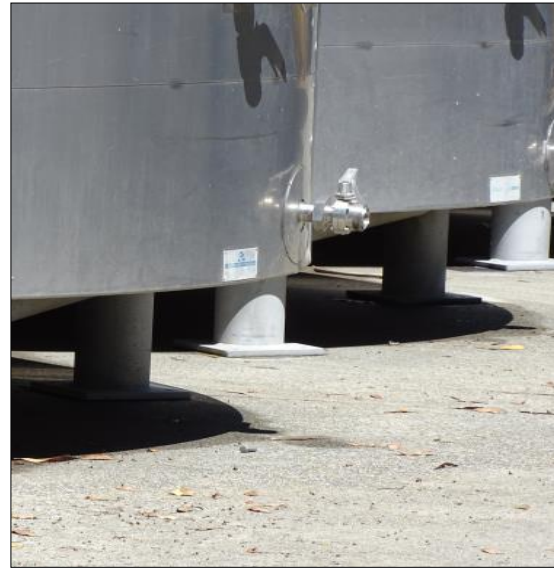
(b) Tanks with squat legs not fixed to the concrete slab – no evidence of significant movement or damage but in some cases translation of 10-20 millimetres (0.14g hPGA)

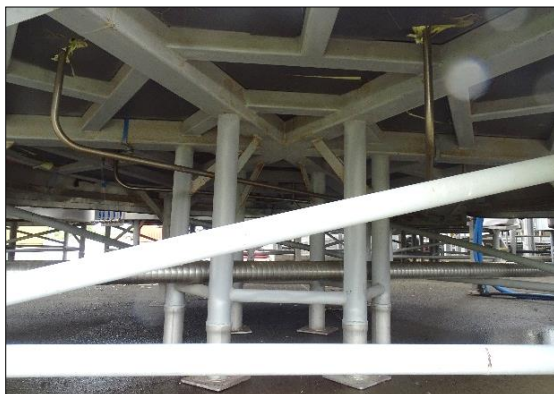
(c) Example of well braced and strong design with minimal/no damage observed (0.23g hPGA). Some of these braced tanks had lower wall fracture, with likely loss of wine, but most performed well

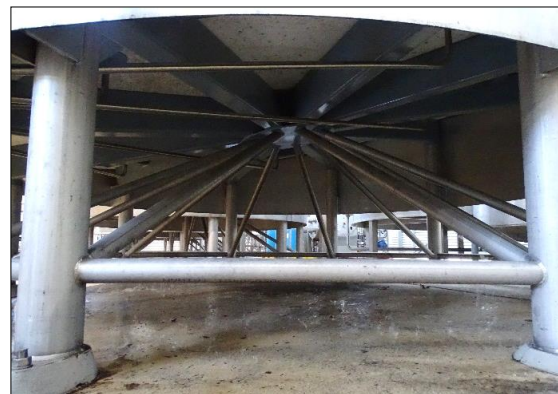
(d) Example of well braced tank with minimal/no damage observed (0.13g hPGA). Some braced tanks had damage to the lower part of the tank wall, with likely loss of wine, but most performed well

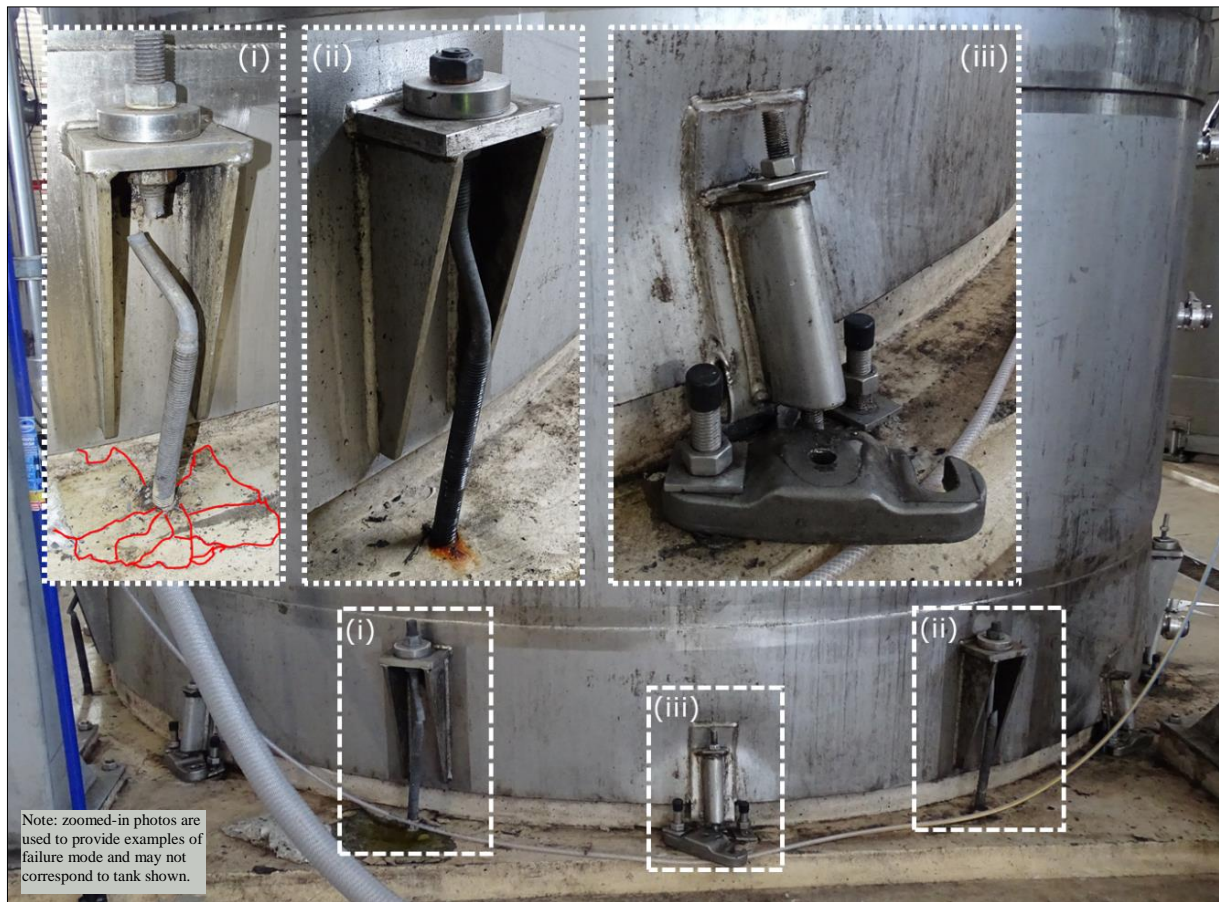
- Use of tension anchors resulting in rupture of anchor rods in tension and/or shear (see Figures 8, 9a, 11).
- Buckling or rupture of tension/compression anchor rods due to the absence of buckling restraints (see Figures 8, 9a). Anchors appeared to have yielded during tension cycle, buckled during compression cycle, and then fractured in subsequent tension cycle due to high stress concentration at the point of buckling (see Figure 10a).

- Pull-out of anchor rods due to adhesive and concrete cone failures, and inadequate design of base plate restraints (see Figures 8a, 9, 11, 16d).
- Stripping of threads at top or bottom of anchor rods due to lack of thread engagement. Common at the connection to a chair from the tank wall or a baseplate (see Figures 8b, 9c).

(a) Use of mixed anchor systems resulting in pull-out of anchors from concrete and yielding, rupture and compression failures of anchor rods, resulting in major damage to the base of the tank (0.13g hPGA)

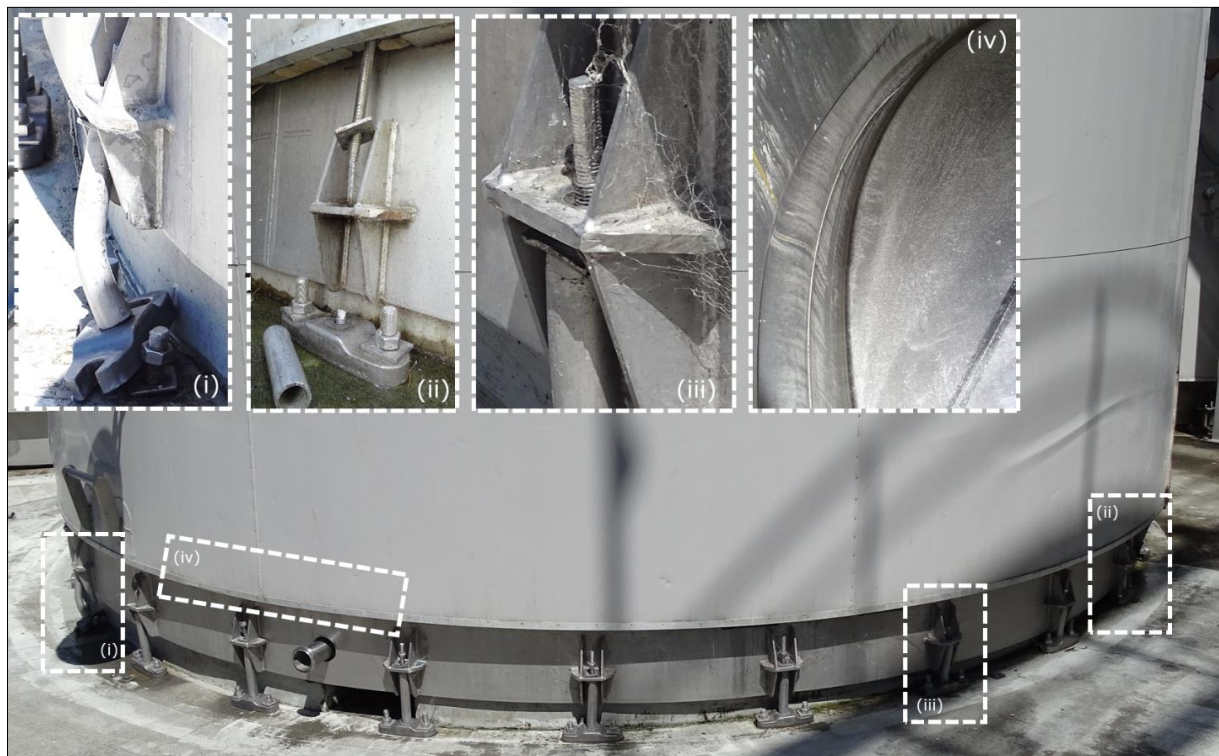
(b) 150 kL tank showing damage to anchoring connections and tank base; (i) buckling of the anchor rod and dislodgement from anchoring bolts; (ii) rupture of anchor rod; (iii) stripped thread and fully coming off the holding nut; (iv) evidence of tank base distortion in 'knuckle-squash' type deformation (0.13g hPGA)

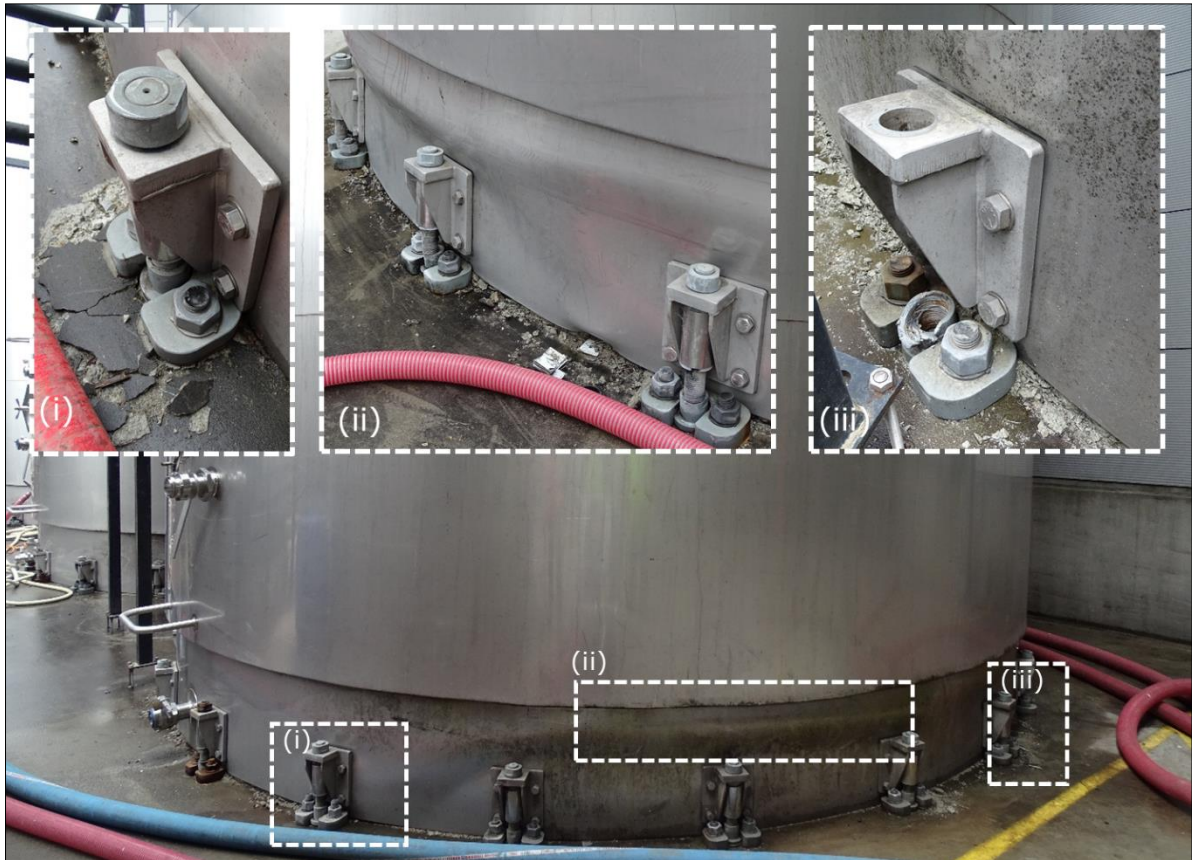
(a) 240 kL tank showing various forms of damage to anchors and base skirt (0.23g hPGA)

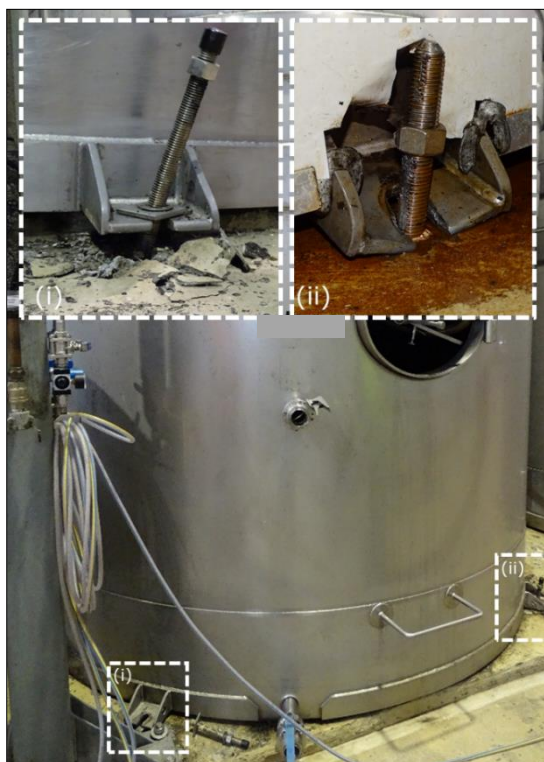
(b) Failure at threaded rod/adhesive interface indicating poor workmanship of adhesive installation (0.13g hPGA)

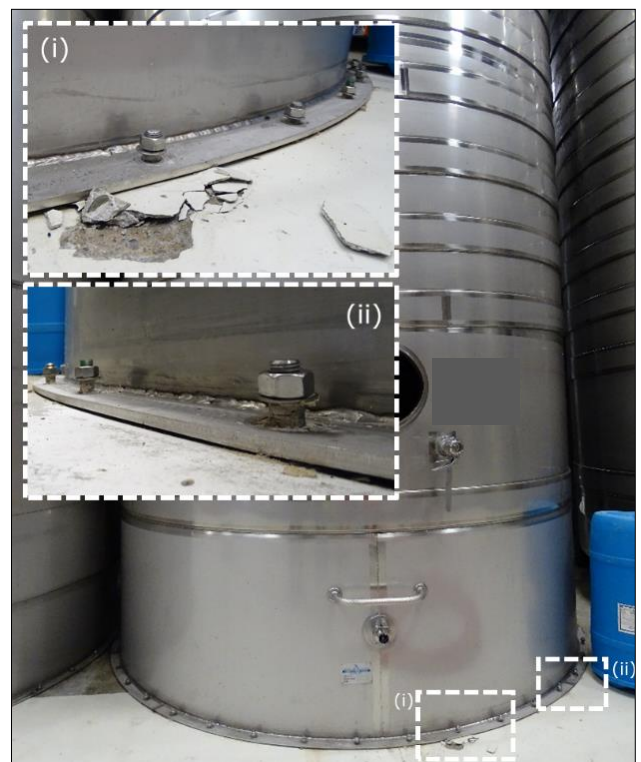
(c) Stripped thread and bolt pull-out from concrete floor (45 kL tanks) (0.20g hPGA)

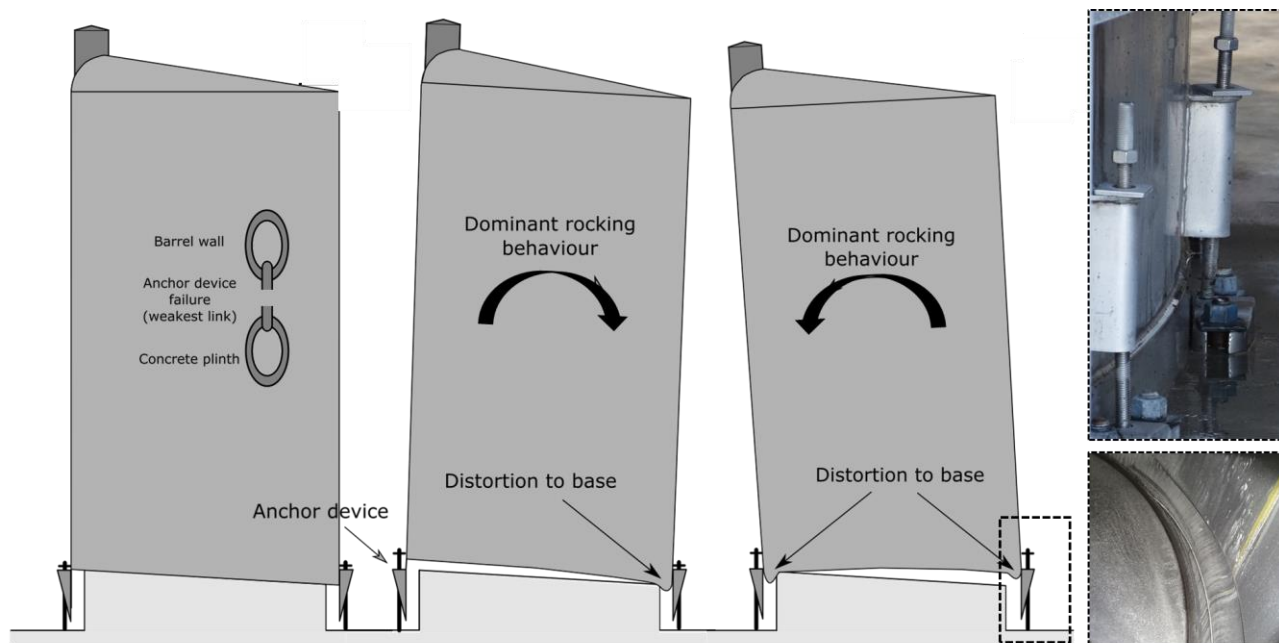
- Capacity of the knuckle against distortion on the compression side is typically minimal when compared with the tension capacity of the anchors. It was observed that the tension side anchors rarely yield, although have the appearance of being stretched due to the downward movement of the tank as it deforms over the plinth. Knuckle deformation typically occurred due to inadequate compression load path, and commonly was observed at locations where the tanks skirt did not extend to the concrete nib (see Figure 10a).

(a) Schematics and photographic examples of flat-bedded tanks with anchor devices

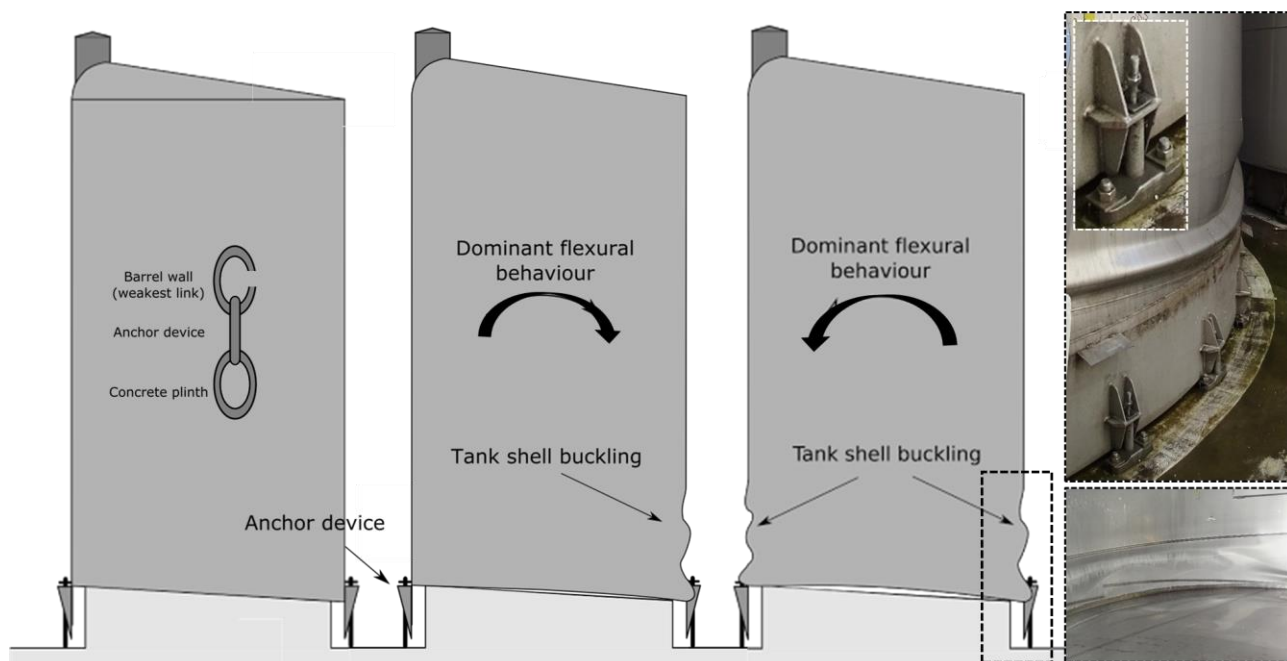
- Local deformation of the thin stainless steel layer due to rocking and horizontal displacement of the tanks (as shown schematically in Figure 10b with examples in Figure 15).

(b) Schematics and photographic examples of flat-bedded tanks with tank shell buckling

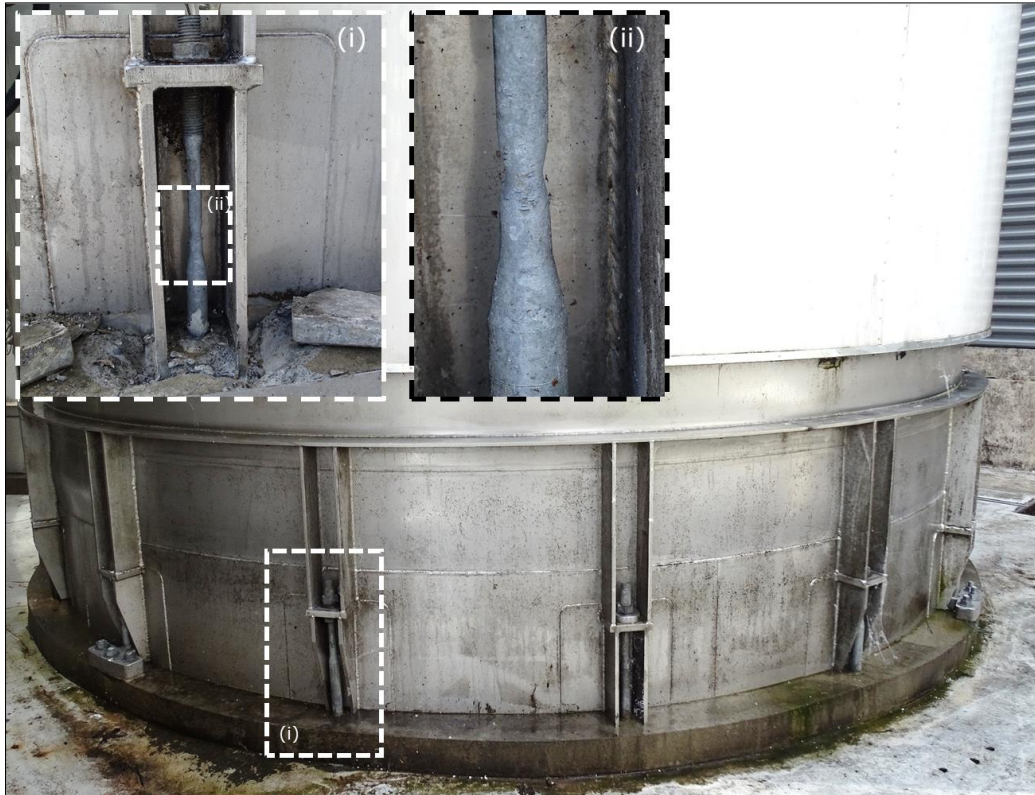
Figure 11: Tank skirting strengthened using extra welded stiffeners and addition of a concrete nib following the 2013 earthquakes; (i) close-up of the anchor connections showing crushing and spalling of concrete at base; (ii) close-up view of cup-and-cone yielding of the fuse rod (0.13g hPGA).

- Adding a skirt extension, or pouring a concrete nib up to the base of the skirt to provide solid bearing for the skirt and prevent knuckle deformation (see Figure 11), was observed to generally work well, although in some cases this intervention transferred failure to a different mechanism. The concrete nib was often observed to crack, particularly where it extends higher than the base of the skirt and encases anchor chairs.
- In some cases additional anchors were added. Additional anchors often resulted in the anchorage being stronger than the tank wall, leading to tank wall buckling.

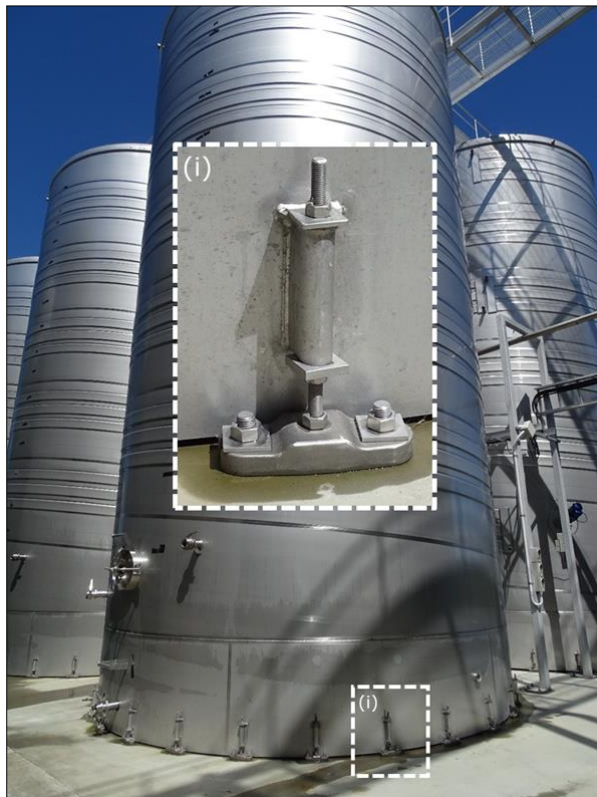
(a) 225 kL tanks secured using frequently spaced steel rod anchors exhibited apparent good performance (0.13g hPGA)

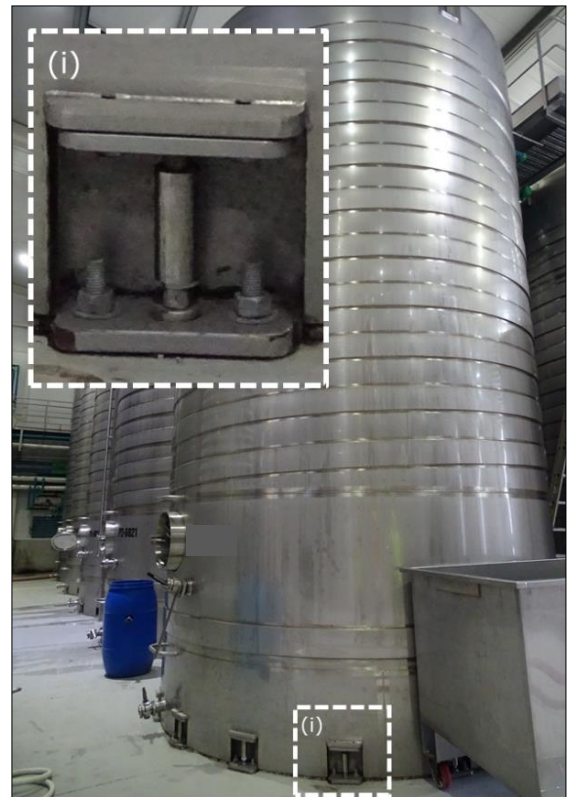
(b) 60 kL tanks with good anchor performance (0.23g hPGA)

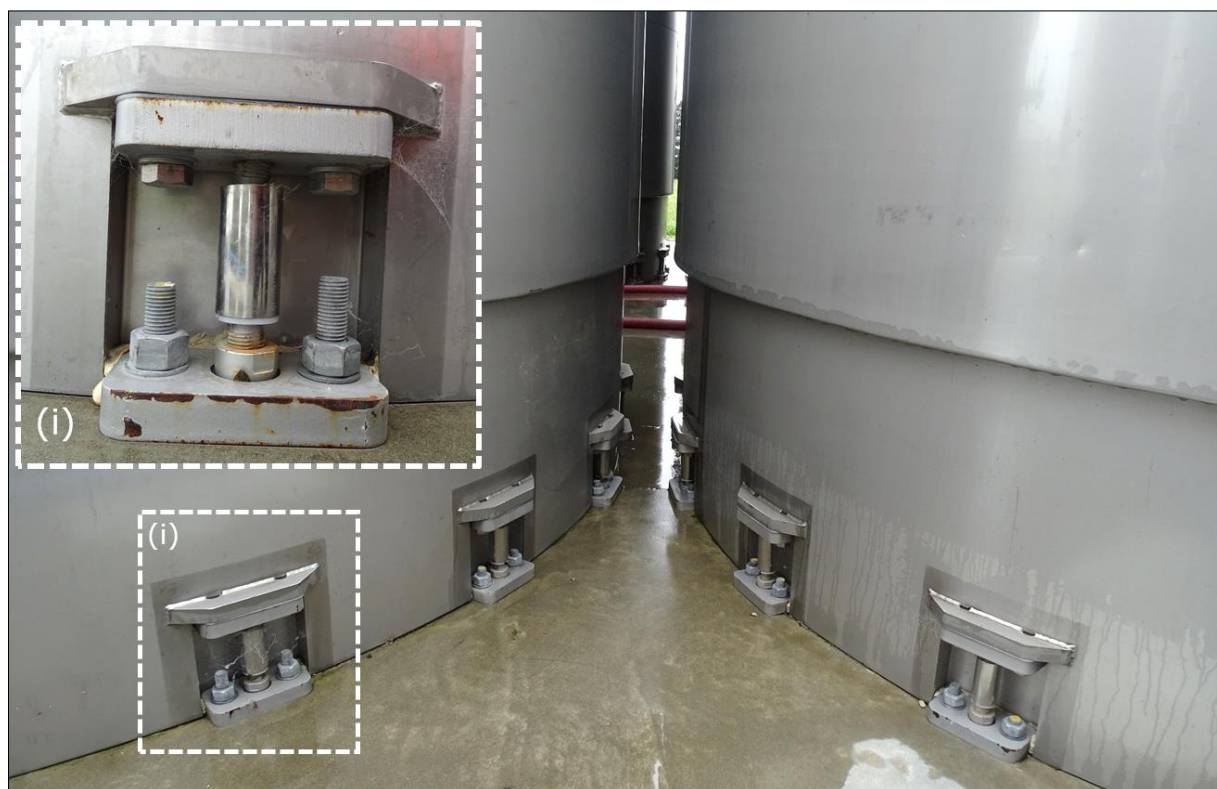
(a) 120 kL tank with no evidence of damage due to good anchor performance (0.20g hPGA)

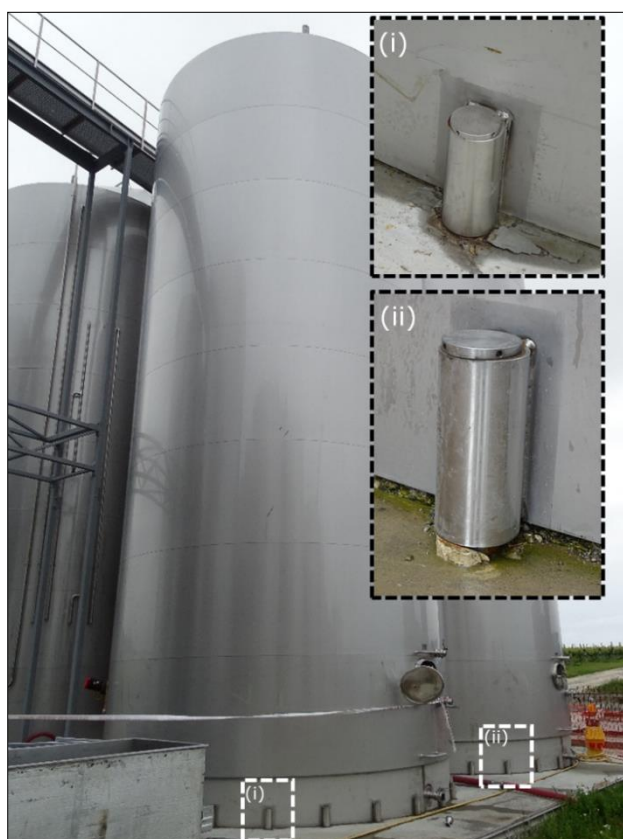
(b) 240 kL capacity tanks with no damage (0.23g hPGA)

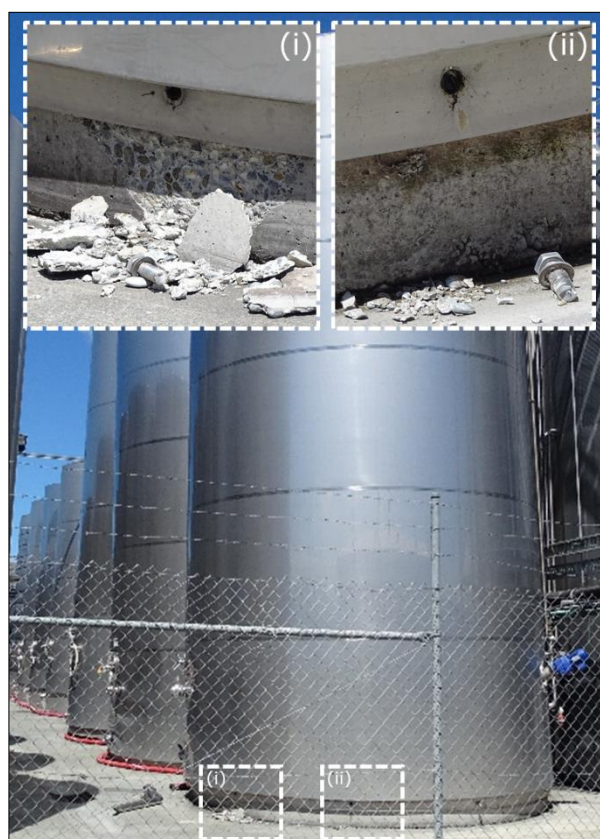
- Anchor bolt connections through the skirt into the concrete plinth were commonly observed to fail in shear (see Figure 13c).
- There were cases where flat-bedded tanks supported on plinths performed well, with no apparent damage (see Figures 11, 12, 13a-b).

(c) Flat-bedded tanks showing buckling near tank base and shear failure of anchor connections (0.14g hPGA)

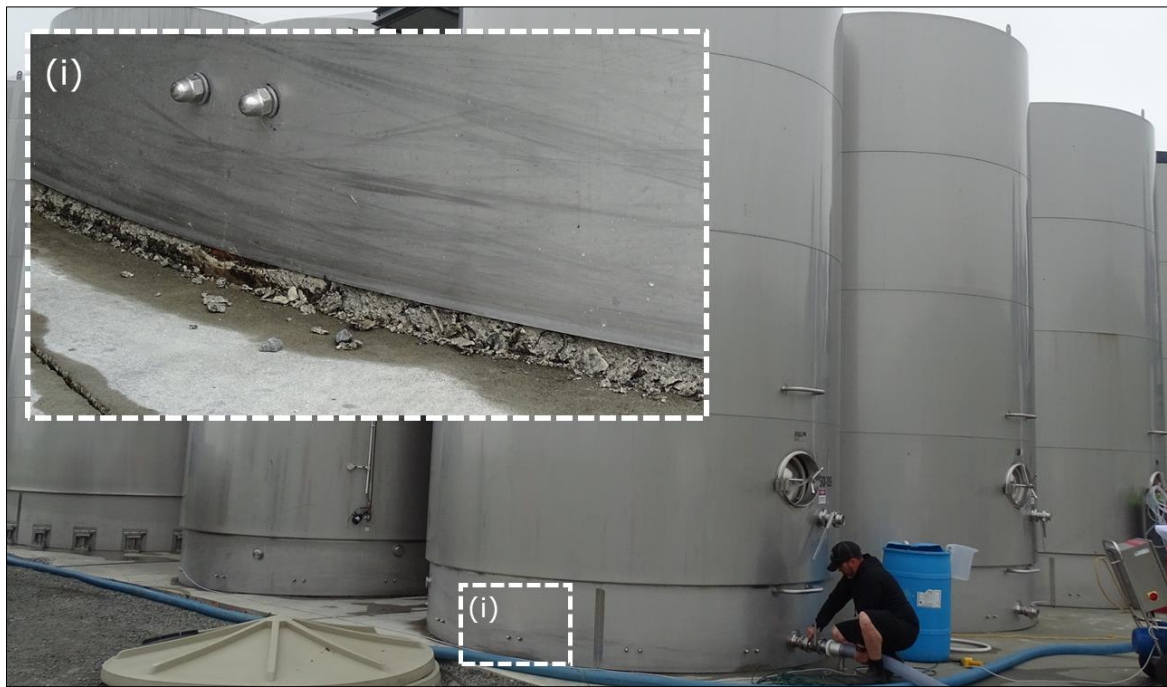
(a) 60 kL tanks with minor evidence of concrete spalling (0.20g hPGA). Note that upon cutting away the skirting for closer inspection, some of the base connections were observed by others to be fractured

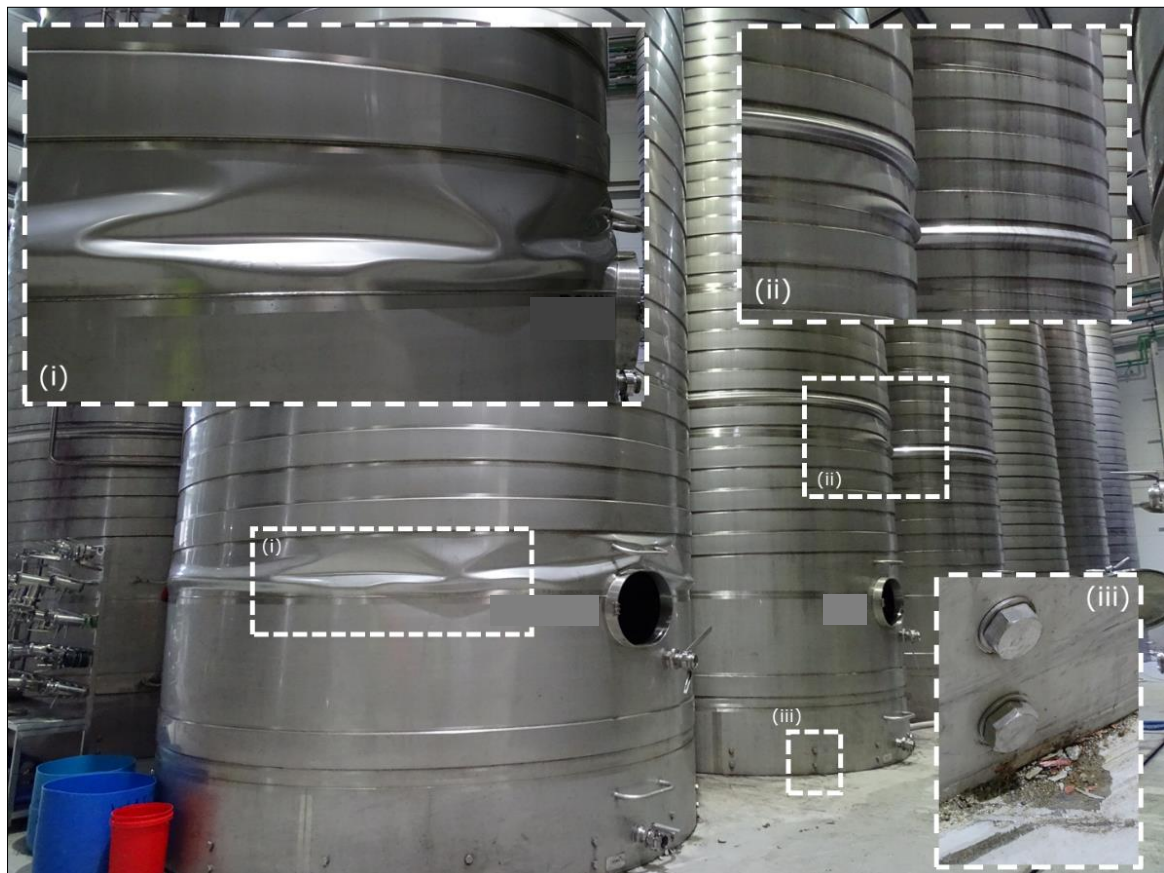
commonly observed in tanks with capacities over 100,000 L (see Figures 14b, 15a-b). Diamond buckling was mainly observed near the bottom of the tank wall. It is hypothesised that refrigeration channels restrain diamond buckling higher up the tank wall because the height of the ‘diamonds’ typically exceeded the height between adjacent refrigeration channels. It was observed that diamond buckling typically formed where no refrigeration channels were present, which is approximately over the lower 1.0 m height of the wall. Some cases were observed following the 2016 Kaikōura earthquake where this local buckling mechanism caused tank perforation and consequently wine loss.

(b) Minor damage to base connections and observed diamond buckling of the tanks at varying heights (0.23g hPGA). Note that some of the base connections were observed by others to be fractured

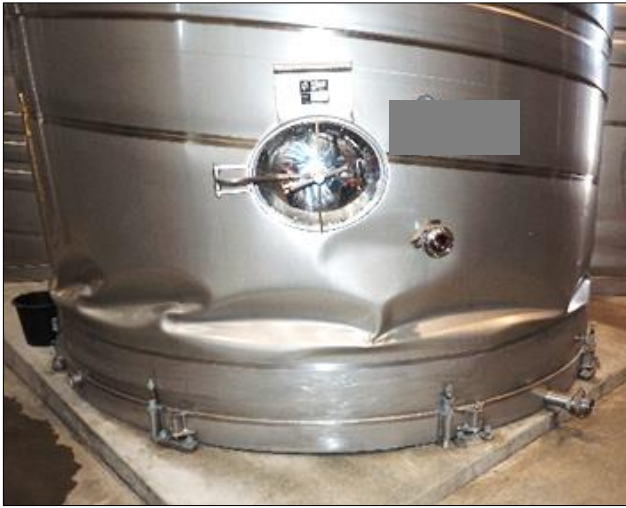
(a) Diamond buckling at the base of the barrel (note the use of double anchors to strengthen following 2013 earthquakes)

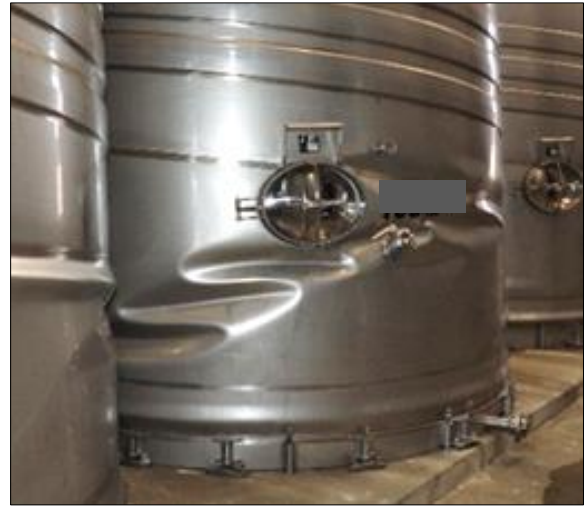
(b) Buckling of the tank shell. This type of damage is also known as "diamond" buckling

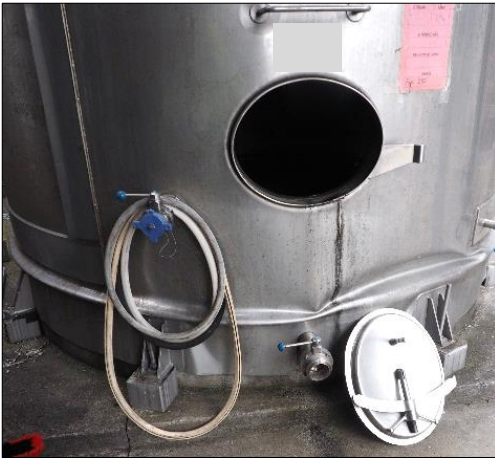
The elephant foot failure mode is an elastic-plastic deformation mode of the tank barrel walls. Failure is typically concentrated at the base of the tank, but also frequently observed higher up the wall, where there is a reduction of tank wall thickness. At times, refrigeration channels appear to have constrained elephant foot buckling. The refrigeration channels increased the stiffness of the tank wall, and hence buckling of the tank wall portion was typically observed over the height between adjacent refrigeration channels. Commonly observed examples of elephant foot buckling are shown in Figure 15c-e.

(c) Elephant foot damage example 1

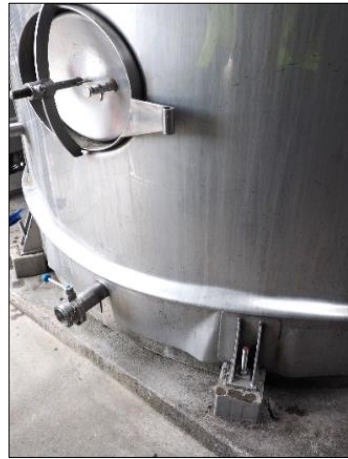
(d) Elephant foot damage example 2

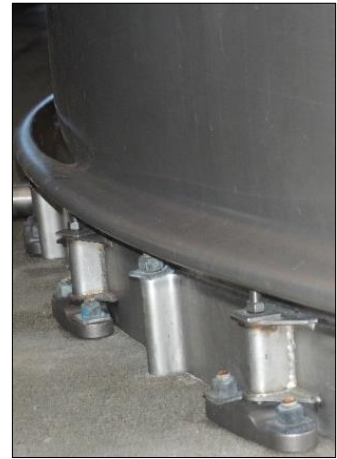
(e) Elephant foot damage example 3

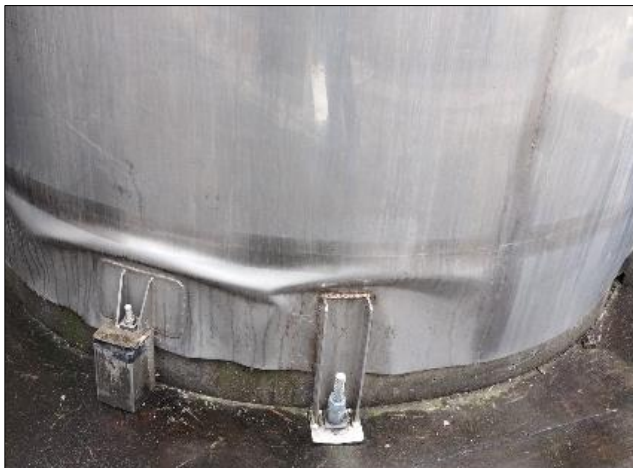
(f) Local buckling of the skirt where damage is concentrated at the steel base bracket locations

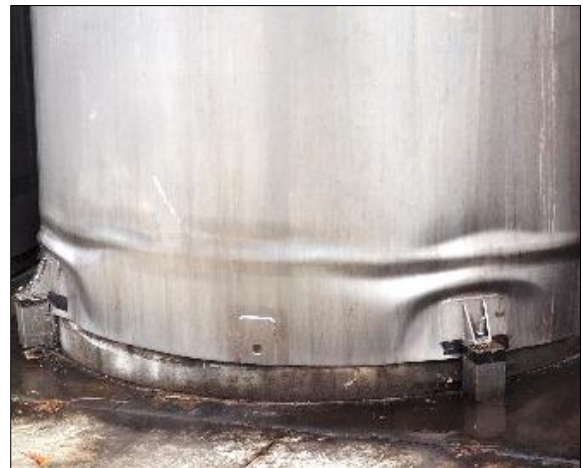
(g) Local buckling of the skirt where damage is concentrated above the locations of the steel base brackets

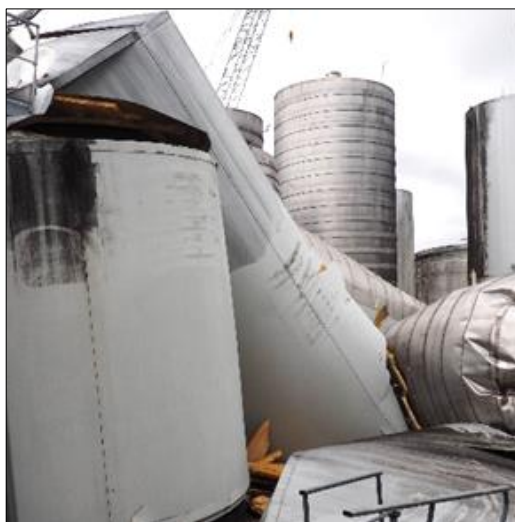
(a) Complete collapse of slender tanks ('domino effect')

In some wineries complete tank collapse was observed, which was likely a result of excessive rocking and displacement of the tanks. In some cases the collapse of one tank led to a 'domino effect' of the neighbouring tanks. This effect was more likely to happen in cases where full tanks were located adjacent to empty ones (see Figure 16). In some cases full collapse was restrained due to the support provided by the neighbour tanks.

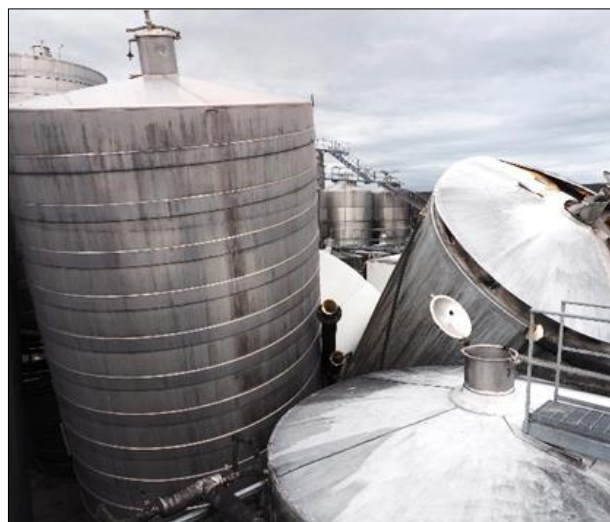
(b) Complete collapse of different sized tanks

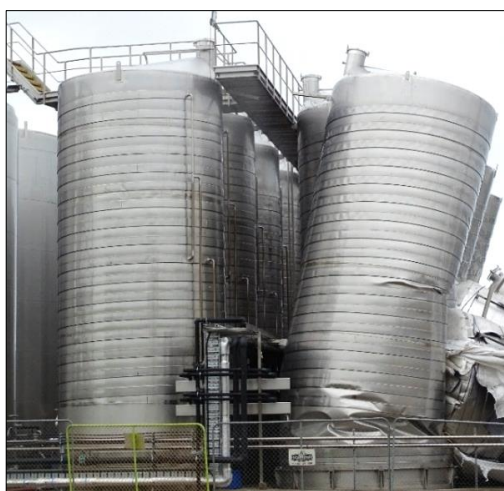
(c) Extreme buckling of tanks and pull out of catwalk support frames (0.23g hPGA)

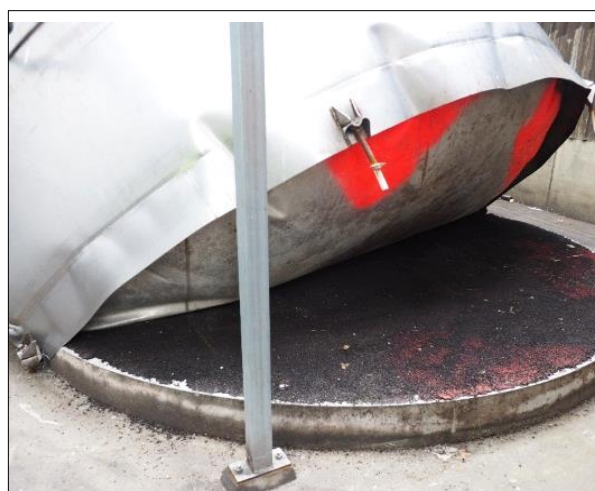
(d) Detail of the base and plinth of a collapsed tank

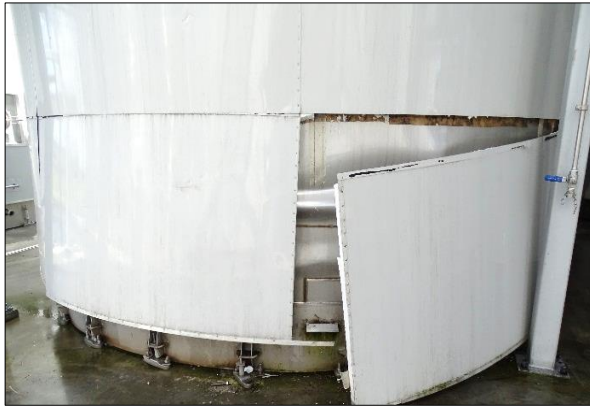
(a) Local buckling of the external insulation layer due to buckling of the tank walls

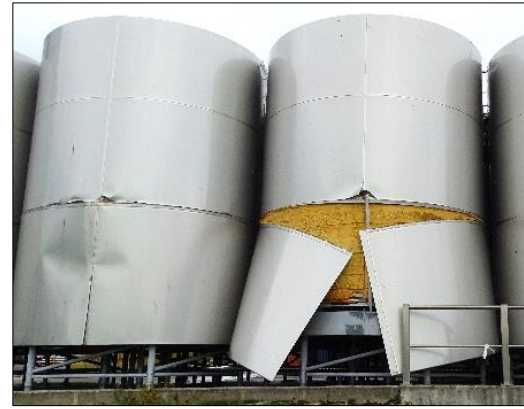
(b) Local buckling of external insulation and loss of layers (0.23g hPGA)
