PERFORMANCE OF WINERY FACILITIES DURING THE 14 NOVEMBER 2016 KAIKŌURA EARTHQUAKE

Dmytro Dizhur¹, Gye Simkin², Marta Giaretton³,
Giuseppe Loporcaro⁴, Alessandro Palermo⁵ and Jason Ingham⁶

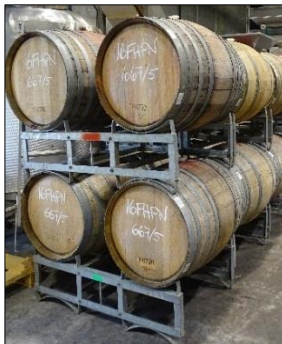
(a) Older racking system consisting of welded steel racks

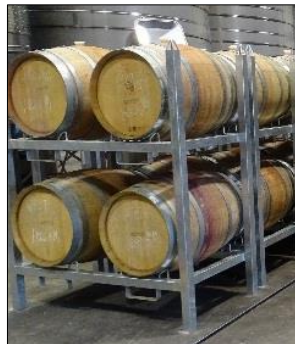
(b) New generation racking system showing no damage

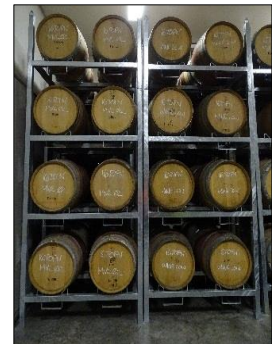
(d) New racking system with no damage but minor sliding at base (0.20g hPGA)

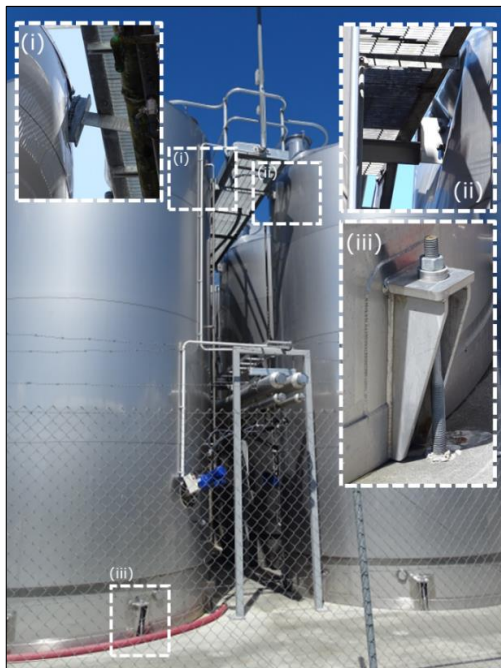
(a) Damage to catwalk connection due to tank movement

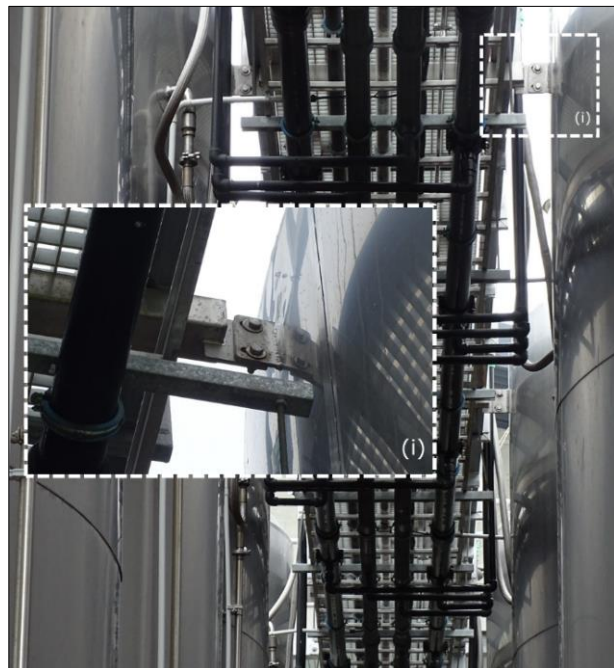
(b) No damage observed in 60 kL tanks where catwalks were well secured at base

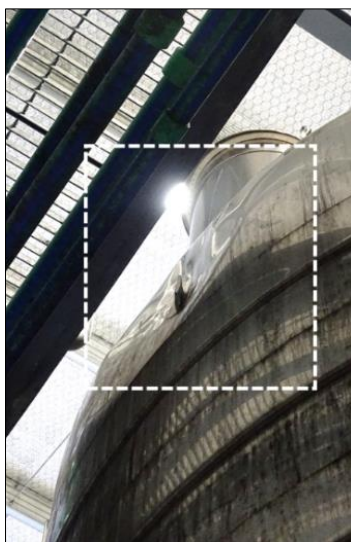
(a) Tank damage from catwalk punching

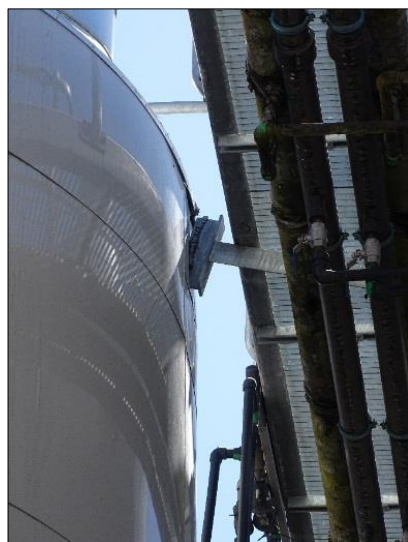
(b) Significant bending of catwalk connections

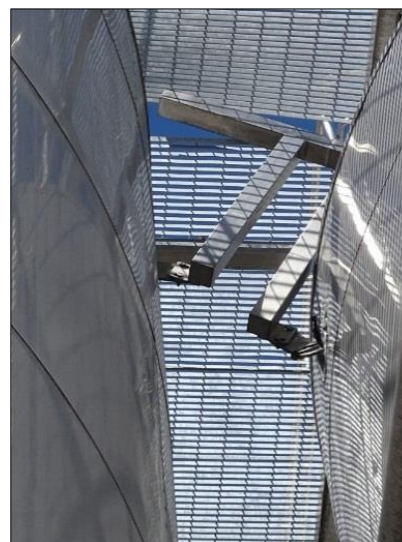
(c) Detachment of catwalk connections

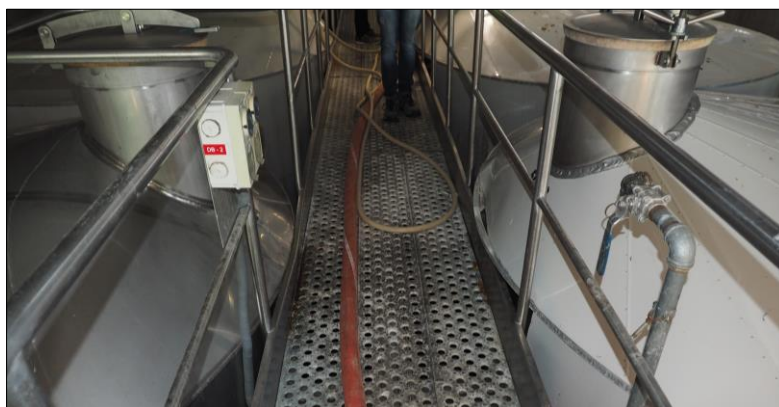
(d) Tank top cone damage due to catwalk
