# IMPACT OF THE KAIKŌURA EARTHQUAKE ON THE ELECTRICAL POWER SYSTEM INFRASTRUCTURE

## ABSTRACT

This paper summarizes the impact the 2016 Kaikōura earthquakes have had on electrical transmission and distribution infrastructure performance. It also provides background context to the distribution network operator's (i.e. MainPower's) prior earthquake preparedness following the 2010 earthquakes in the region.

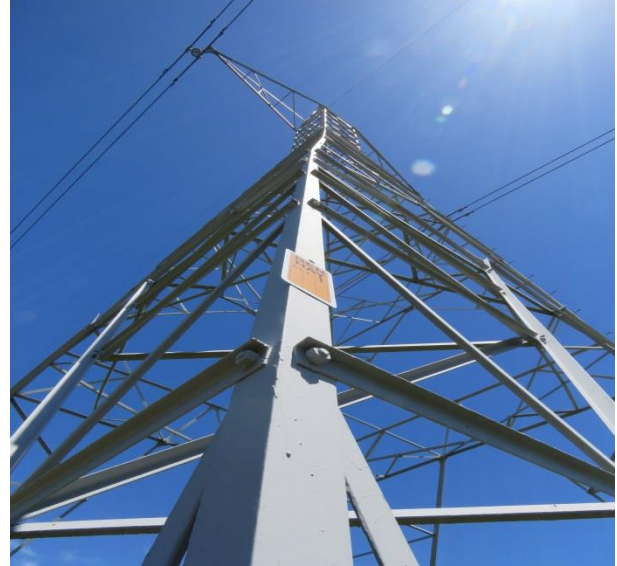
Transpower identified a tower on the HVDC line in Marlborough region north of Kaikōura that had earthquake damaged and needed replacement following the Kaikōura earthquake. One of the damaged legs of the HVDC line tower is shown in Figure 5. Figure 6 illustrate the face damage between two legs and Figure 7 shows multiple ground cracks between the HVDC tower legs.

*Figure 5: Leg damage of the HVDC Tower.*

Considering the location and the impact on the HVDC link, Transpower decided to use temporary tower poles and currently has plans for the construction of a new tower. Despite the need for replacement, the HVDC tower was not at immediate risk during normal conditions and it was decided that the tower should be kept under regular observation until replacement works were completed. As a consequence of this earthquake damage, the tower is more prone to further damage from larger aftershocks or extreme storms/winds. To accommodate this risk, Transpower changed the risk classification of the HVDC when unusually high winds are

The tower repair was completed on 21 January 2017 and the requirement to change the risk reclassification of the HVDC when unusually high winds are forecast was cancelled.

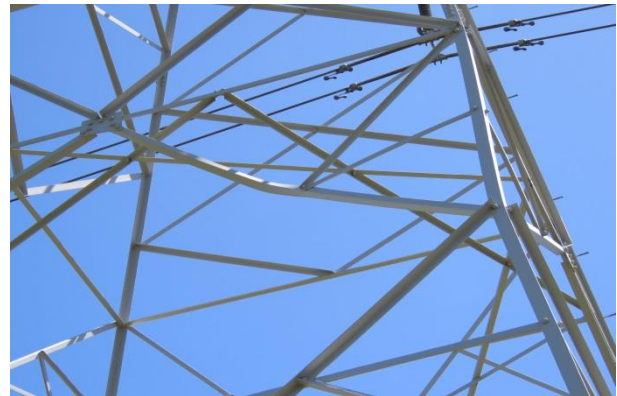
*Figure 6: Damaged face of the HVDC Tower.*

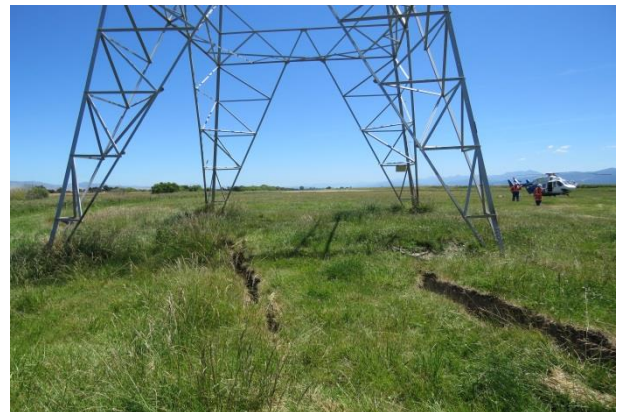
*Figure 7: Ground crack between legs of the HVDC tower.*

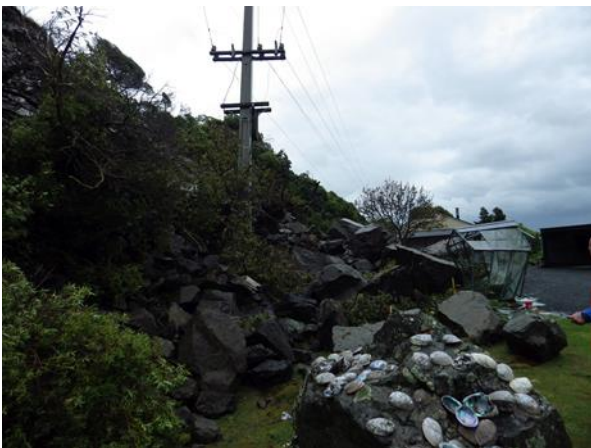
The earthquake damage to the lines south of the Waiau River was minor and most customers there had power restored by late afternoon of the 14<sup>th</sup> November. On the contrary, there was extensive damage to HV and LV lines in the vicinity of the Waiau town and Inland Rd to Kaikōura. As a result, 400 Waiau area customers were without power at the end of first day. Figure 8 shows a damaged 33kV pole in Oaro.

*Figure 8: Oaro 33kV pole damage.*

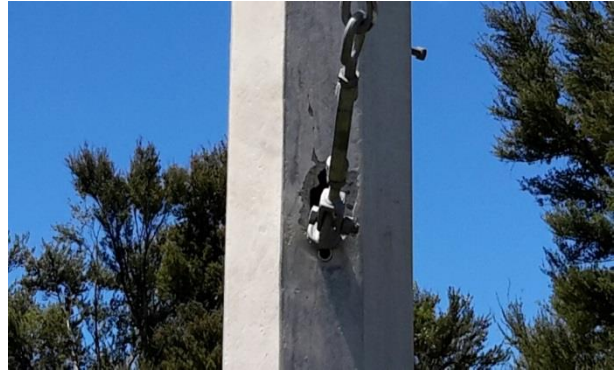
were affected. Figure 9 shows a cracked 66kV pole. The 33kV coastal link was patrolled by helicopter and power restored to the substation via 33kV from Waipara by 1 pm on the 14<sup>th</sup> November. The Inland Rd 66kV line was also patrolled with many poles with a substantial lean found.

*Figure 9: Cracked 66 kV pole.*
