# IMPACT OF THE DARFIELD EARTHQUAKE ON THE ELECTRICAL POWER SYSTEM INFRASTRUCTURE

Neville R. Watson

## SUMMARY

This paper gives a brief summary of the performance of the electrical infrastructure in the earthquake that struck Christchurch and surrounding regions on 4<sup>th</sup> September 2010.

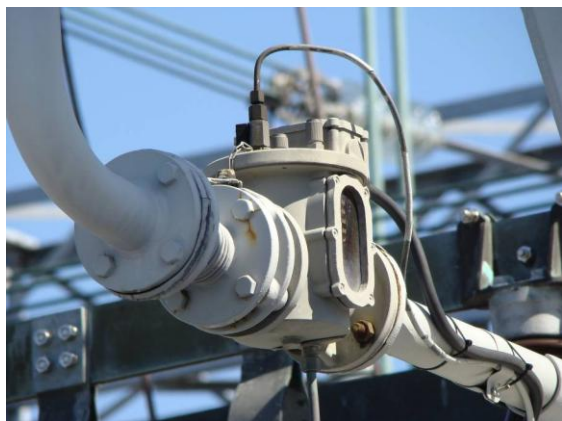
Protection relays, known in the industry as Buchholz relays (Figure 1), provide essential protection for transformers. The three conditions they detect are: gas accumulation, loss of oil and oil surges. When an electrical fault occurs within the transformer, gas forms rapidly causing an oil surge. Early Buchholz relay used mercury switches to detect surges.

Figure 1: Buchholz relay that is between the transformer tank and conservator.

Unfortunately seismic events caused the mercury to move and trip the transformer. Transpower subsequently installed seismic blocking devices to block the operation of Buchholz mercury switches during earthquakes. Buchholz devices have now been mostly updated over time to replace the mercury switches with reed switches which are less sensitive to seismic events. Buchholz devices also have baffles to minimise incorrect operation during seismic events but they can potentially operate for large surges caused by seismic events. Some Transpower transformers use mercury switches as part of over-temperature protection. The initial earthquake jolt resulted in some transformers tripping due to the mercury moving in their over-temperature protection devices. This

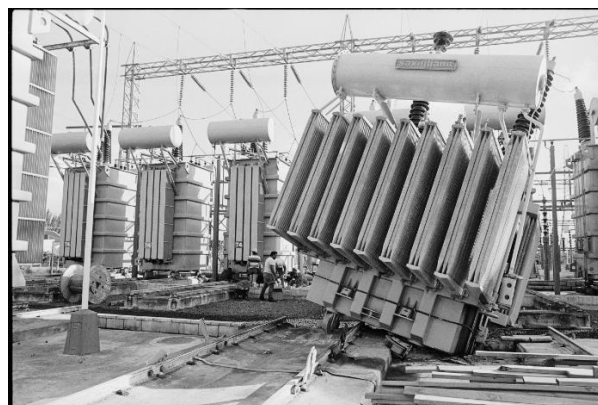
Figure 2: Workmen are dwarfed by a 20-tonne transformer toppled from its mountings at Edgcumbe substation. Photograph taken 4th March 1987 by Evening Post staff photographer John Nicholson (courtesy: Alexander Turnbull Library).

One lesson learnt from the Edgecumbe earthquake in 1987 was the need for seismic restraints on the transformers (see Figure 2). These have been fitted to transformers, as shown in Figure 3, and ensured no transformers toppled off their foundations. This was true for both Transpower and the Lines companies. The use of flexible cables rather than solid conductors to make connections between the busbars and substation equipment also allows some flexing without breakage.

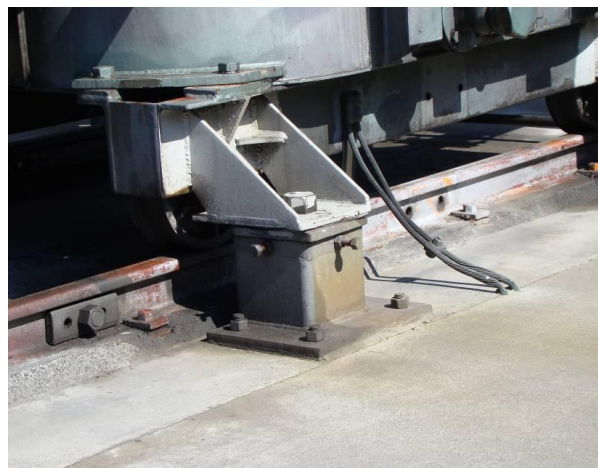
Figure 3: Seismic restraint on transformers (Papanui Substation).

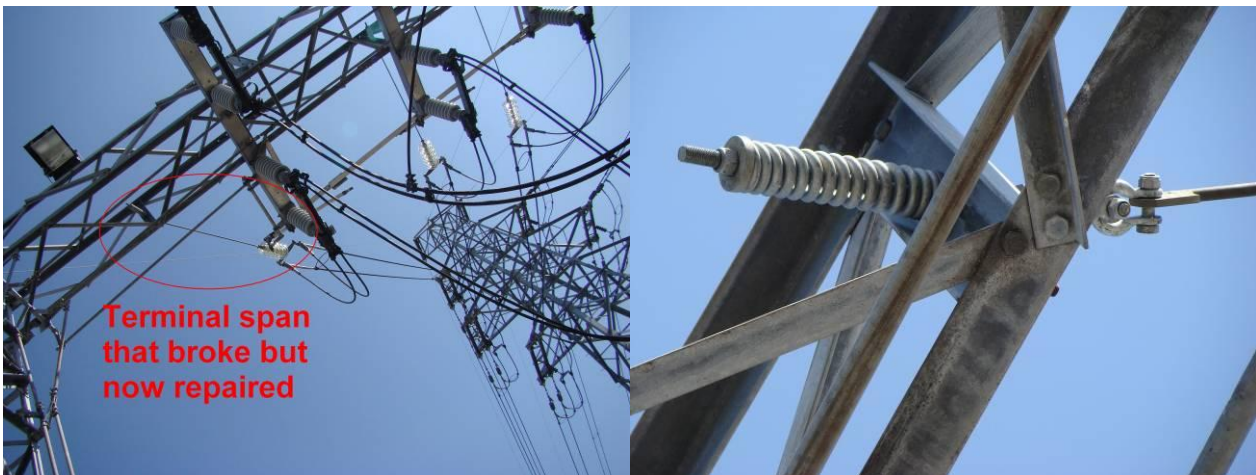
Figure 4: Terminal span Islington-Papanui.

(a) Terminal span showing Phase that failed

(b) Spring tensioner on terminal span

Although the ground movement has displaced some pylons 3 to 4 metres the HV overhead transmission lines were reasonably resilient, with only one terminal span breaking and a tripping of the other circuit on the pylon. This caused the loss of supply from Transpower's Papanui GXP to Orion. Even though anchoring of one phase of a terminal span broke, the conductors stayed attached. Figure 4(a) shows the terminal span that broke while Figure 4(b) shows how the terminal span is connected via a spring tensioner. Figure 5 shows evidence of fault rupture near a HV pylon. The movement has resulted in extra stresses on conductors and towers.

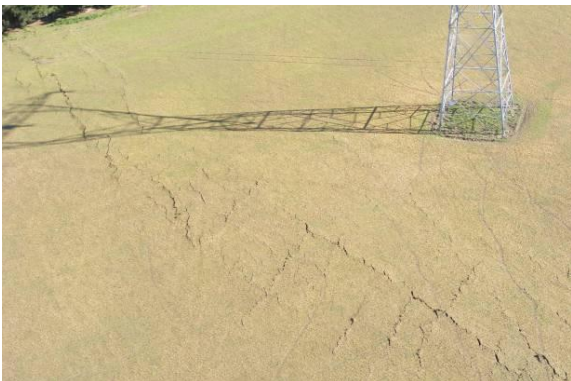
Figure 5: Fault rupture near a 220 kV pylon.

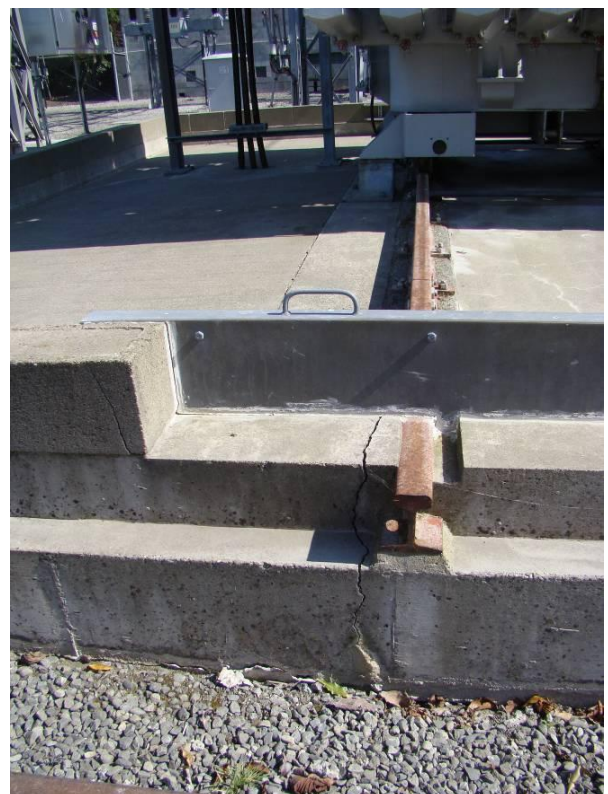
Only minor damage occurred at most of Transpower's substations (cracks, broken windows, loose items falling), with the base of one surge diverter breaking at Islington. At Papanui substation, liquefaction occurred and the transformer bunding moved and in one case cracked (shown in Figure 6). Bunding is a containment system so that if a transformer leaks

Figure 6: Crack in the bunding (Papanui Substation).

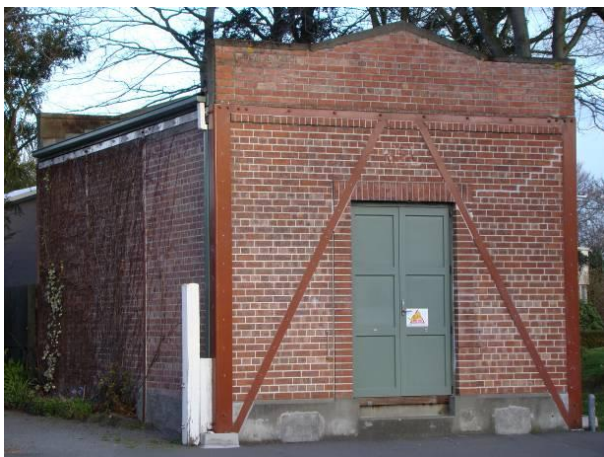
**Figure 7: Zone substation with seismic strengthening.**

Orion has been actively pursuing a policy of earthquake (and storm) hardening their electrical network. Zone substation transformer foundations have been reviewed and upgraded as necessary (with oil containment) and the many network centre building substations in urban Christchurch (many using old brick construction) have been strengthened. An example of seismic strengthening is shown in Figure 7. Pole mounted structures/transformers have been reviewed and upgraded as necessary to withstand earthquakes. The result of this work was that only a few major Orion substations were affected by the earthquake, and these occurred where there was significant ground and/or foundation movement. None of these affected the immediate operational capacity of the network.

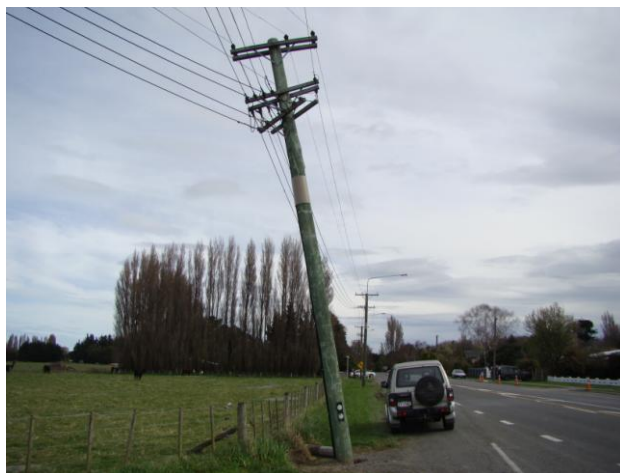
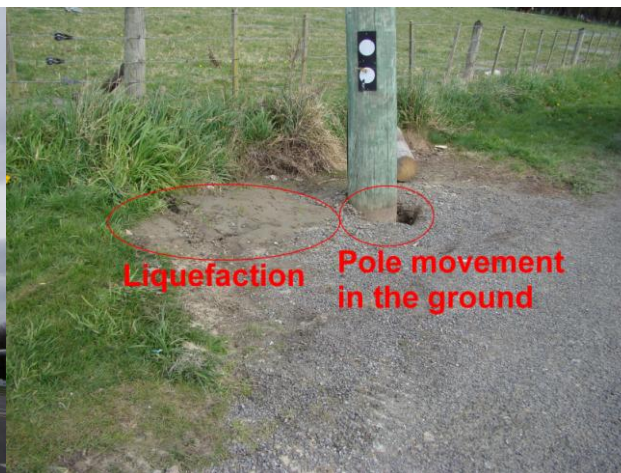
**Figure 8: Lean on Pole due to liquefaction (Halswell).**

and conductors which damaged insulators and broke some weaker/smaller conductors, especially those made of copper. Land movement and liquefaction have caused some poles to lean but in most cases did not cause an interruption of supply. The earthquake has left some poles leaning (see Figure 8), putting more tension on some spans and making others slacker, but the system kept operating remarkably well.

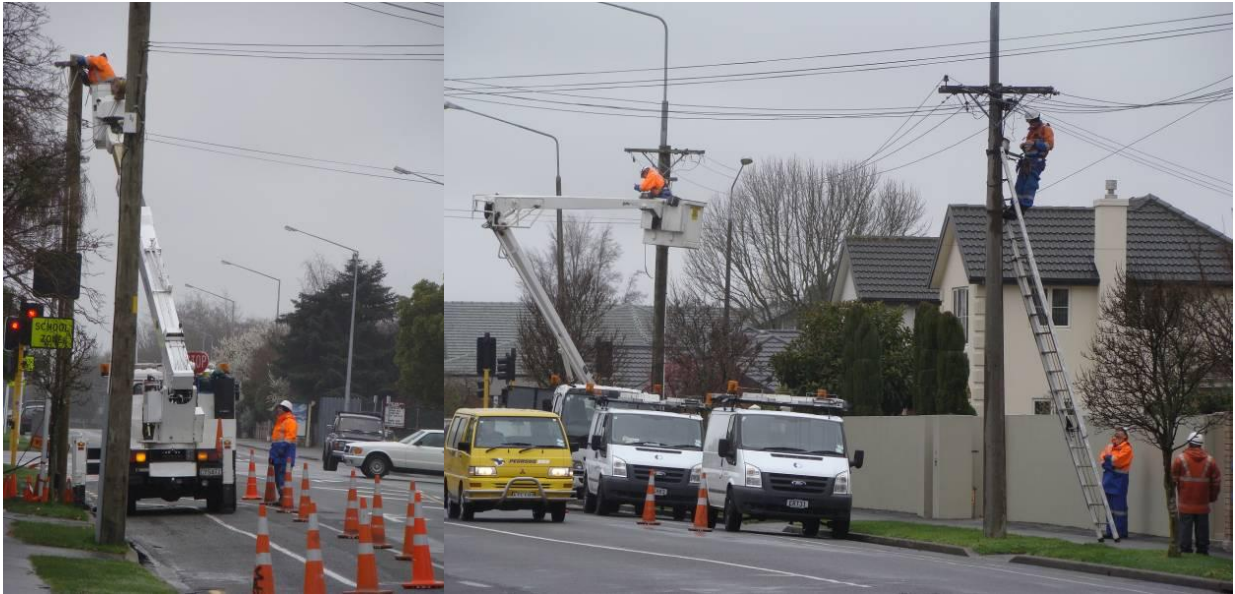
As expected MainPower's major damage has been due to land movement from liquefaction. The overhead network generally stood up well and was repaired very quickly. Initial faults were due to conductor clashes, poles leaning severely, two 100 kVA transformer poles tipping over at Kairaki Beach, conductors off insulators, and EDO (Explosive DropOut) fuses being broken. Most overhead areas had power restored on the 4<sup>th</sup> September with the remainder on the following day. A number of heavy poles e.g. concrete poles and wooden transformer poles, sunk significantly requiring immediate or short term rectification. There will be ongoing work for the next few months straightening and repositioning lines in areas of significant ground movement but this will not affect availability other than for short planned outages required for the work. Reliability in high winds will have been compromised until this work is completed, and some ground clearances are reduced.

*Figure 9: Linesmen at work repairing overhead lines (10 September 2010).*
