AGRICULTURAL LAND REHABILITATION FOLLOWING 2010 DARFIELD (CANTERBURY) EARTHQUAKE: A PRELIMINARY REPORT

SUMMARY

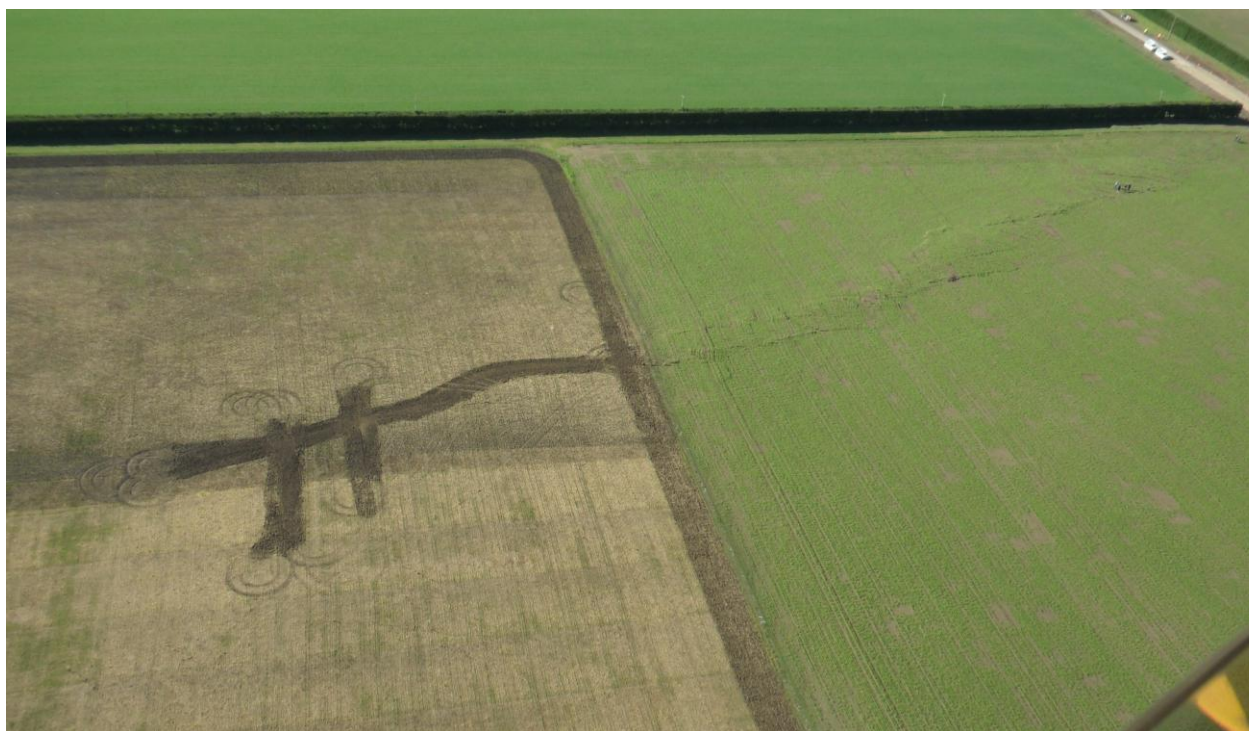
The main impact to agricultural operations was the ~1 m high fault scarp, and fracturing associated with the vertical and horizontal displacement of the ground. Fractures were sub-parallel and oblique to the fault trace. In areas of unmodified fault scarp, subsoil fractures had partially in-filled from collapsed gravel subsoil and topsoil two weeks after the earthquake. This process is continuing at the time of writing

Figure 2 : *Early cultivation of the Greendale fault. Several passes with roto-crumbler cultivation has been used in the left paddock; whilst the paddock on the right shows the unaltered surface rupture.*

Interviews on 11-12 September with farmers in the central zone indicated deep cultivation across the scarp (ploughing and/or rotocrumbling to 400 mm), followed by rolling was sufficient to close fractures and reduce the contour to allow normal farming practice. Where fractures were deep and persistent, subsoiling to disturb the gravels (300-800 mm depth) followed by rolling were sufficient to mitigate this.

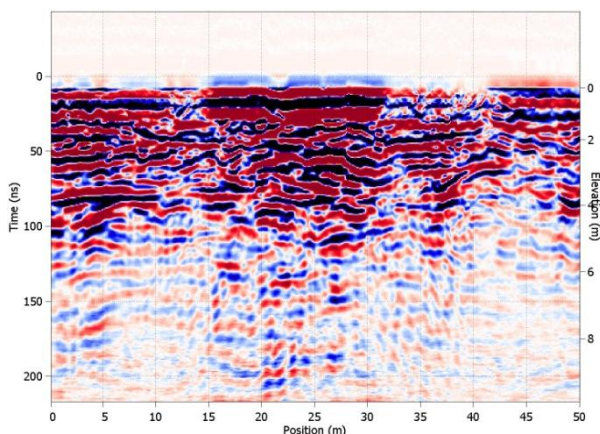
A further GPR survey was made of a section of fault scarp close to Courtenay road prior to heavy cultivation with an implement used commonly for conversion of forestry land to dairy pasture. This was to assess the implement's effectiveness and to directly compare GPR profiles of the same transect immediately before and after cultivation; which was a limitation of the previous profiles. Comparison of the before and after GPR profiles showed fractures and voids in the top 2 metres were mostly filled or closed, but voids beyond 2 m depth were not substantially modified (Figure 3). The cultivation significantly reduced the micro-topography of the fault scarp (by up to 0.5 m) and infilled fractures resulting in an acceptable surface for normal farm practices, especially when followed by Cambridge or heavy rolling. For the voids which remain at depth, we anticipate the gravels will eventually fill them in over time, without significant subsidence at the surface. Observations of the rehabilitated land in late October 2010 indicated no noticeable subsidence in the fault rupture zone. GPR surveys are planned for March 2011 to track the behaviour of the voids.

Figure 3: *Migrated difference between pre- and post-cultivation of fault scarp GPR profiles (0.10 m/ns) at Courtney Road site. GPR profiles were 500 V and use spreading and exponential compensation (SEC) gains, with a maximum gain of 150 and attenuation of 1 dB/m.*

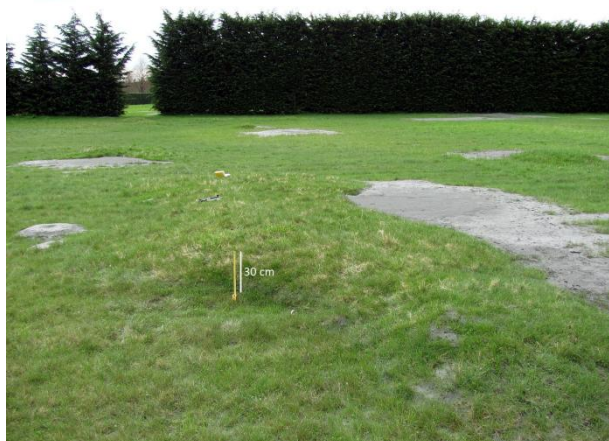
Blisters, while not immediately reducing pasture production, needed to be removed in order to produce a suitable microtopography for harvesting machinery. The blisters were sufficiently steep and high that tines and plates on bailing equipment would catch on them and get bent. Our pits showed that the sand inflating the blisters was generally injected into the boundary between the topsoil and the subsoil where the density of roots decreased (Figure 5). We found that two passes of a rotary hoe followed by two passes with power harrows completely removed even the largest blisters (Figure 6). Across the crest of the blisters much more topsoil was removed and cultivated layer had a much larger component of ejected sand mixed in with it; so much so that in places the topsoil re-liquefied with the vibration caused by cultivation. However, we found that within two days the materials had dried out sufficiently to have solidified.

Figure 4: A liquefaction blister, ~300 mm high. The ejected liquefaction sediment to the right of the blister was caused by excessive extension of the topsoil, causing the blister to 'burst'.

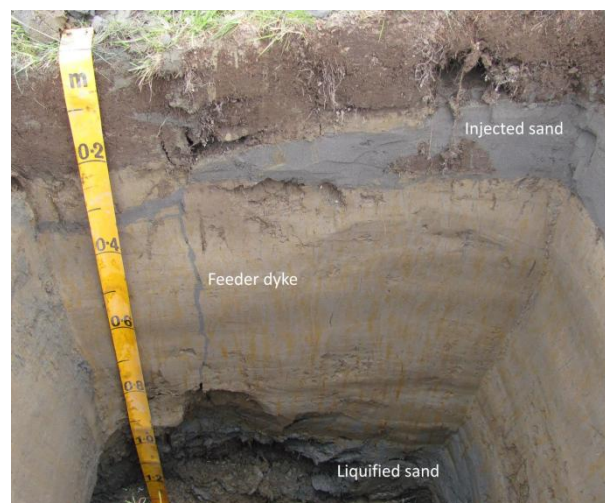
Figure 5: Soil pit exposure of a liquefaction blister. Blue-grey sand has been injected beneath the topsoil, inflating the ground surface. Note the feeder dyke from the liquefied sand beneath the water table.

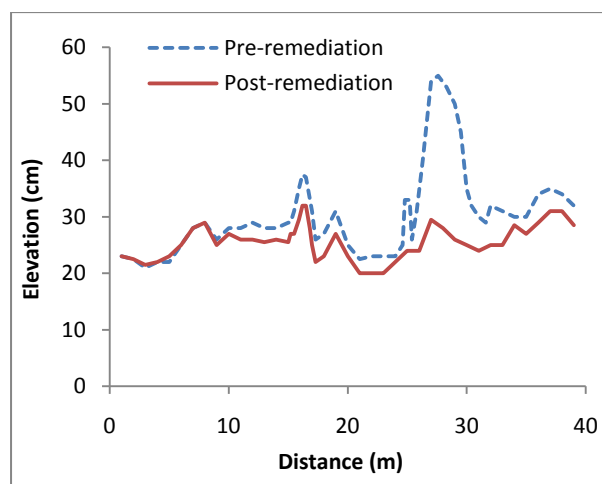
Figure 6: Topographic surveys of 'blistered' land before and after treatment by rotary hoeing and power harrowing.
