SEISMIC PERFORMANCE OF REINFORCED CONCRETE BUILDINGS IN THE 22 FEBRUARY CHRISTCHURCH (LYTTELTON) EARTHQUAKE

Weng Y. Kam¹, Stefano Pampanin², Ken Elwood³

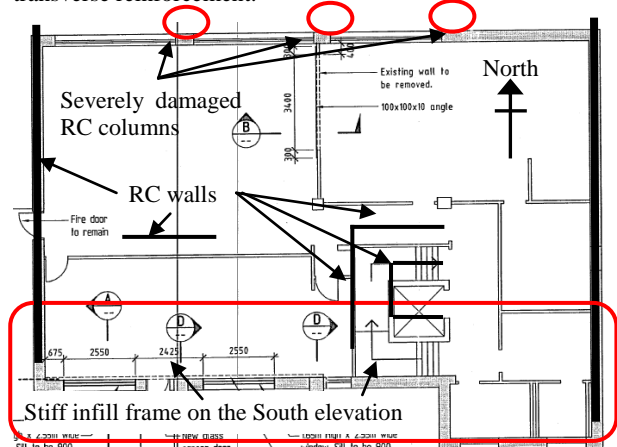
Plan irregularity and column shear failure: Figure 9 and Figure 10 show a 4-storey 1950s RC frame-wall building with severe columns damage on the Northern frame. The building is reinforced with plain round bars. As seen in Figure 10, the columns, which failed in shear, have almost negligible transverse reinforcement.

Figure 9: Plan stiffness eccentricity due to stiff infill frame and internal RC ‘non-structural’ RC walls.

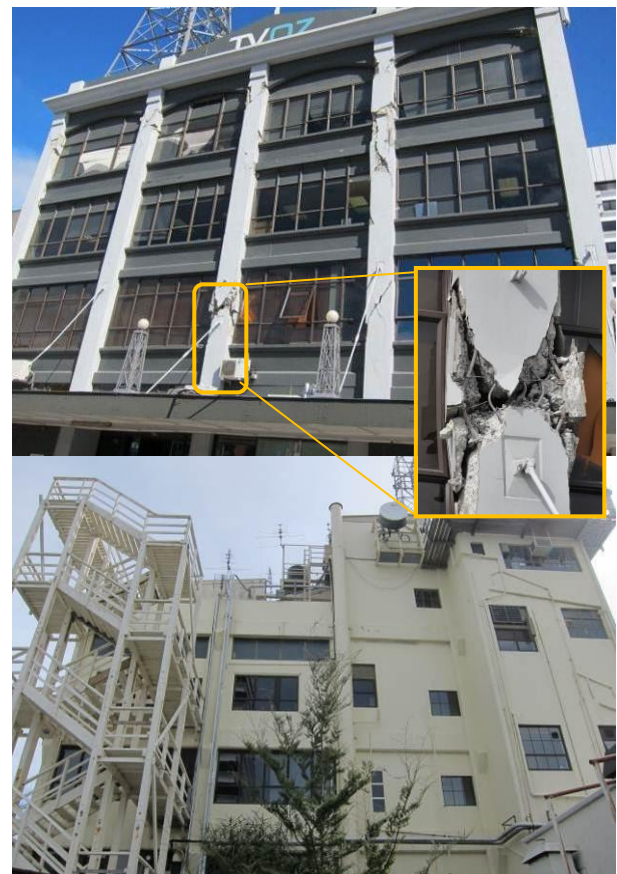
Figure 10: Severe column shear failures of the front (North) façade frame of a 4-storey RC frame-wall building.

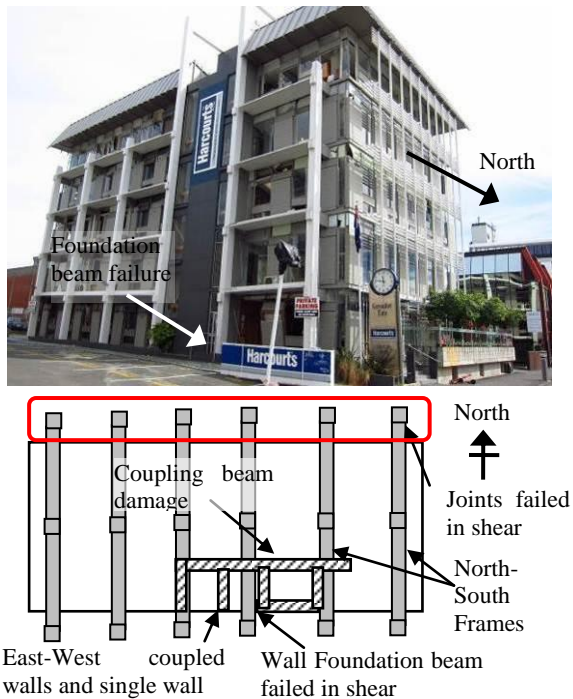
Foundation beam, coupling wall and joint shear failure: Figure 11 and Figure 12 show a 5-storey RC frame-wall building with multiple elements failing in brittle behaviour. It comprises six one-way RC frames in the North-South direction and several coupled- and single RC walls acting predominantly in the East-West direction.

Figure 11: Pre-1970s RC frames-walls building with multiple elements experiencing a brittle failure mode.

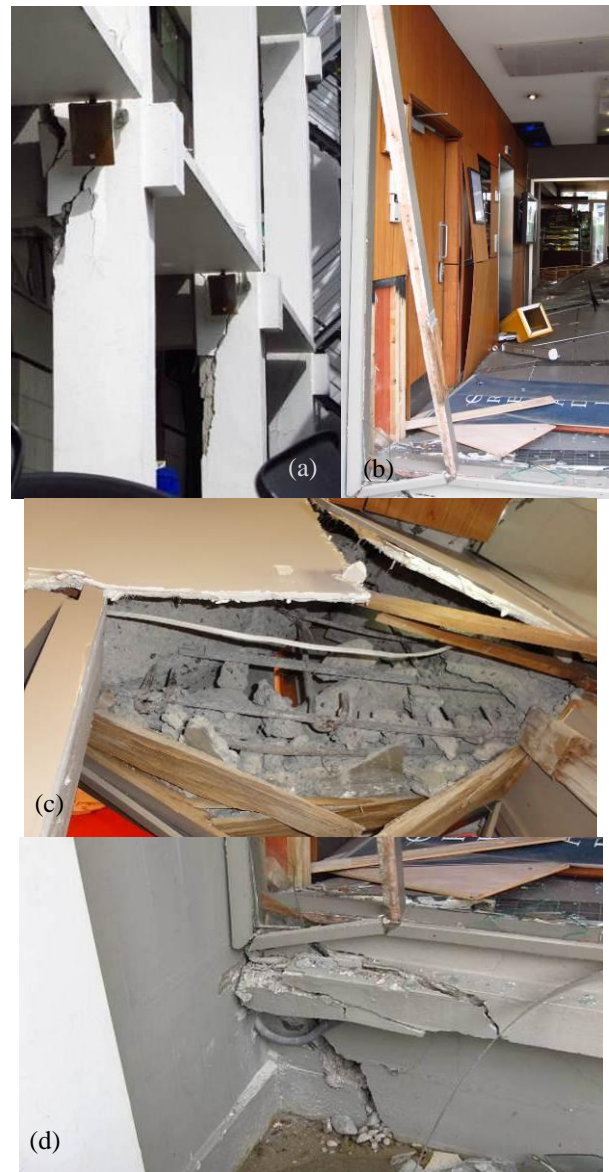
The lateral resisting system in the East-West direction appears to be severely damaged. The coupled walls in the internal grid line had severe damage on its coupling beams at the lower three storeys (Figure 12c). The coupling beams are lightly-reinforced with plain round bars. The foundation underneath the core walls around the lift-shaft appears to have failed and dropped approximately 400 mm (Figure 12b). One of the foundation ground beams was observed to have failed in shear with evidence of liquefaction observed in the vicinity of the foundation beams (Figure 12d).

It is likely that the RC frames resisted a significant portion of the lateral load in the North-South direction and torsional load from the East-West shaking. The failure of the walls system and foundation beam in the East-West direction and the vertical drop of these core walls also ‘dragged’ the RC frames inward, resulted in shear-failure of the beam-column joints as the frames deformed inwards. The unreinforced beam-column joints developed the highly brittle shear-wedge mechanism.

Figure 12: Pre-1970s RC frame-wall building: a) Exterior joint shear failure ; b) Approximate 400mm drop of the RC walls; c) Coupling beam failure; d) Shear failure of the foundation beam.

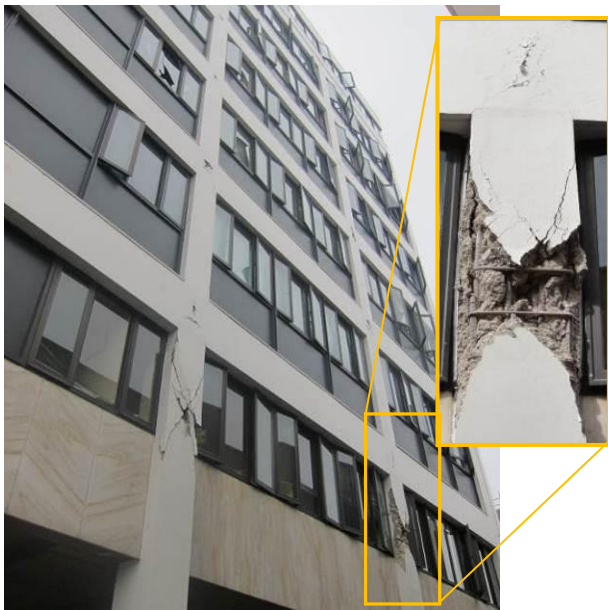
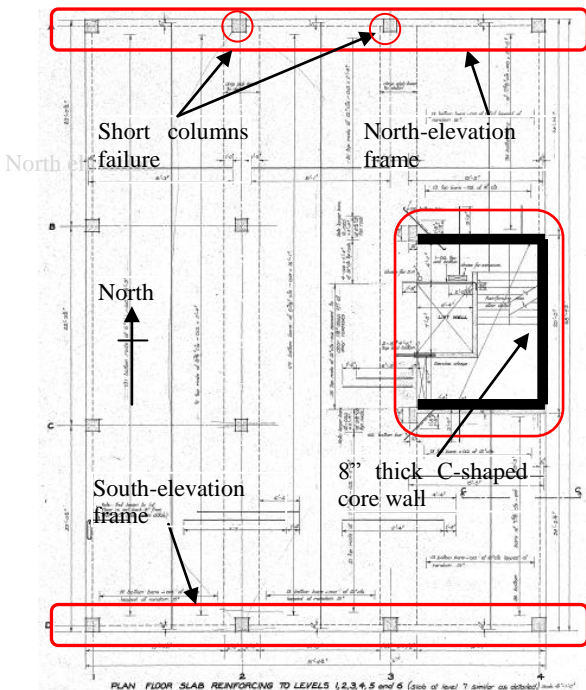
Short column and joint shear damage of an early 1970s building: Figure 13 shows an 8-storey 1973 building of two-way RC frames with a C-shaped core-wall structural system. Typical 457 mm square columns are reinforced with 12 distributed D28 (28 mm diameter deformed) longitudinal bars and D10 stirrups at 230 mm centres. The beam-column joints are reinforced with 1-2 stirrups. The C-shape wall is

The first floor columns on the North elevation failed in shear with the upturned spandrel beam creating a short-column effect. In both Northern and Southern elevation frames, the beam-column joints were cracked with limited spalling. No apparent damage of the shear-core wall was observed.

By most accounts, this early 1970s RC building has performed reasonably well despite the onset of the brittle failure mode in the columns. The redundancy provided by the dual frame-wall systems ensures the building remains standing despite the onset of brittle failure of the East-West perimeter frames.

The core wall did not seem to resist a significant amount of the seismic inertial forces. Relative minor cracks were observed within the core walls. The diaphragm area (~4.5 m x 2 lengths) tied into the core wall is limited by the voids within the core and the location of the walls.

Figure 13: An 8-storey building with two-way RC frames system had a mix of column and beam-column joint shear failures.

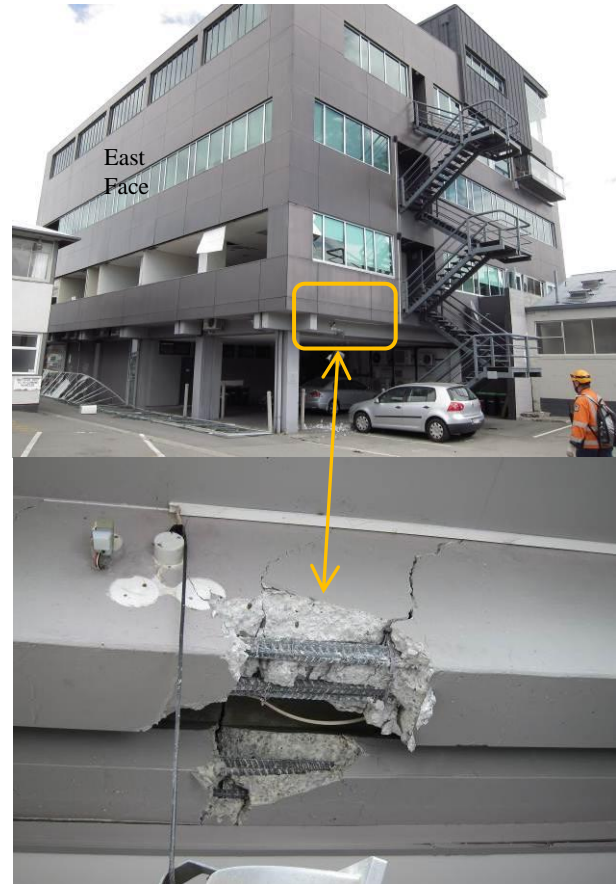
Beam lap-splice failure: Figure 14 illustrates the typical damage sustained by a 5-storey 1967 RC frame building (plan view shown in Figure 15). The building comprises six two-bay RC frames in the East-West direction and three five-bay RC frames in the North-South direction.

Figure 14: Ground floor beam lap-splice failure.

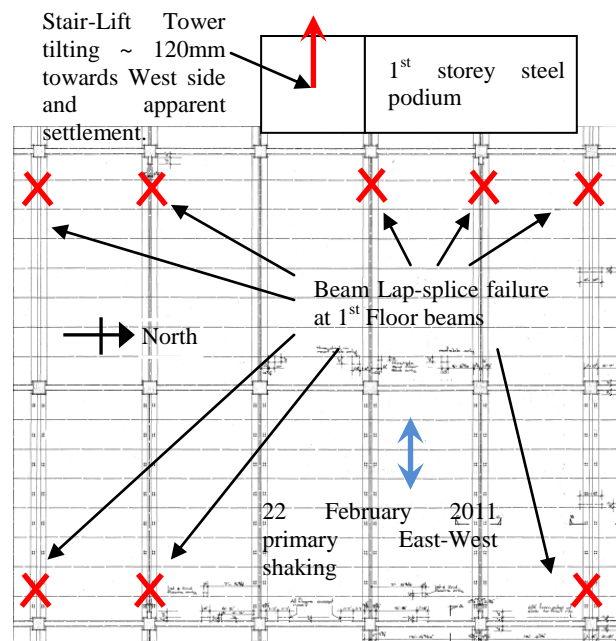
Figure 15: 5-storey RC frame building built in 1967 with beam lap-splice failure.

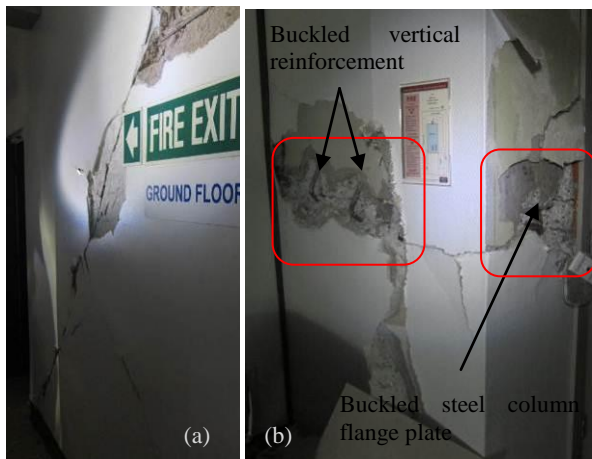
Figure 16: Typical shear and flexural failure of RC walls in buildings built prior to the 1970s.

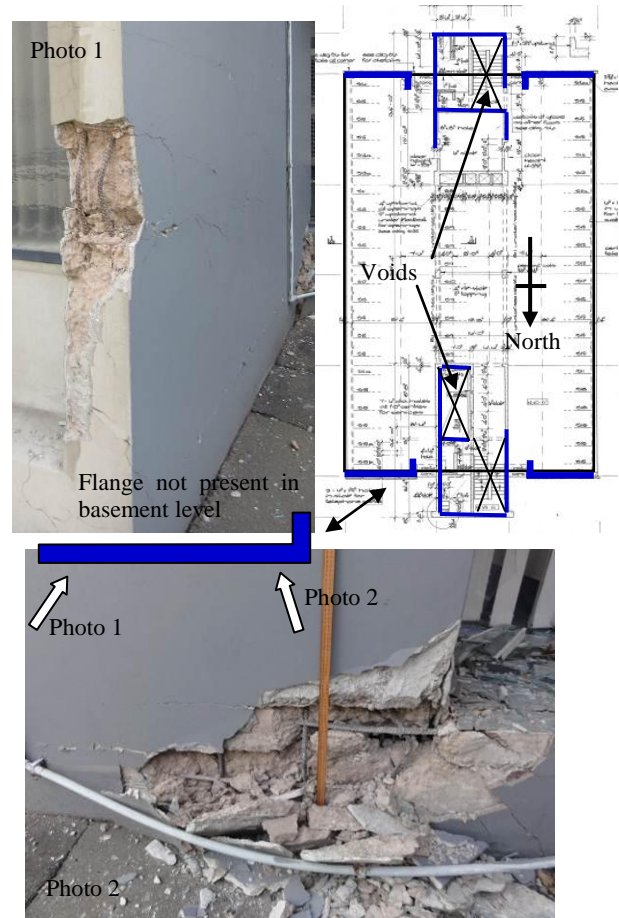
Figure 17: Wall boundary compression zone crushing and buckling failure.

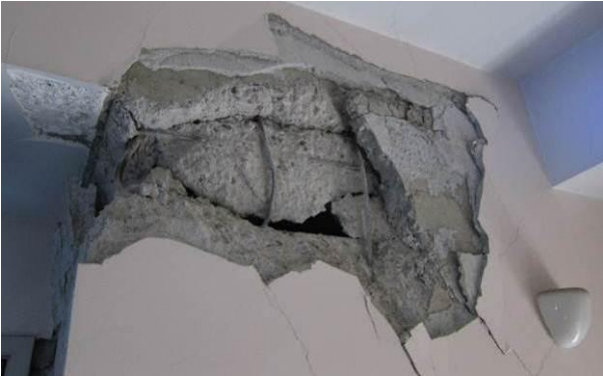
Figure 18: *Compression zone failure of pre-1970s RC walls. Photo is taken from the ground floor wall of an early 1960s 9-storey RC building.*

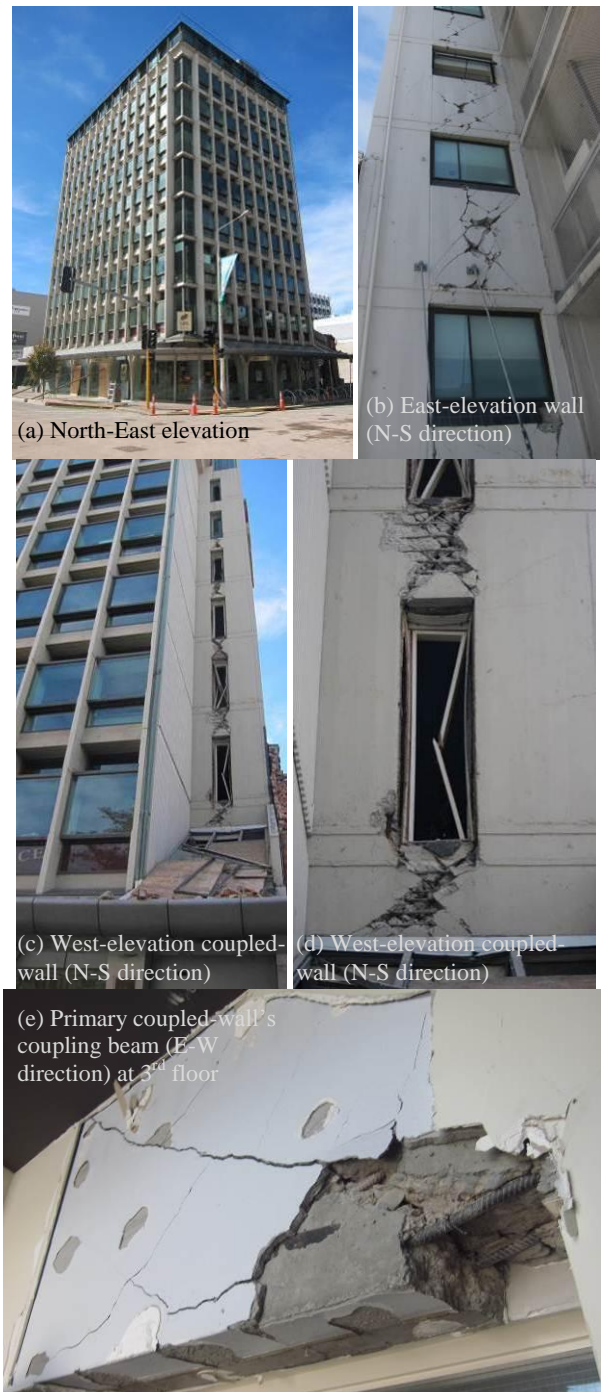
Figure 19: *a) Seven-storey 1960s coupled-RC walls building with significant damage on the coupling beams. b) Shear walls damaged at East elevation; c-d) Coupled-wall damage at the West elevation; e) Damaged coupling beam at the internal coupled-walls (East-West direction).*

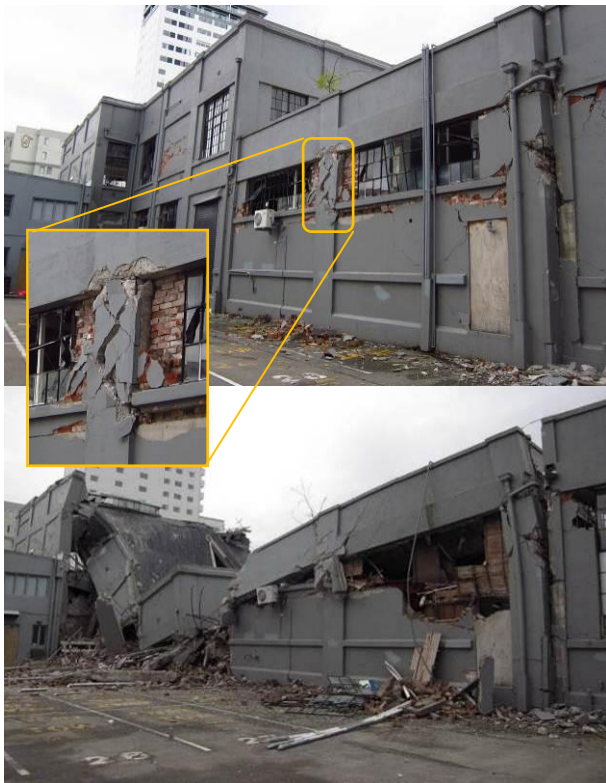
Figure 20: Reinforced concrete frame buildings collapse/damage patterns: Pre-1930s three-storey RC frame with masonry infill a) Survived the 22 February 2011 M_w 6.2 earthquake; b) Collapsed after the 13th June M_w 6.0 aftershock; insert: short column failure.

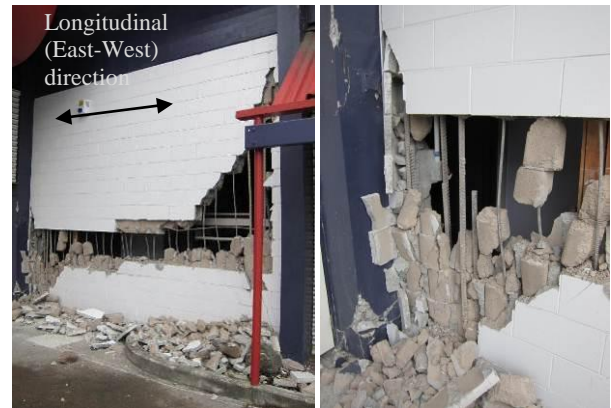
Figure 21: Flexural-shear damage of a RC masonry infill wall within two-storey RC frames.

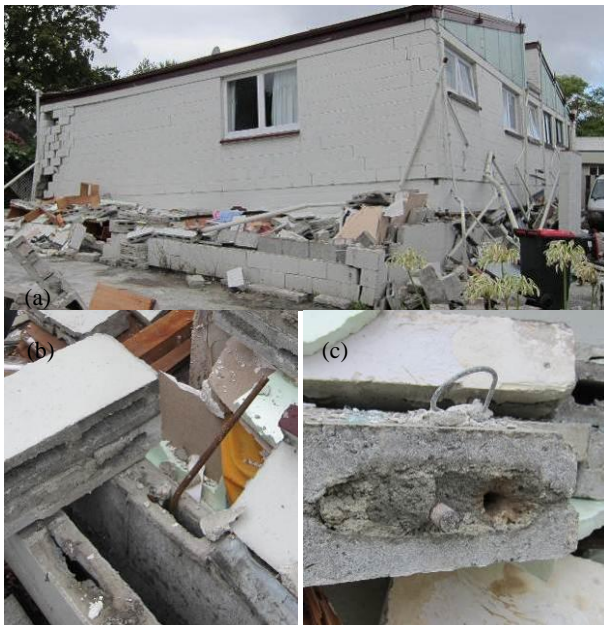
Figure 23: a) Soft-storey collapse of a 2-storey residential RCM building. (b-c) Anchorage pull-out failure of the lapped vertical reinforcement.

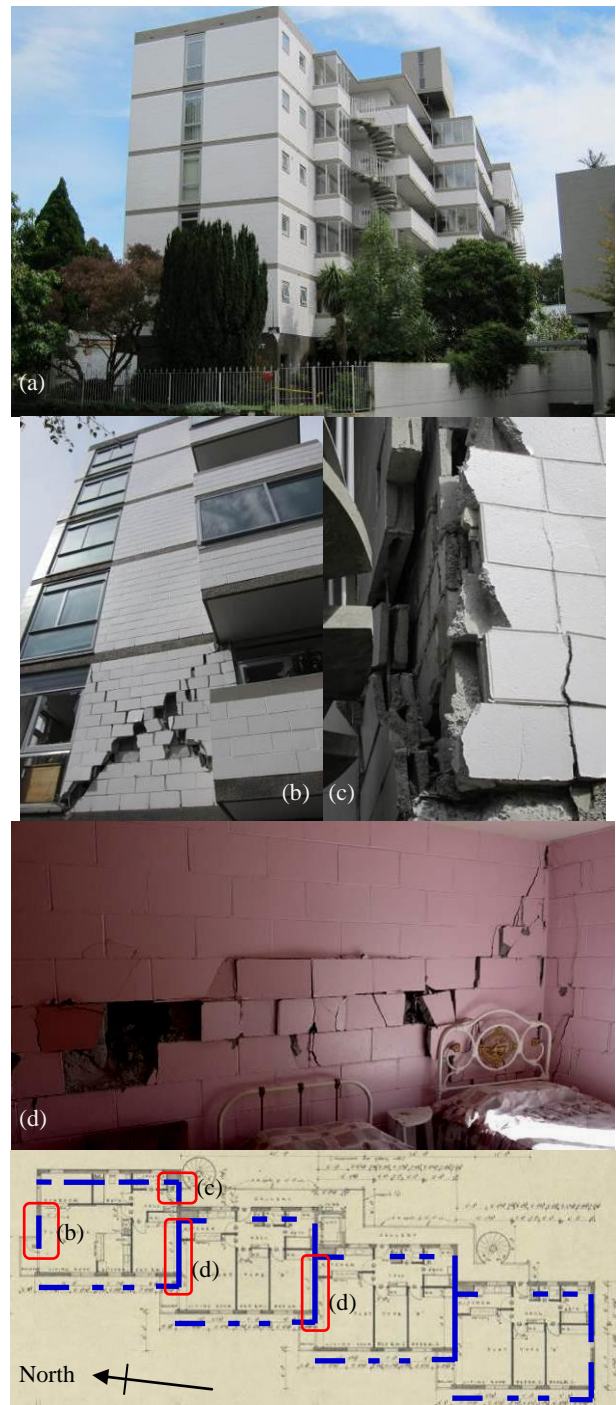
Figure 24: Typical shear and compressive failure of reinforced concrete masonry walls construction.

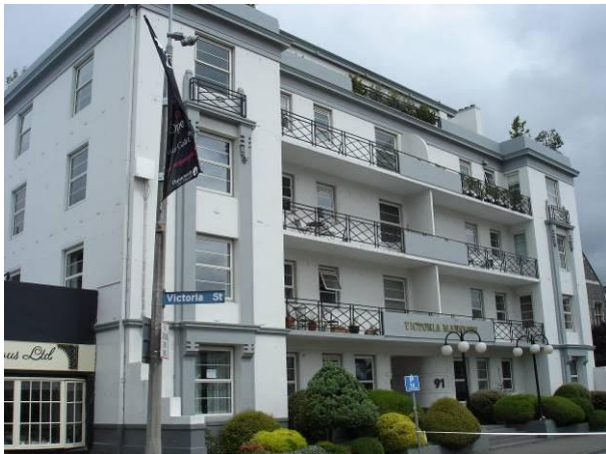
Figure 25: a) 4-storey Victoria Mansion (1935), with RC walls or possibly RC frame with infill walls, had limited structural damage; (b) 4-storey RC frame/wall National Bank / Isaac House (1926) showed limited cracking and damage from preliminary inspection.

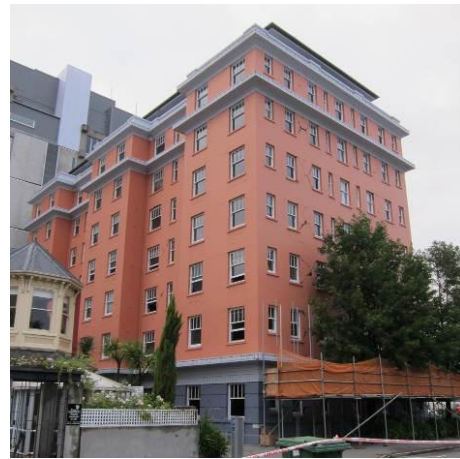
Figure 26: The 8-storey St Elmo Courts (1935) suffered heavy masonry infill walls damage.

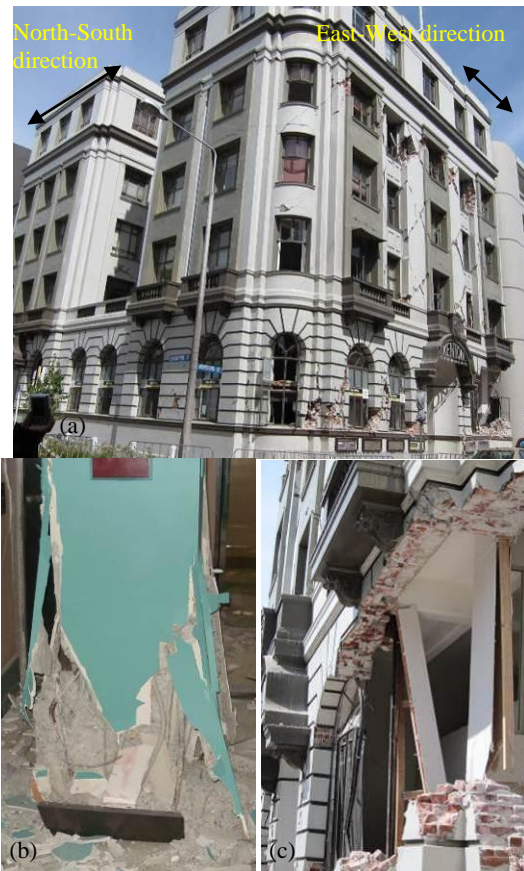
Figure 27: The 6-storey Kenton Chambers (1929) with perimeter URM walls and interior RC frames.

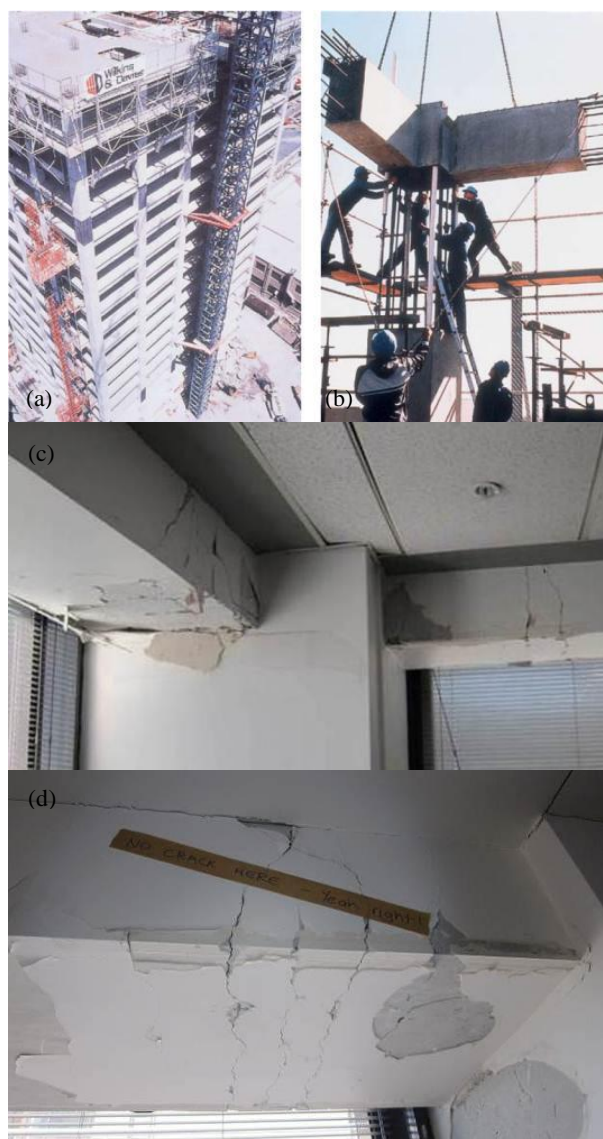
Figure 28: *Post-1970s RC moment-resisting frame buildings collapse/damage patterns: a-b) 22-storeys precast concrete frame building under construction; c) Two-way plastic hinging on 5th floor of a 22-storeys office tower; d) Beam plastic hinge mechanism occurred in both the 4 September and 22 February earthquakes.*

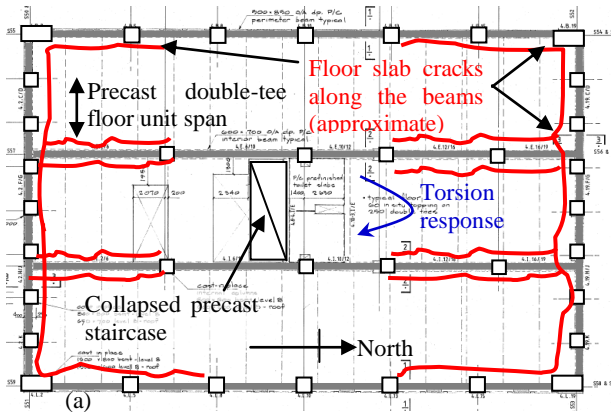
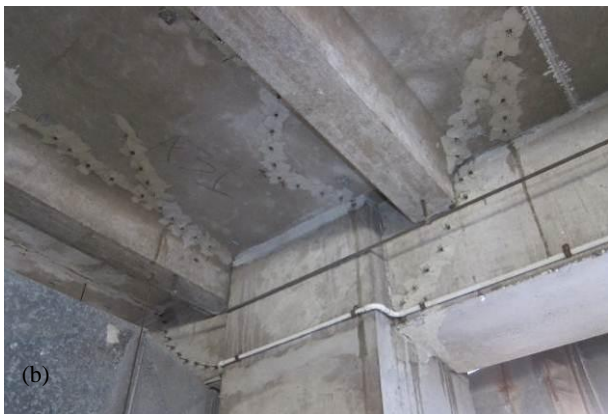
Figure 29: Ductile RC perimeter frames building with beams hinging, floor slab damage and collapsed precast staircase at upper levels (8th to 11th floor). Photo (b) is showing the crack repair done after the 4 September earthquake.

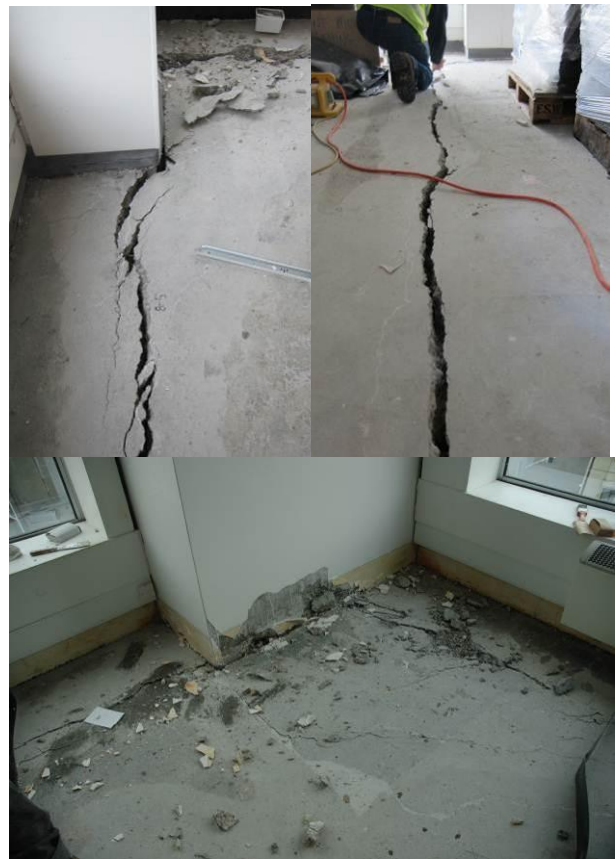
Figure 30: Extensive damage of floor diaphragm and loss of floor support for building in Figure 29 due to the beam-elongation effects of concrete frame inelastic response.

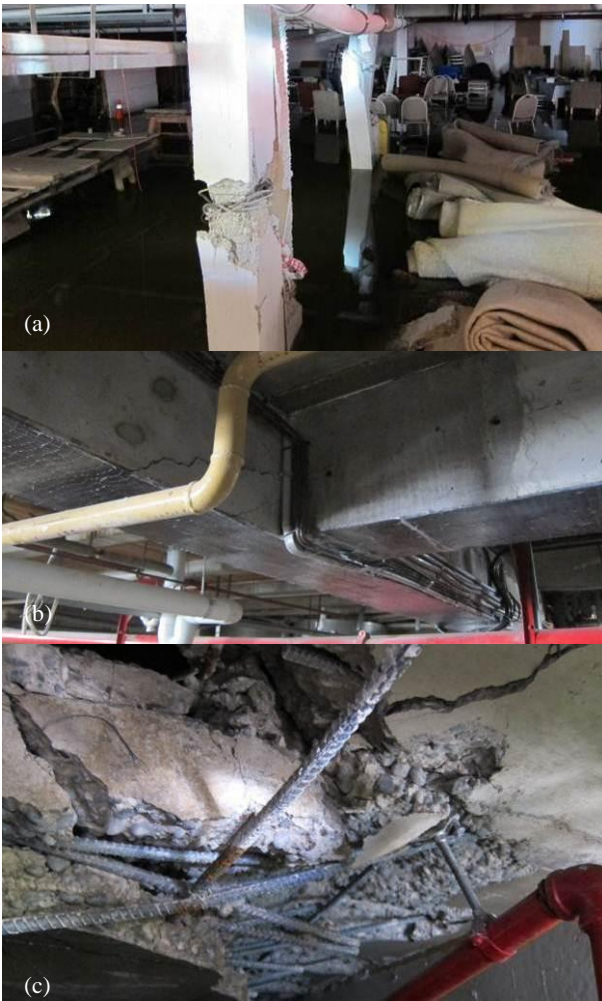
Figure 32: Vertical irregularity resulting in (a) severe basement columns shear-axial failure; (b) transfer beam repair and damage; (c) Ground floor transfer slab failure.

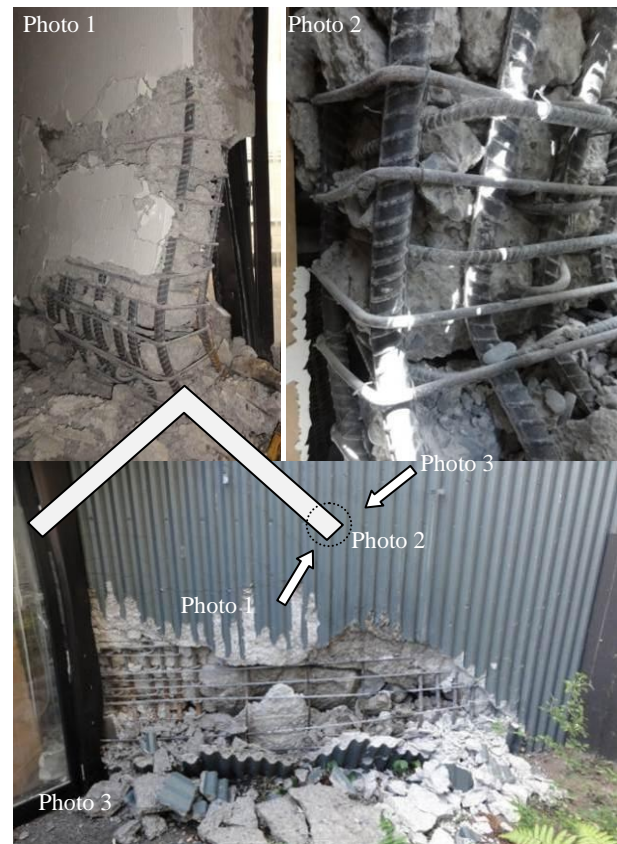
Figure 33: Seven-storey 1980s office block with significant compression failure of the V-shaped RC shear wall.

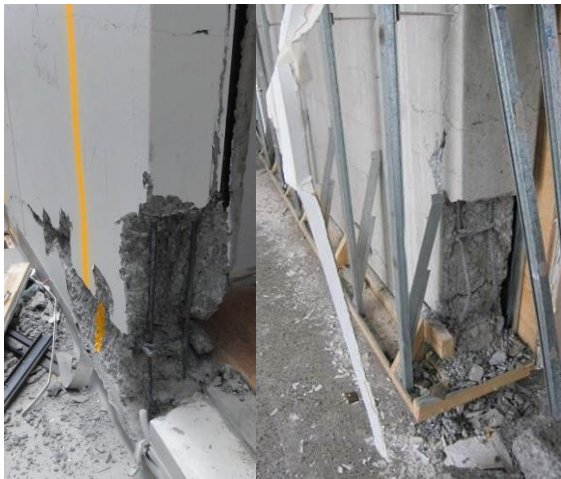
Figure 34: Bar buckled and fractured in lightly reinforced slender RC shear wall: a) North-South Wall; b) East-West Wall.

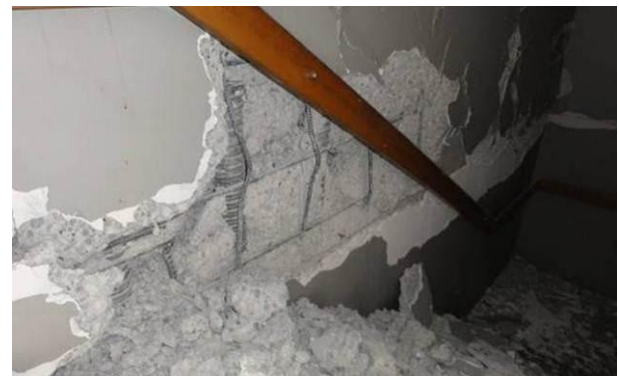
Figure 36: Failure of unconfined grouted duct splice for longitudinal bars of precast concrete walls.

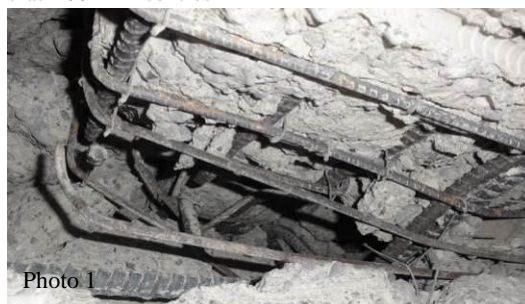
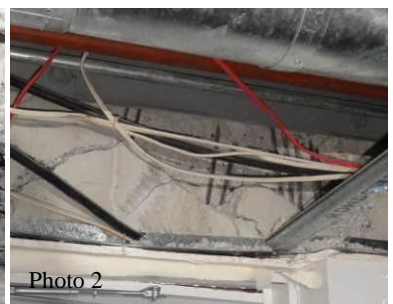
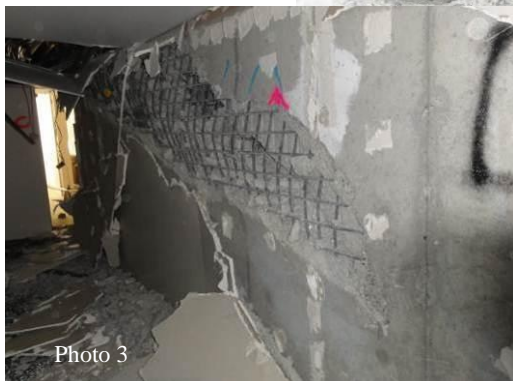
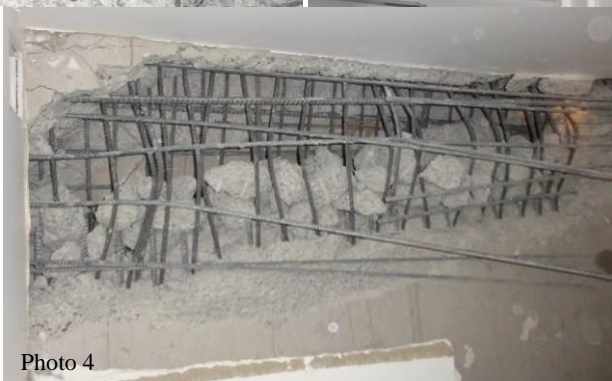
Figure 35: Boundary bar fracture and slender wall shear-axial failure in the Ground Floor of an 8-storey plus basement residential apartment building built in the 2000-2010.

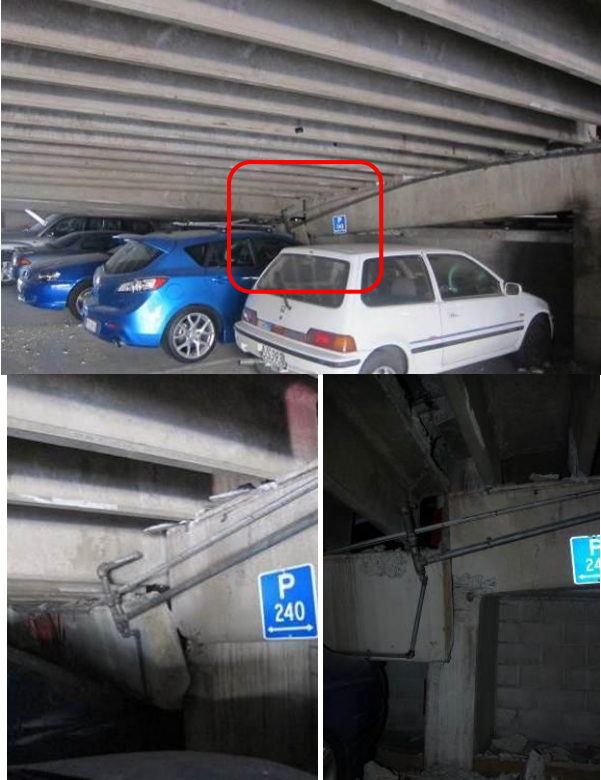
Figure 37: Localised collapse and loss of gravity support at the 1st floor at the 5-storey car park due to corbel failure.

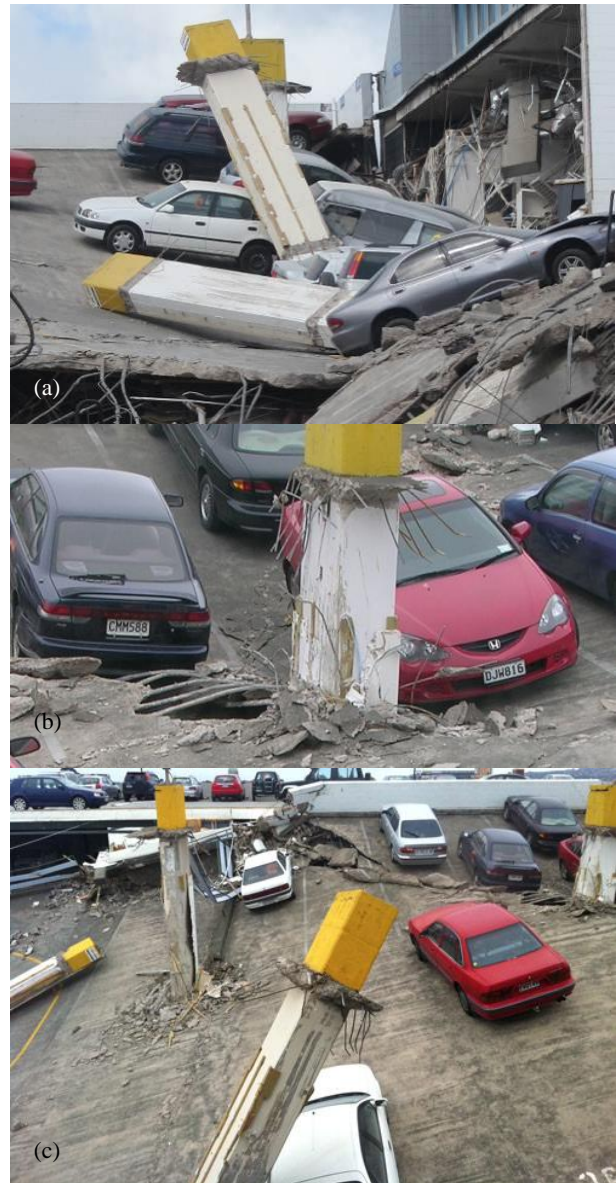
Figure 38: Punching shear failure of a 5-storey post-tensioned flat-slab and columns building. (Photograph (c) is courtesy of David Swanson).

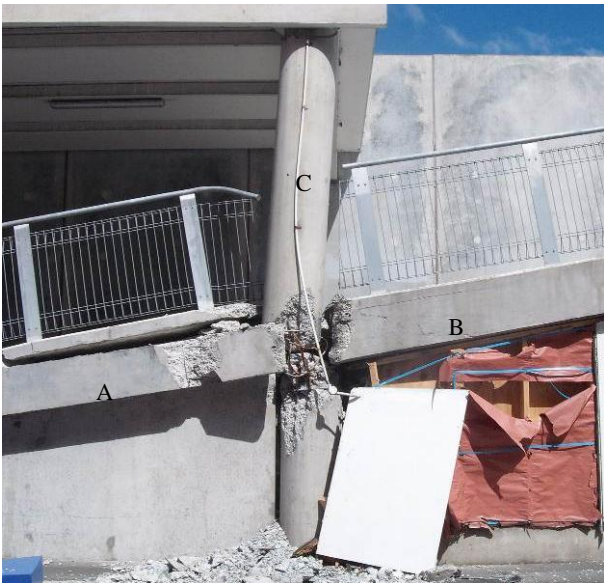
Figure 39: Lack of displacement allowance for ‘simply-supported’ elements such as car park ramp leading to a column shear failure.

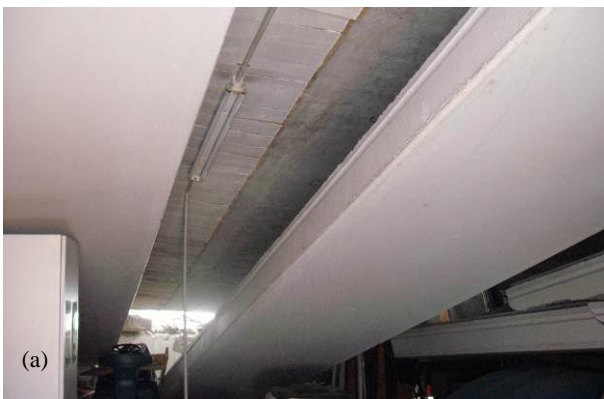
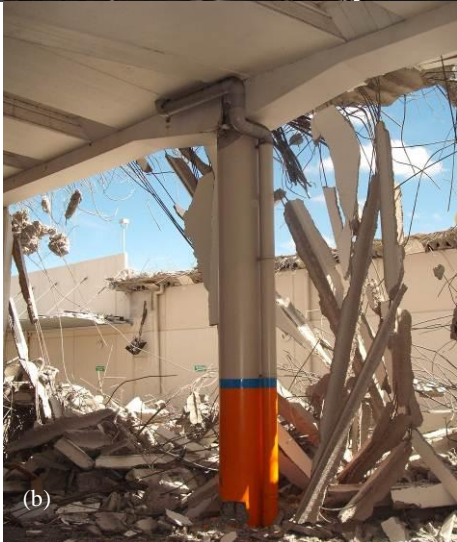
Figure 40: Lack of displacement allowance for ‘simply-supported’ elements leading to failure and collapse of car-park ramp: a) Unseating of hollow core unit at one-simply supported end; b) Collapse of one bay of ramp, possibly due to compressive buckling and pounding with the abutment. Photographs are courtesy of John Marshall [38].

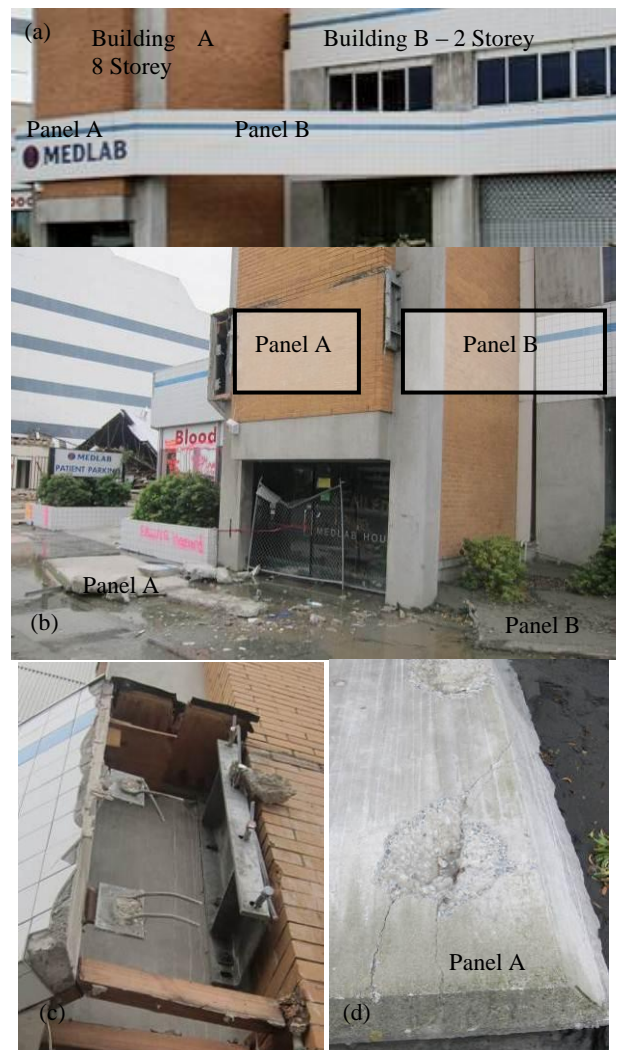
Figure 41: Failure of heavy precast concrete panel connections: a) Panels prior to the earthquake; b) collapse of the panel at the entrance; c) Close-up view of the two anchorage types; d) Pull-out concrete cone on the panel.

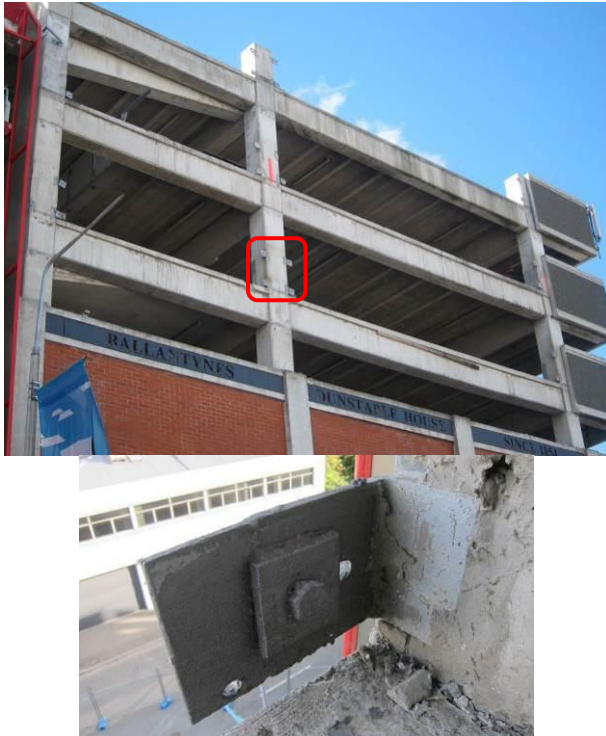
Figure 42: Failed precast concrete façade panels “welded and slotted-bolt” connection (construction error).

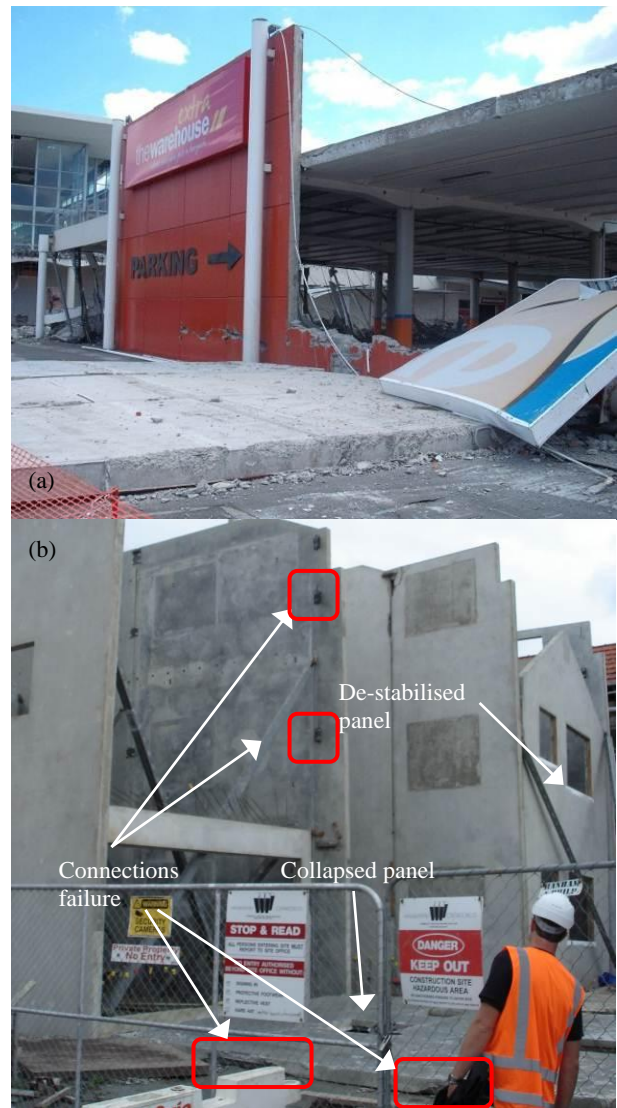
Figure 43: Collapse of precast concrete tilt-up structural walls: a) Localised flexural failure along the base of the wall panel; b) Destabilisation of tilt-up concrete wall under construction.

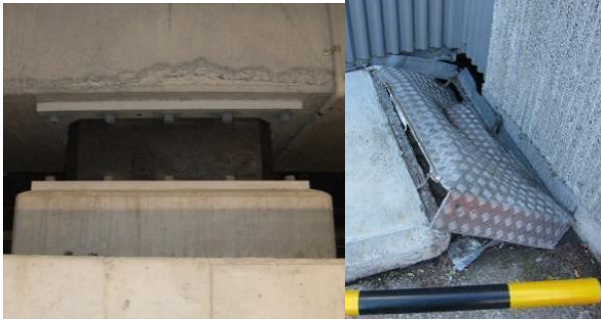
Figure 44: a) A Lead-Rubber-Bearing isolation device with near zero residual deformation (compared to 50mm after the 4 September earthquake); b) The seismic moat cover on the ground level indicates significant lateral movement during the earthquake.

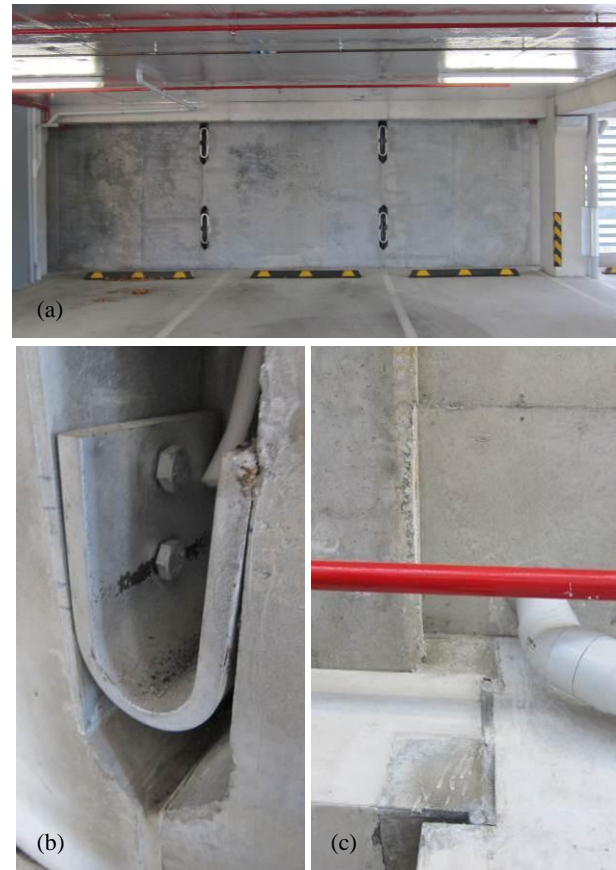
Figure 45: Self-centring precast concrete system implemented for a newly constructed private hospital facility: a) Coupled post-tensioned rocking walls; b) Yield lines observed in the U-shaped flexural plates coupling the post-tensioned rocking walls; c) No residual crack along the rocking interface at the beam-column connection.

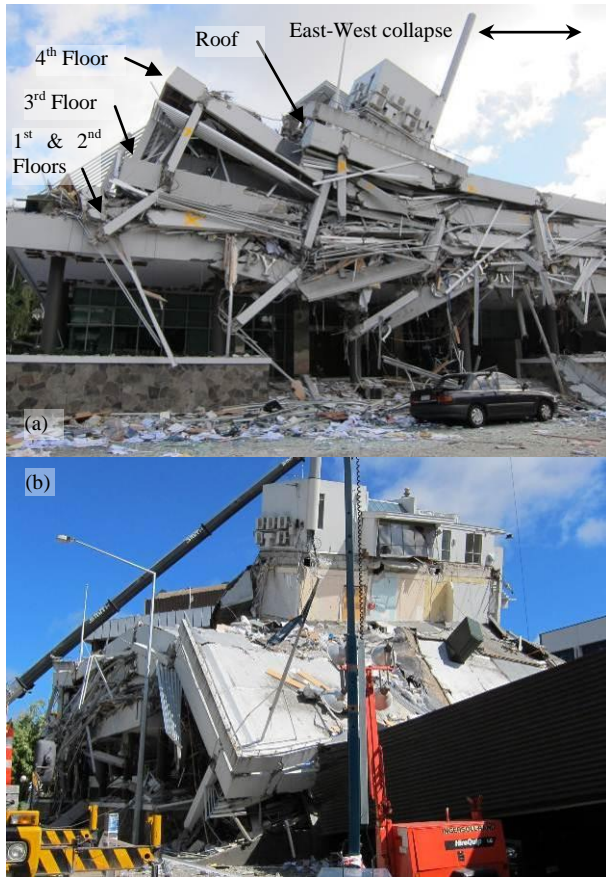
Figure 49: a) Southern elevation of the collapsed PGC building; b) South-Eastern elevation of the collapsed PGC building.

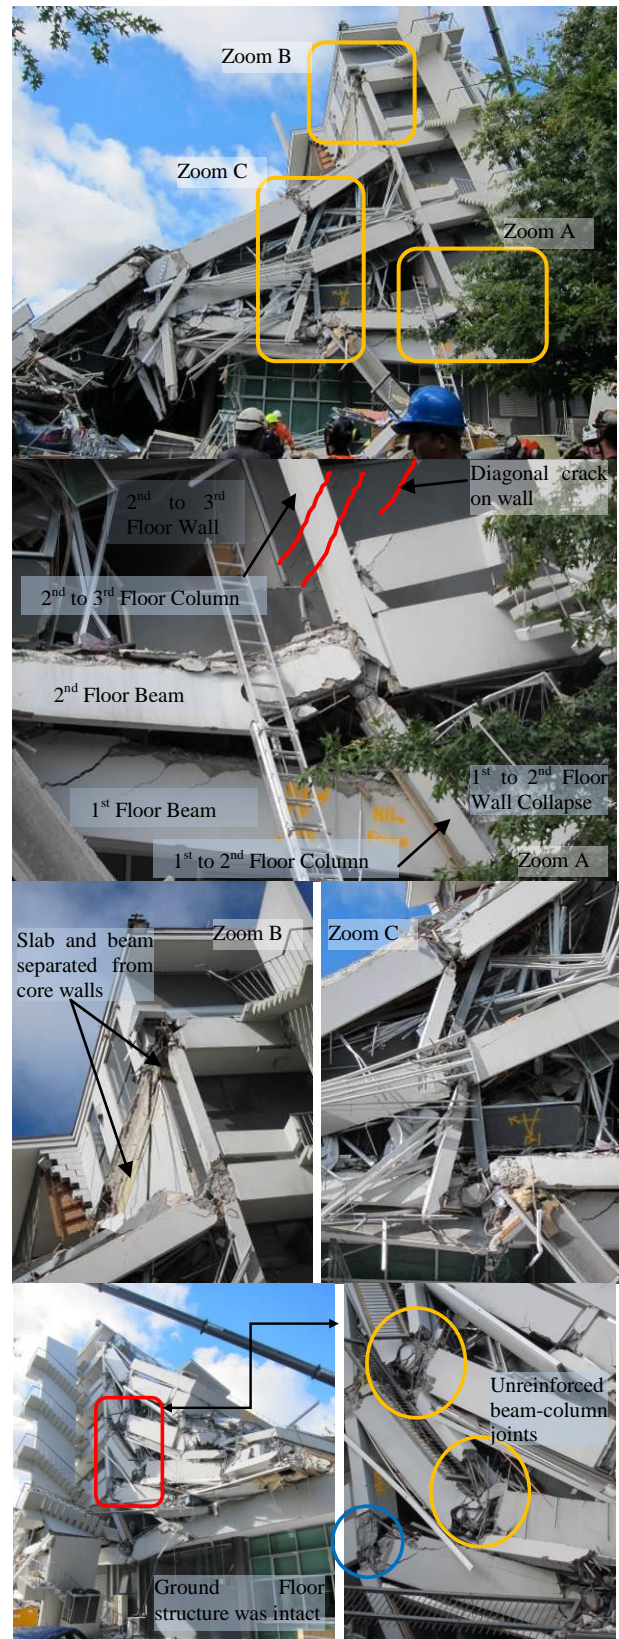
Figure 50: Various failure mechanisms observed on the Northern elevation of the collapsed PGC building.

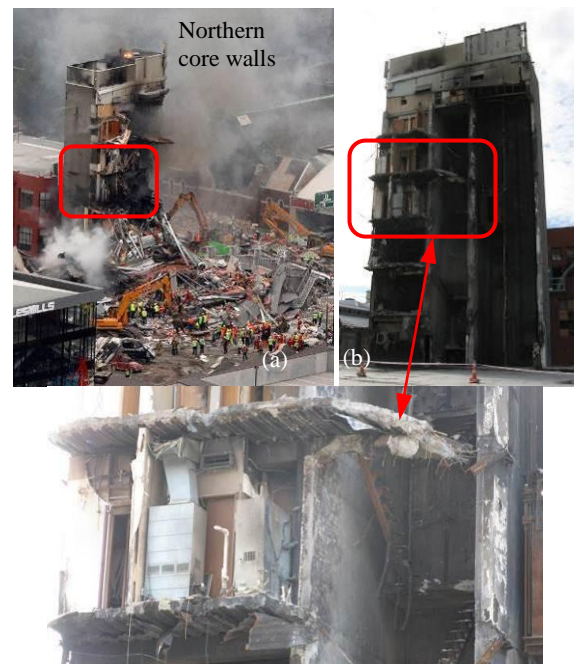
Figure 54: Northern RC core walls of the CTV Building. Photograph (a) is taken on the 23rd February 2011 by Mark Mitchell published in New Zealand Herald. Photograph (c) illustrates the remains of the Hi-Bond floor slab deck at 3rd and 4th Floors.

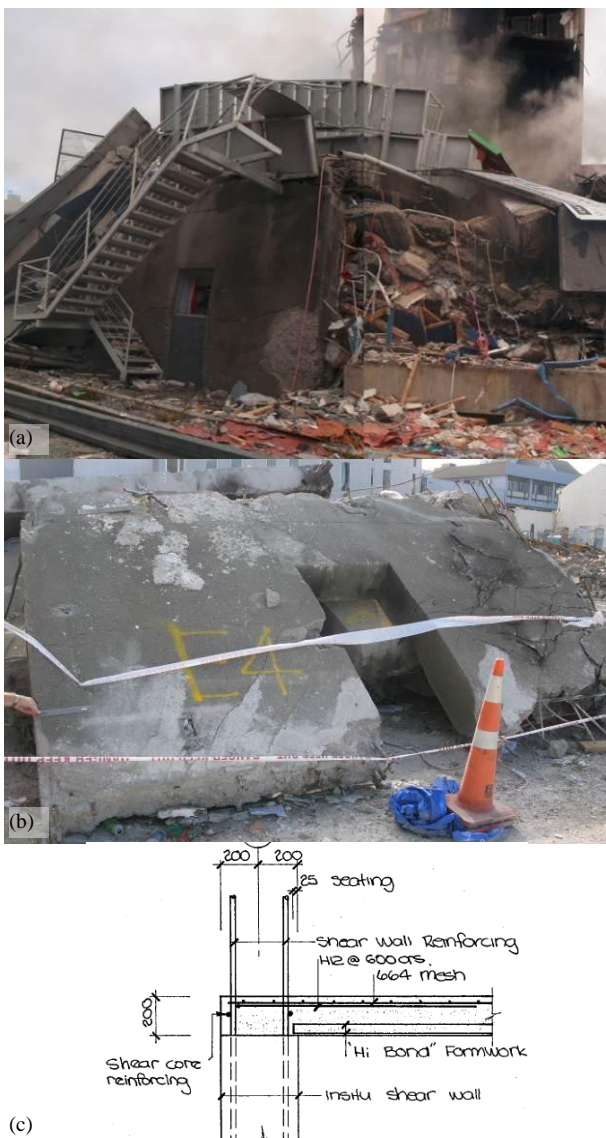
Figure 55: Coupled walls on the Southern side: a) the coupled walls remains intact on the Ground Floor with limited flexural or shear cracking; b) All six pairs of the coupled-walls were accounted for during a post-demolition inspection – limited damage were observed on these walls; c) the connection detail of slab-to-coupled walls.

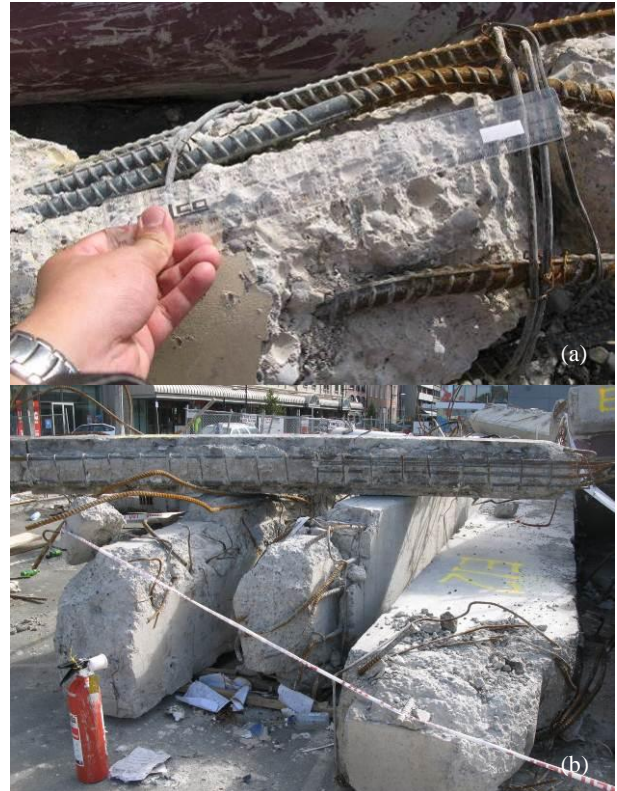
Figure 56: Post-demolition inspection of the RC frame elements: a) RC column with R6 spiral ties at 250 mm centre and six-HD20 longitudinal reinforcement.
