SEISMIC PERFORMANCE OF REINFORCED CONCRETE BUILDINGS IN THE 22 FEBRUARY CHRISTCHURCH (LYTTELTON) EARTHQUAKE

Weng Y. Kam¹, Stefano Pampanin², Ken Elwood³

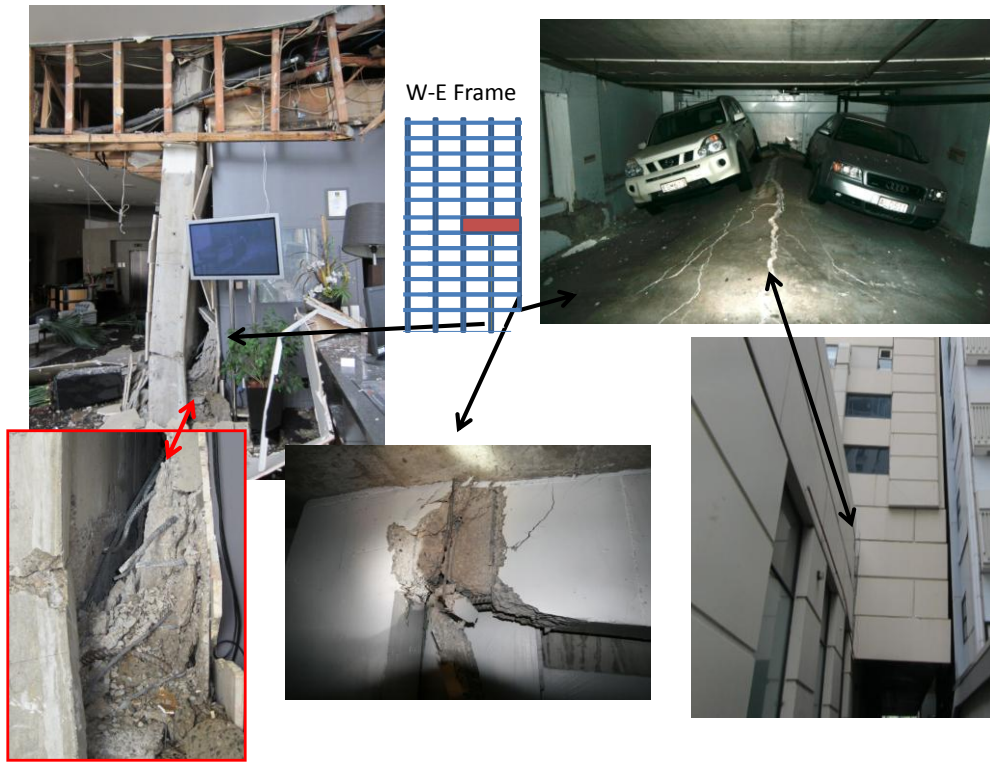
Figure 59: Grand Chancellor Hotel: The shear-axial failure of the RC wall D5-6 and the resulting damage pattern.

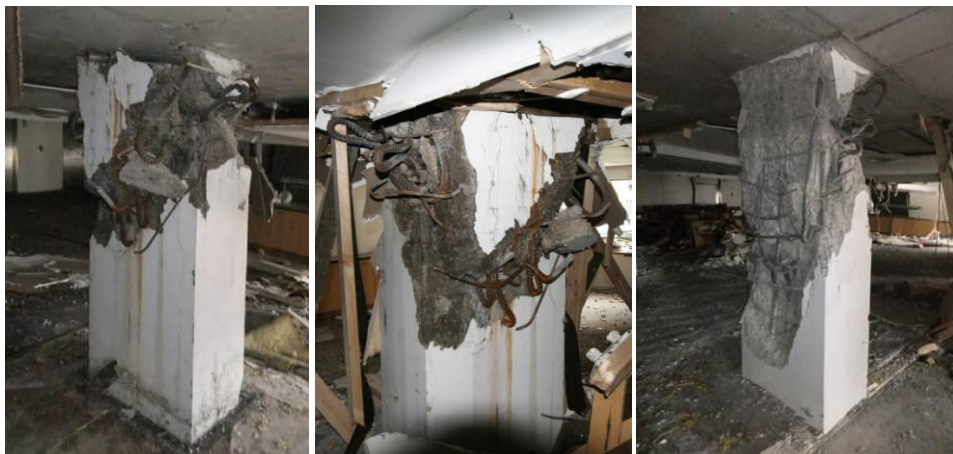
Figure 60: Grand Chancellor Hotel: The shear-axial failure of the RC columns below the transfer girders at Level 10 and 11.

Figure 67: Emergency stabilisation repair of the columns with axial-shear failure. See Figure 60 for the pre-repair condition of the columns.

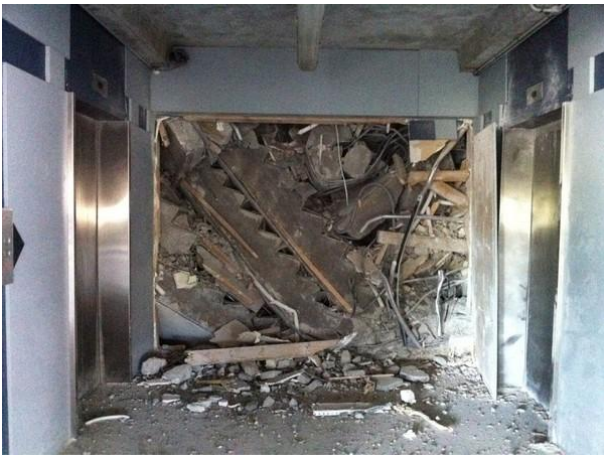
Figure 61: Collapse of precast concrete staircase in multi-storey buildings.

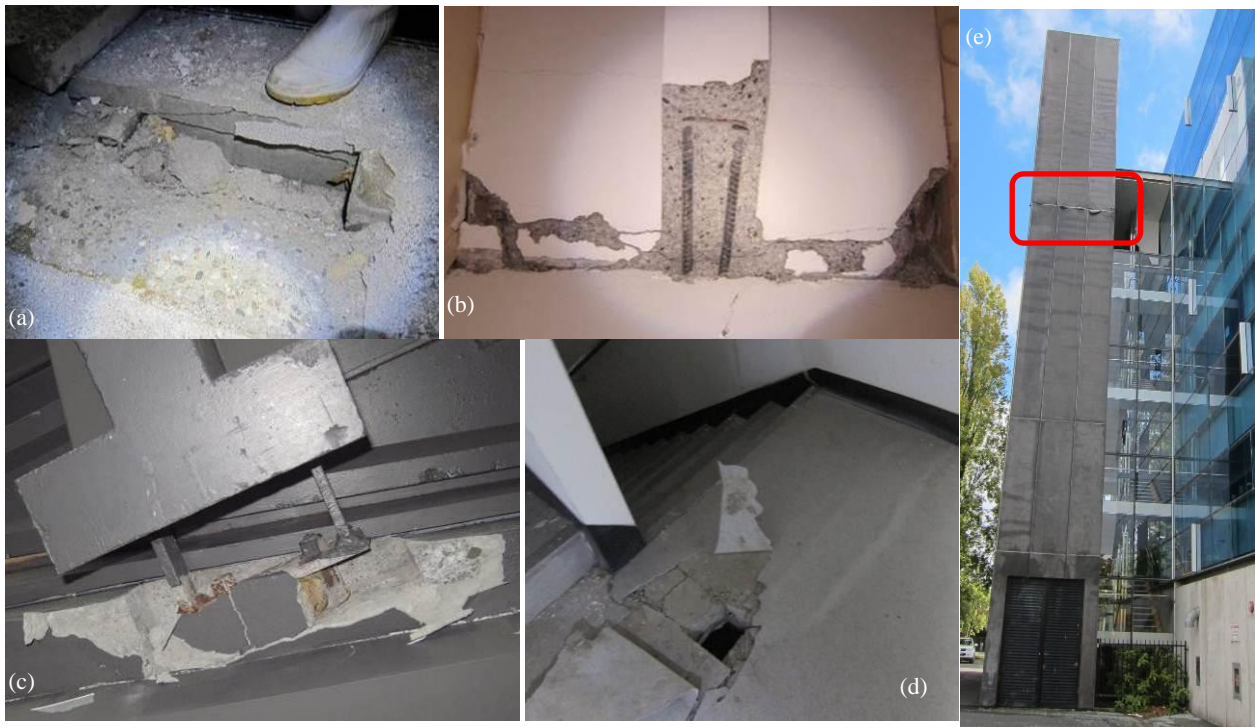
Figure 62: Typical ‘severe’ top and bottom landing damage of precast concrete staircase in multi-storey buildings.

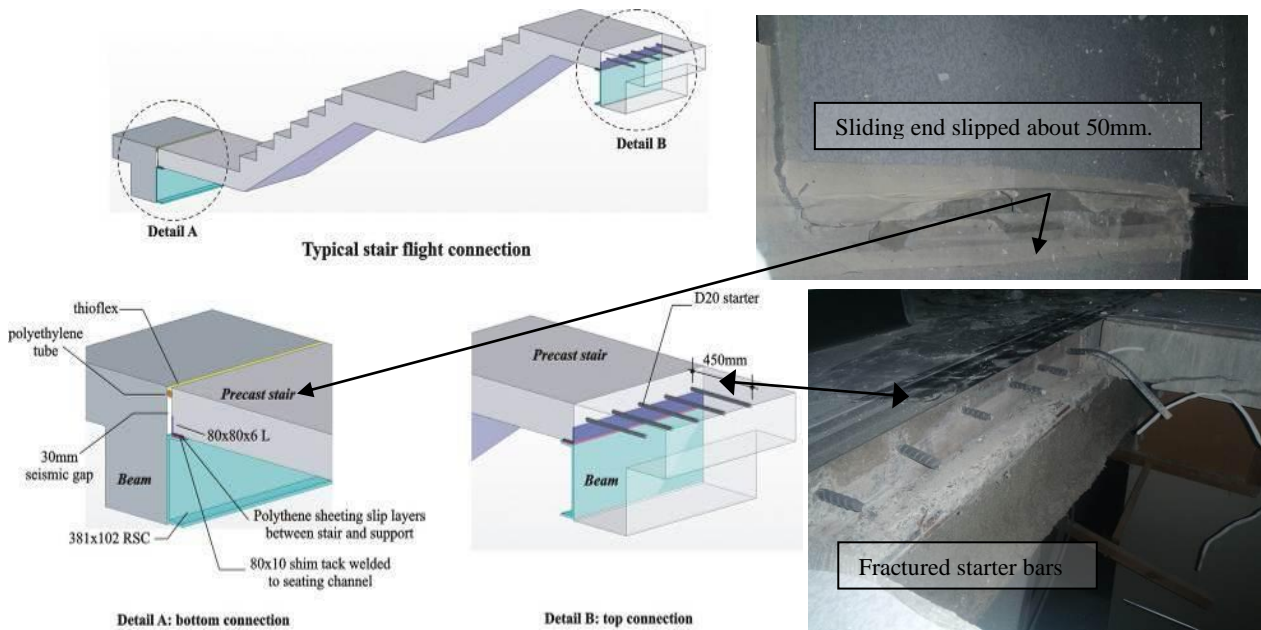
Figure 63: Typical detailing and damage of staircase with partially pinned-slide bottom connection; cast-in-situ connection at top with longitudinal starter bars lapped at landing. Image (left) is courtesy of Umut Akguzel and photographs (right) are from USAR engineers.

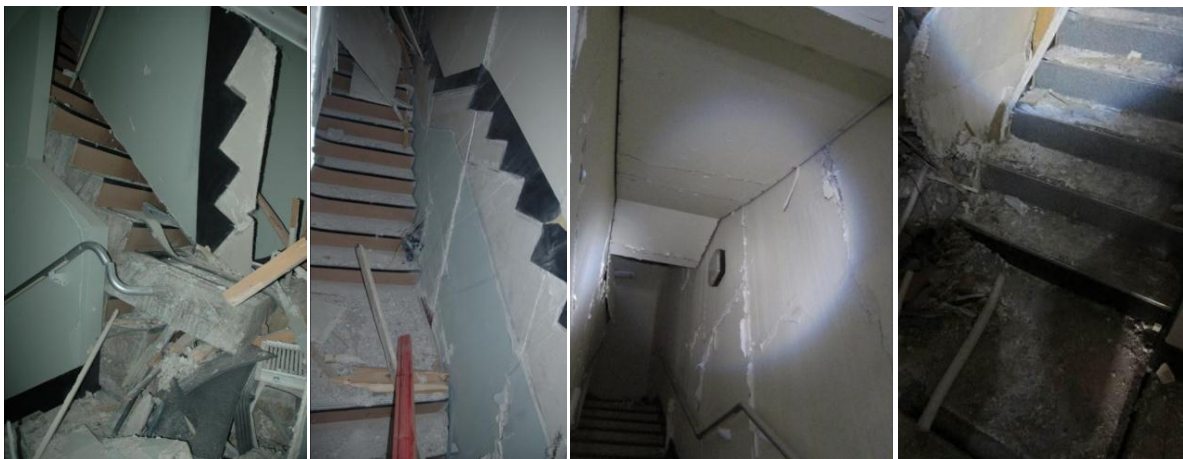
Figure 64: Collapse of one out of two internal scissor staircases in a multi-storey RC frame building. The staircase was under repair work for the damage sustained in the 4 September 2010 earthquake.

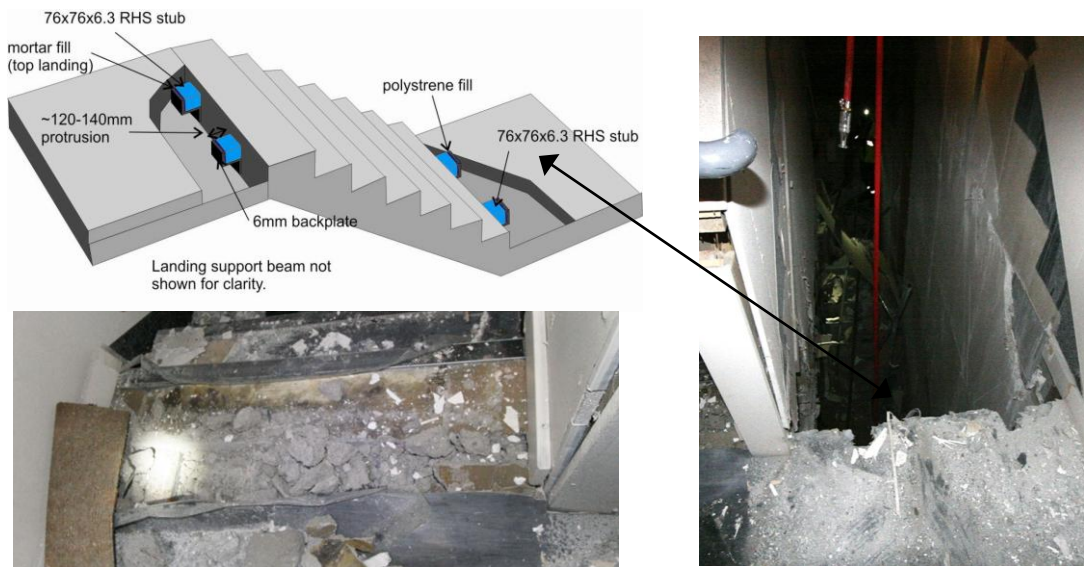
Figure 65: Alternative typical detailing of staircase- Type A - Pinned-slide connections with RHS shear keys on both ends and observed failures. (Damage photographs are courtesy of USAR engineers).

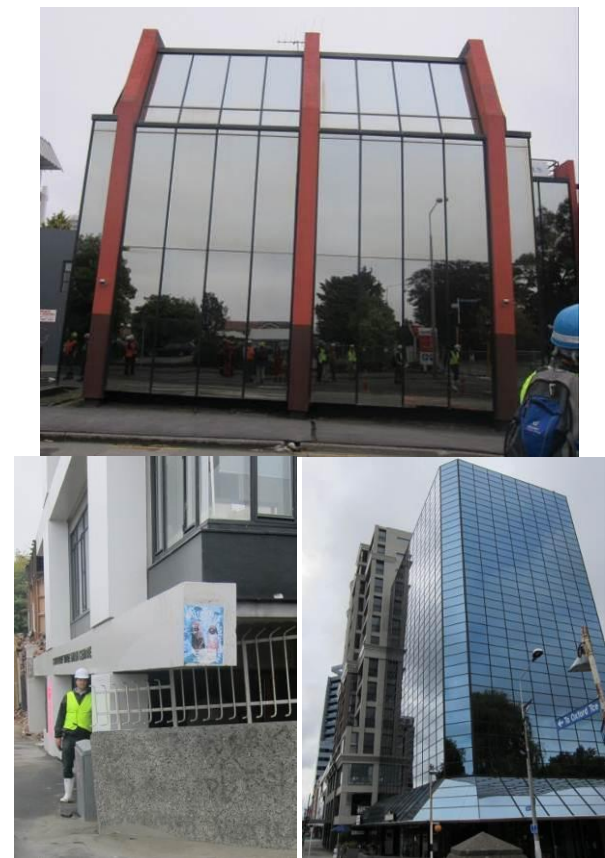
Figure 72: Liquefaction induced differential settlement resulting in significant tilting of mid- to high-rise buildings of various foundation and soil details: a) Four-storey with shallow foundation; b) Six-storey with shallow foundation; c) Two high-rise buildings with substantial differential settlement and tilting.

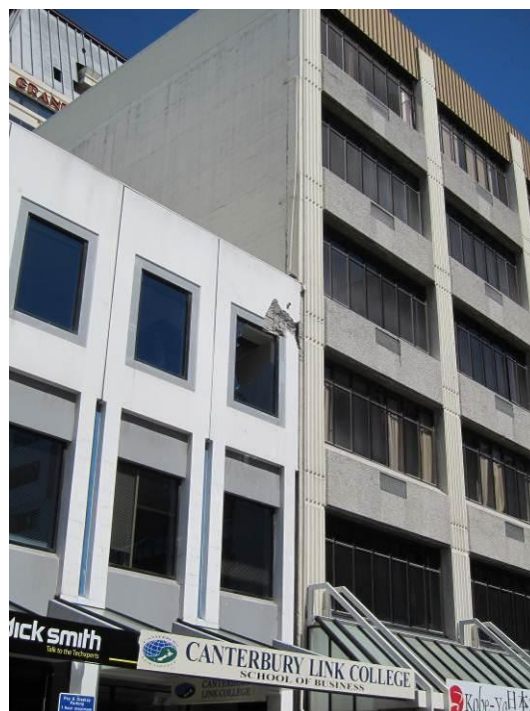
Figure 73: Pounding damage was not widely observed.
