PERFORMANCE OF CEILINGS IN THE FEBRUARY 2011 CHRISTCHURCH EARTHQUAKE

Rajesh P. Dhakal¹, Greg A. MacRae¹ and Keith Hogg²

SUMMARY

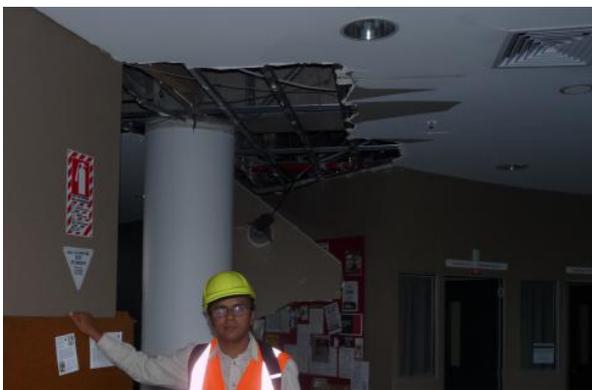
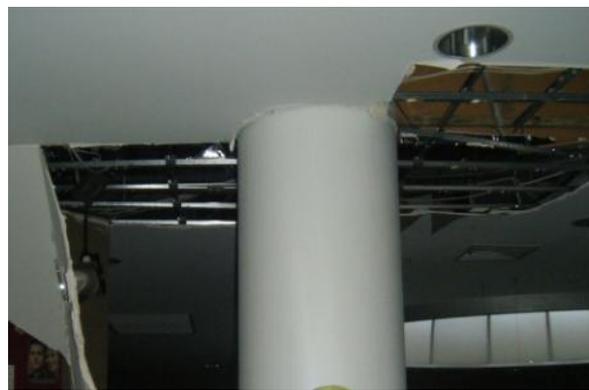
Some multi-storey office buildings in the city were found to have flush type ceilings which had gypsum plasterboards glued and nailed underneath steel channels. This type of ceiling was found in two buildings the authors inspected in the city. As shown in Figure 4, these ceilings were found to have suffered damage of different extent. In a four storey building in Hereford Street which had significant but repairable structural damage, parts of the plasterboard had ripped off at different locations; mainly in the periphery of circular RC columns (see Figure 4 first row). This damage seemed to have been caused due to a combination of the column drift and movement of services above the ceiling, both of which applied extra force on the ceiling board. In another high-rise building (more than 10-storey) which also had significant structural damage, the flush type ceilings were found to have been damaged in the lower 3 floors (upper floors could not be

accessed due to safety concerns). In this building too, the ceiling damage was in the form of long/wide cracks leading to tearing of the board at some locations. The damage was found to be more around the edge/corner and less (almost none) towards the middle.

Damage to flush type ceiling in a four story building in Hereford Street

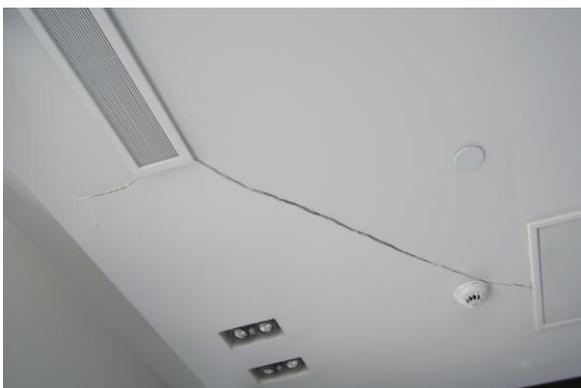
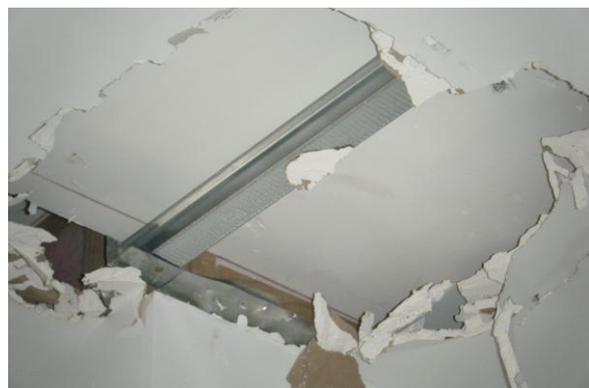
Damage to a plasterboard ceiling in a high rise office building in the city

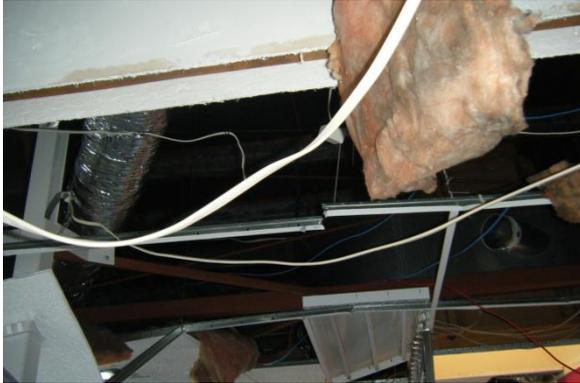
Breaking, buckling and twisting of grid members due to large compression force

Grid damage results from excessive force on the grid members or connections. This then results in distortion of the ceiling grid under compression and subsequent buckling of the grid members or failure of the connections while the perimeter connections remained intact. Often, failure of one member or connection in a grid leads to a progressive failure of other members and connections; thereby resulting in a chaotic global collapse of the whole ceiling system. As tiles generally fall from the damaged grid, this type of damage poses a life-safety hazard. In some cases heavy tiles fell as far as 6 m onto the area below and it was fortunate that there was no injury or loss of life.

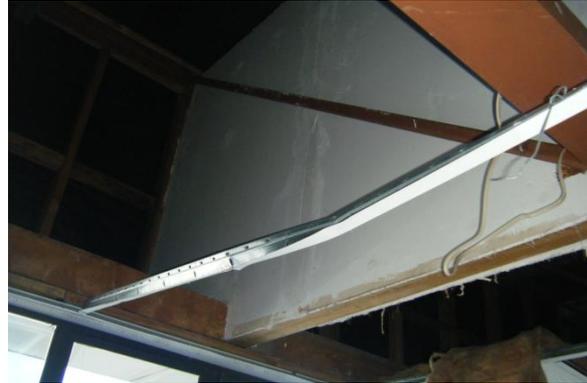
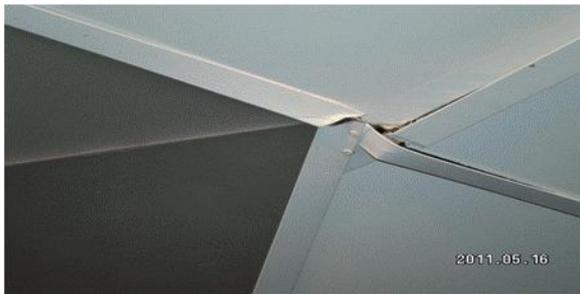
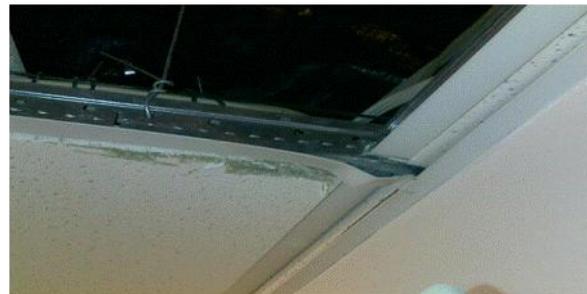
Damage to grid members due to excessive compression force (Photos: K Hogg)

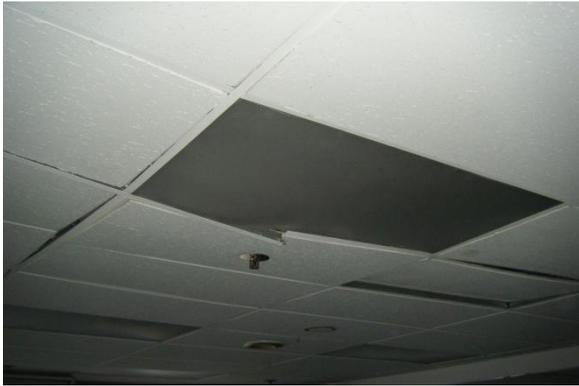
Localised damage to ceiling grid and tile due to interaction with sprinkler

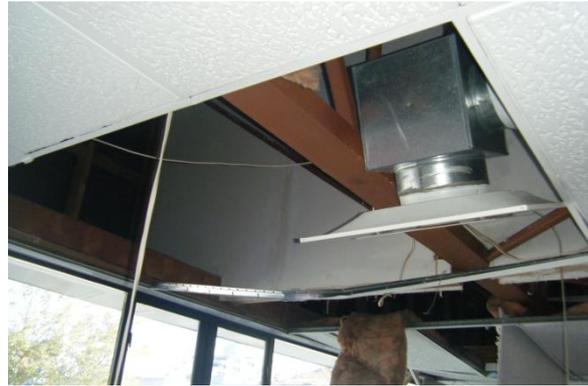
Interaction with service

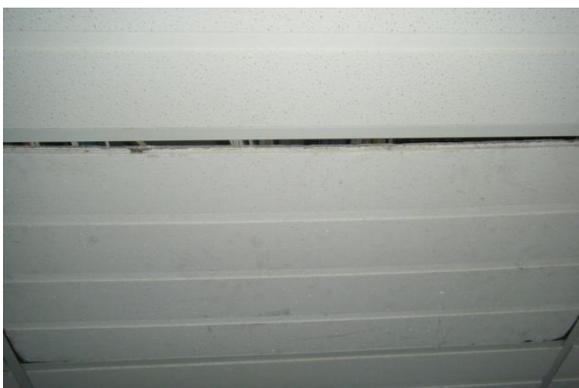
Typically the ceiling tiles sit on the flange of inverted T-beams of the grid without any fastening. No clips are used to hold the tiles in place, which implicitly assumes that the weight of the tiles is enough to keep them on the beam flanges. However, large vertical accelerations (as high as 2.2g) were recorded in some stations in and around Christchurch. When the tiles are subjected to vertical acceleration in excess of 1g, they will jump up, and when they come down they may not sit exactly inside the same grid. Vertical movement of ceilings may also have resulted from vertical deformations or rocking of some structural systems. As a result, it is not surprising to see some tiles dislodged from their original positions, and some fallen ceiling tiles possibly resulting from the vertical acceleration effect. In one case, the grid members

Dislocation of ceiling tile due to vertical acceleration

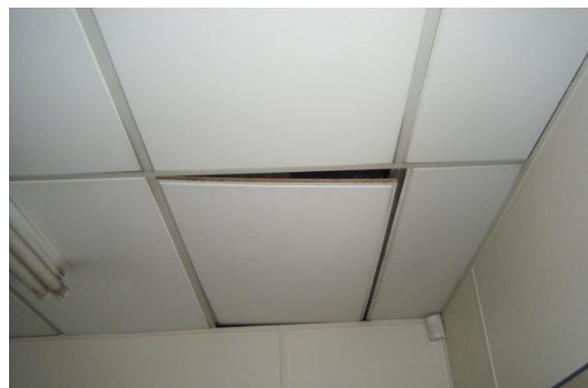
were intact in the shape of a rectangle but the tile was missing. In another case, the impact from the jumping tile seemed to have broken the flange of the grid member; resulting in skewed and tilted ceiling tiles (see Figure 9). The consequences of damage possibly caused by vertical shaking were not as severe as that caused by horizontal shaking.

Damage to flange of the grid beam due to tile impact

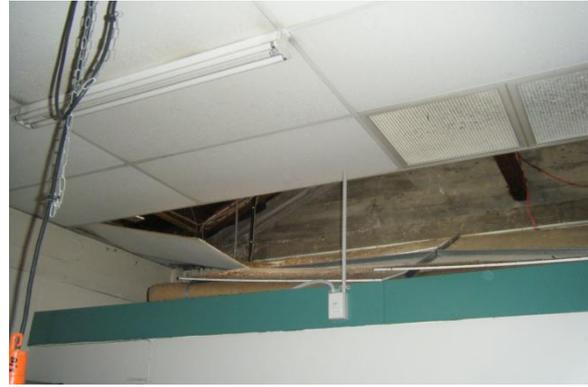
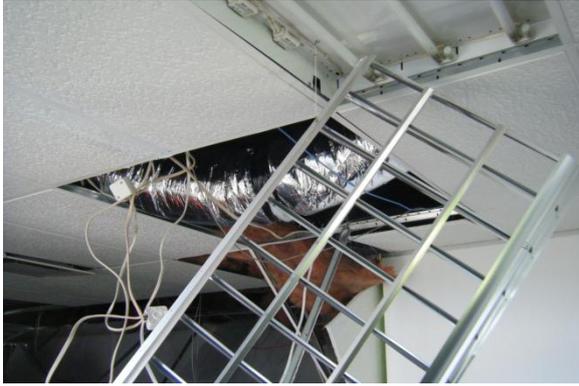
Figure 11 shows the different extent of damage observed in ceilings of different size. The second row in the figure shows damage to ceilings (using heavy tiles) in two rooms of the same building (in the corner of Colombo Street and Peterborough Street). The one on left is the ceiling in a smaller room; whereas the right photo is of the ceiling in a bigger room (7 m × 12 m). As can be seen, the damage to the smaller ceiling is trivial; and this may have been caused by the interaction with the service pipe and not due to the excessive axial force; because the grid members are intact in the perimeter and a service pipe seems to have pushed the dropped tile. On the other hand, the damage suffered by the

Damage incurred to a small ceiling

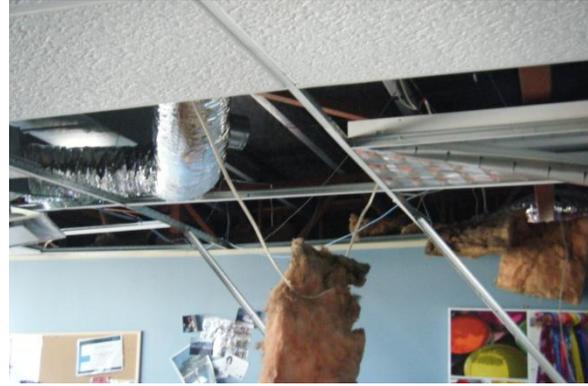
Damage to a large (7 m x 12 m) ceiling

ceiling in the bigger room is visibly more severe with failed grid members and connections in the perimeter and a large number of tiles fallen down. This strongly indicates that the size of the ceiling has a significant effect on the extent of damage.

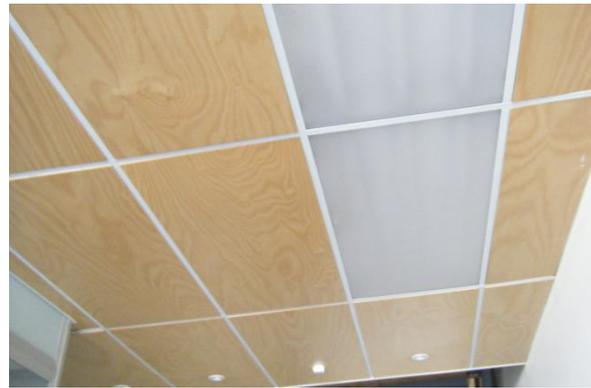
Undamaged light tile ceiling in the lower floor

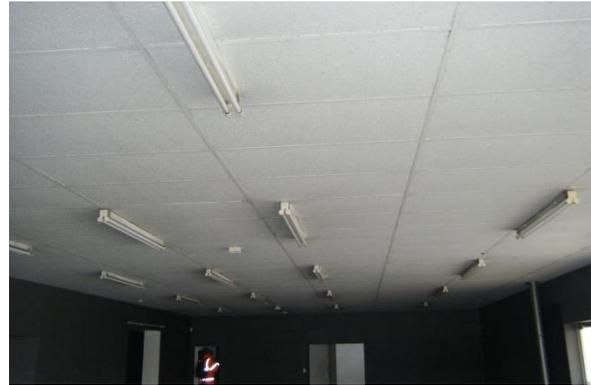
The second row of Figure 12 shows two ceilings which were reasonably large (one was 15 m long) but still remained intact after the earthquake. The left one is from a single storey lecture theatre in the University of Canterbury and the right one is from the ground floor of a two-storey commercial building in Tuam Street. Both of these ceilings used light-weight tiles. All heavy tiled ceilings of comparable size the authors visited were severely damaged. These observations further support the argument that the weight of the tiles has significant effect on the damage of suspended ceilings.

Rare cases of large suspended ceilings with little or no damage (both had light tiles)
