Damage ratios for brick buildings in the 1942 Wairarapa earthquake

D. J. Dowrick & D. A. Rhoades
Institute of Geological and Nuclear Sciences Limited

**NZSEE 2001
Conference**

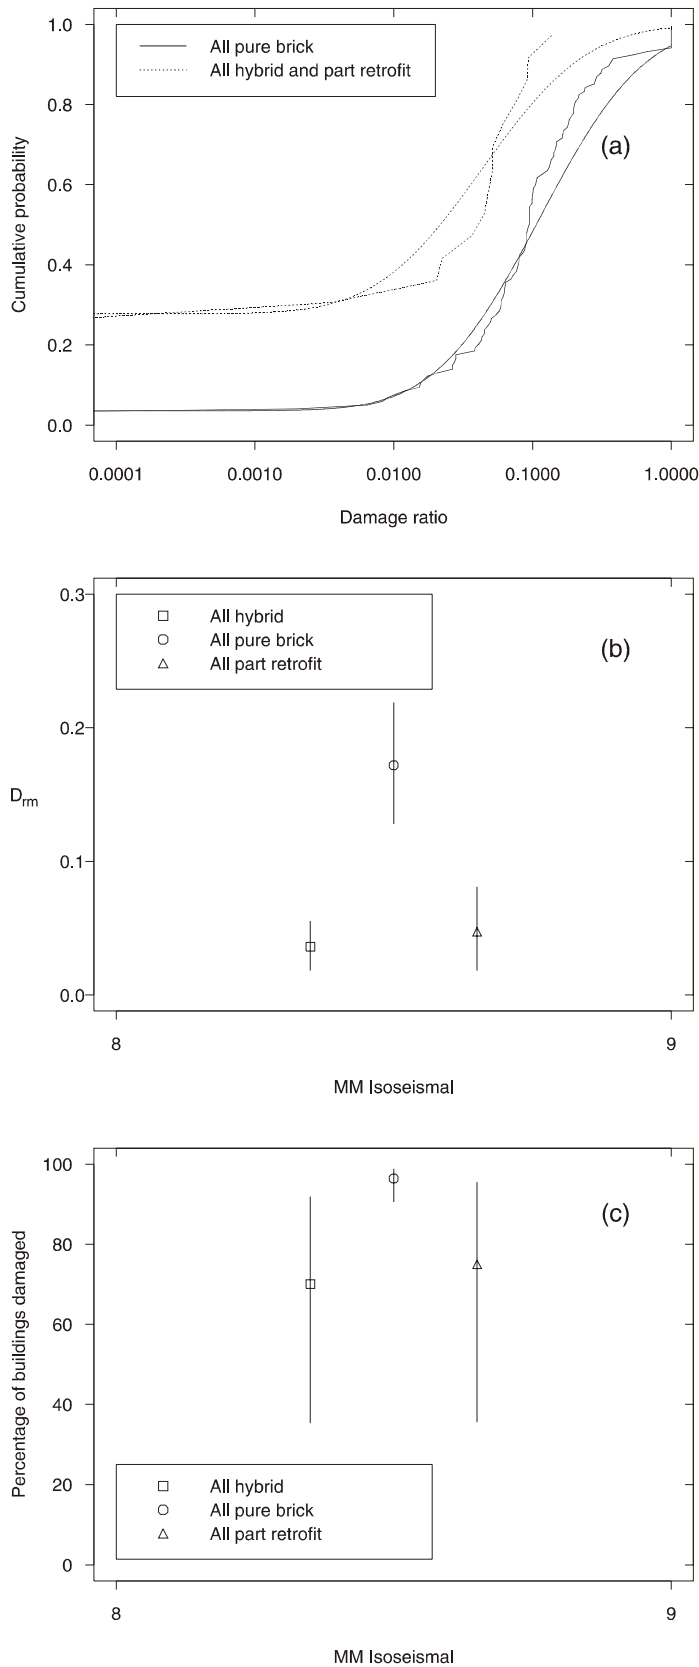
Plots of cumulative probability of damage ratios at intensity MM8 in the Wairarapa earthquake are shown in Figure 2(a) for two classes of building, i.e. pure brick, and hybrid plus partial retrofits. The shapes of the plots are broadly similar to the fitted lognormal curves, but the fits are not as close as we have obtained in studies of larger datasets (Dowrick & Rhoades 1997; Dowrick et al. 2000).

When considering mean damage ratios and percentages of buildings damaged, all three building classes are plotted (Fig. 2b, c). The beneficial effect of even small amounts of reinforcing steel is very apparent in all three plots of Figure 2. In particular, D_{rm} for the reinforced buildings at about 0.04 is only a quarter of the value for pure brick (0.17). The proportion of pure brick buildings damaged is 96% compared with 72% for the hybrids and partial retrofits.

Figure 2. Three measures of vulnerability for three classes of non-domestic brick buildings in the MM8 intensity zone of the June 1942 Wairarapa earthquake: (a) Cumulative probability distributions of damage ratio, (b) D_m and its 95% confidence limits, and (c) Percentage of buildings damaged with its 95% confidence limits.

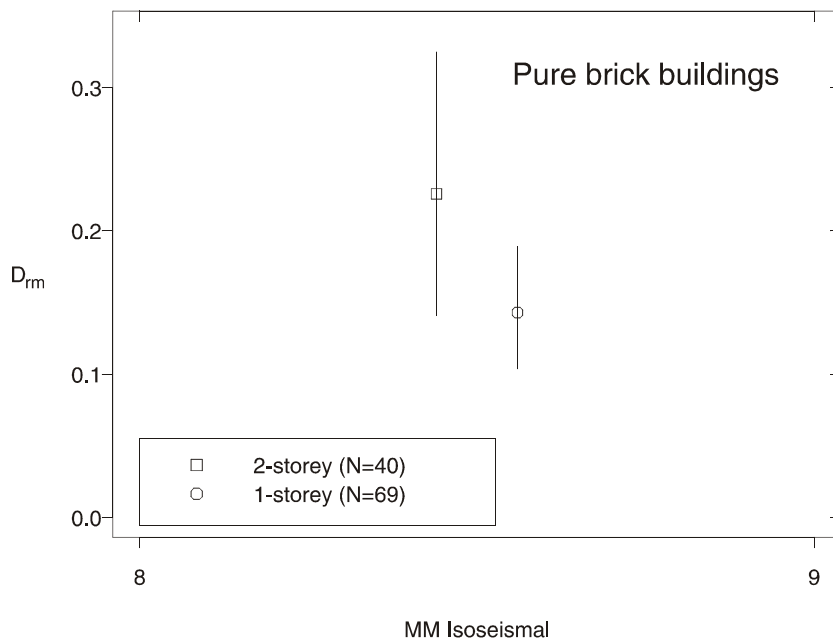
The vulnerabilities of pure brick buildings of one and two storeys at intensity MM8 are compared in Figure 3, where their D_{rm} and the associated 95% confidence limits are plotted. The vulnerability of two-storey buildings ($D_{rm} = 0.22$) is substantially greater than that for one-storey buildings ($D_{rm} = 0.14$). The difference in the above two values of D_{rm} was found not to be statistically significant, but only just, the p -value of the difference being 0.057.

Figure 3. D_{rm} and its 95% confidence limits for one and two-storey non-domestic pure brick buildings in the MM8 intensity zone of the June 1942 Wairarapa earthquake.

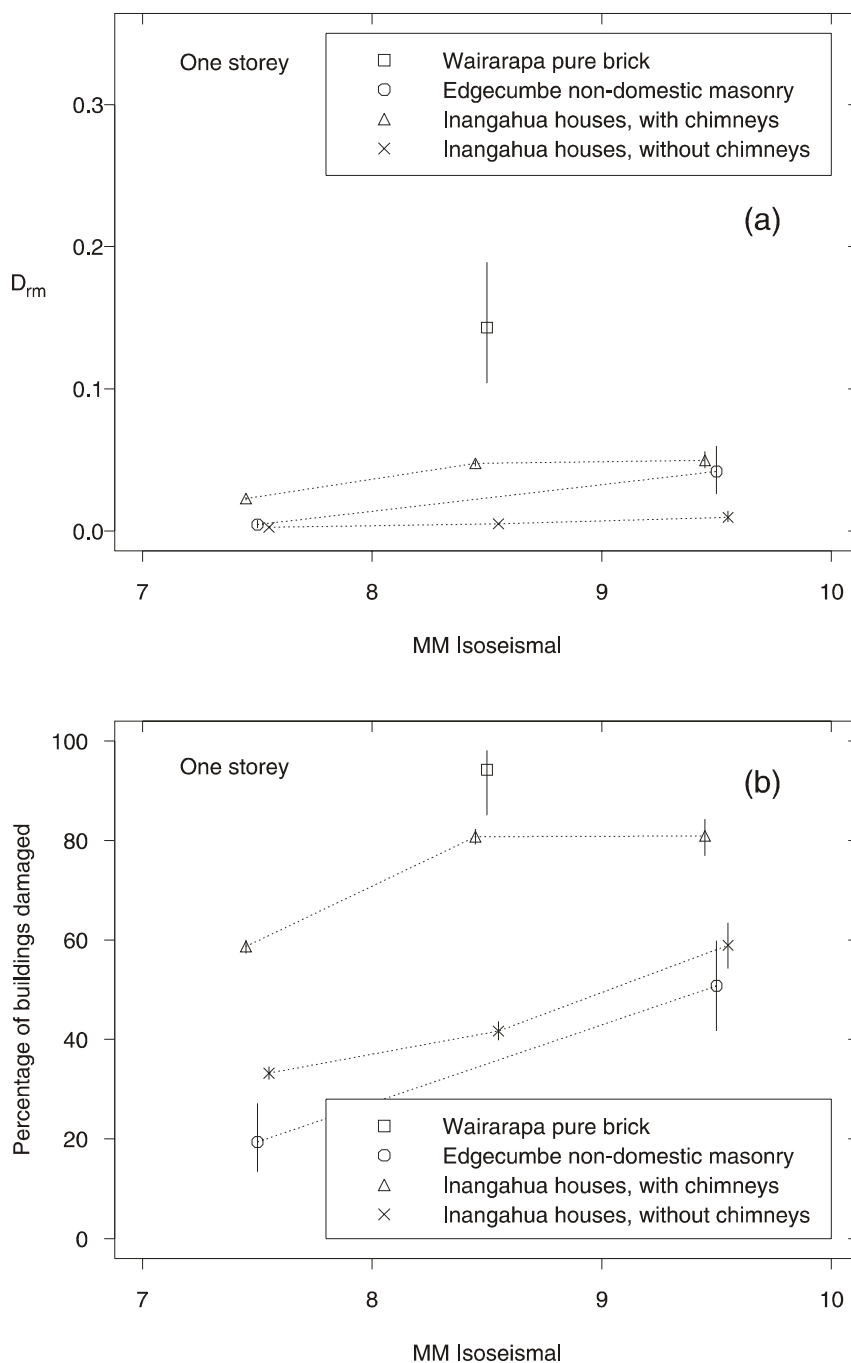
As seen in Figure 4a, D_{rm} for pure brick one storey buildings at MM8 is 2.9 times higher (at 0.14) than the next worst class of buildings, i.e. houses with brittle chimneys, for which $D_{rm} = 0.048$ at MM8 and 0.050 at MM9. In addition, the 95% confidence limits are widely separated. Also shown in Figure 4a, D_{rm} for pure brick is approximately seven times greater than that (~ 0.02) for 1935 - 1979 code-designed concrete masonry buildings (estimated by linear interpolation between the Edgecumbe earthquake MM7 and MM9 D_{rm} values).

Considering the percentage of buildings damaged (Fig. 4b), pure brick buildings are again worse (92%) than the next worst class of buildings, houses with brittle chimneys, for which $n/N = 81\%$ at both MM8 and MM9. Reinforced concrete masonry buildings from the Edgecumbe earthquake have $n/N = 35\%$, estimated by linear interpolation between the MM7 and MM9 results.

Figure 4. Two vulnerability measures for pure brick Wairarapa non-domestic buildings compared with those for three other building classes from the 1968 Inangahua and 1987 Edgecumbe earthquakes:

- (a) D_{rm} with its 95% confidence limits, and
- (b) Percentage of buildings damaged with its 95% confidence limits. The houses are timber framed.
