Preliminary results from the testing of a precast hollowcore floor slab building

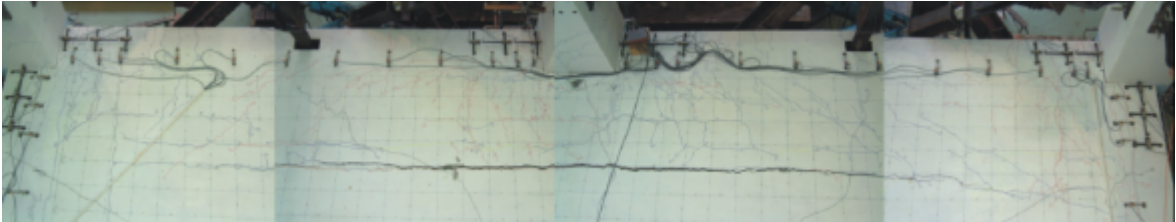
Overall the specimen behaved well up to interstorey drifts of $\pm 1.0\%$ ($\mu=2$). However significant cracking in the topping slab developed. As the drift increased this led to a tear forming within the floor slab at a drift of 1.9%. This tear was due to the elongation within the beam causing the central column to translate outwards and taking the first hollowcore unit with it. The reinforcing mesh in the topping slab between the first and second hollowcore units fractured. The tear can be seen in Figure 3(a).

(a) Longitudinal tear that formed at 1.9% drift.

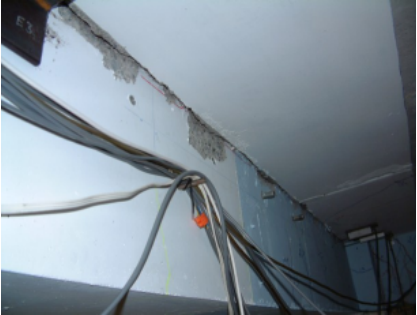
At the completion of the -2.0% cycle, the entire seating for the hollowcore units were damaged (Figure 3(b)), with some of the units dropping 10mm. There was also significant web splitting within the first hollowcore unit. It is considered that when compared to real dynamic earthquake loads, the test was possibly unconservative. This is because if any live load or vertical accelerations had been concurrently applied to the building it would be questionable as to whether the floor would remain standing. At the completion of the -2.0% drift cycle the central column displaced transverse to the direction of loading by 25mm. This also caused the first floor unit to rise 12mm relative to the rest of the floor. The extent of the crack propagation is shown in Figure 3(c) and (d). The translation was not only due to the elongation of the main beam. The newly formed inverted L shaped beam (beam plus the adjacent floor acting as a flange) contributed to some of this displacement as it tried to bend about its sloping principal axes. Since the central column is no longer tied to the floor slab it is possible for the column to fail under buckling. The reason for this is that the floor tear could occur over several floors of the building greatly increasing the columns effective length and hence reducing its load carrying capacity.

(b) Entire seat has been lost at the completion of the Phase I (-2.0% drift)

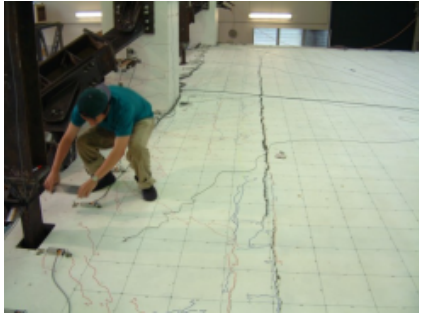
(d) Longitudinal view of floor slab tear at the end of Phase I (-2.0% drift)

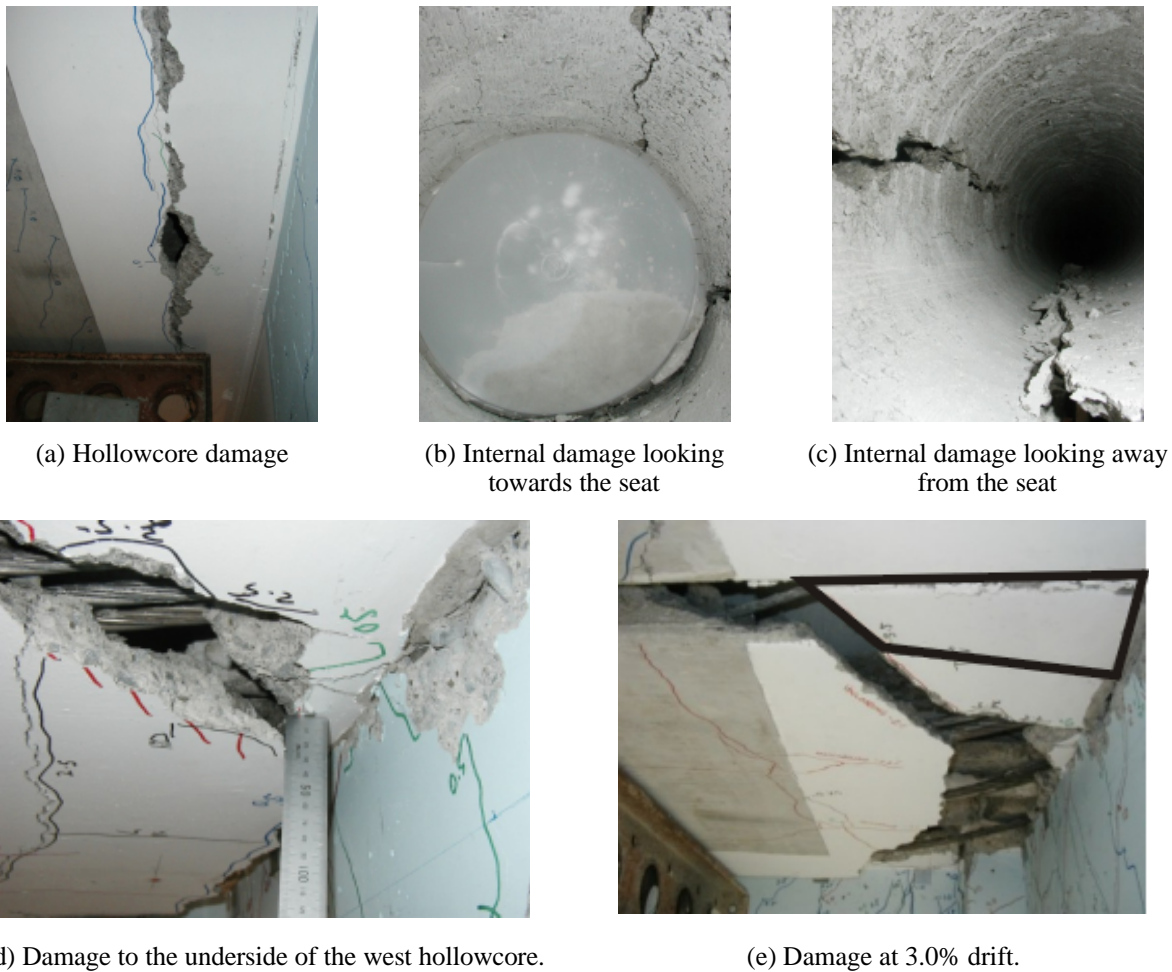
Figure 4. Observed damage during Phase II testing

Since the side of the first hollowcore was adequately bonded to the beam, it caused the crack within the soffit of the first hollowcore unit to open some more. This meant that the condition of the hollowcore unit degraded as the transverse loading preceded. The first sizeable piece of concrete fell out around 2.0% drift. This is shown in Figure 4(a). Once the piece of concrete had fallen out of the hollowcore unit it was possible to look at the internal damage within the first hollowcore unit adjacent to the perimeter beam. Extensive damage could be seen to have occurred. Figure 4(b) and (c) shows the extent of the damage. The width of web crack within the hollowcore unit was approximately 25mm. At this stage, the webs of the first hollowcore unit had split halfway along the unit (approximately 6m). For some time now one small triangular shaped piece of concrete was holding the first floor unit up. This small section of concrete could not be relied upon to hold every time. This can be seen in Figure 4(e) at the top of the picture.

It should be noted that the hollowcore unit dropped some 30mm at this stage as shown in Figure 4(d). Figure 4(e) shows the first floor unit after a large piece of floor fell out. At this stage, the floor had dropped by some 60mm.

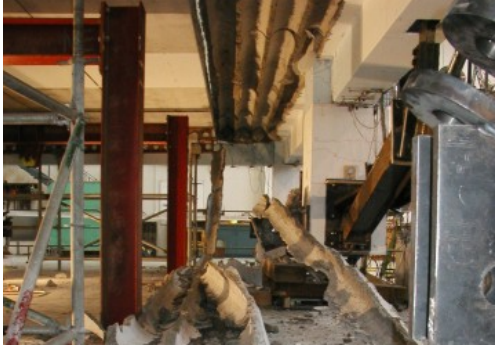
Eventually there was sufficient damage within the first hollowcore unit to allow the entire bottom section to drop as shown in Figure 6 (a) and (b). This failure occurred at a interstorey drift of 2.0%. These photos look very similar to those taken following the 1994 Northridge earthquake (Norton et al 1994).

(a) Failure of the first hollowcore unit

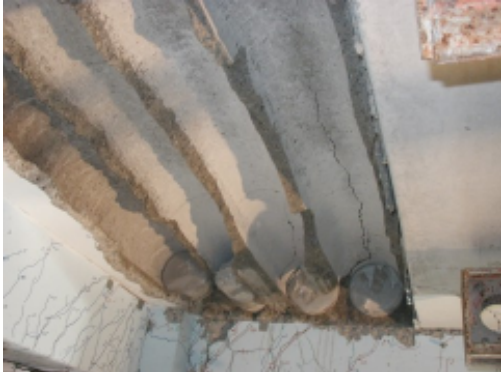
(b) Close up looking at the seat damage

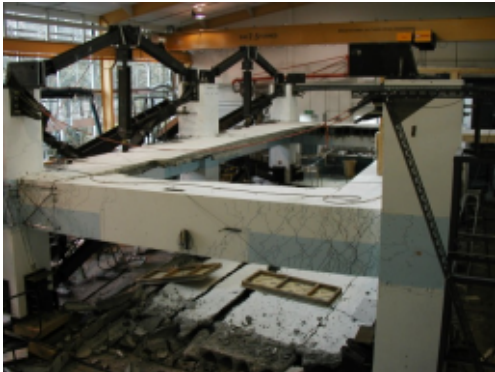
Upon further loading, to the -2.5% drift amplitude, the remainder of the floor failed when the design live load was applied. Again, the photos of this failure (Figure 6(c)-(f)) were very similar to that seen in Northridge.

(c) The frame after the floor collapsed

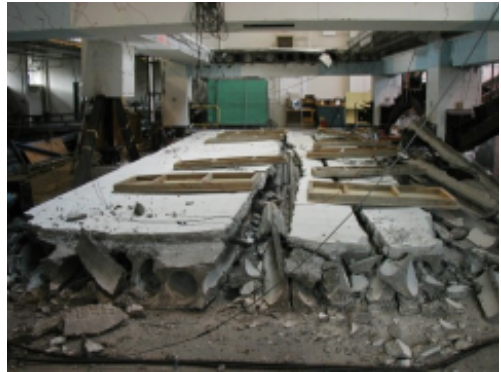
(d) Collapsed floor units

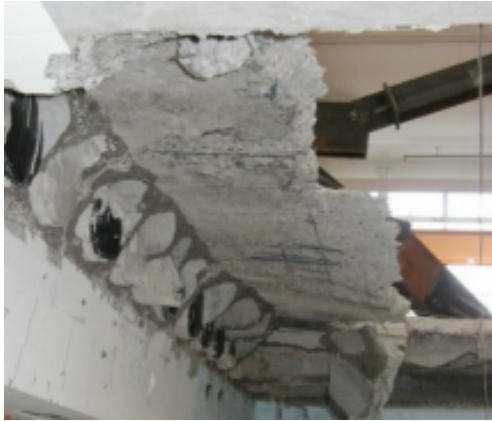
(e) The remaining topping and ends of the hollowcore units after collapse.

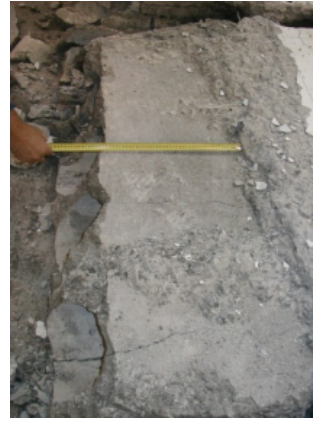
(f) The delaminated topping on the failed unit.

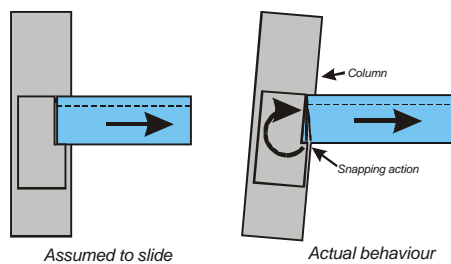
One major difference between the expected seating performance and the observed performance was the way in which the floor unit moved relative to the beam it was seated. In design it is customary to assume that hollowcore units would slide relative to the beam; this was not the case in the experiment. There was enough bond/friction to cause the end of the unit to fracture rather than slide, as shown in Figure 7.

Figure 7. Assumed versus actual hollowcore to beam performance.

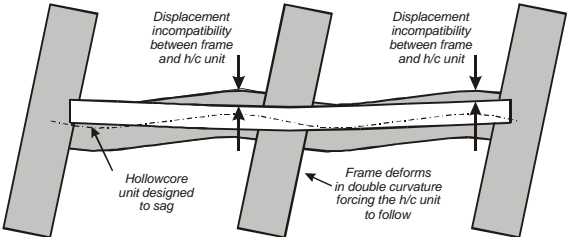
A hollowcore floor unit is designed to act as a simply supported one-way floor system. The first unit placed adjacent to the perimeter frame does not act in this manner as it is adequately tied not only at its ends but also along its entire length. This leads to the unit being displaced in a quasi-two way manner as the hollowcore unit is forced to undergo the displaced shape of the perimeter beam. This displacement incompatibility between the double curvature of the perimeter beam and the simply supported hollowcore unit causes the hollowcore unit to fail (Figure 8). Since the hollowcore unit has no redundancy in its design the unit fails through web splitting and the bottom half of the hollowcore unit drops.

Figure 9. Displacement compatibility between the frame and the hollowcore floor units.

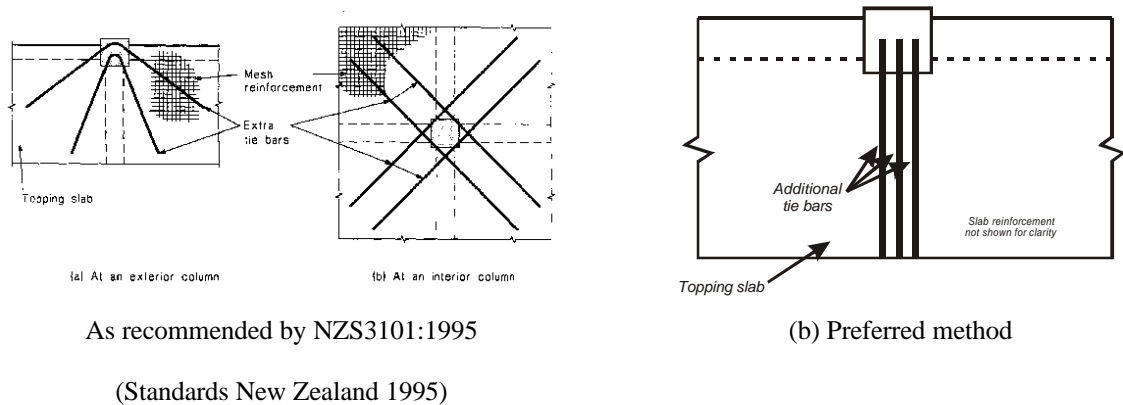
During the experiment a longitudinal tear formed within the floor diaphragm due to the overloading of the diaphragm reinforcement as floor-frame set up displaced. This tear within the floor now affects the column effective length. If such a tear occurred over several floors in a real multi-storey frame then the column may become unstable.

Figure 11. Recommended tie details.

As specified by the NZS3101 the bars should be placed at angles close to 45° . This does help tie the column in but also contributes to the perimeter beams overstrength actions. The bars would be better placed transverse to the perimeter beam. These two comparisons are shown in Figure 10.
