Lessons on Response and Recovery from the 1931 Hawke's Bay Earthquake

N. L. Evans

2006 NZSEE
Conference

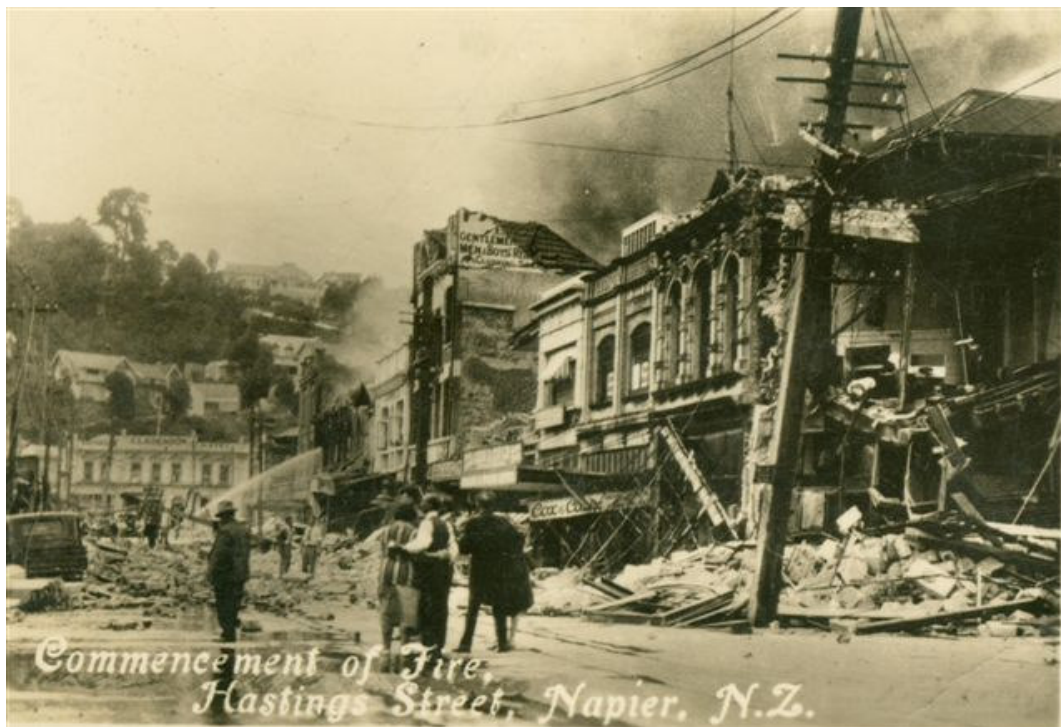
Figure 1. A critical moment: Minutes after the earthquake fire started in Hastings Street, Napier.

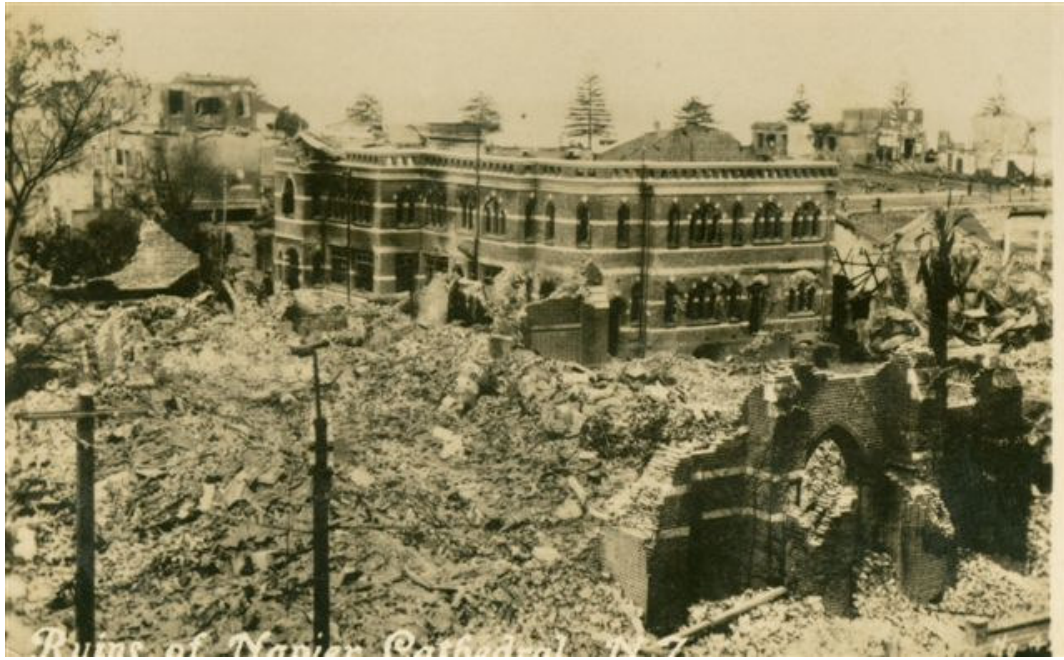
Figure 4. Ruins of Napier Cathedral

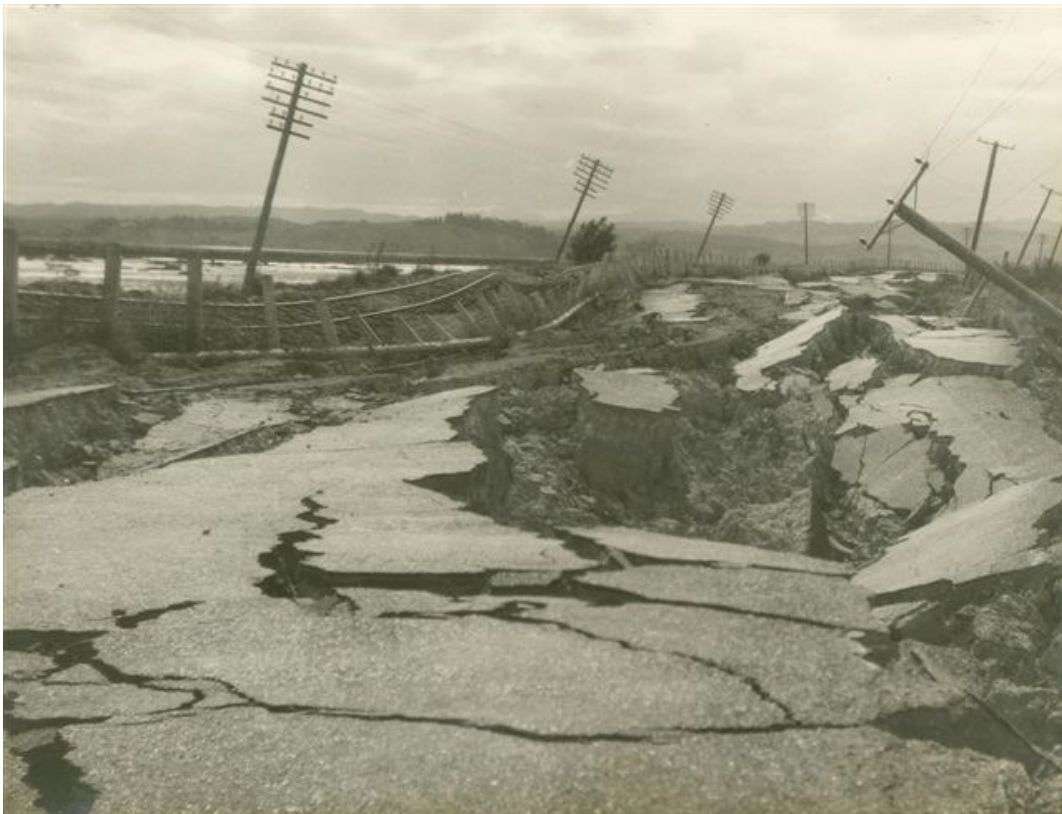
The railway was significantly damaged south from Napier for about 80 km to the Kopua Viaduct. Rails were bent, embankments displaced and bridge approaches subsided.

Figure 5. Damage to the rail, road, power and communications services was significant. An example of the extent of the damage can be seen in this photograph of Embankment Road in Napier.

Priority was placed on repairing the rail south of Napier with repairs initially good for low-speed traffic. The first train reached Hastings in the afternoon of 5 February and Napier the following day. The reinstated railway played a significant role in evacuating the injured and Napier's women and children (mostly for public health reasons) to Palmerston North and other communities south. 4,783 people had been evacuated by 7 February, a quarter of them by train.

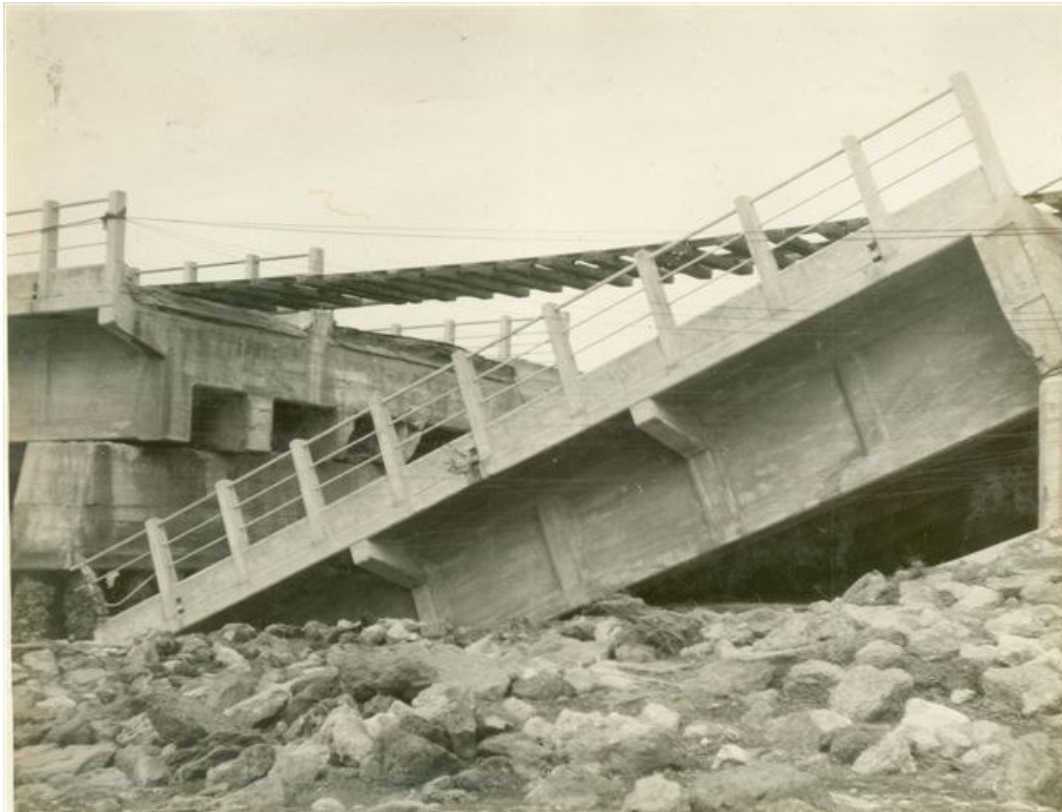
liquefaction of foundation material had induced lateral spread of the embankment (figure 6) was not repaired until 1932. Westshore residents were appeased by the construction of a direct footbridge. This was subsequently destroyed by the 1960 tsunami.

Figure 6. Damage to the Westshore Bridge, Embankment Road.

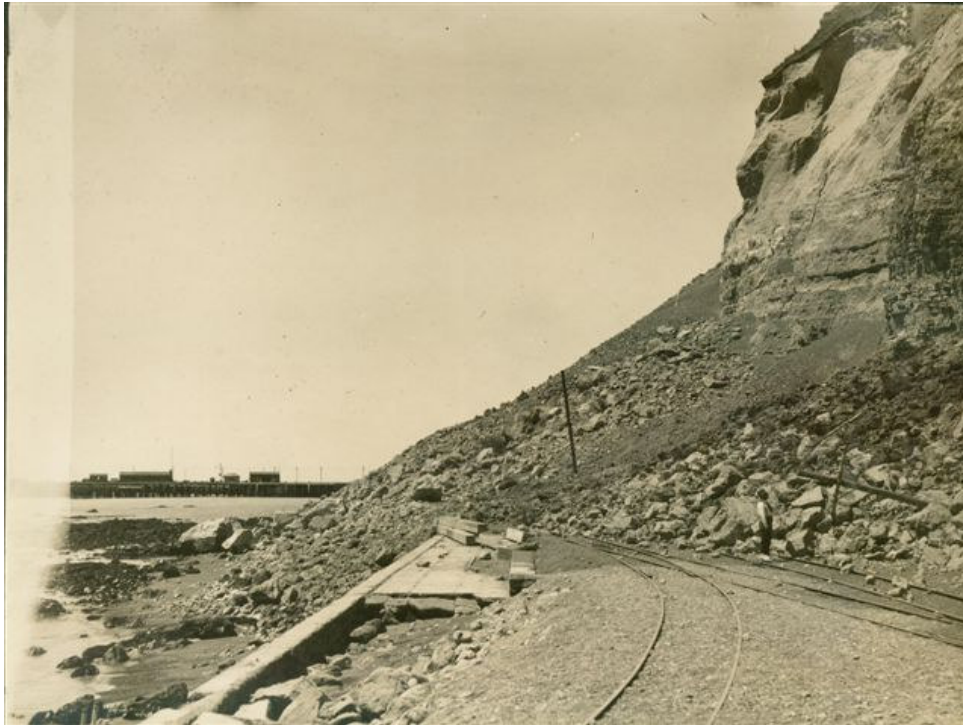
Damage to the Breakwater Harbour was estimated to cost as much as the Inner Harbour. Furkett (1933) describes Glasgow Wharf suffering damage to piles below the level of pile bracing.

Figure 7. Damage to Napier's Breakwater Harbour and Bluff Hill obliterated parts of the road and railway line.

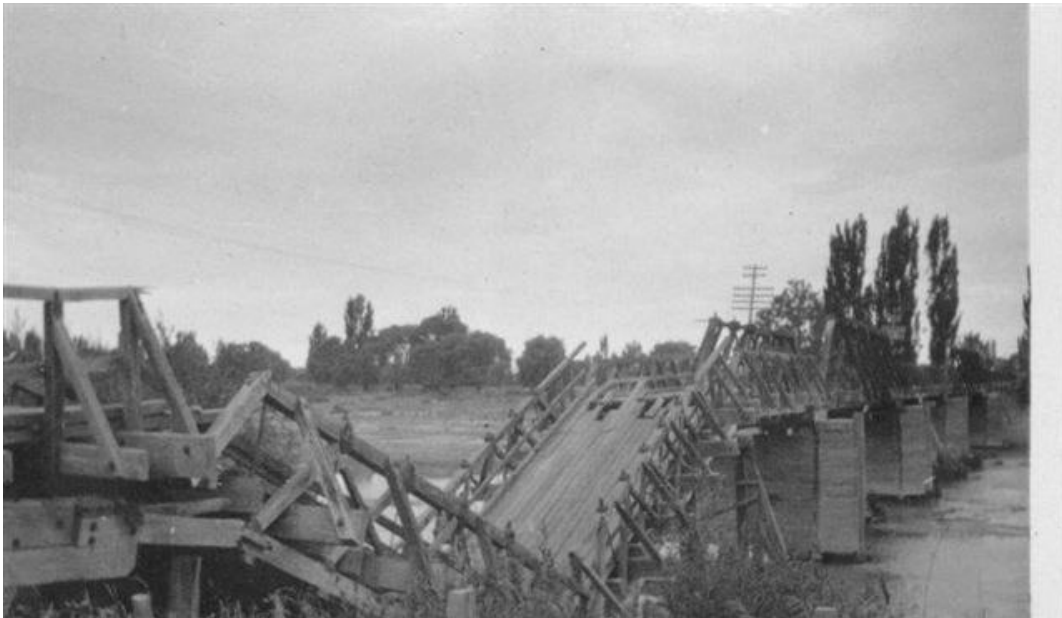
Figure 8. Because of its strategic importance to the Redclyffe Substation, damage to the Redclyffe bridge at Waiohiki near Taradale added to the disruption of power supply services.

Demand for power increased and a spare 20 ton transformer was moved as close as possible to the Redclyffe Substation. This was one and a half kilometres away on the southern bank of the Tutaekuri River, and could not be brought closer due to the damaged bridge at Waiohiki. The transformer was then temporarily connected via aerial cable lines across the river. Supply from this transformer was available from 22 February. The main transformers that had been temporarily reactivated were then lifted back on to their pads one by one.

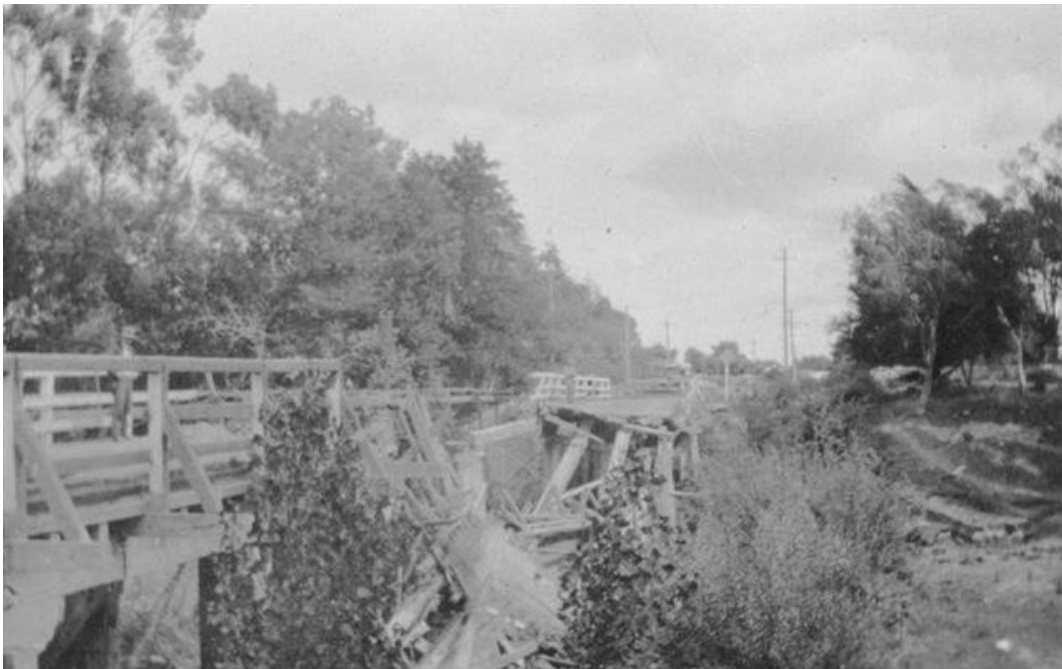
Scott (1931) describes how the main from the Hastings reservoir in the Havelock Hills was ruptured when the bridge at Havelock North collapsed. As a result, the town relied solely on the artesian pumps which remained functional throughout the crisis period.

Figure 10. The Havelock North Bridge was one of many bridges in the region damaged during the earthquake.

Leakage was excessive on the mains and mostly due to broken connections to damaged buildings. Stage by stage and street by street leaks were stopped and mains recommissioned. Water was restored all over the town by the end of the week. Temporary repairs were made to the river crossing at Havelock North and the reservoir filled a week or two later to fully reinstate services.
