A Revised Guide for the Design, Construction and Operation of High Level Storage Racking Systems following the Darfield Earthquake

G J Beattie

S R Uma

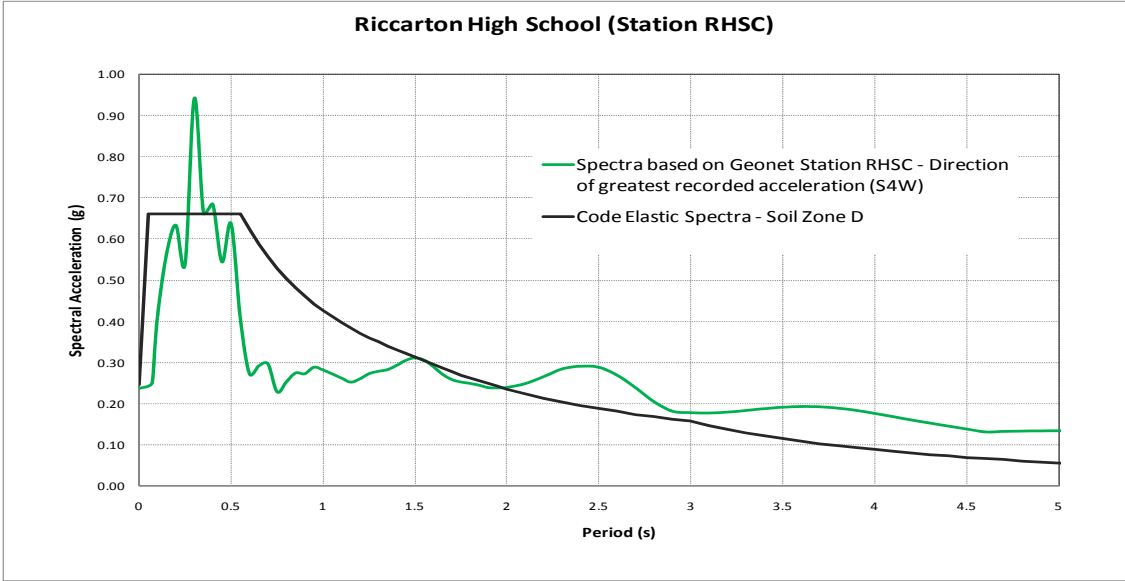
aisle frames. First mode periods for full racks are expected to be greater than 1 second. Inspection of Figures 1 and 2 indicates that the recorded earthquake was very likely to have been greater than the design level earthquake.

Figure 1 Acceleration response spectra for the S4W direction recorder at Riccarton High School

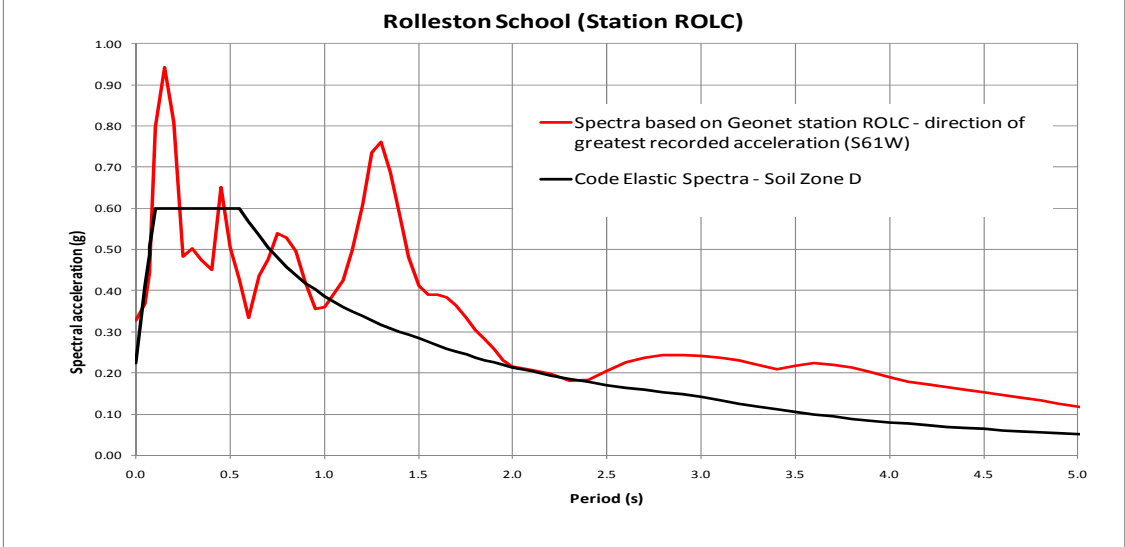
Figure 2 Acceleration response spectra for the S61W direction recorder at Rolleston School

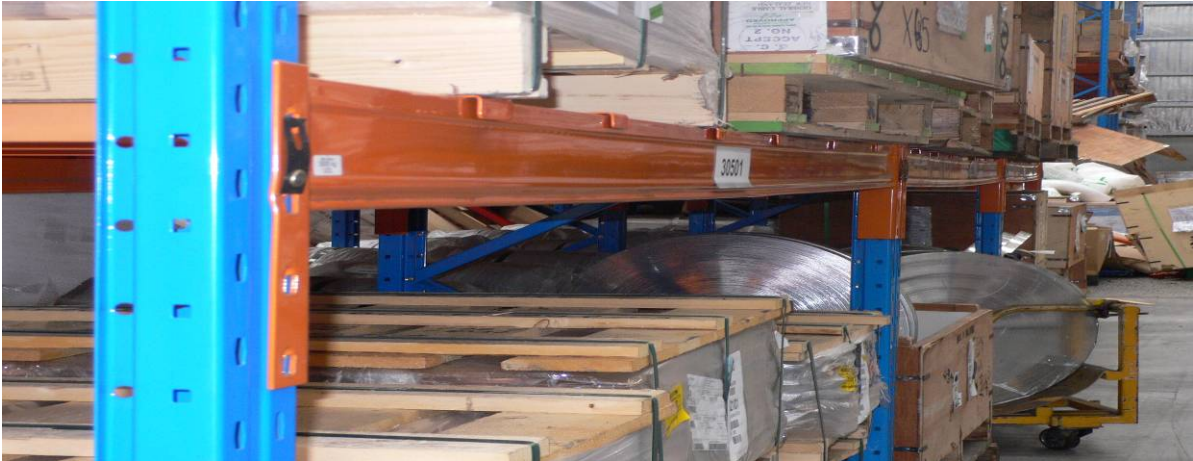
The authors have not observed any instances of beam member failures and none have been notified to us. Certainly bent beam members were observed in collapsed racking but it is believed that these were a result of the failure of other elements. In one instance the beams in undamaged racks showed definite signs of deflection under the stock load. In Figure 3, the load on the beams was approximately half of the specified maximum uniformly distributed load.

Figure 3 Beams deflecting under approximately half of the specified maximum UDL

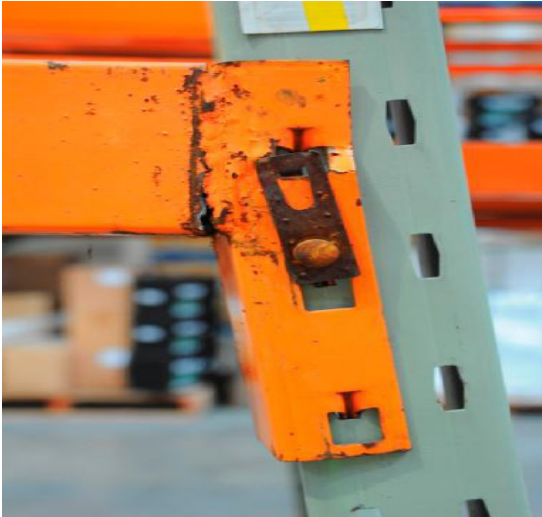
The authors are aware of some instances where welded connections had failed. When all the energy dissipation down the aisle is expected to take place in the ductile connection between the beam and post, to have a brittle failure in the adjacent welded joint between the beam and the connection bracket (Figure 5) is not acceptable.

Figure 5 Failure of welded joint between beam and bracket

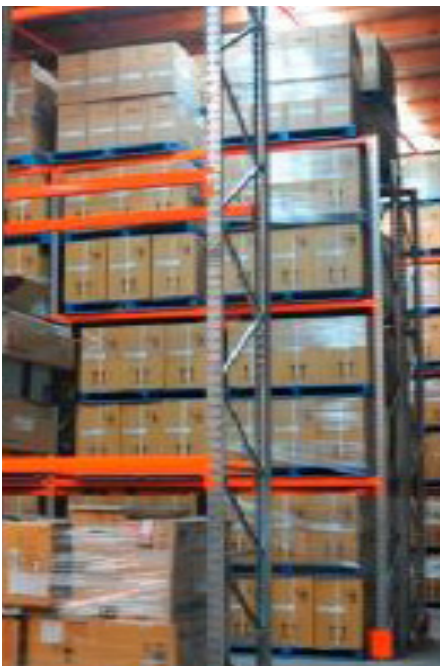
Figure 6 An example of a completely filled commercial racking system

On the other hand, commercial racking is generally built to store palletised products over the full height of the system and the beams are installed at levels which just allow full pallets of the stored product to fit. Commercial demands invariably mean that the racking is loaded to very near completely full all of the time (Figure 6).

For bulky items, such a level of “fullness” may not equate to the full loading that the racking is capable of carrying, but for dense products such as cans of produce, the racking will very likely be placing heavy gravity and seismic demands on the racking. In these cases, the designer will hopefully be provided with accurate product weights.

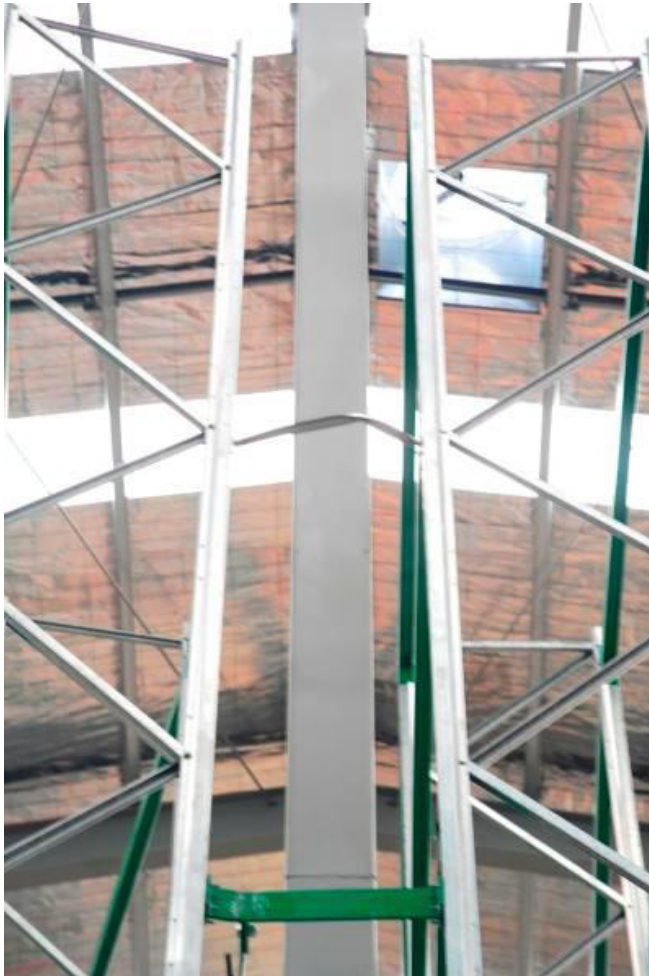
Figure 7 Evidence of impact damage to a racking system from the adjacent building structure

Storage racking is invariably designed to be free-standing without support from the surrounding structure. It is important that seismic displacements of the racking can be accommodated without impacting on the building structure. The authors are aware of at least one instance where parts of a rack have impacted the building structure (Figure 7). In this case, fortunately the rack did not collapse as a result of the impact. However, such impacts could easily alter the response of the racking system to the earthquake motion and introduce unexpected loads on the system.
