Seismic strengthening and restoration of Cargill's Monument

Bevan White, Geoff Anderson & Jerry Kearney

Calibre Consulting (formerly Spiire New Zealand Ltd), New Zealand

2015 NZSEE
Conference

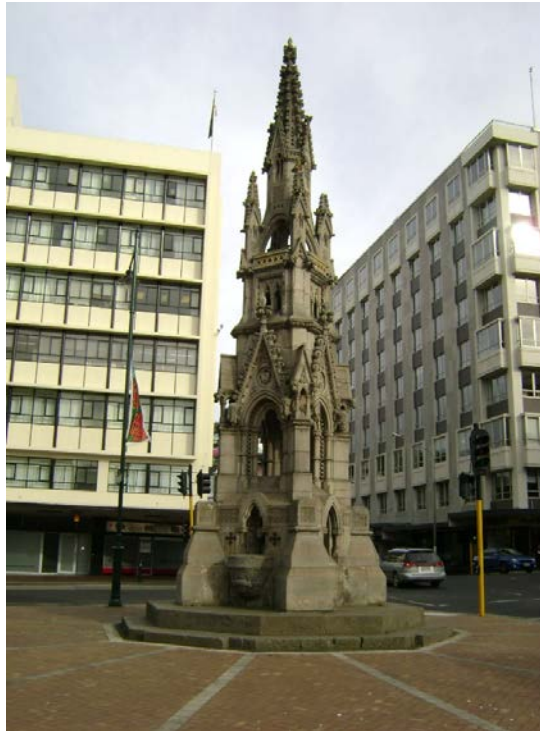
Figure 3. Cargill's Monument before restoration.

The Wainwright report [6] identified damage to stonework from abrasive cleaning and from water ingress through the joints, causing the original metal ties to corrode causing further damage especially around the upper flying buttresses and lower vault arches. The Williams report [7] made recommendations for repair and restoration works which included the systematic deconstruction of the upper part of the monument to enable removal of the corroded steel armature and damaged stones. It also revealed several archaeological features in the immediate vicinity of the structure, which needed to be considered if the ground was to be disturbed. In the event of disturbance below the monument it was possible that evidence of earlier subterranean public toilets (said to have been filled in with sand and broken toilets), remains of the former Mechanics' Institute, and pre-1900 use of the site by both Europeans and Maori, could be encountered.

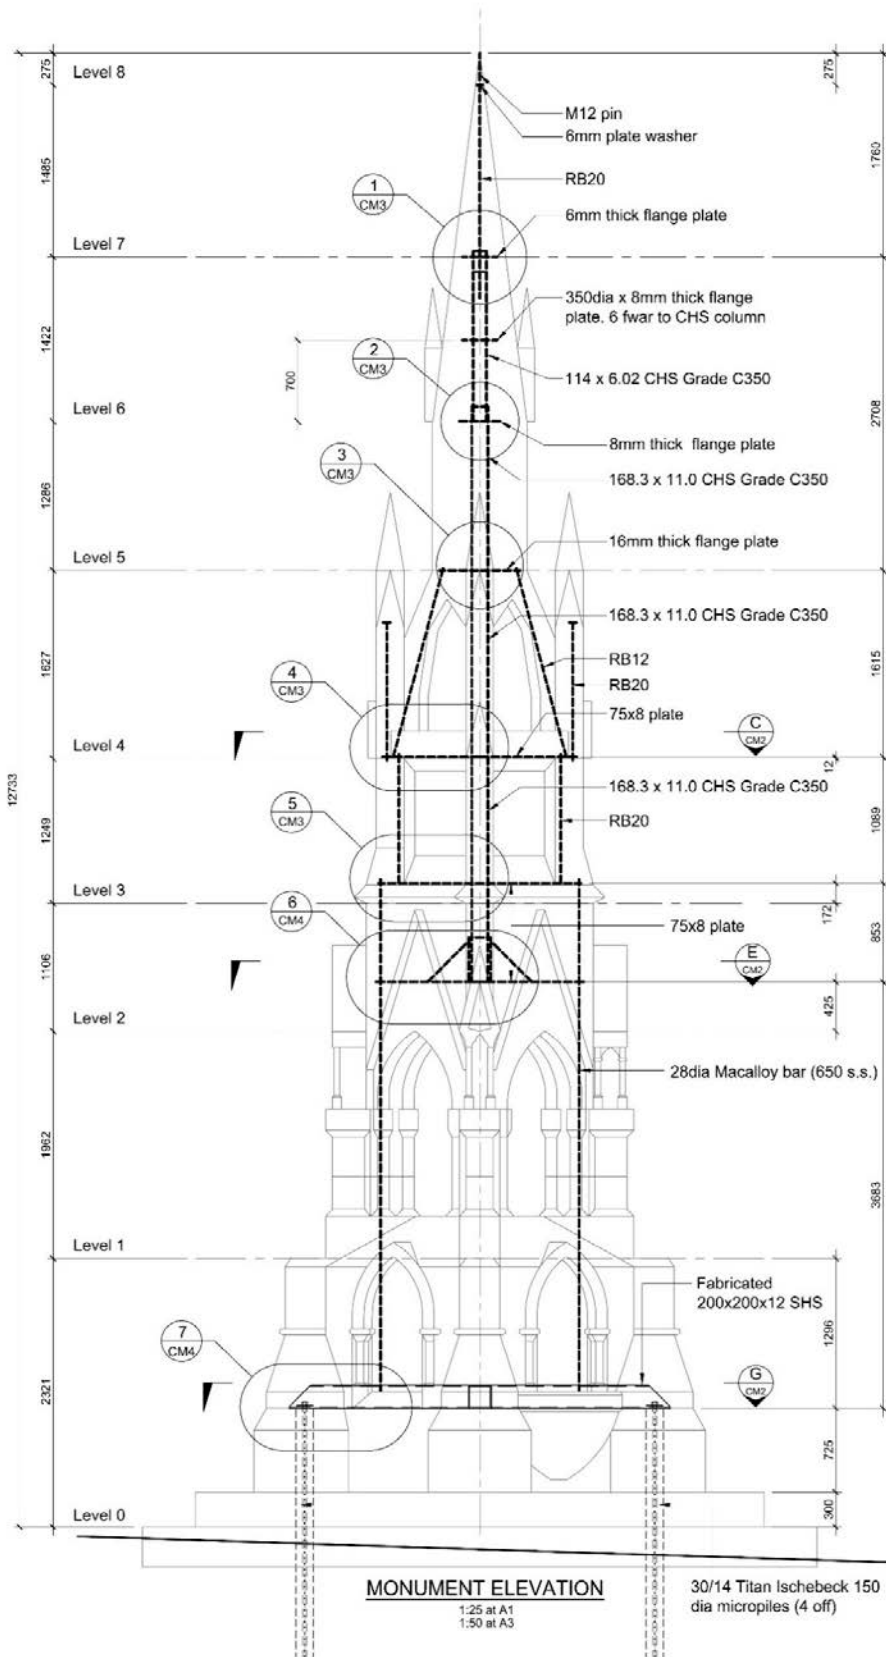
Figure 6. Seismic strengthening frame model.

The monument's structure was analysed using Microstran computer analysis software to determine the expected design forces within each of the structural elements. This was conducted by modelling a frame structure that consisted of equivalent sized concrete members replicating the stone dimensions and properties in conjunction with the new central steel tie elements (Fig. 6). The analysis used the equivalent static method with the forces applied at the six levels throughout the monument where diaphragm action was expected to occur with the installation of the new steel plate members.

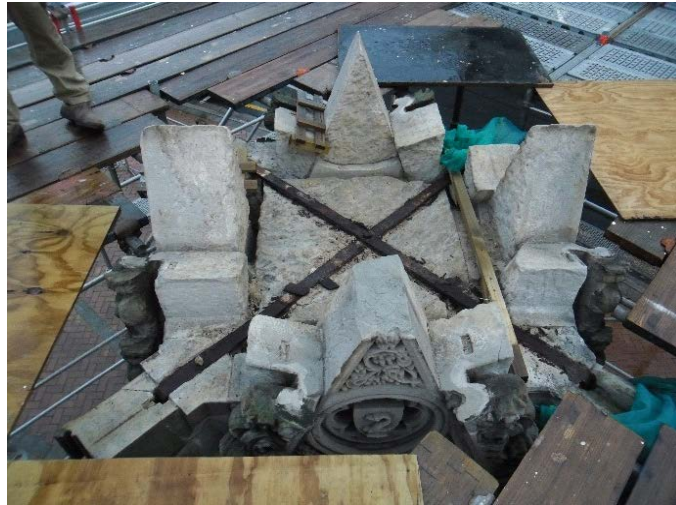
The monument was carefully dismantled in late 2011 to a low level just above the lower arches, removing all corroded steel (Fig. 7). The stone elements removed were transported to a workshop for repair and for coring vertical holes to fit the proposed rods.

Figure 7. Dismantling revealing original corroded tie bars.

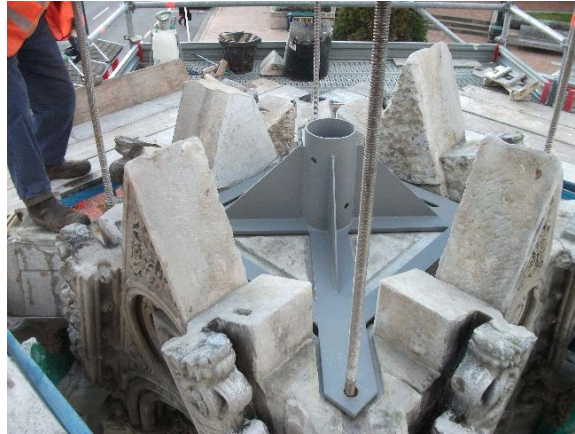
Figure 8 Reconstruction.

Above the lower arch there was sufficient internal void to enable a central steel column to provide lateral restraint from plates and rods at various levels (Figs. 8 and 9).

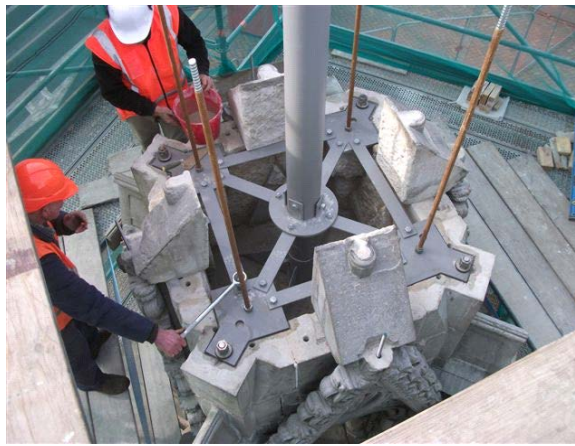
Figure 9. Re-Construction plates and rods.

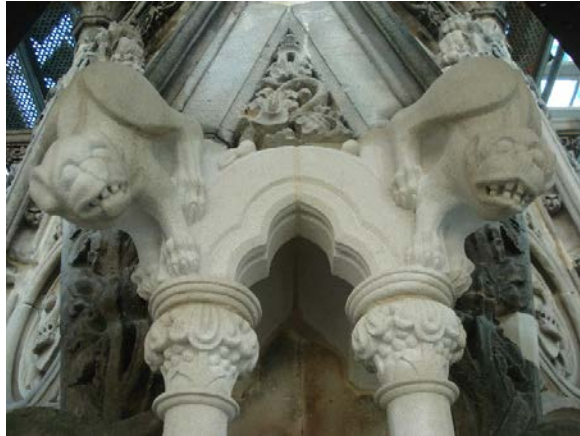
Figure 10. New carved stone Grottoes.

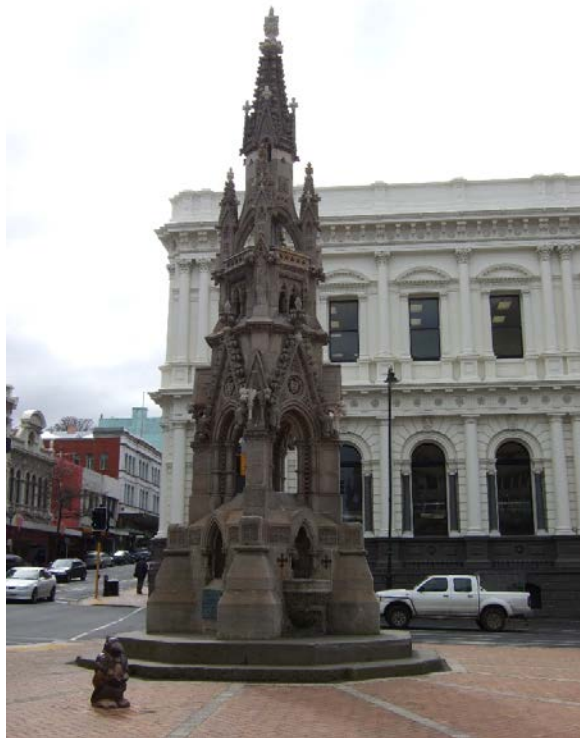
Figure 11. Restored and Strengthened Monument.
