# Learning from Earthquakes Significant Event Report – VERT Venezuela June ‘26 - Version 1.0

**Report Issued: 2nd July 2026**

Location (Geographical): **near Veroes, Yaracuy, Venezuela**

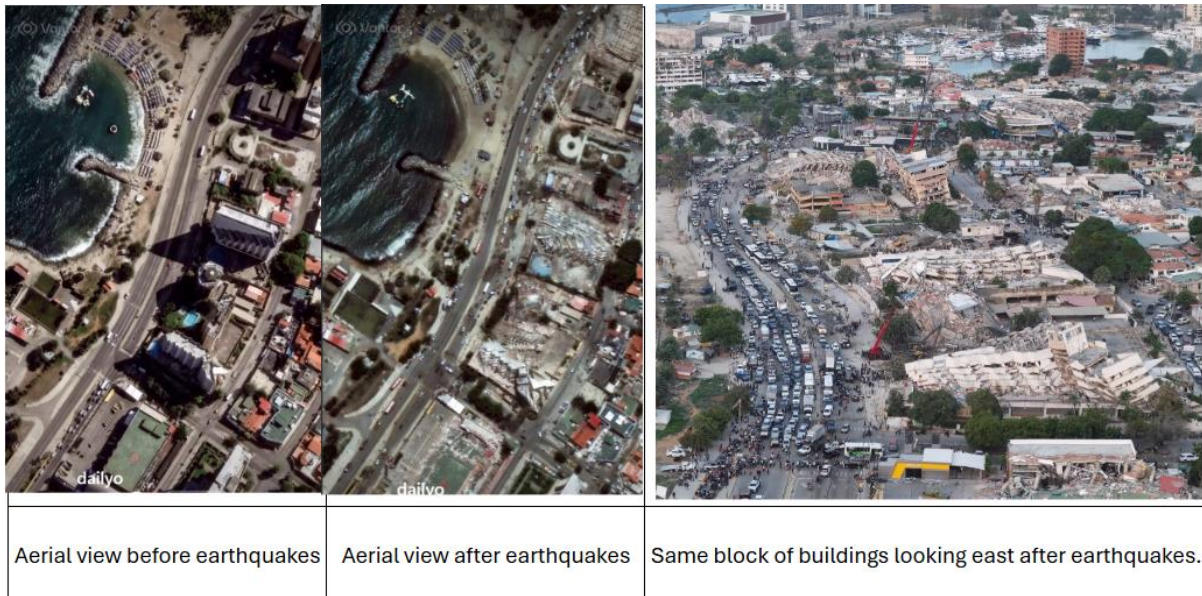
The high rise (8+ floors) buildings in the regions of Catia La Mar, Maiquetia, and Caraballeda, suffered the most significant and catastrophic damage. Before and after aerial photographs shown in Figure 18 show at least half of the taller apartment buildings have completely collapsed.

Figure 18. Aerial imagery comparisons for the Catia La Mar region. Source: Vantor Satellite Imagery, ([The Guardian](#)).

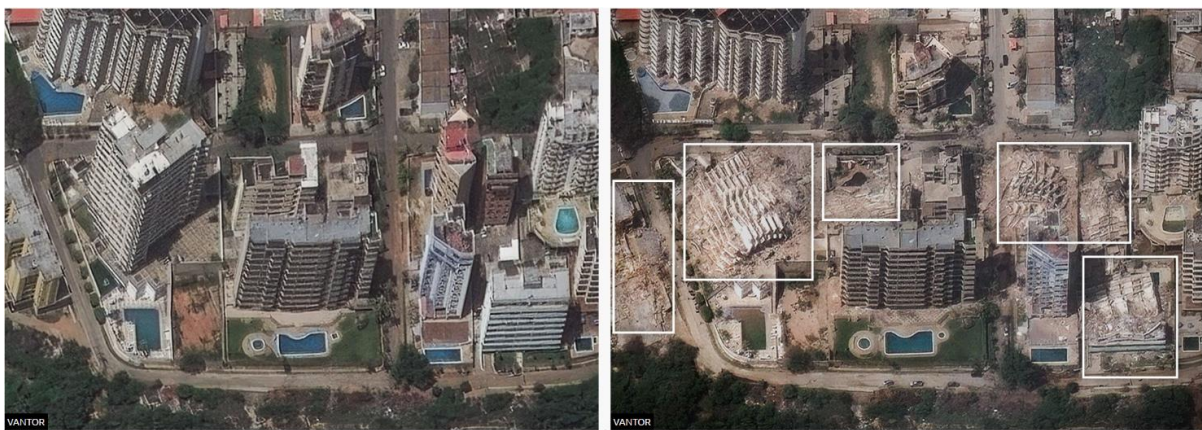
In Maiquetia, many of the collapsed buildings in Playa Grande are situated along the top of the escarpment south of the coastline as outlined in Figure 19.

Figure 19. Before and after comparisons along the Playa Grande escarpment. Source: Vantor Satellite Imagery.

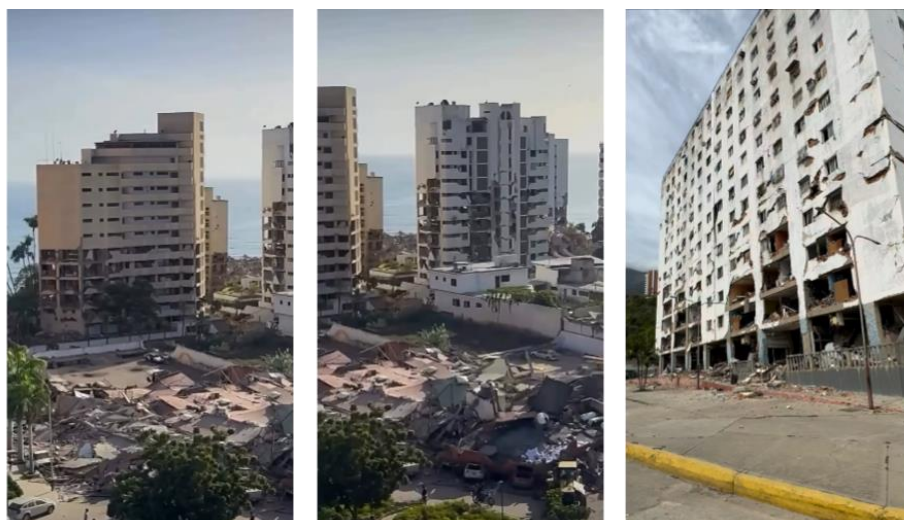
Typical masonry infill are comprised of unreinforced hollow-clay bricks plastered over with mortar. This appears to be used widely for external partitions, balcony balustrades, parapets and inter-tenancy walls. Infill damage such as that shown in Figure 20 is widespread. In severe cases, entire walls dislodged out of plane. In high-rise structures, this damage tends to be concentrated in the lower 4-8 storeys, indicating damage governed by drift demands rather than accelerations.

Figure 20. Typical infill damage in non-collapsed buildings (Social Media).

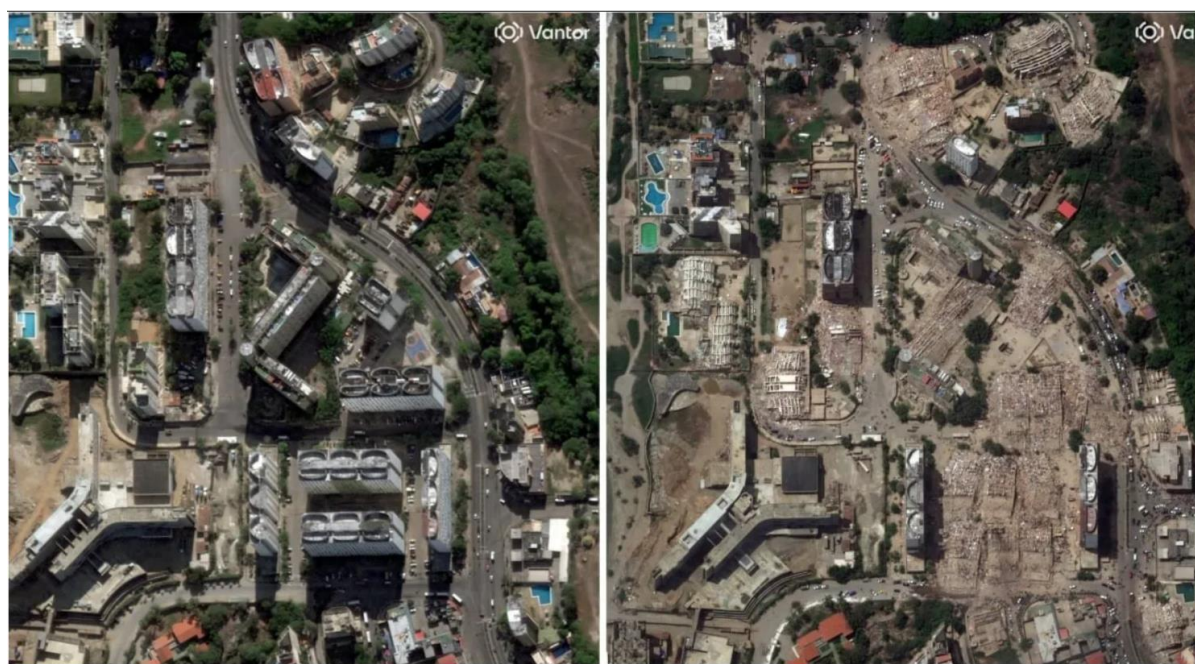
Recent public apartment buildings such as those shown in Figure 21 and Figure 22 have been built throughout Venezuela’s main cities around 2012. In Caraballeda, almost all these types of buildings in one localised area suffered complete collapse.

Figure 21. Before and after aerial comparison of government housing (circular plant enclosures on roof).  
 Source: Vantor Satellite Imagery.

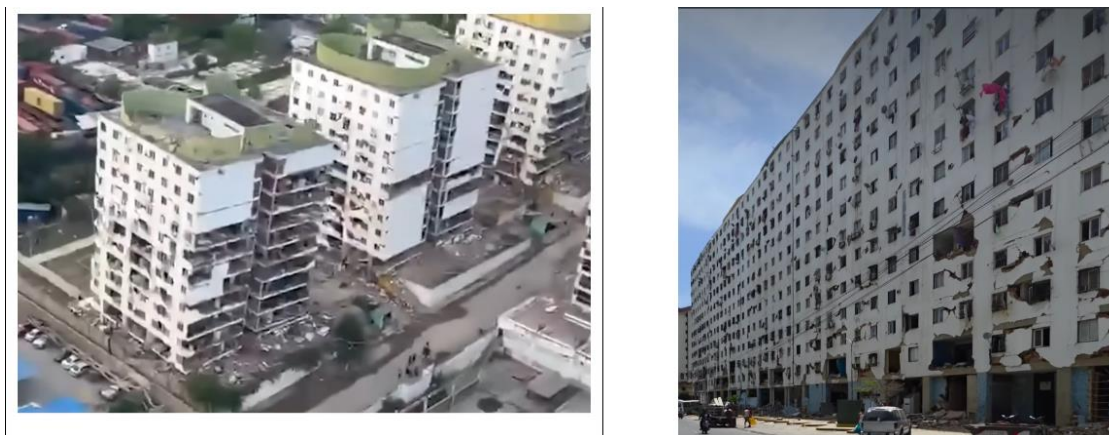
Figure 22. Government housing in Catia La Mar with collapsed ground floor (left, [Social Media](#)) and in Caraballeda (right, [Social Media](#)).

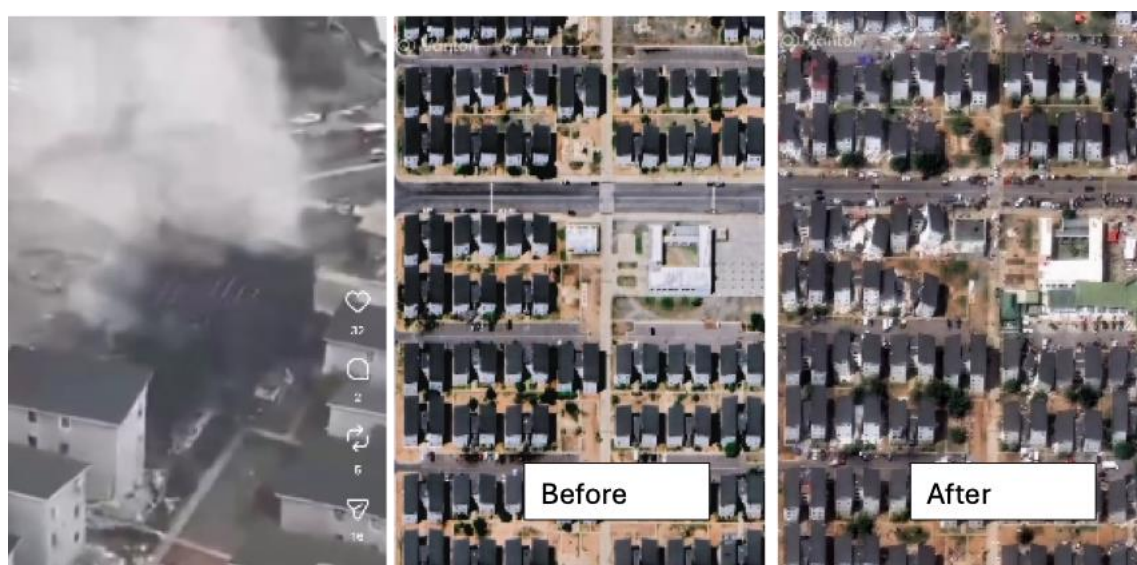
Figure 23. Damage to a development in Playa Grande built during the Great Mission Housing Programme 2011-13. Building on fire (left, [Social Media](#)) and many collapses (middle to right, source: Vantor Satellite Imagery). These structures are steel frame and steel stud, rather than the predominant concrete elsewhere in the region.

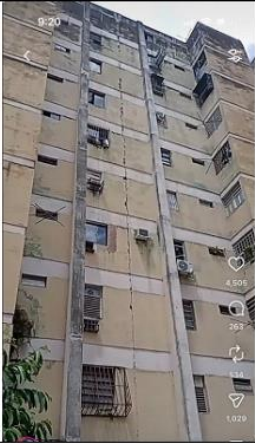
| <p>Vertical crack on the Urbanización Kerdell building.</p> | <p>Masonry façade and infill damage at the Residencias Villas Sol.</p> |

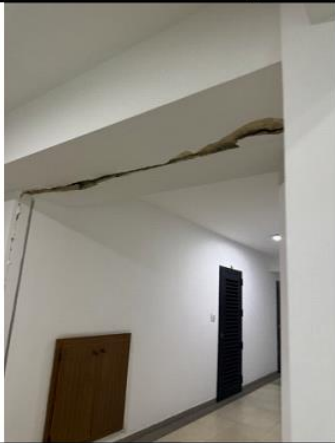
| <p>Cracking at beams and columns reported at all levels of the Urbanización Kerdell building.</p> | <p>Partition wall crack at the Residencias Villas Sol, reports of damage to water and gas pipes.</p> |

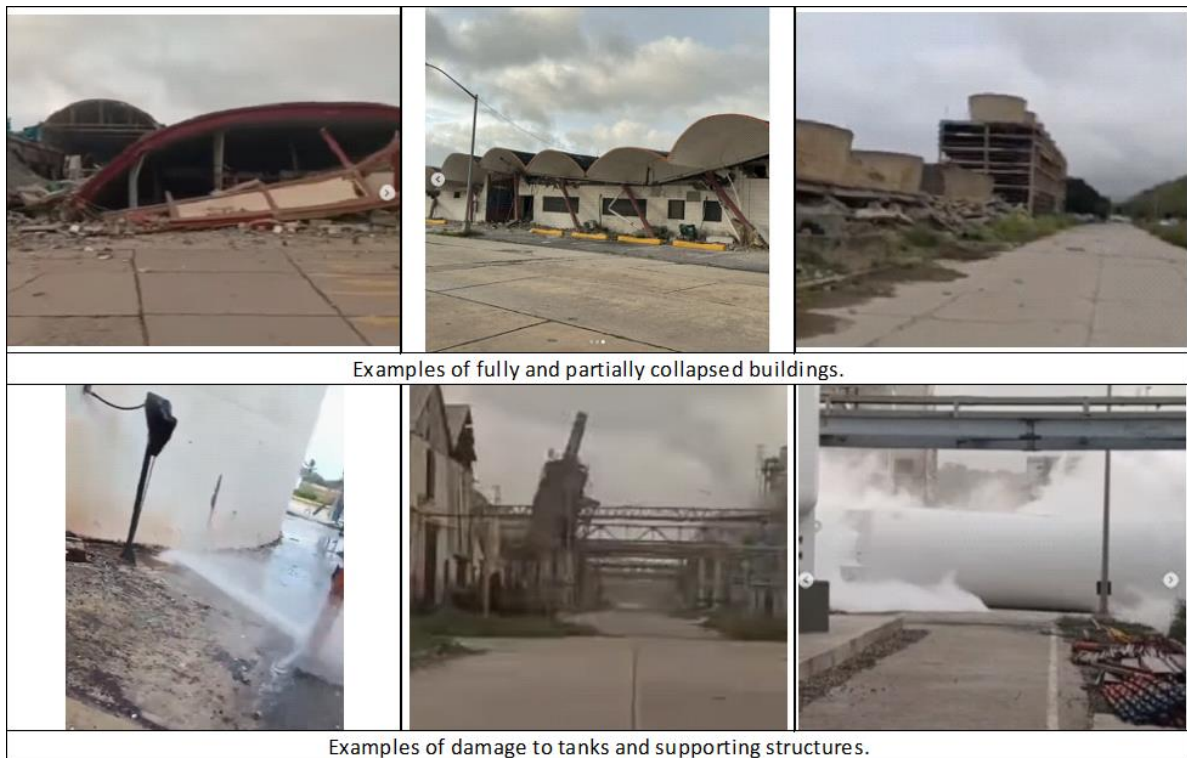
Table 6. Damage at a petrochemical plant in Mórón, Carabobo (Complejo Petroquímico de Morón) ([Social Media](#), [Social Media](#), [Social Media](#))

Several structures have fully or partially collapsed at a petrochemical plant in Móron and multiple tanks are damaged, including instances of leaks, collapse, and permanent deformation of supporting structures (Table 6).

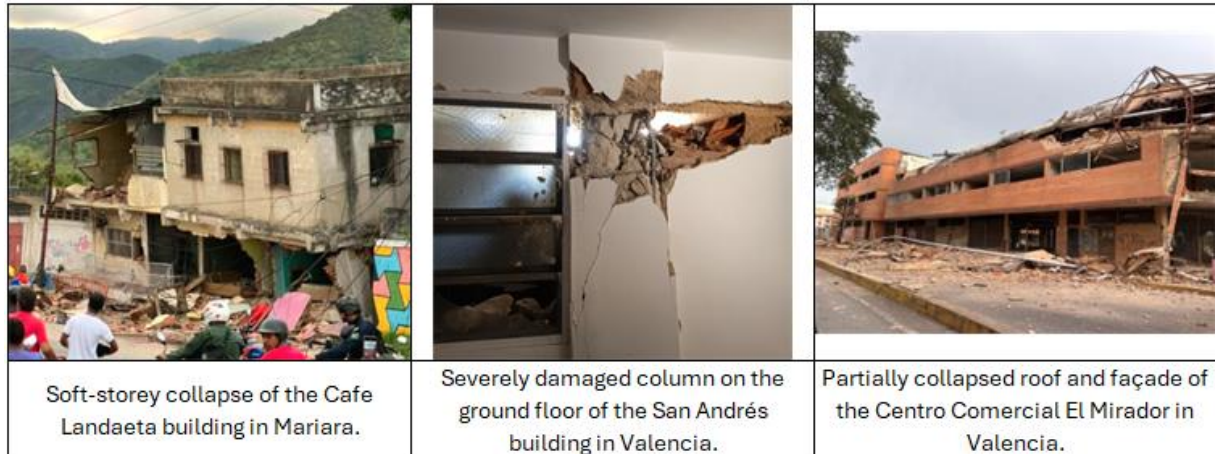
Table 7. Severely damaged and collapsed low-rise buildings in Carabobo ([link](#)).

The structures that experienced significant structural damage or collapse in this region appear to be low-side (1-3 storey) residential and commercial structures (Table 7).

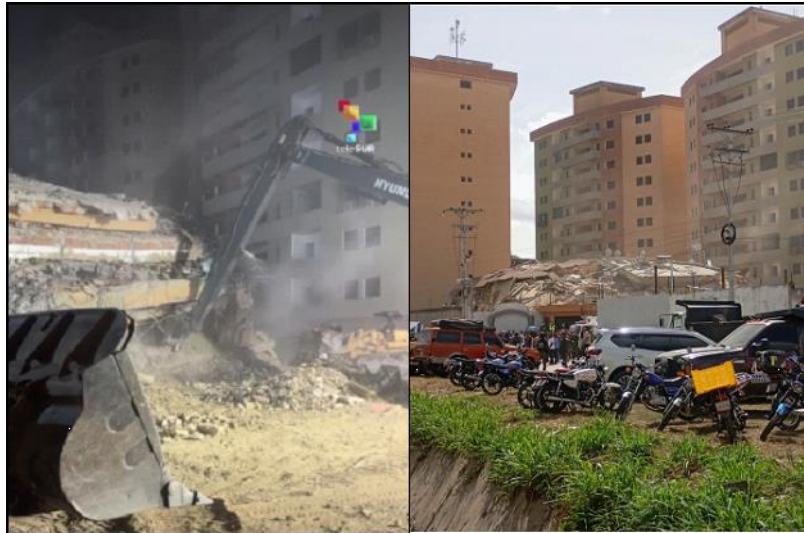
A 10-storey building in the Bosque Lindo condominium complex in Turmero, Aragua, collapsed catastrophically. At the time of writing, there is no indication of the reason for collapse in the media or mention of damage to the other three towers which remain standing (Figure 24).

Figure 24. Images of the collapsed tower four at the Bosque Lindo in Turmero, Aragua ([terremotovenezuela](#), [Social Media](#), [Media](#)).

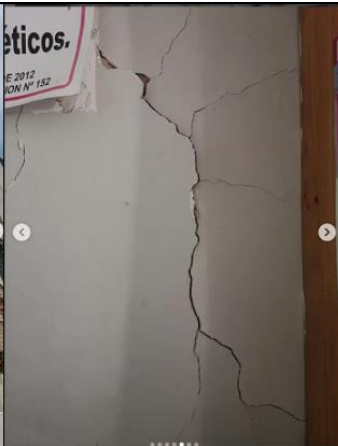
| <p>Façade and masonry infill wall damage at the Residencias Roa.</p> | <p>Damage to a partition wall at the Residencias Roa building.</p> | <p>Masonry wall damage at the Edificio Alfa.</p> |

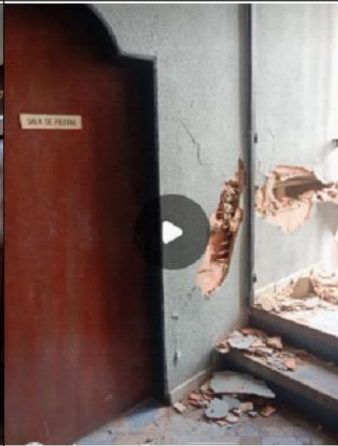
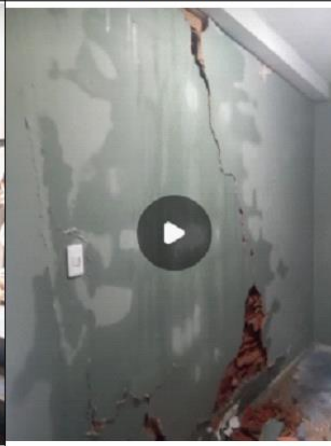
| <p>Damage to a partition wall at the Edificio Alfa.</p> | <p>Masonry infill wall damage at the Victoria Plaza Building.</p> | <p>Partition wall with cracking and water damage at the Victoria Plaza Building.</p> |

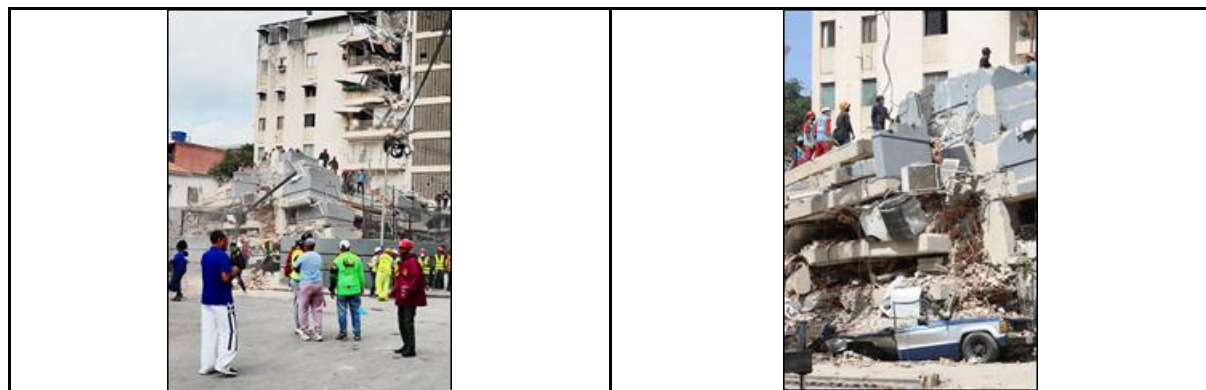
Figure 26. Edificio San Judas Tadeo - a collapsed 7-storey residential Reinforced Concrete (RC) building. The neighbouring building, originally a similar height, shows localised damage without collapse.

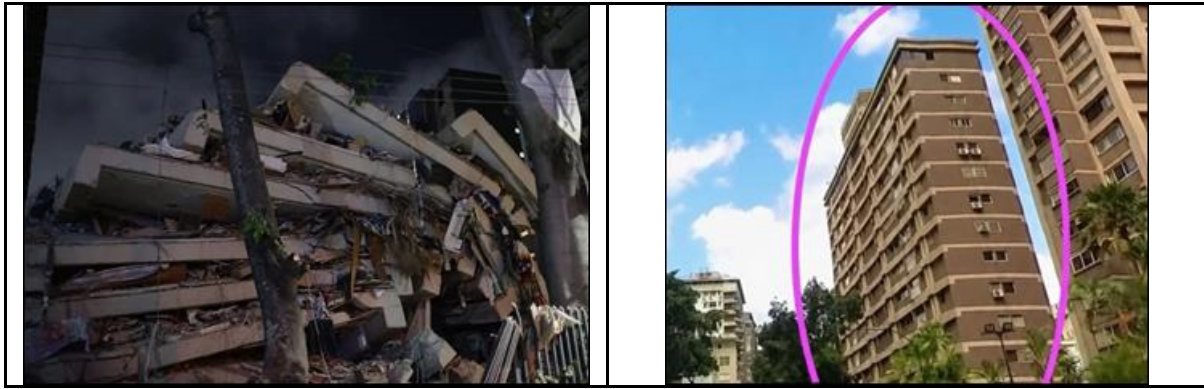
Figure 27. Edificio Petunias – a collapsed 14-storey residential RC building (left) and its original state (right).

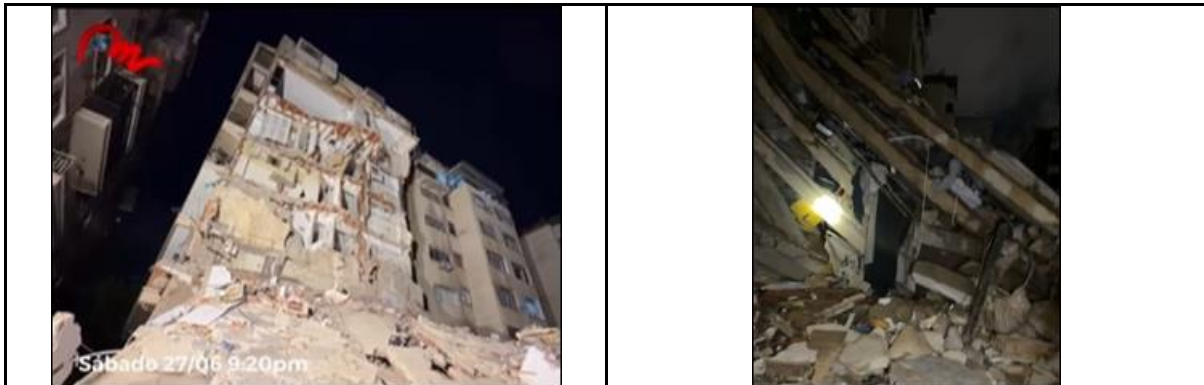
Figure 28. Edificio Don Pepe – a collapsed 7-storey residential RC building. In this building, only its back portion collapsed..

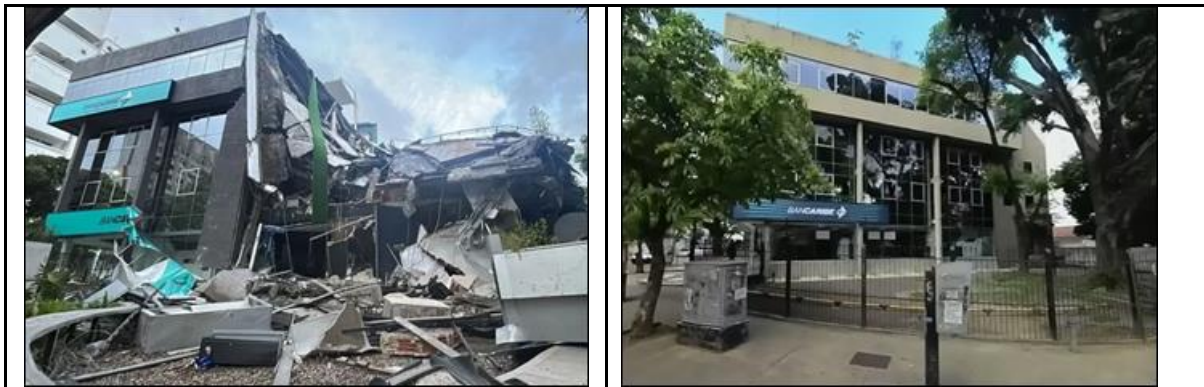
Figure 29. Edificio Bancaribe – a collapsed commercial building understood to be partially steel-framed.

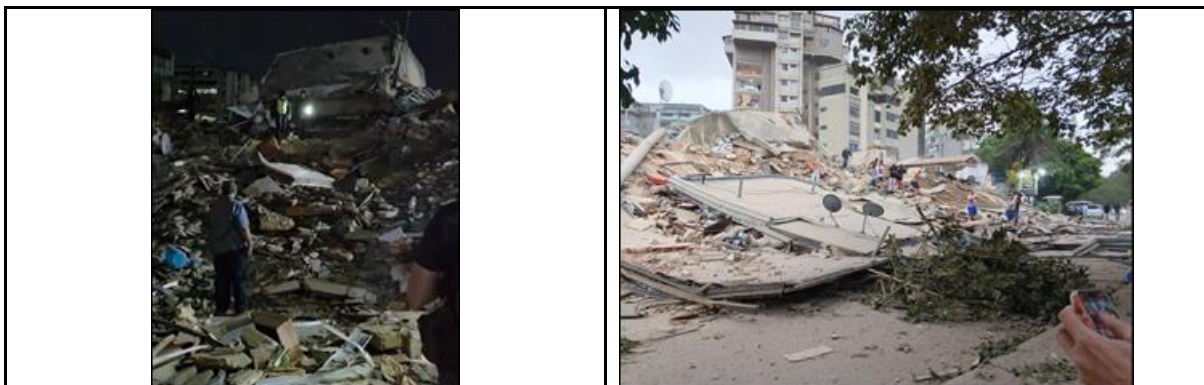
Figure 30. Edificio Rita – a collapsed 7-storey residential RC building.

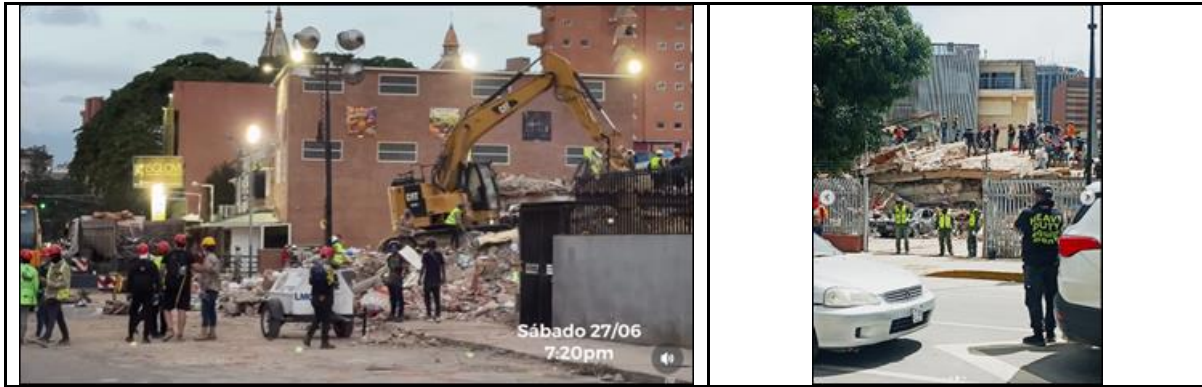
Figure 31. Edificio SJT (left) -a collapsed 7-storey residential RC building, and Edificio Obelisco- a collapsed 4-storey residential RC building.

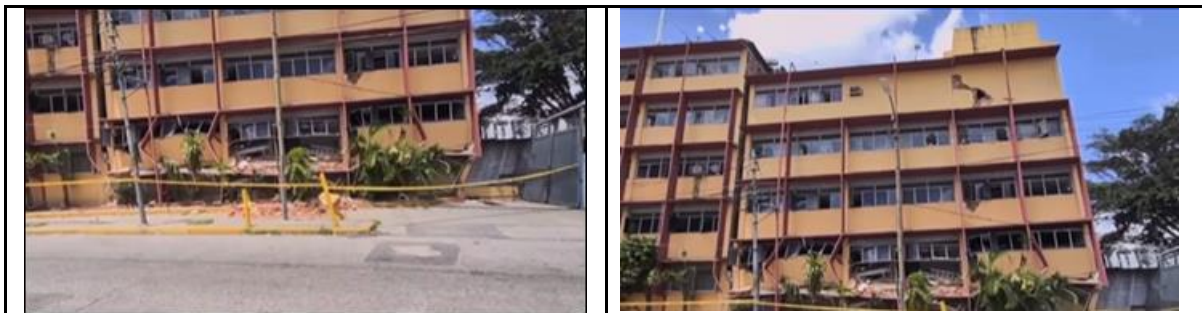
Figure 32. Hospital Risquez showing a ground floor soft-storey.

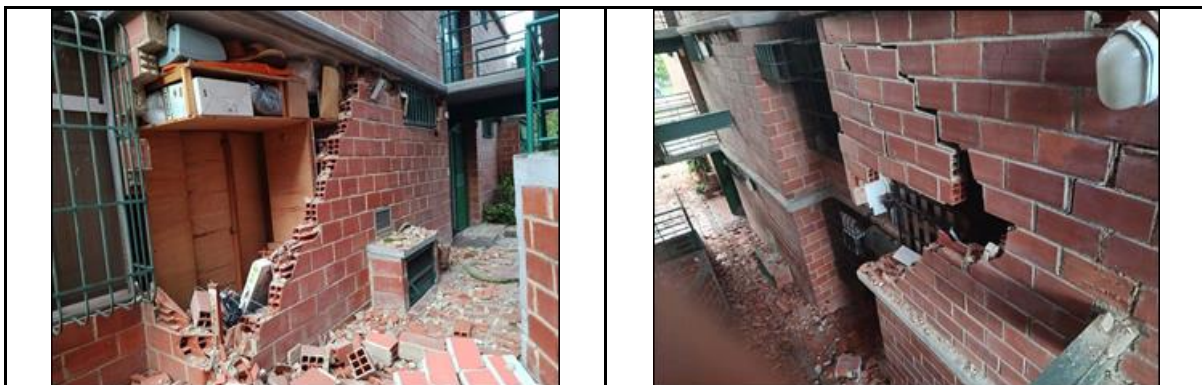
Figure 33. Residencias El Tablon – showing an unreinforced-unconfined clay masonry wall in the 4-storey building and shear failures, mainly at ground and first floor levels.

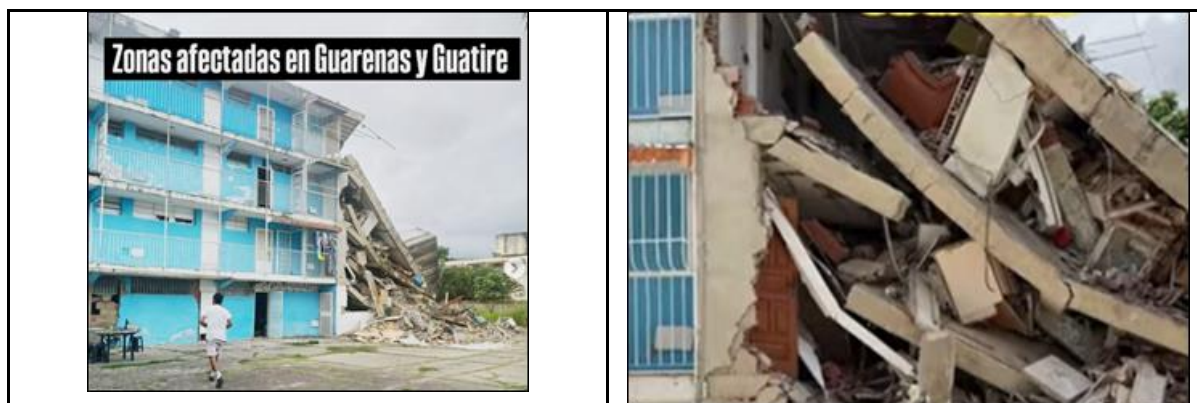
Figure 34. Bloque 8 Oropeza Castillo - a 4-storey residential RC and clay masonry building. From photographs and videos, this building is likely either to have been extended or built in more than one stage. Also, there was a water tank at the roof level.

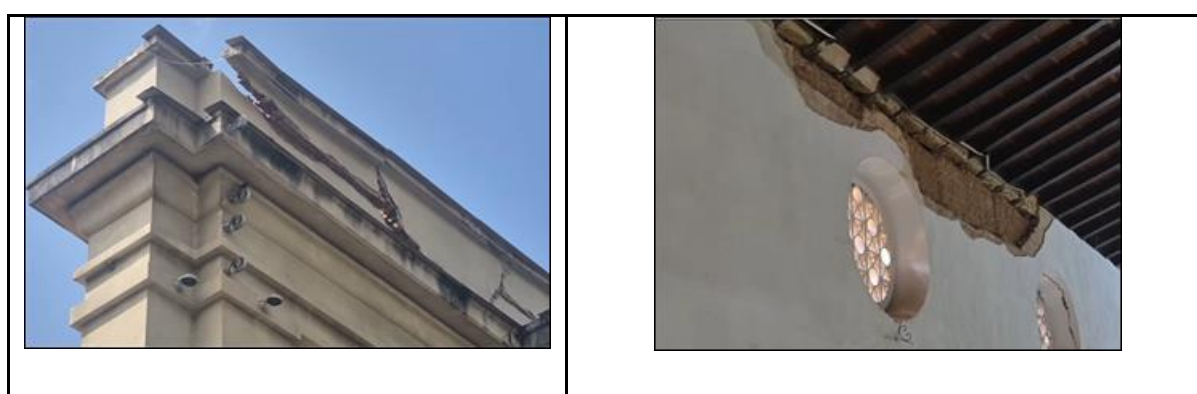
Figure 35. Catedral de Nuestra Señora de Copacabana. This building was built in 1800, using adobe as construction material, with a renovation in 1950. It appears to have experienced minor damage, mainly through parapet cracking.

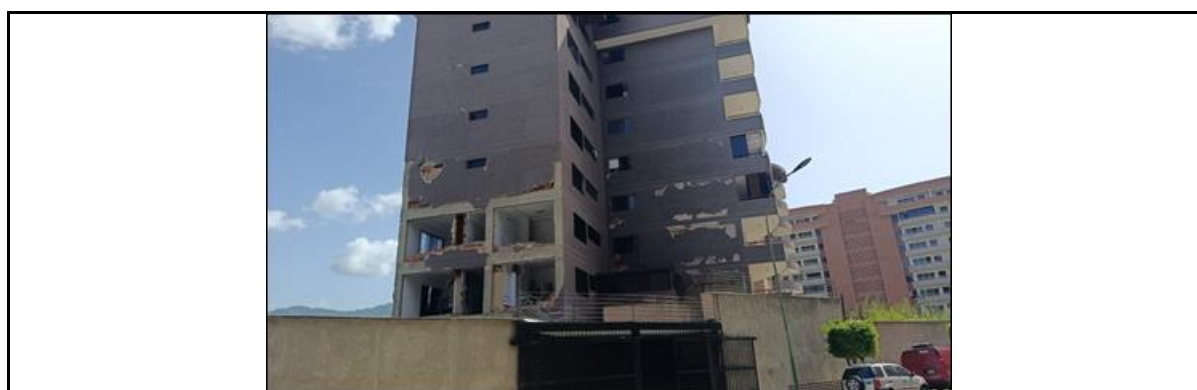
Figure 36. Edificio El Almendron – a high-rise residential RC framed building which suffered many of the same failure mechanisms seen in other regions.

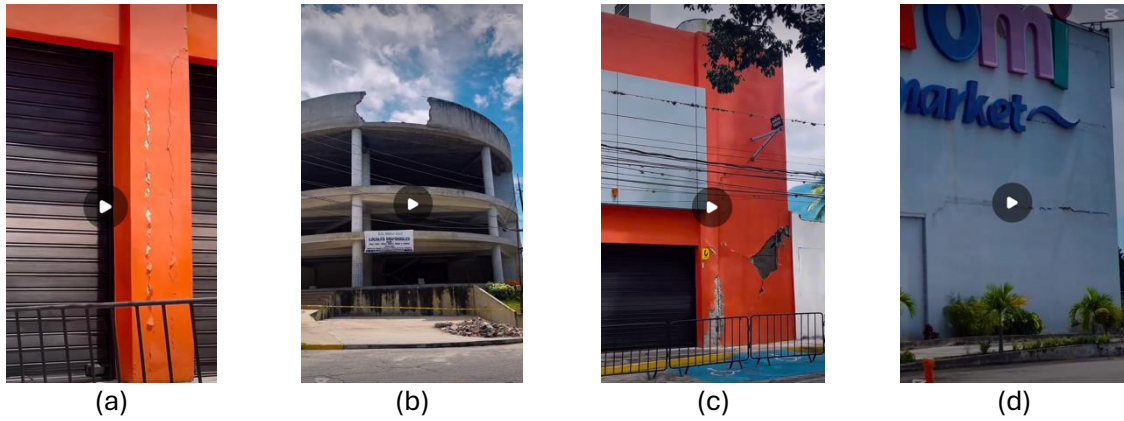
Reinforced Concrete (RC) commercial buildings in the Yaracuy and Lara regions showed concrete cover cracking and spalling at column bases, cracking in curved wall components, and separation between infill walls and structural frames (Figure 38). Extensive damage was observed in non-structural components as shown in Figure 39, including partition walls, masonry infills, and suspended exposed ceiling systems, with failures such as grid buckling, tile misalignment, and falling ceiling panels. Some other examples of typical damage in these regions is shown in Figure 40 and Figure 41.

Figure 37. Damage of RC low-rise commercial buildings in San Felipe: (a) concrete cover cracking; (b) cracking in curved wall components; (c) damage of infill wall; (d) separation between infill walls and structural frames.

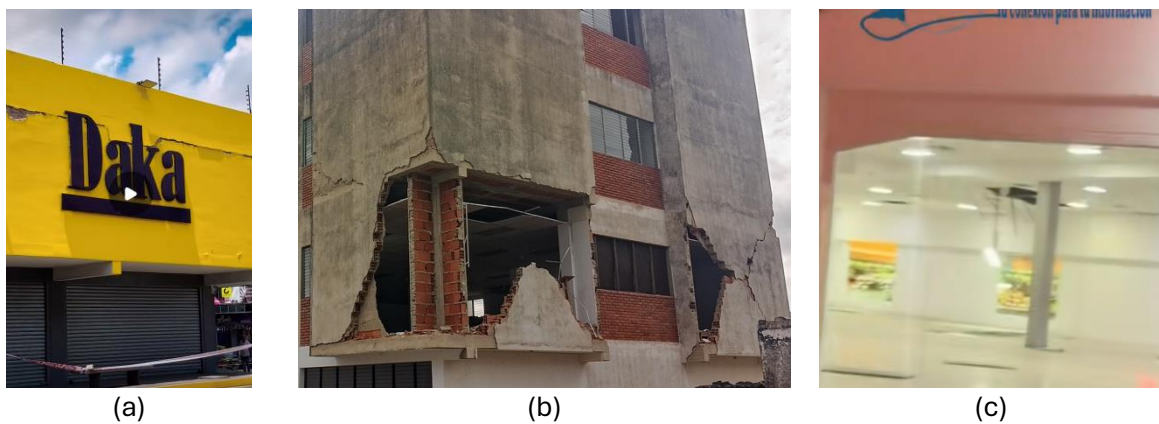
Figure 38. Further damage to commercial buildings in San Felipe: (a) horizontal crack along the display wall; (b) infill wall damage; (c) exposed ceiling system failure.

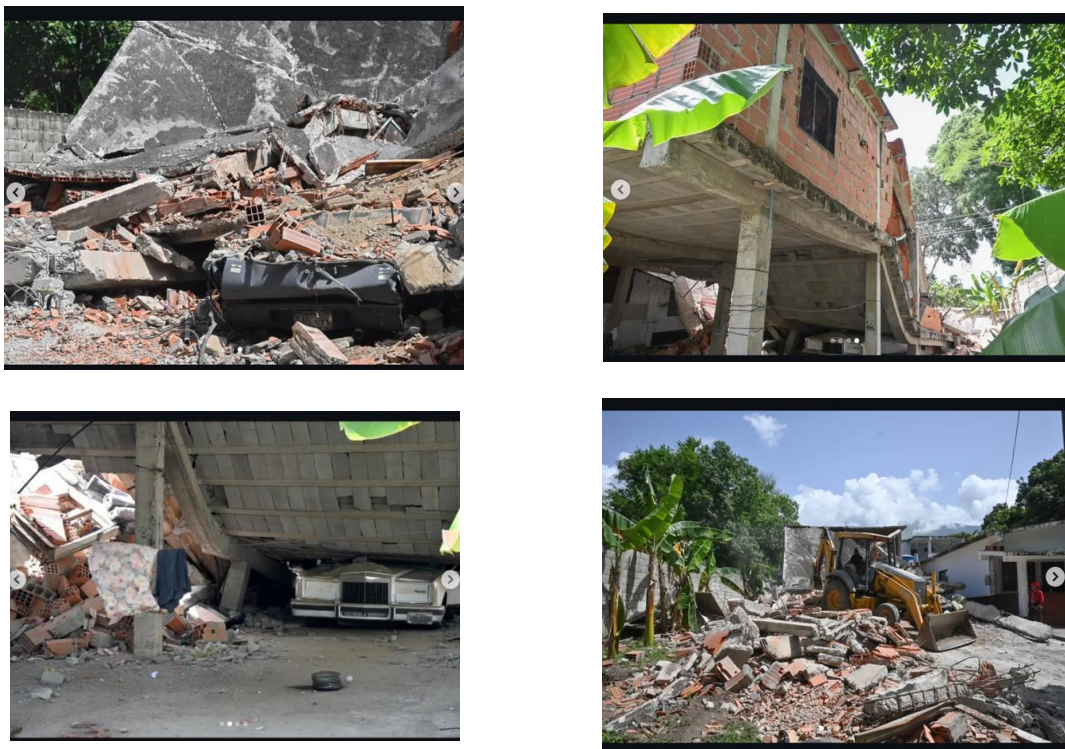
Figure 39. Severe damage of residential buildings in Cocorote.

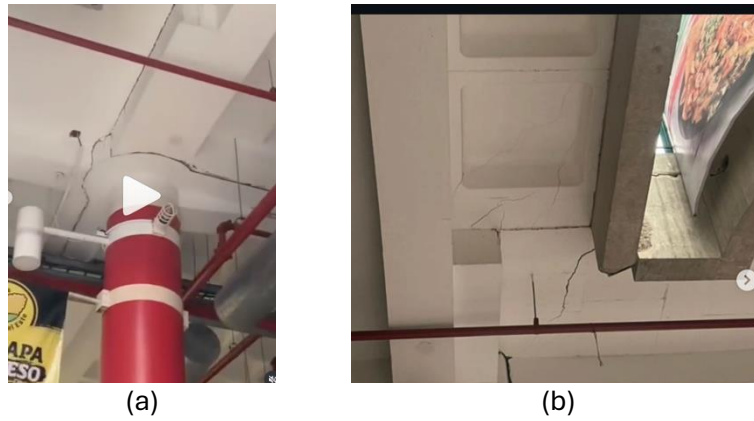
Figure 40. Cracking observed in a low-rise RC frame building at C.C. Metropolis, Barquisimeto: (a) beam-column joint; (b) floor interface.

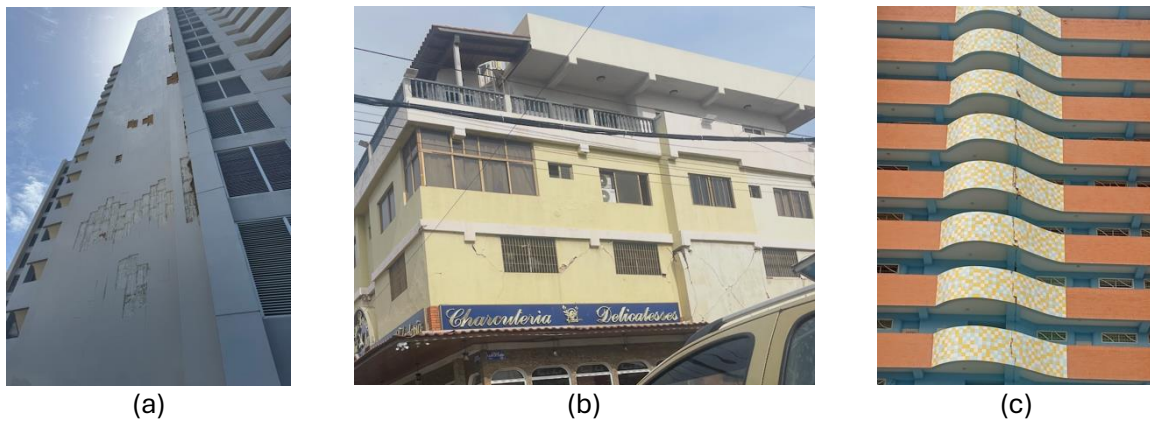
Commercial buildings in Falcón mainly exhibited damage to architectural components, including detachment of facade cladding, cracking of infill walls, and damage to elements associated with seismic separation joints outlined in Figure 42. Figure 43 shows an L-shaped mid-rise RC frame building complex, where one wing completely collapsed while the adjacent perpendicular wing remained relatively intact. Figure 44 shows other damage observed in Falcón.

Figure 41. Architectural component damage in Tucacas: (a) detachment of facade cladding; (b) cracking of infill wall; (c) damage to elements associated with seismic separation joints.

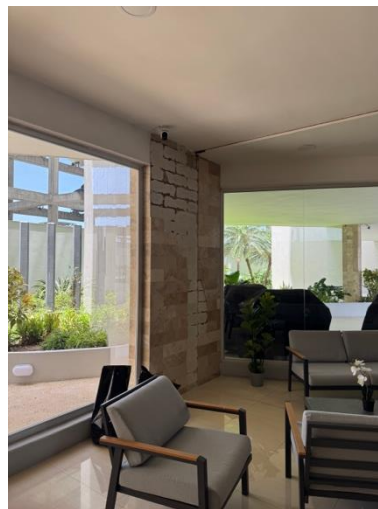
Figure 43. Minor damage to concealed ceiling system in low-rise RC frame buildings at Residencias Atlántica, Tucacas.

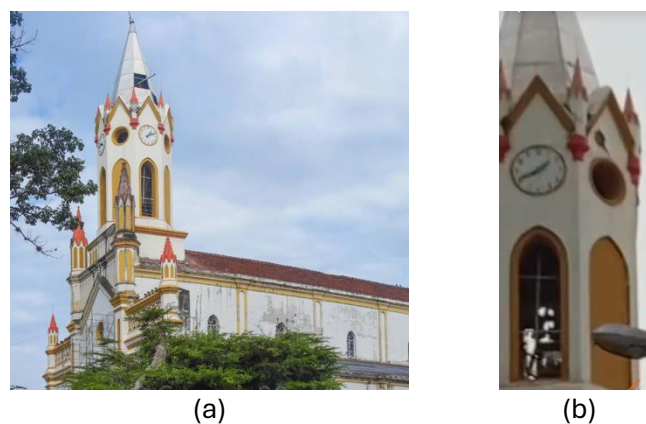
The historic church tower in Cojedes exhibited cracking and opening at the tower top as shown in Figure 45.

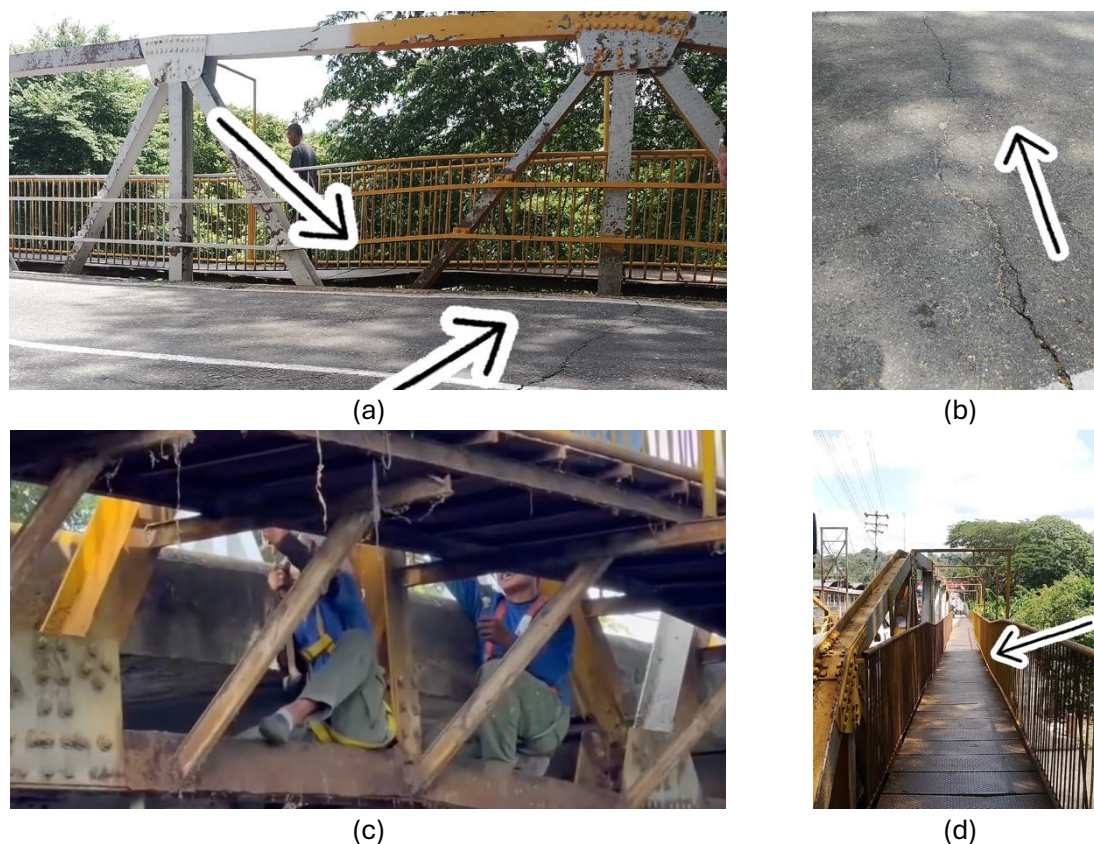
The steel bridge in Trujillo remained functional but showed truss member deformation, deck pavement cracking, pedestrian walkway deformation, and buckling and distortion of steel pedestrian walkway plates. Figure 46 outlines this damage.

*Figure 45. Damage of steel truss bridge Puente de Motatán, Motatán: (a) truss member deformation; (b) deck pavement cracking; (c) pedestrian walkway deformation; (d) buckling and distortion of steel pedestrian walkway plates*

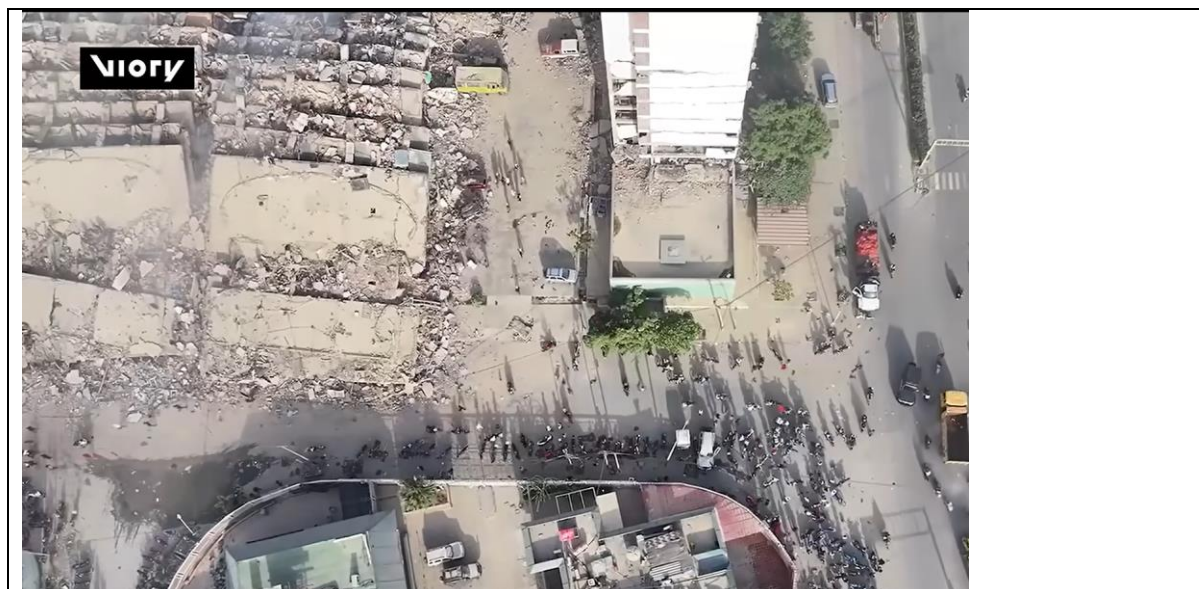
*Figure 46. Overhead view in area of high damage in Carraballeda. Light coloured material on ground inferred to be from the collapse of the building rather than evidence of ejecta. (10.615N,-66.841E).*

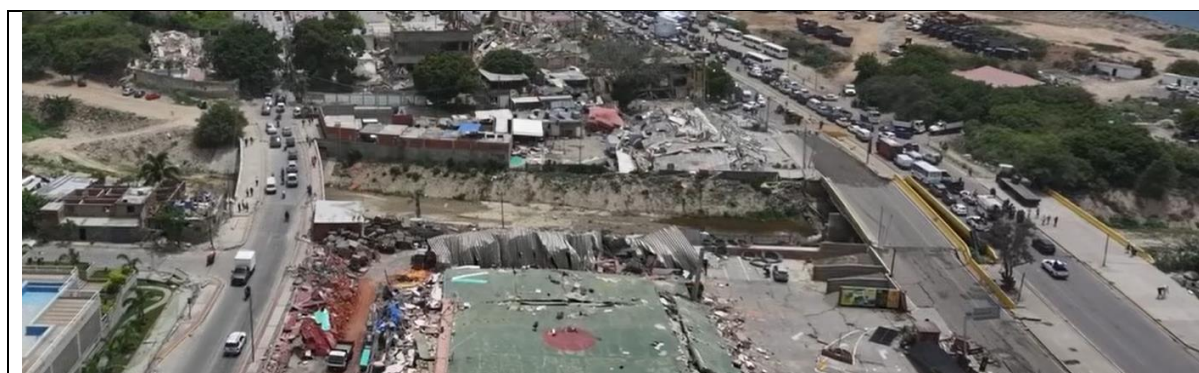
In the areas of Caraballeda and Macuto, the bridges crossing the Rio Camuri Chico and the Rio San Julian appeared to suffer damage near the abutments, as a result of settlement of the approach soils (Figure 47). Large cracks through the road were also visible 200m east of the Rio San Julian bridge, close to the location of collapsed buildings.

*Figure 47. Settlement of approach soils at bridge crossing Rio San Julian (10.619N,-66.851E).*

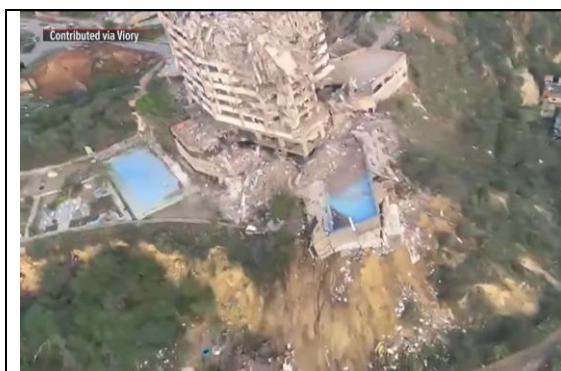
Inland from the low-lying areas the ground rose steeply. A number of small land-slips were visible, as well as cracks close to the crest of slopes. In one location in Catia la Mar, both supporting fills to the north and the residential building complex collapsed (Figure 49). Close-

*Figure 48 (left). Failure of fills supporting at North corner of a building at Catia La Mar (10.611 N, - 67.008E).*

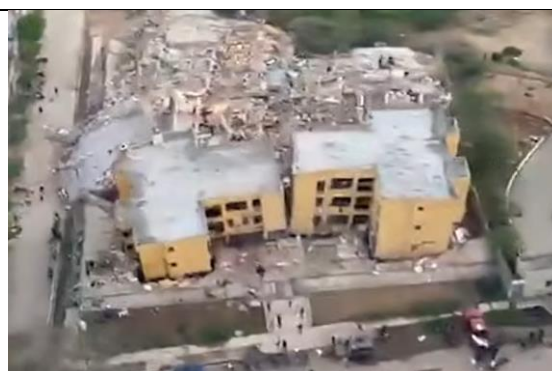
by, a residential complex consisting of 5 buildings suffered heavy damage, with 3 of 5 buildings collapsing, and the remaining two showing significant damage, rotating outwards with apparent foundation failure (Figure 50).

*Figure 49 (right). Foundation failure evident on remaining 2 buildings at location in Catia la Mar (10.611 N, -67.011E).*

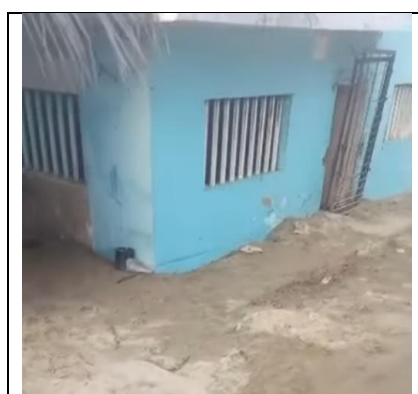
Instances of liquefaction were reported in social media on beach towns between Chuao and Puerto Cabello, along the Yaracuy River (notably between Agua Negra and Palmarejo), and in the coastal settlement of Boca de Aroa (Figure 51). These areas appear to be comprised of loose sandy soils, where liquefaction would be expected.

*Figure 50. Liquefaction-induced settlement of a house in Boca de Aroa. (Exact position not located).*

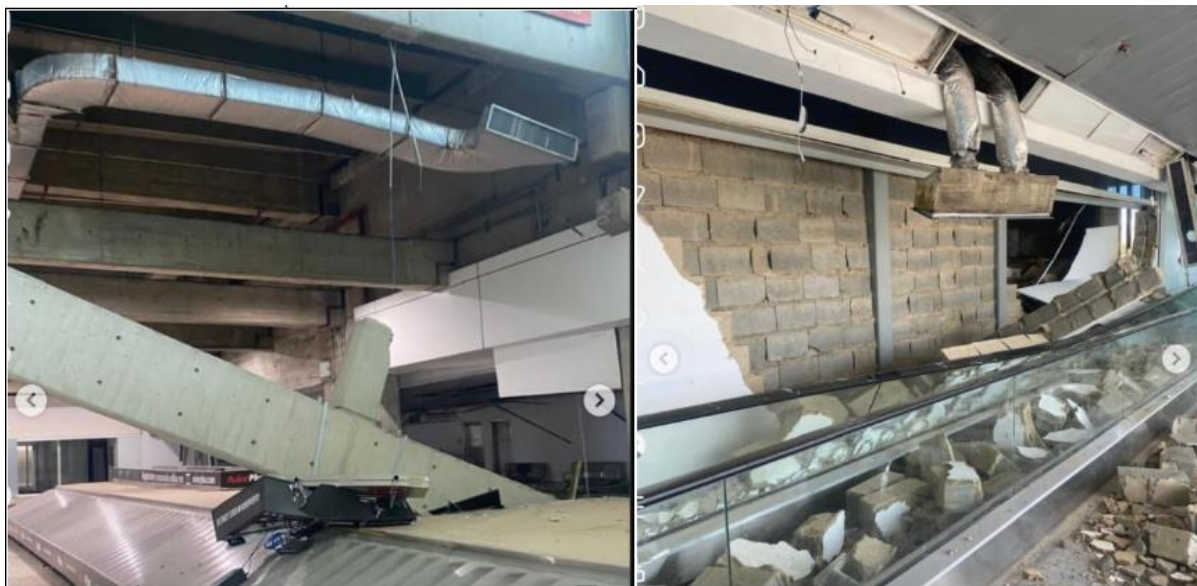
- Some structural damage was recorded in the Simón Bolívar International Airport buildings including loss of support to large precast concrete beams and collapse of infill walls as shown in Figure 51.
- While the Port of La Guaira remained operational throughout (Inchcape Shipping Services, 2026), logistics were hampered by surrounding roading failures, lack of personnel and utilities outages.

*Figure 51. Loss of support of precast beam (left) and infill wall and building services collapse (right) at Simón Bolívar International Airport ([Social Media](#))*
