# Learning from Earthquakes Significant Event Report – VERT Kumamoto, Japan, 28<sup>th</sup> July 26- Version 1.0

**Report Issued: 4<sup>th</sup> August 2026**

Magnitude: **M<sub>j</sub> 7.1 (JMA), M<sub>w</sub> 6.8 (USGS)**

Location (Geographical): **Kumamoto City, Kumamoto Prefecture**

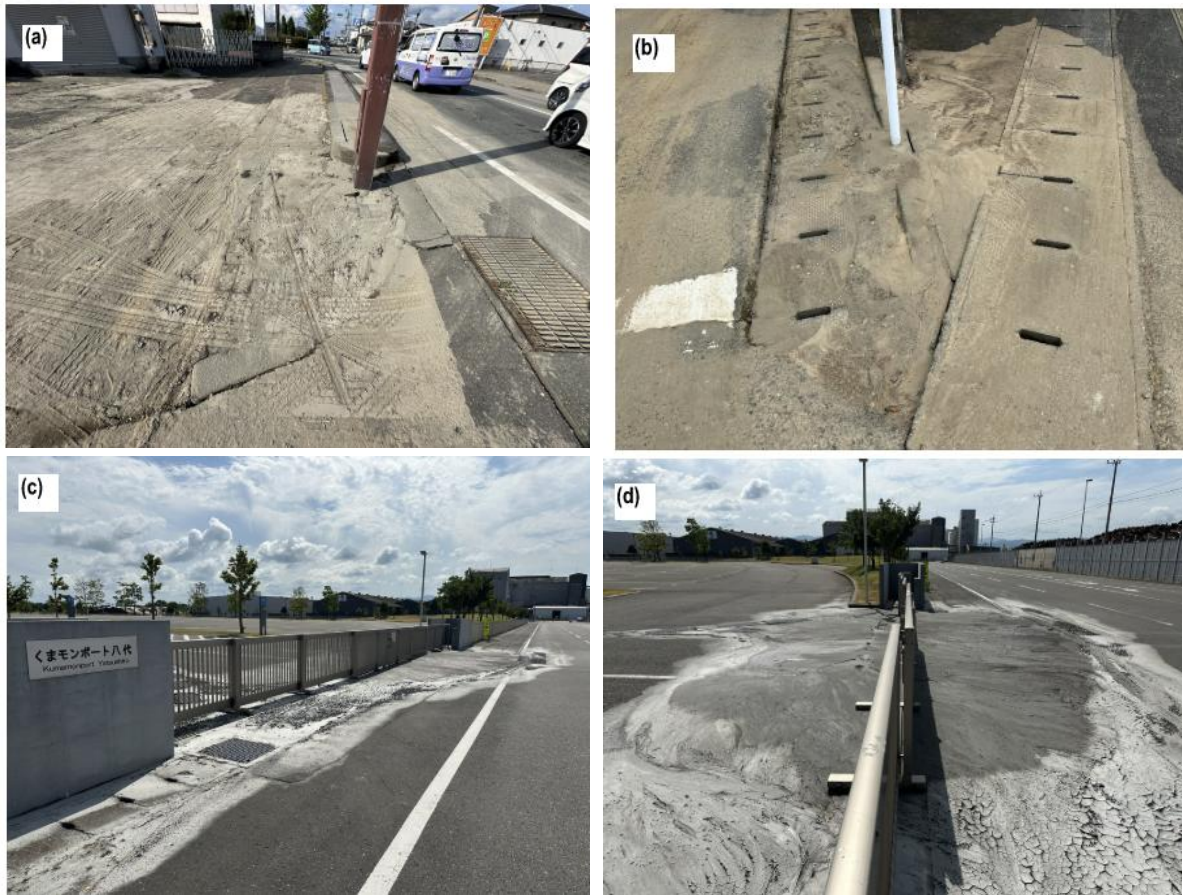
The full extent and severity of liquefaction-related impacts will become clearer as ground-based reconnaissance are undertaken. However, initial reports from social media and news outlets indicate evidence of surface manifestations, including sand boils and ejecta, at several locations such as Minami Ward, Yatsushiro Port (more information in following sub-sections), and Yamaha's manufacturing facility near the Yatsushiro port (refer Figure 15m Figure 24 and Figure 25). Some of these locations, including Yatsushiro Port were reported to have been damaged by liquefaction during the 2016 earthquake as well.

Figure 15 Sand ejecta (following liquefaction) observed at (a) Near 149-15 Tomiimachi Sugijima, Minami Ward, Kumamoto<sup>21</sup> (b) Yatsushiro Castle<sup>22</sup> (c) & (d) Yatsushiro Port<sup>23</sup> (refer Figure 25 for aerial imagery)

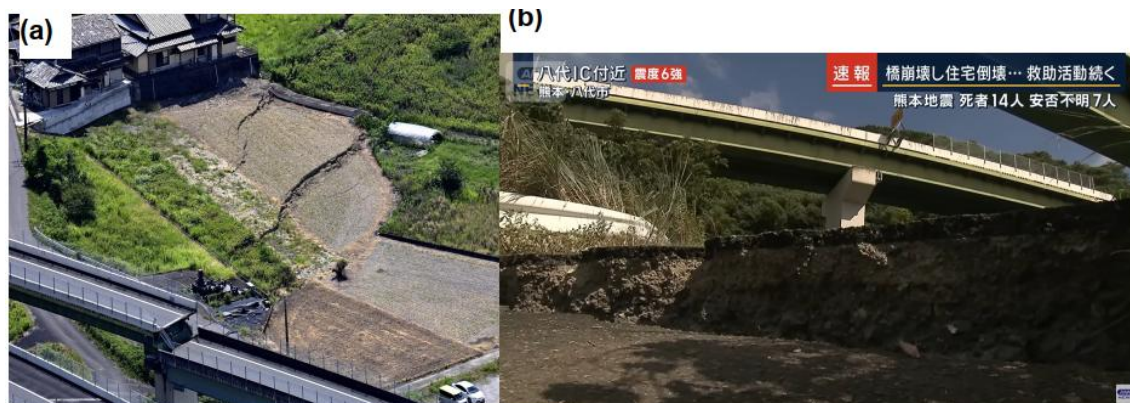
One of them of note was in the proximity of Kyushu Expressway overpass near Ohirayama Tunnel in Yatsushiro City. An aerial photography taken after the earthquake shows a set of cracks likely associated with the fault rupture running through a field onto the road. Note the vertical displacement of the road on the mountain side (Figure 17). This corresponds to area close to the maximum vertical displacement indicated in Figure 16.

Figure 17. (a) Vertical displacement in the Kyushu Expressway overpass in the foreground with cracks in the adjoining farm in the background<sup>25</sup>, and (b) vertical displacement of the ground observed in the field (and looking up at the overpass)<sup>26</sup>

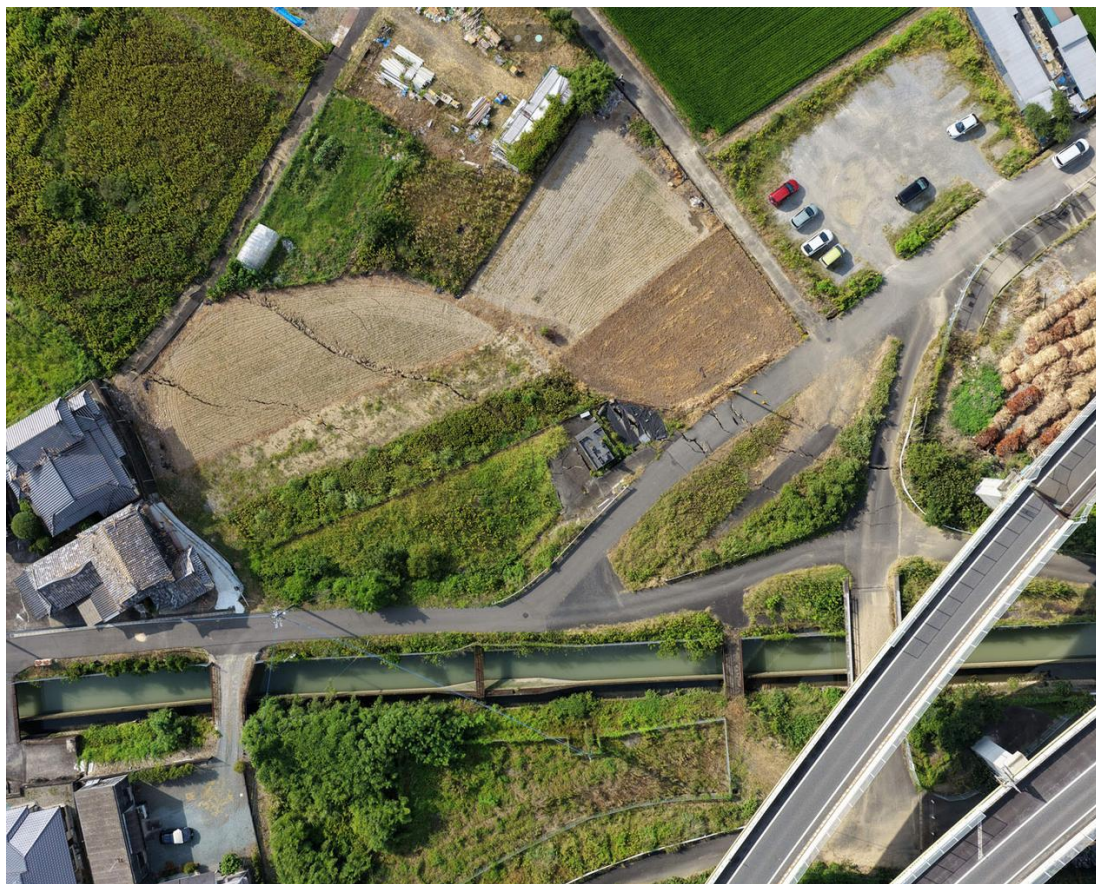
*Figure 18. Aerial photography for the case in Figure 17<sup>27</sup>*

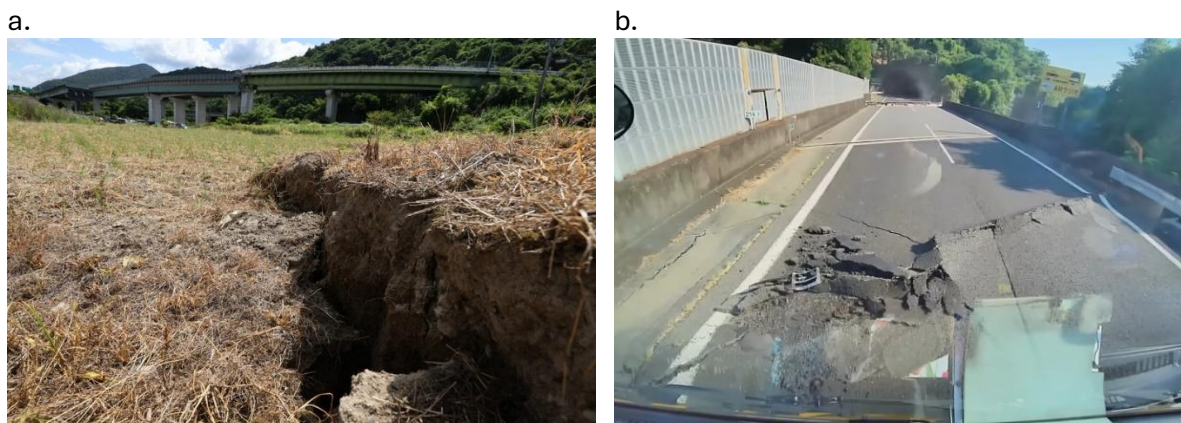
A road crack on the Kyushu Expressway running parallel to the above cracks was also observed approximately 250 m away (Figure 19b).

*Figure 19. a) A close up of the rupture in Figure 17 and 18<sup>28</sup> b) A crack by the Ohirayama Tunnel entrance, 150 m from the site at Figure 19a*

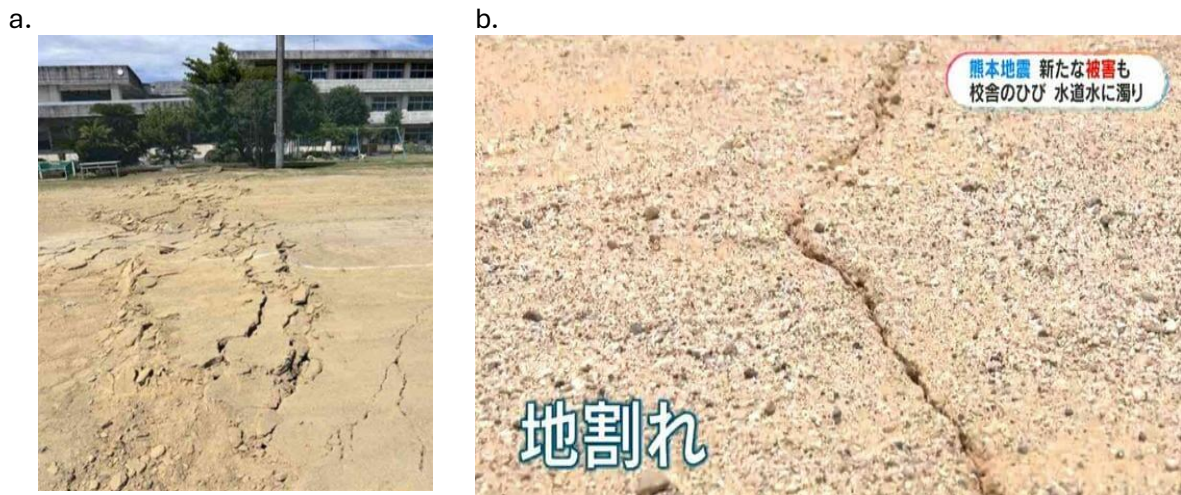
More cracks were observed along the fault zone at Ryuho Primary School in Yatsushiro City, also running parallel to the Yashiro active segment, mere 260 m away from the fault (Figure 20a). The

cracks run across the entirety of the school ground for approximately 50 m and is up to 50 cm deep (TV Kumamoto, 2026)

Minor ground cracks were observed as far as 90 km away from the epicentre at Miyanojo Middle School in Satusma District, Kagoshima (Figure 20b). The site however does not sit in the proximity of the Hinagu Fault.

Figure 20. a) Ground cracks at Ryuho Primary School<sup>29</sup> b) Ground cracks at Miyanojo Middle School<sup>30</sup>

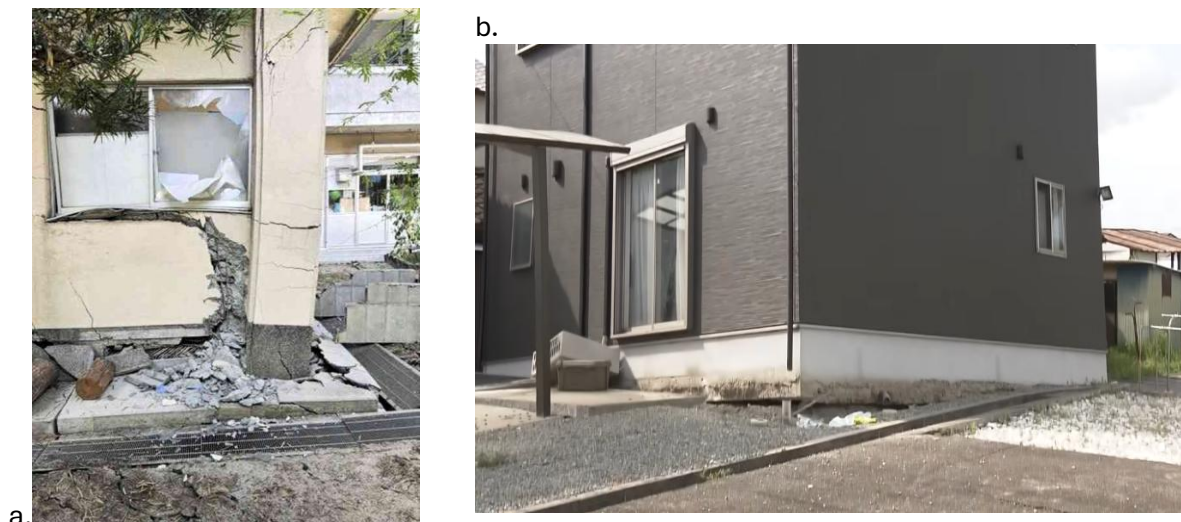
Reporting on foundation damage has been limited due to the presence of rubbles at most of the damaged buildings preventing close-up photos/assessment of the foundation conditions. There have been some damage reported including damage to concrete pads seen at Ryuho Primary School in Yatsushiro City (Figure 21a), and significant differential settlement observed at a recently constructed residential structure in Uki City (Figure 21b).

Figure 21. a) Concrete foundation damage at Ryuho Primary School<sup>31</sup> b) Differential settlement in Uki City<sup>32</sup>

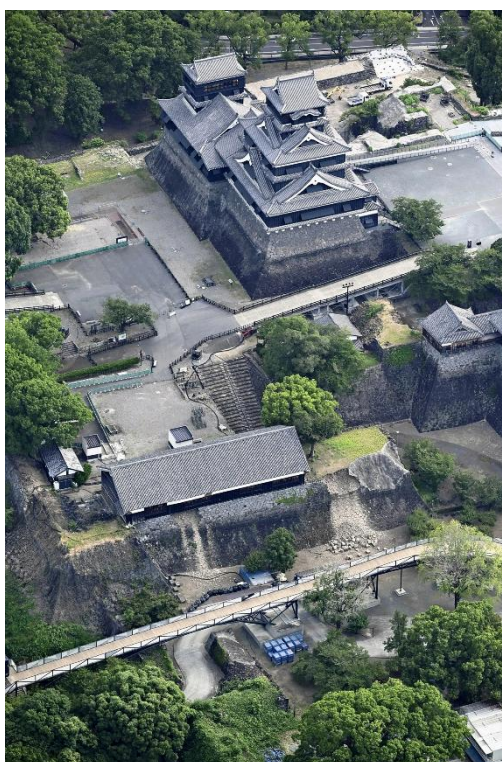
Notable slope-related impacts were reported at several significant assets, including a landslide at the Hitoyoshi Castle Ruins, damage to the historic stone walls of Kumamoto Castle and Yatsushiro Castle Ruins (Figure 22), and a slope failure affecting water-supply infrastructure at the Grassland and Livestock Research Institute.

*Figure 22. Kumamoto Castle with collapsed stone walls (Source: Yomiuri Shimbun<sup>34</sup>)*

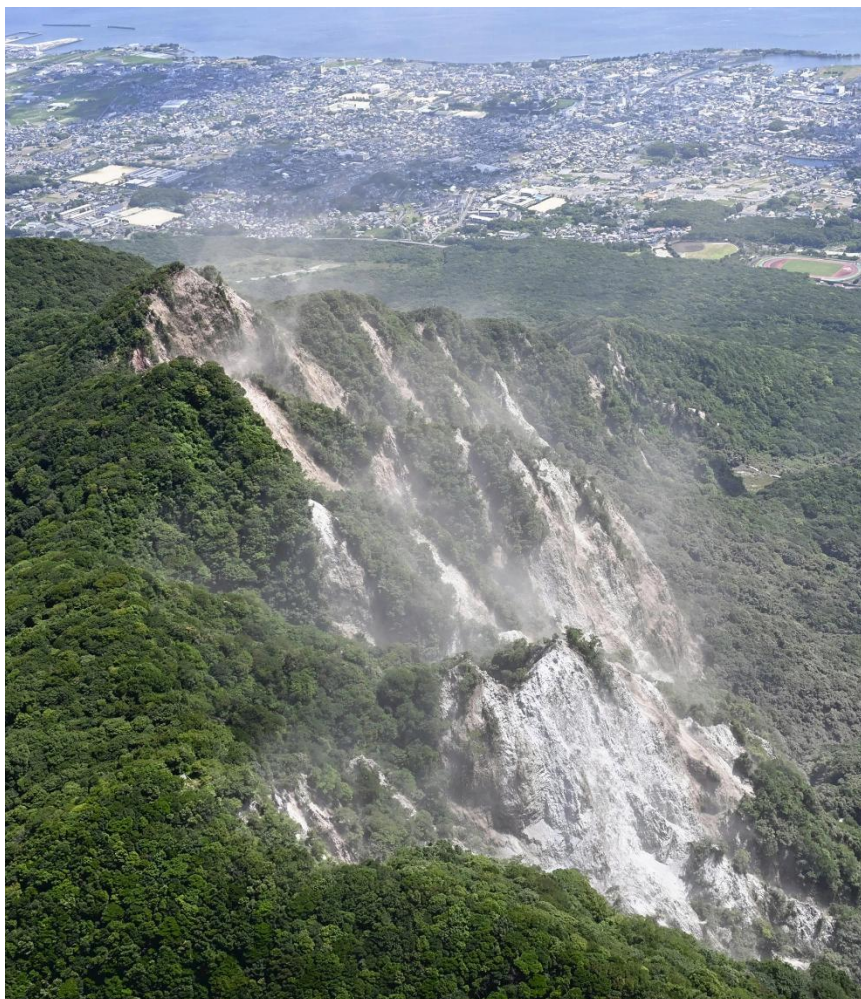
*Figure 23. Landslides on the slopes of Mount Mayuyama, Shimabara City (Source: Yomiuri Shimbun<sup>35</sup>).*

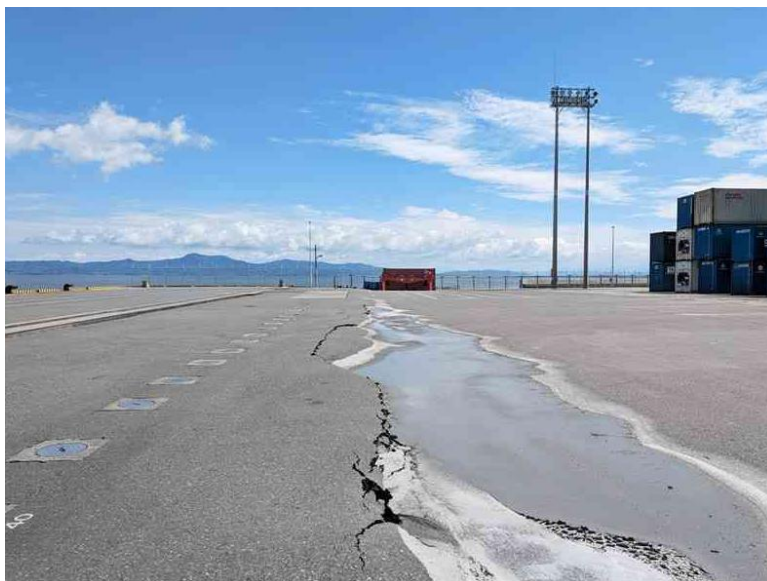
The most extensive damage was reported at Yatsushiro Port (Figure 24 and Figure 25), where liquefaction occurred within the container terminal yard and other reclaimed areas. Associated damage included ground settlement, distortion of crane rails, damage to gantry cranes, liquefaction of adjacent roadway infrastructure, apron cracking, and damage to wharf structures.

Figure 24. Liquefaction effects at Yatsushiro Port, including ground subsidence, sand boils, and surface cracking following the 2026 Kumamoto Earthquake (Source: NHK News<sup>36</sup>)

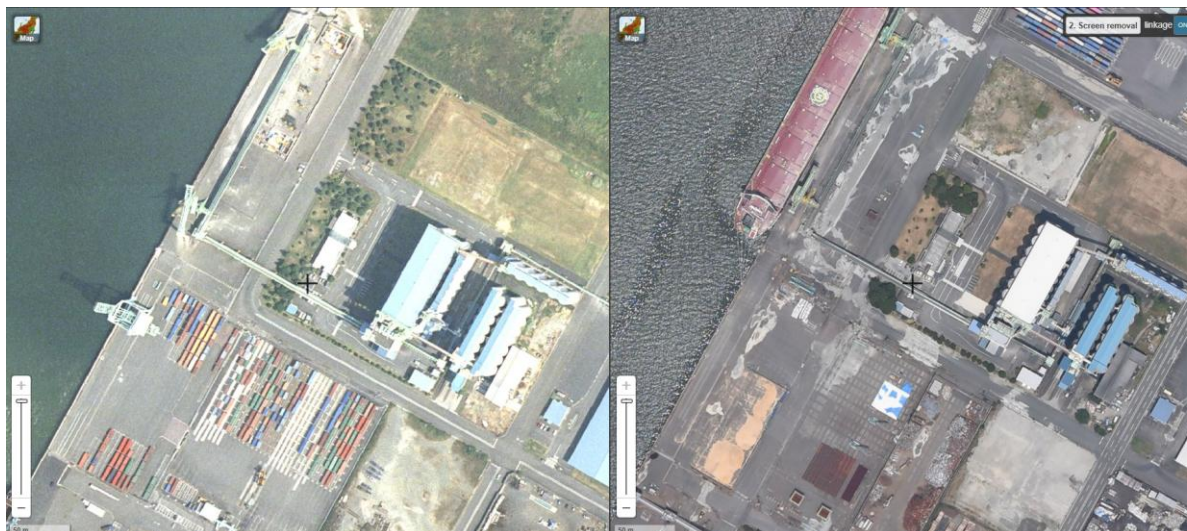
Figure 25. Comparison of satellite imagery of Yatsushiro Port before and after the 2016 Kumamoto Earthquake sequence, illustrating earthquake-induced ground deformation and liquefaction on reclaimed port areas. (Source: Geospatial Information Authority of Japan (GSI) online map service<sup>37</sup>)

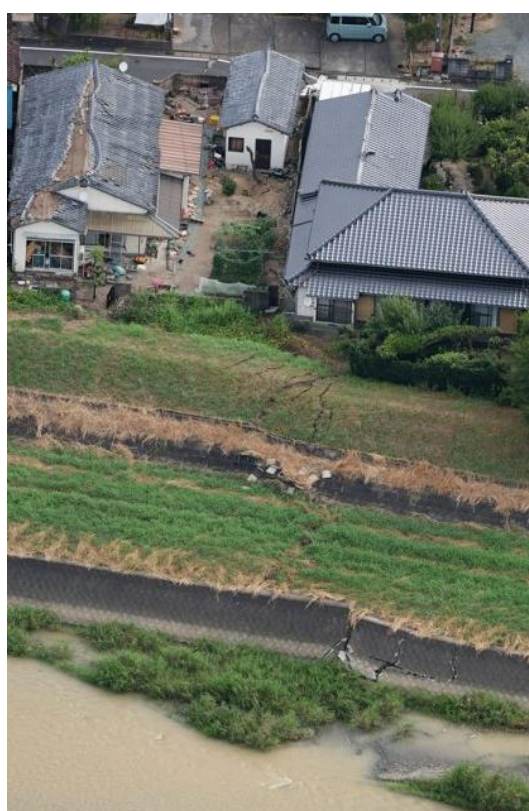
Riverbank damage was widespread, with embankment settlement and revetment cracking reported at 25 locations across 12 rivers. In several cases, longitudinal crest cracking and displacement of revetment elements were observed, indicating permanent ground deformation and lateral movement towards river channels, potentially due to fault rupture, liquefaction and/or lateral spreading (Figure 26).

*Figure 26. Surface expression of the suspected active fault associated with the 2026 Kumamoto Earthquake sequence, showing visible ground rupture and displacement causing levee cracking in Hikawa, Yatsushiro District (Source: Asahi Shimbun<sup>38</sup>)*

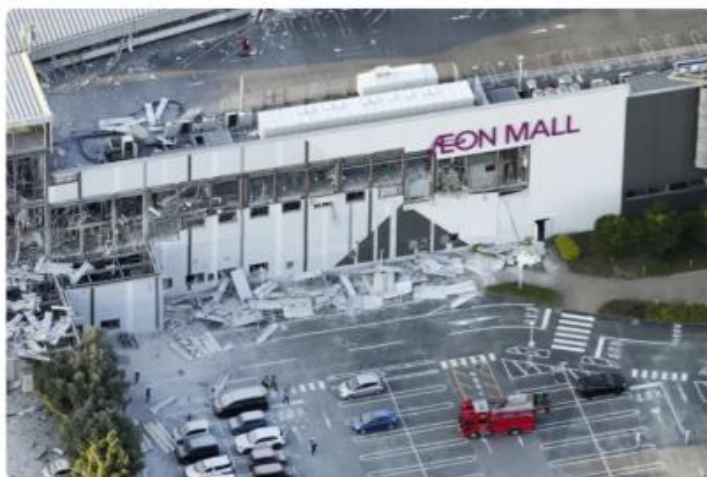
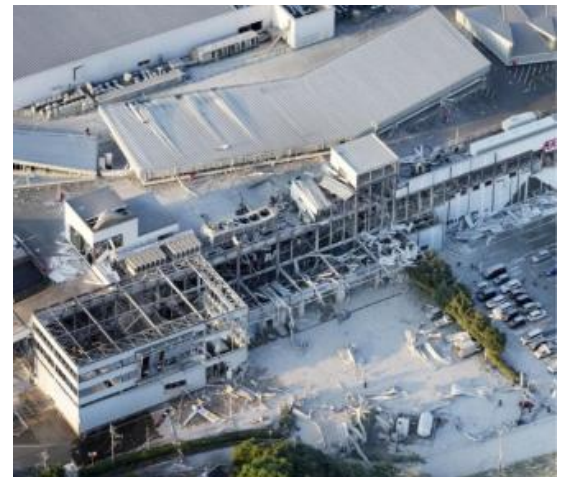
**AEON Mall**<sup>39, 40</sup> is 2-storey reinforced concrete structure located in Kashima Town, Kumamoto Prefecture, Japan. Following damage in the 2016 earthquake, a 2017 retrofit<sup>41</sup> sought to improve seismic performance; including ceilings, lighting and other building-service equipment. In 2026 earthquake, ceiling sections and parts of the exterior wall fell, sprinklers activated, and the mall was evacuated. Aeon reports that evacuation was completed by 17:00 and that an explosion occurred approximately 50 minutes later.

Damage to the gas system led to a major explosion in the rebuilt section in 2017. This caused the collapse of the second-floor structure, damaged floor slabs, roof bearings, and secondary structural members (See Figure 27). Non-structural damage included: ceilings, glazing, exterior walls and storefronts, interior partitions, mechanical and electrical systems (see Figure 28).

Figure 27. Fire explosion damage from Aeon Mall (a - [Link](#)<sup>42</sup> and b - [Link](#)<sup>42</sup>)

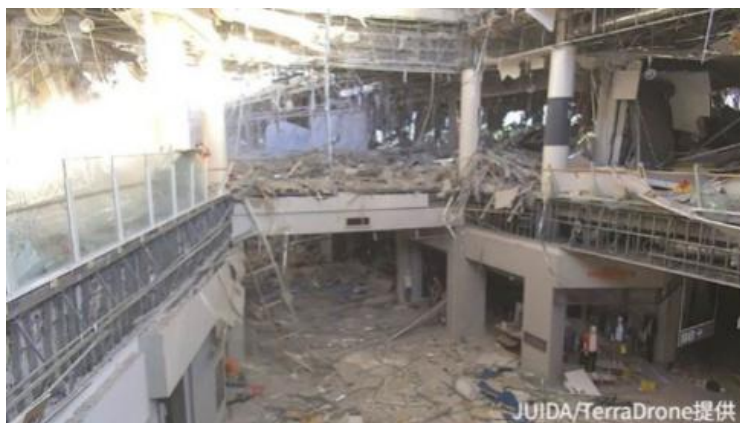
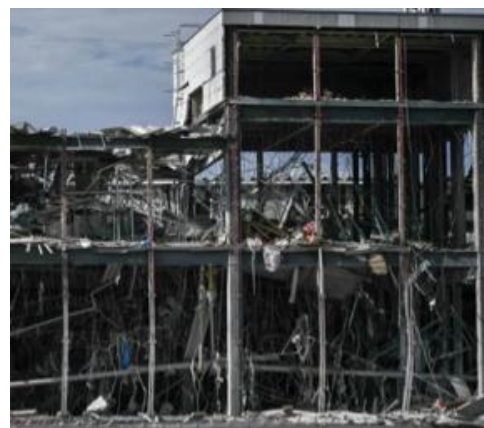
Figure 28. Non-structural damage in AEON Mall (a - [Link<sup>43</sup>](#) and b - [Link<sup>44</sup>](#))

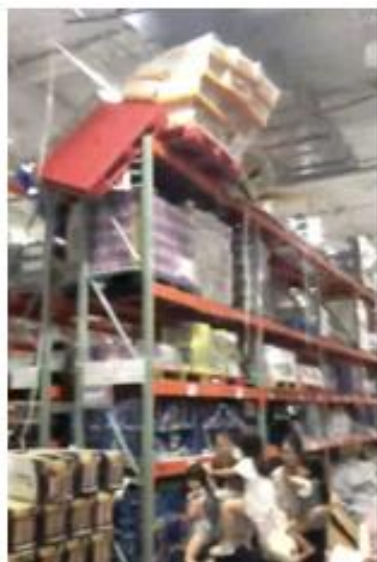
The **Costco Wholesale Kumamoto Mifune Warehouse** was built in 2021. The shelving system, roof-mounted NSEs and building structure appear to have performed well. The heavy contents on pallets atop the shelving system were unsecured and fell from tall shelving racks. Video footage<sup>45</sup> appears to show people underneath, as shown in Figure 29.a. Geotechnical damage was observed in the car park (see Figure 29.b).

a) Pallets fall from Costco shelves ([Link<sup>45</sup>](#))

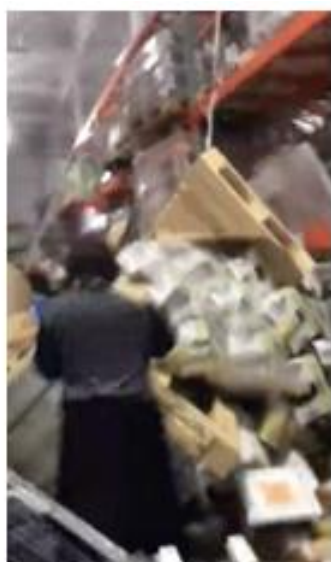
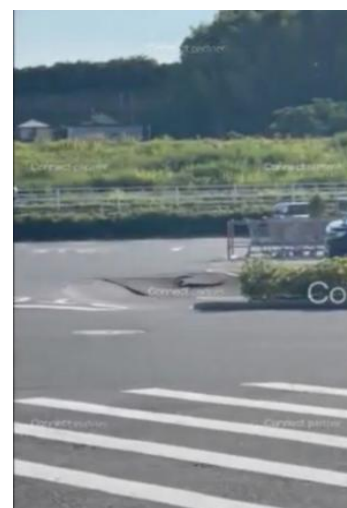
**Ground and Parking Lot Damage:** The intense seismic forces caused the soil in and around the store's parking lot to cave in, resulting in a localized ground collapse and sinkholes (Spectee, 2026). Additionally, the paved asphalt roads immediately leading to the Costco store buckled and cracked heavily (Newsflare, 2026).

b) Carpark damage ([Link<sup>46</sup>](#))

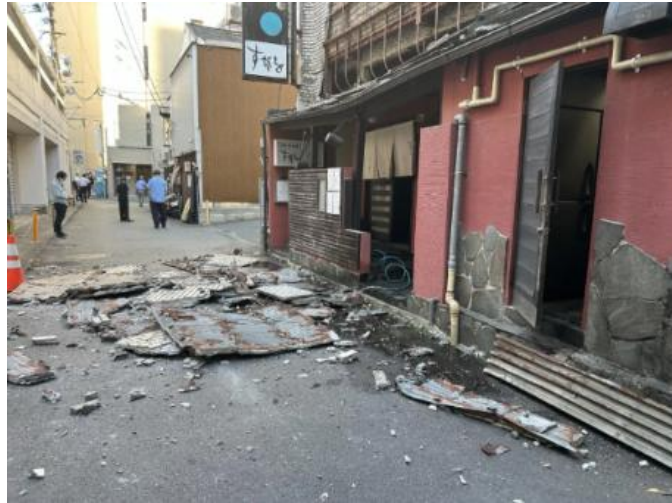
Elsewhere in Kumamoto City, minor damage to facades and awnings were observed (see Figure 30).

Figure 30. Facade linings losing bonding to exterior walls in a commercial area ([Link<sup>47</sup>](#))

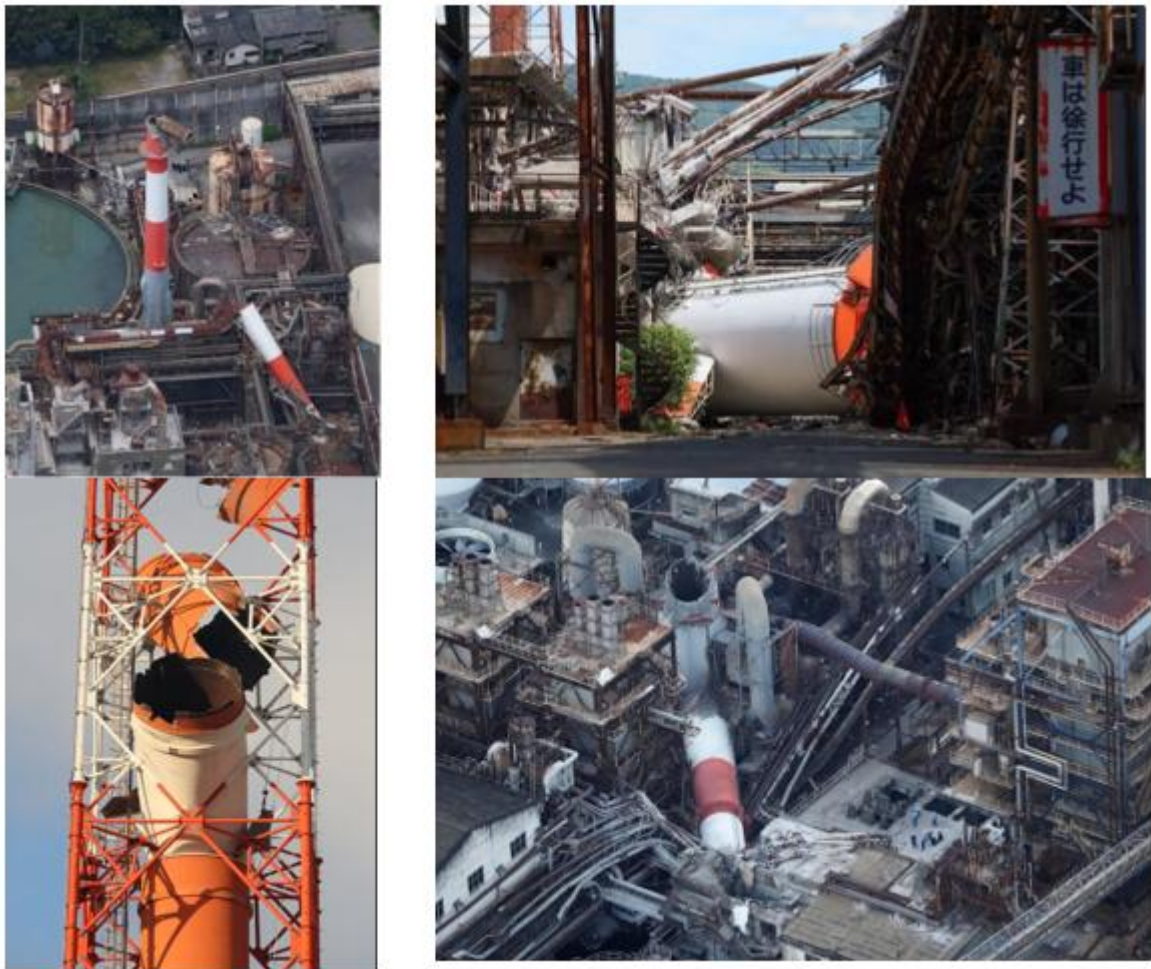
At **Nippon Paper Industries Yatsushiro Mill**, industrial chimneys snapped near their bases and collapsed onto the mill's office blocks (see Figure 31), utility lines, and production buildings (QAB, 2026; Yomiuri Shimbun, 2026c). The falling concrete and steel debris crushed a two-story facility, trapping 11 workers inside<sup>48</sup>, of which 9 died and 2 had moderate injuries. The falling chimneys damaged piping and surrounding buildings, resulting in steam leaks<sup>48</sup>. Production has halted indefinitely<sup>49</sup>. The newest 110-metre concrete and steel chimney was built in November 2009. Older chimneys were 70 meters tall.

(b) After earthquake ([Link<sup>50</sup>](#), [Link<sup>51</sup>](#), [Link<sup>50</sup>](#), [Link<sup>52</sup>](#))*Figure 31. Chimney failure in Nippon Paper Industries (a) before the earthquake (b) After the earthquake*

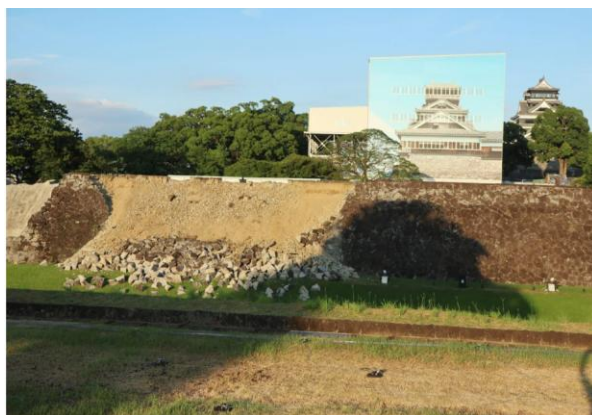
*Figure 32. Partially collapsed stone walls at Kumamoto castle.*

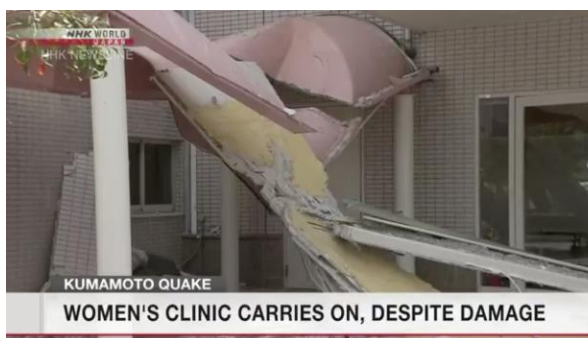
(a) Exterior canopies damage

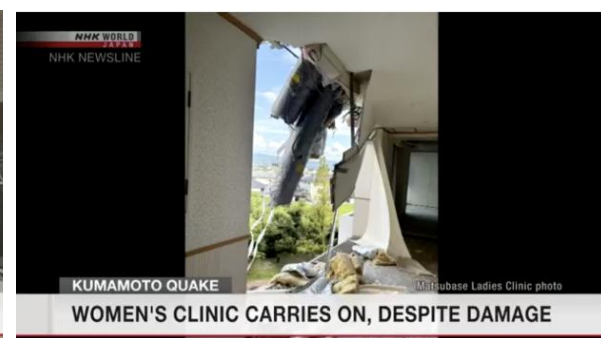
(b) Wall damage

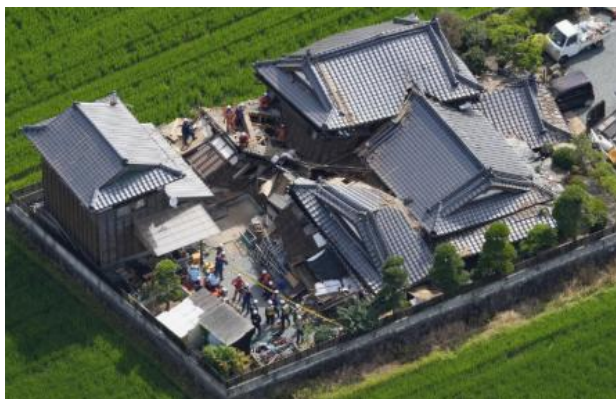
(a) partial or complete collapse of building ([Link<sup>69</sup>](#))

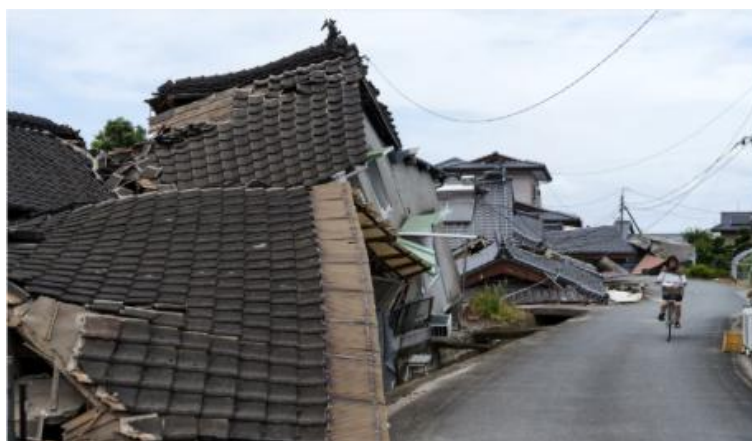
(e) complete collapse of building ([Link<sup>72</sup>](#))

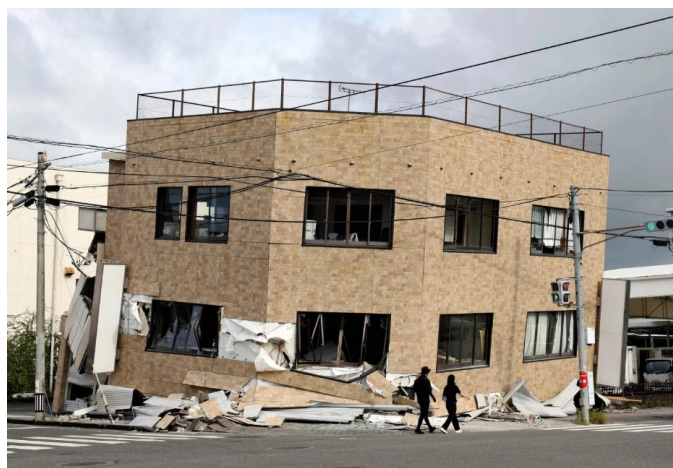
*Figure 40. soft storey damage of two-storey building*

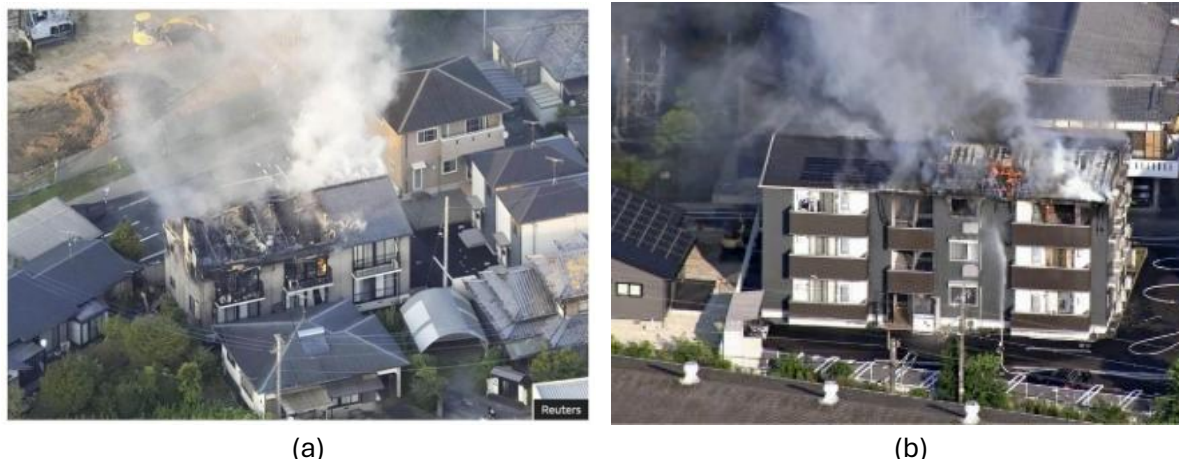
Figure 41. Fire damage to residential buildings (a - [Link<sup>74</sup>](#) and b - [Link<sup>75</sup>](#))

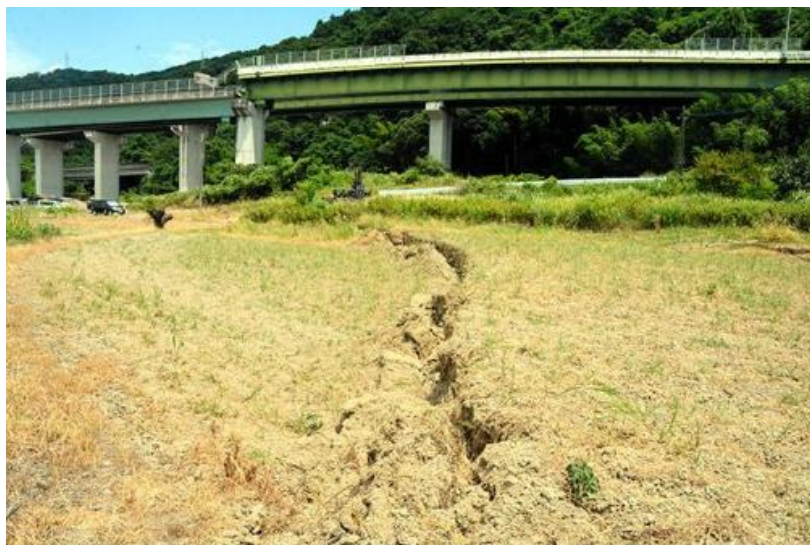
Figure 46. Ground on right side of fissure near the damaged expressway was raised by about 1 meter in Yatsushiro, Kumamoto Prefecture ([Link<sup>92</sup>](#))

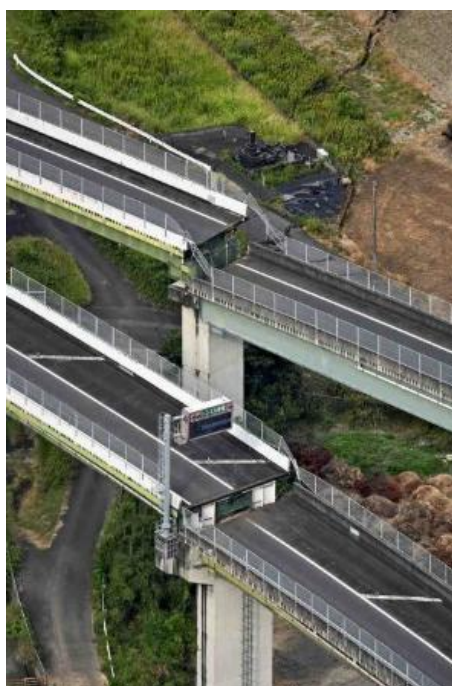
Figure 47. About 1.5 m drop in a bridge deck ([Link<sup>93</sup>](#))

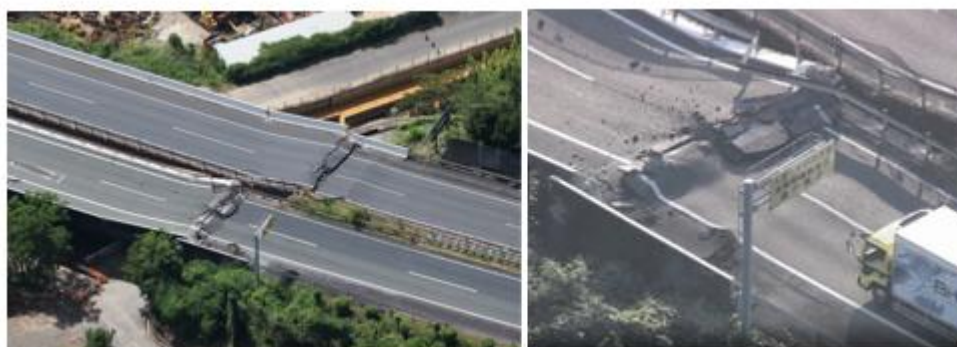
Figure 48. Damage to Kawada Brid ([Link<sup>95</sup>](#))

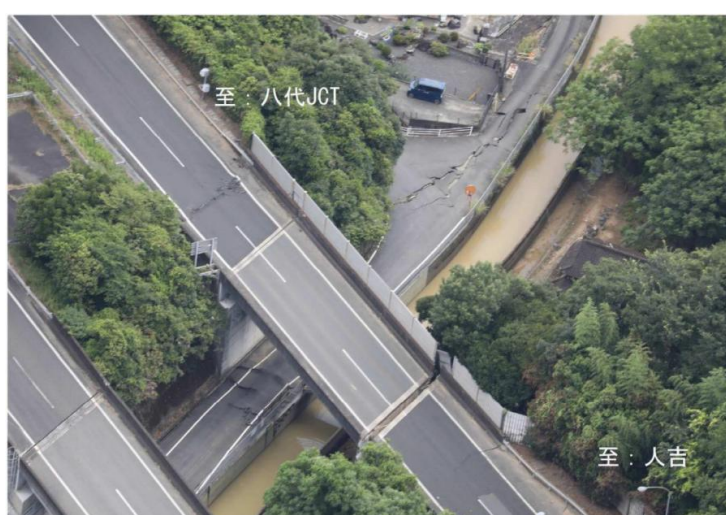
Figure 49. Damaged Katanogawa bridge ([Link<sup>96</sup>](#))

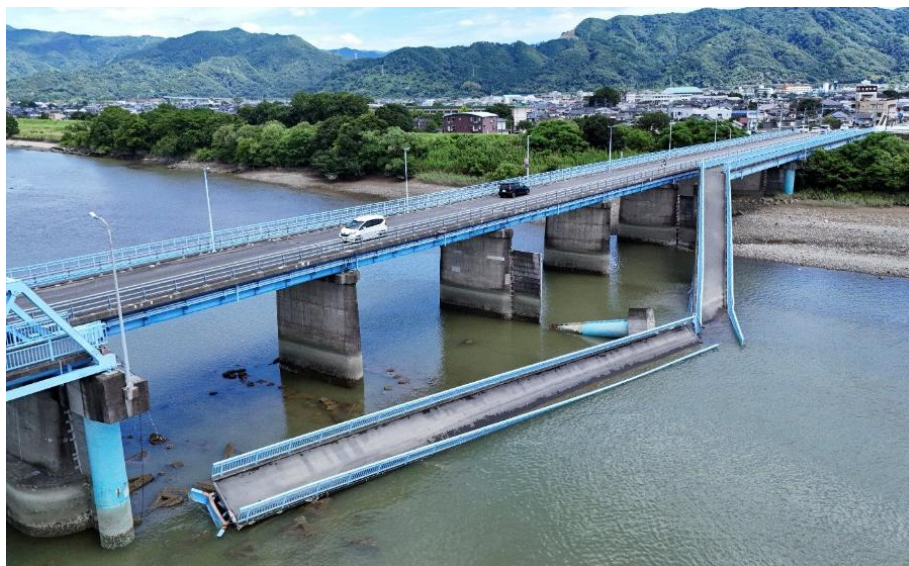
Figure 50. An aerial drone view shows a damaged bridge in Yatsushiro after a magnitude 7.1 earthquake struck Kumamoto Prefecture in southern Japan ([Link<sup>98</sup>](#))

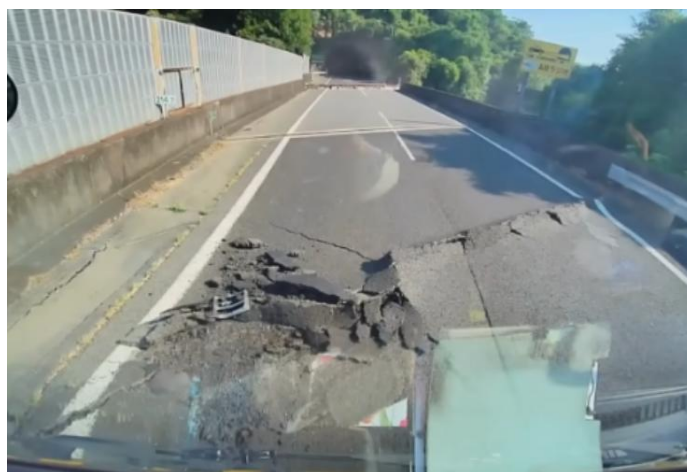
Figure 51. Road damage ([Link<sup>100</sup>](#))

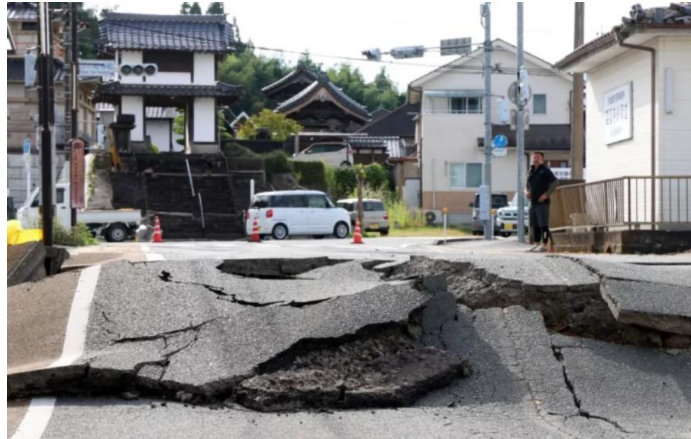
Figure 52. road collapse in Ogawa Town ([Link<sup>101</sup>](#))

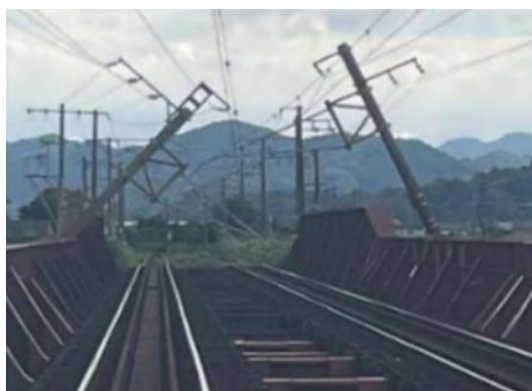
(a) Utility pole damage observed between Ogawa and Arisa ([Link<sup>103</sup>](#))

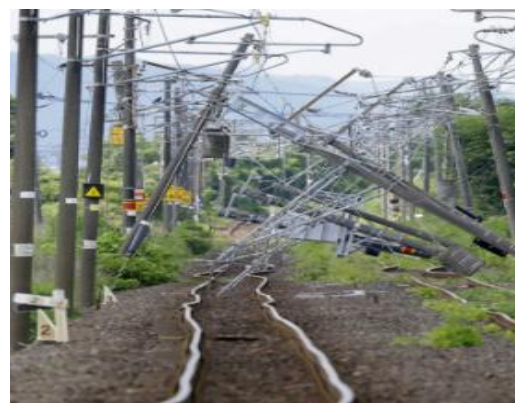
(b) Collapse of utility pole and deformation of railway Between Ogawa and Arisa stations on JR Kagoshima Line ([Link<sup>104</sup>](#))

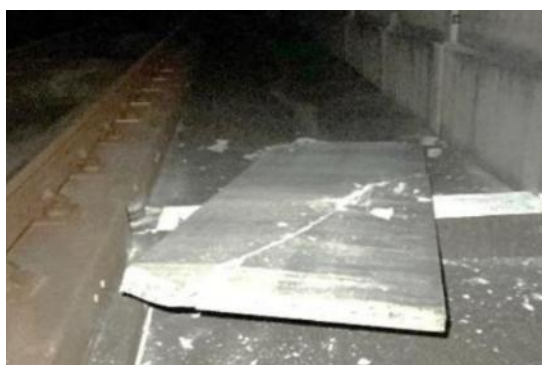
*Figure 55. Noise barrier collapse between Kumamoto and Shin-Yatsushiro ([Link<sup>105</sup>](#))*

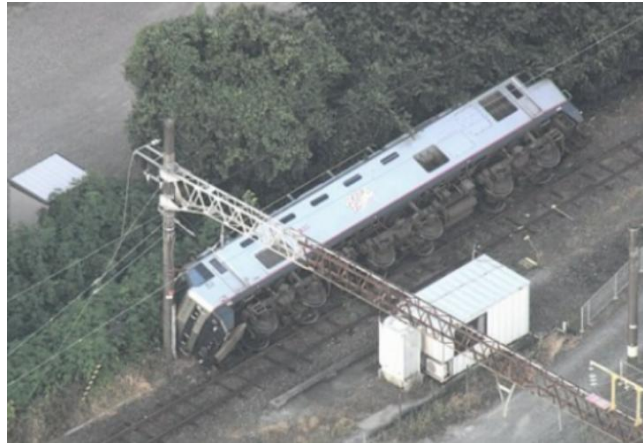
Figure 56. Locomotive and freight car derailment ([Link](#)<sup>105</sup>)
