# New Zealand Earthquake Reconnaissance Programme (NZERP) Significant Event Report – Virtual-NZERP

## San José del Palmar M7.4 - Version 1.0

This report presents preliminary findings from the New Zealand Earthquake Reconnaissance Programme (NZERP) – Virtual-NZERP team following recent seismic activity in Colombia. Based on remote observations and preliminary datasets, the team has compiled and analysed building performance, material vulnerabilities, and regional damage patterns to understand the structural impacts of the event.

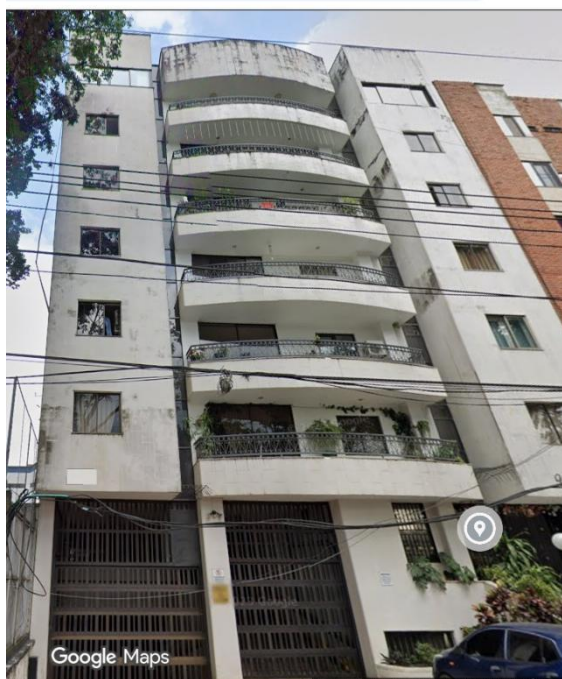
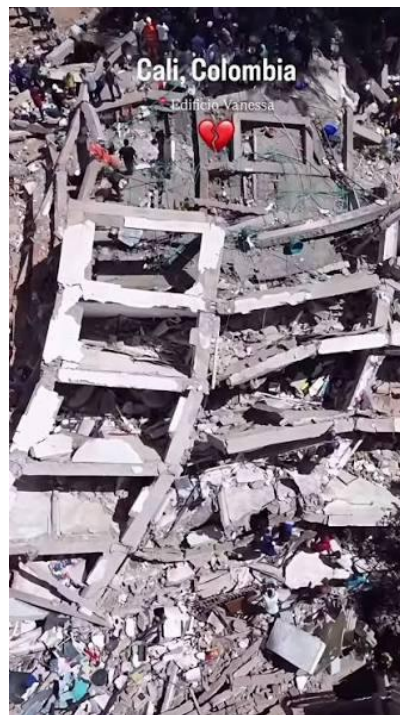
Figure 8 Hotel Vanessa RC building, Cali, Colombia, (a) before and (b) after earthquake<sup>2</sup>. Pancake collapse. Reference: Google Maps (2026)

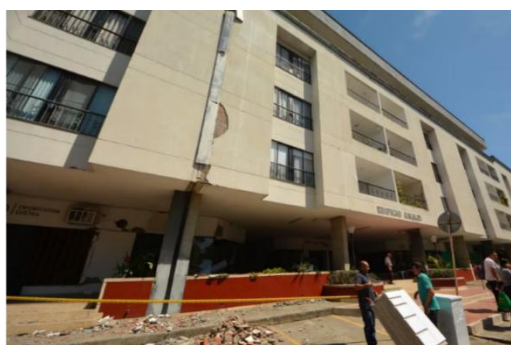
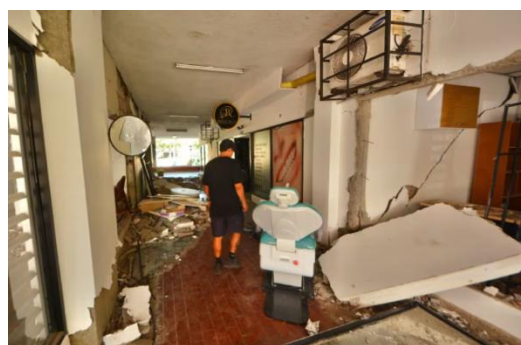
Figure 9 Amalfi RC building, Cali, Colombia, serious structural damage due to pounding movement between adjacent blocks<sup>3</sup>.

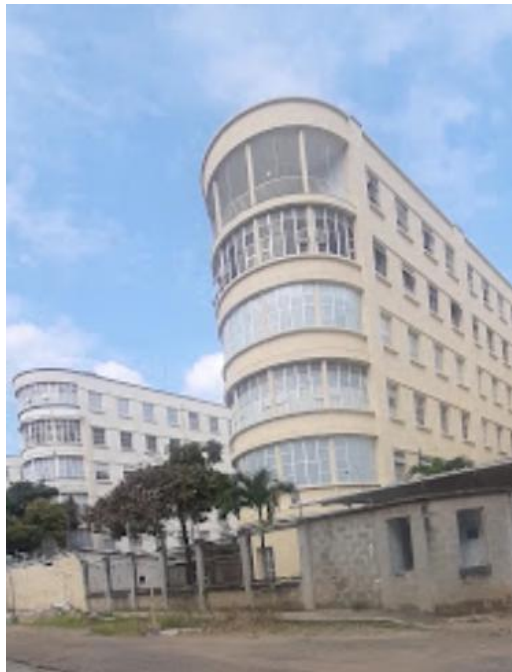
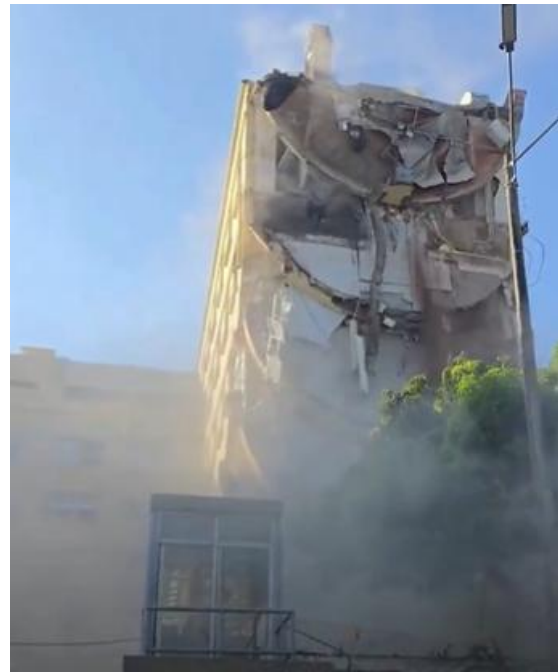
Figure 10 Hospital Universitario del Valle Evaristo García, Cali, Colombia; (a) before and (b) after earthquake<sup>4</sup>

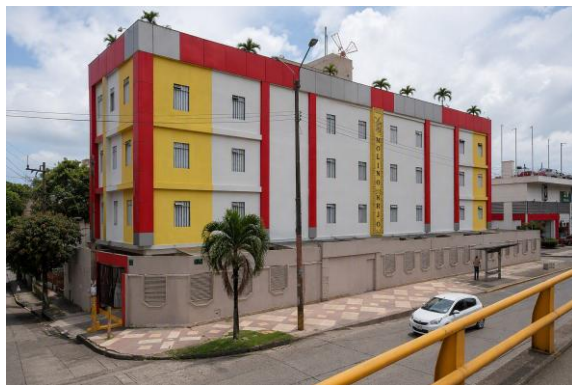
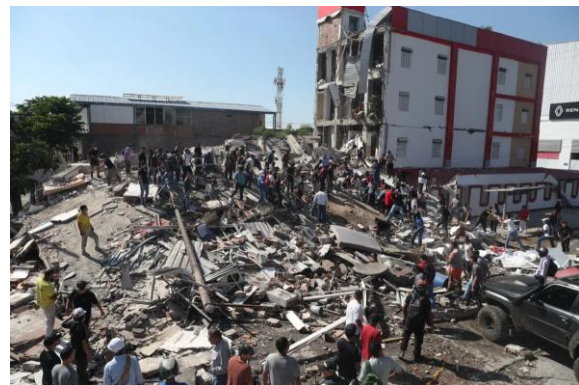
Figure 11 Aparthotel Molino Rojo (a) prior to Earthquake and (b) Partial collapse of the Molino Rojo in Cali<sup>5</sup>

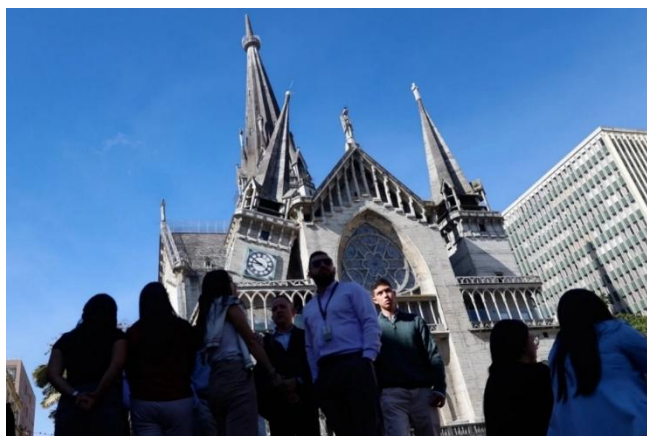
Reports from locals mention over 20 buildings very heavily damaged and/or collapsed<sup>6</sup>. The North-West tower of the Cathedral Basilica of Our Lady of Rosary (Figure 12), the tallest in Colombia, collapsed on top of the main nave, which resisted the impact. This RC building has been reconstructed several times following previous earthquakes. A range of collapse mechanisms were observed including overturning from failure in the lower stories (Figure 13), pancake collapses (Figure 14) and soft-storey collapse Figure 15. Minor damage has been

Figure 12 Cathedral Basilica of Our Lady of Rosary, Manizales<sup>7</sup>

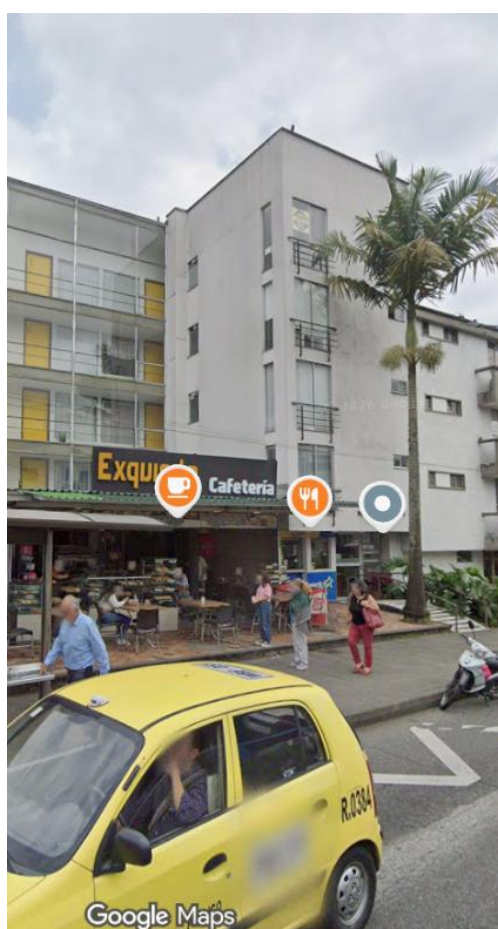
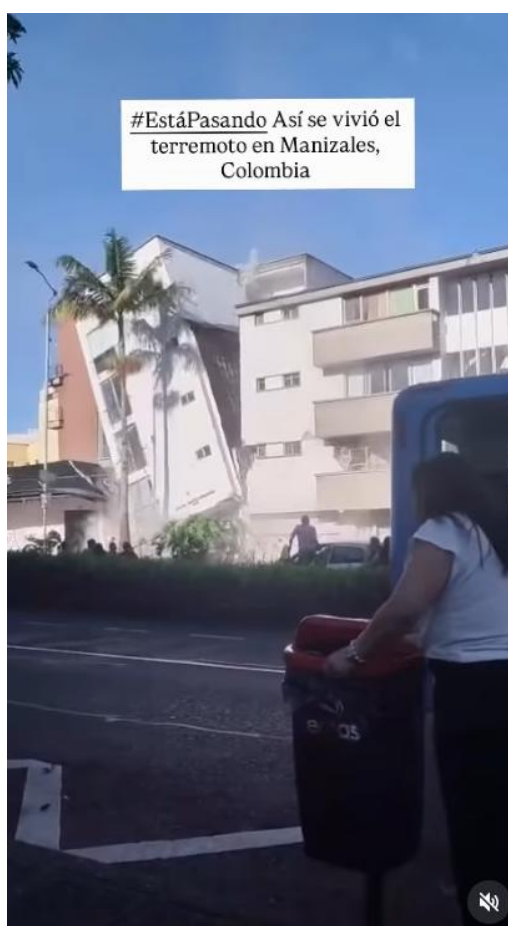
Figure 13 Edificio Plaza Santo Domingo; (a) before and (b) after earthquake<sup>8</sup>

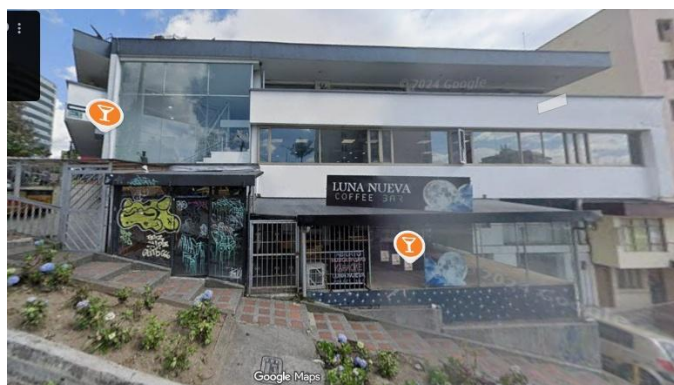
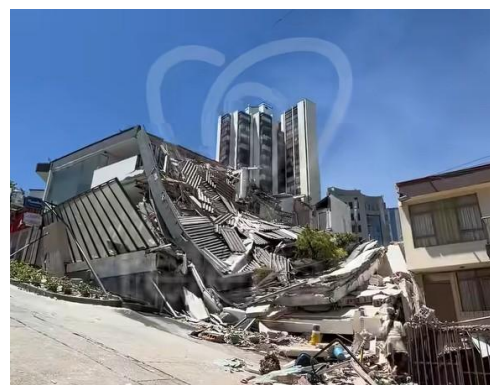
Figure 14 Edificio in calle 61; (a) before and (b) after earthquake<sup>9</sup>

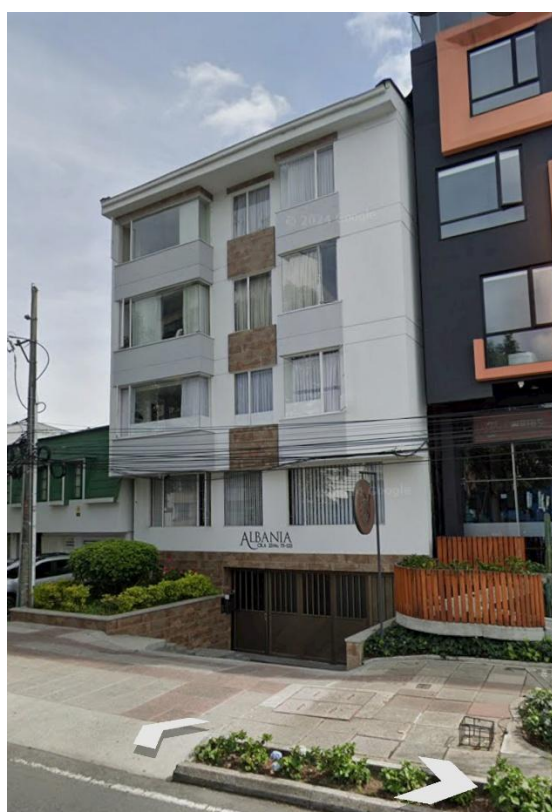
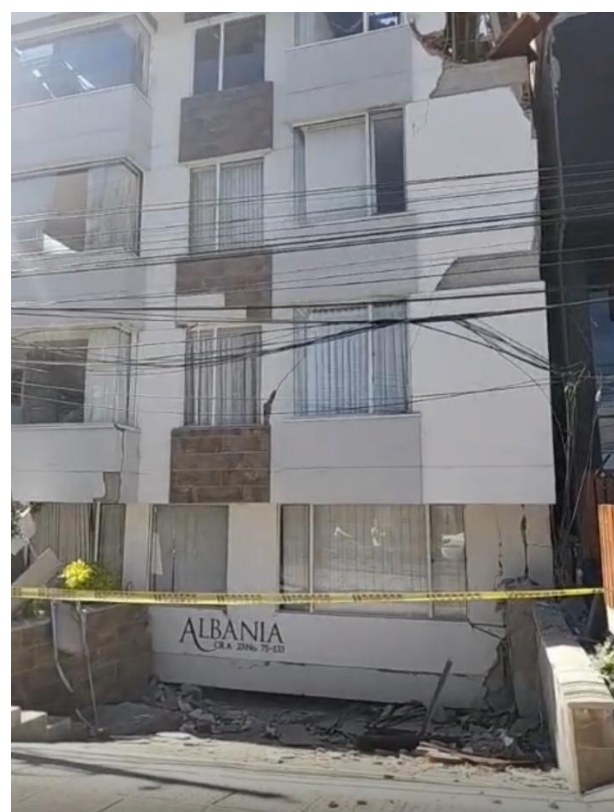
Figure 15 Edificio Albania; (a) before and (b) after<sup>10</sup> earthquake, note the collapse of the lowest level

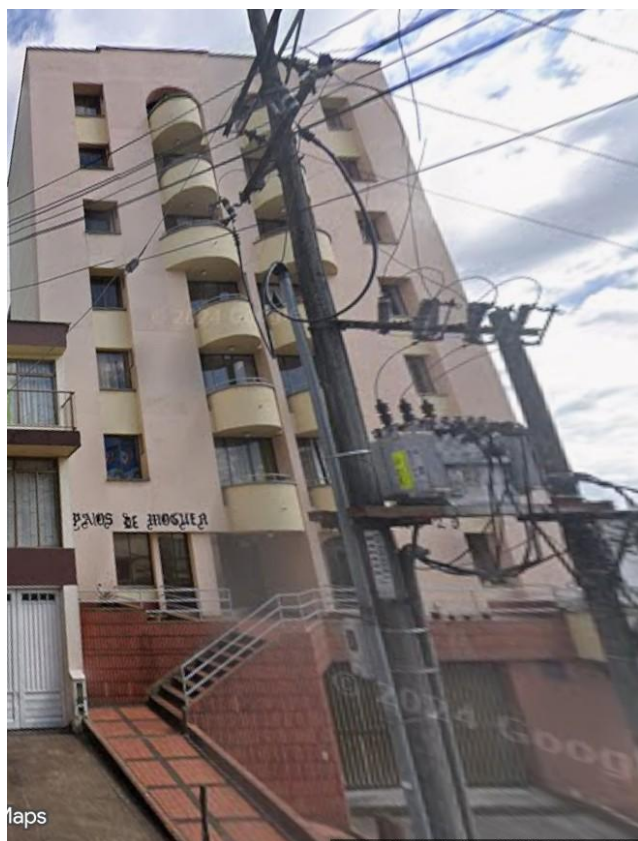
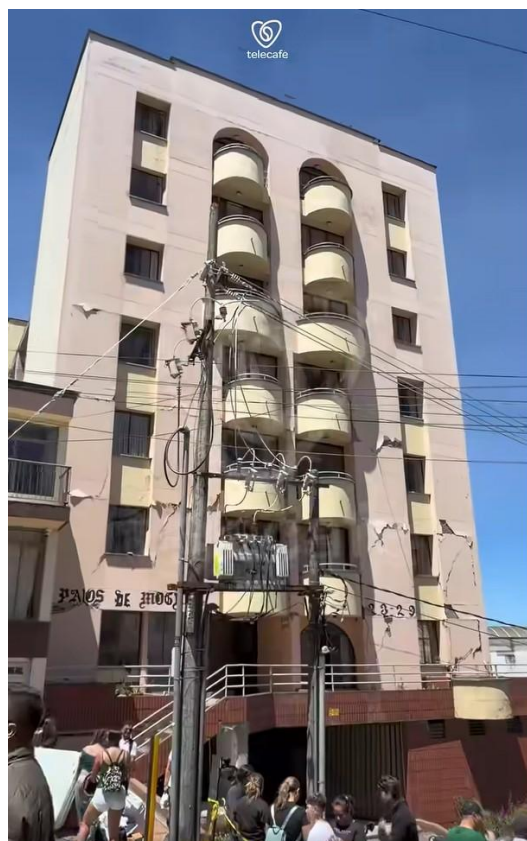
widely observed, in many cases related to RC frames with URM infill, and URM construction, as shown in Figure 16 and Figure 17.

Figure 16 Edificio Palos de Moguer; (a) before and (b) after<sup>11</sup> earthquake

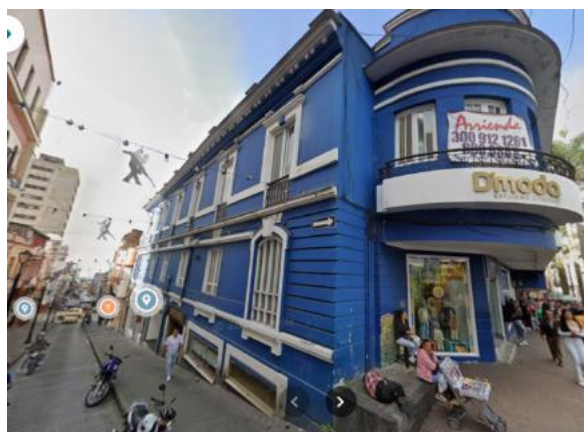
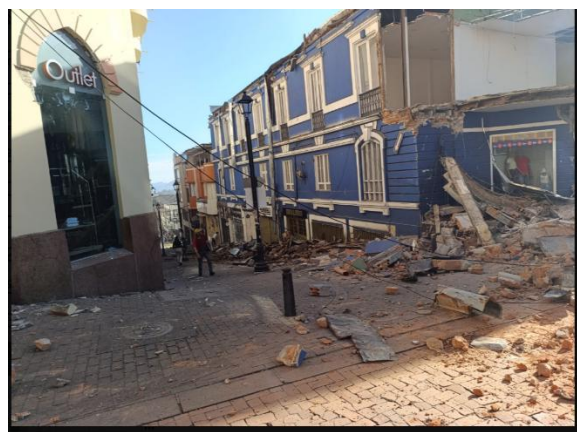
Figure 17 Edificio Dimoda; (a) before and (b) after<sup>12</sup> earthquake.

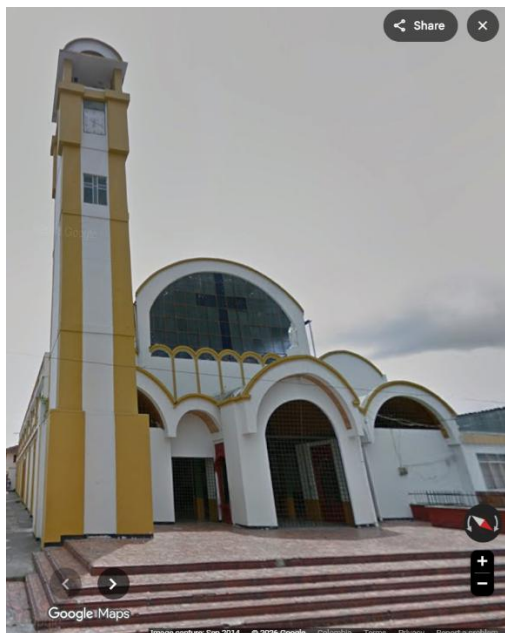
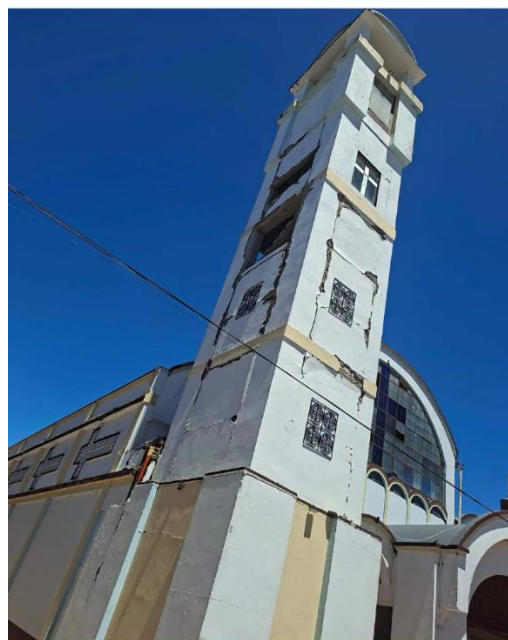
A local church has suffered damage in the bell tower, with the URM infill cracking and partially collapsing after detaching from the RC frame. Other examples of URM failure (Figure 18 and Figure 19) in low rise structures have been observed.

Figure 18: Parroquia Nuestra Señora Del Carmen; (a) before and (b) after earthquake<sup>13</sup>.

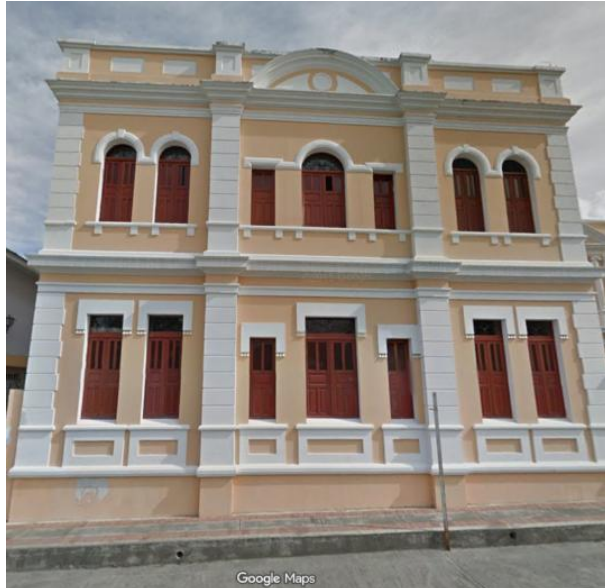
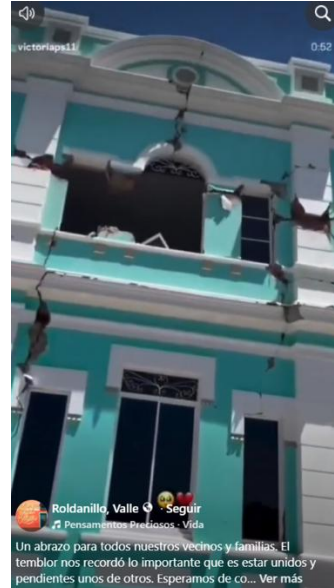
The Institute of Education building has experienced severe damage. This structure appears likely to be of URM construction.

*Figure 20 Instituto de Educación Técnica Profesional de Roldanillo (a) before and (b) after earthquake.*

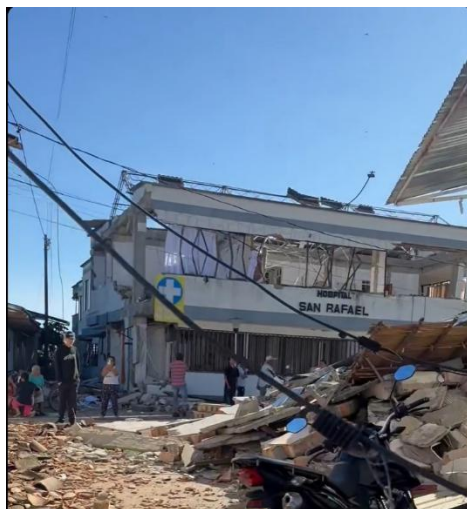
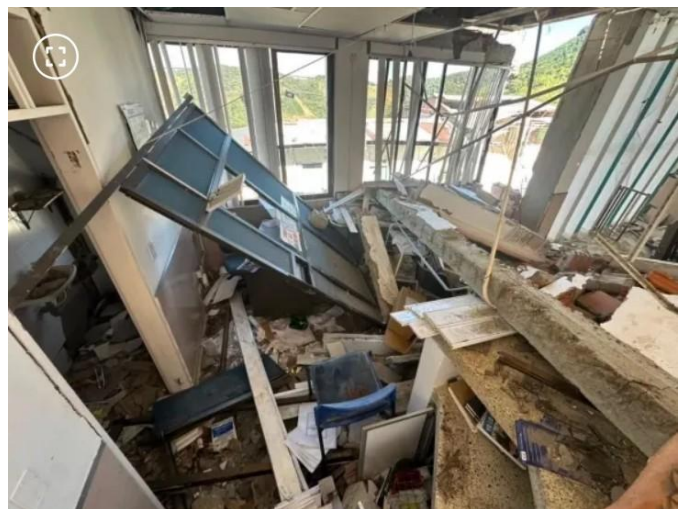
The local medical centre has collapsed. Other residential buildings in the area also experienced severe failures that have left 1000 citizens (10% of the local population) without a home<sup>15</sup>. The local church has also been severely affected.

*Figure 21 Hospital San Rafael<sup>16 17</sup>*

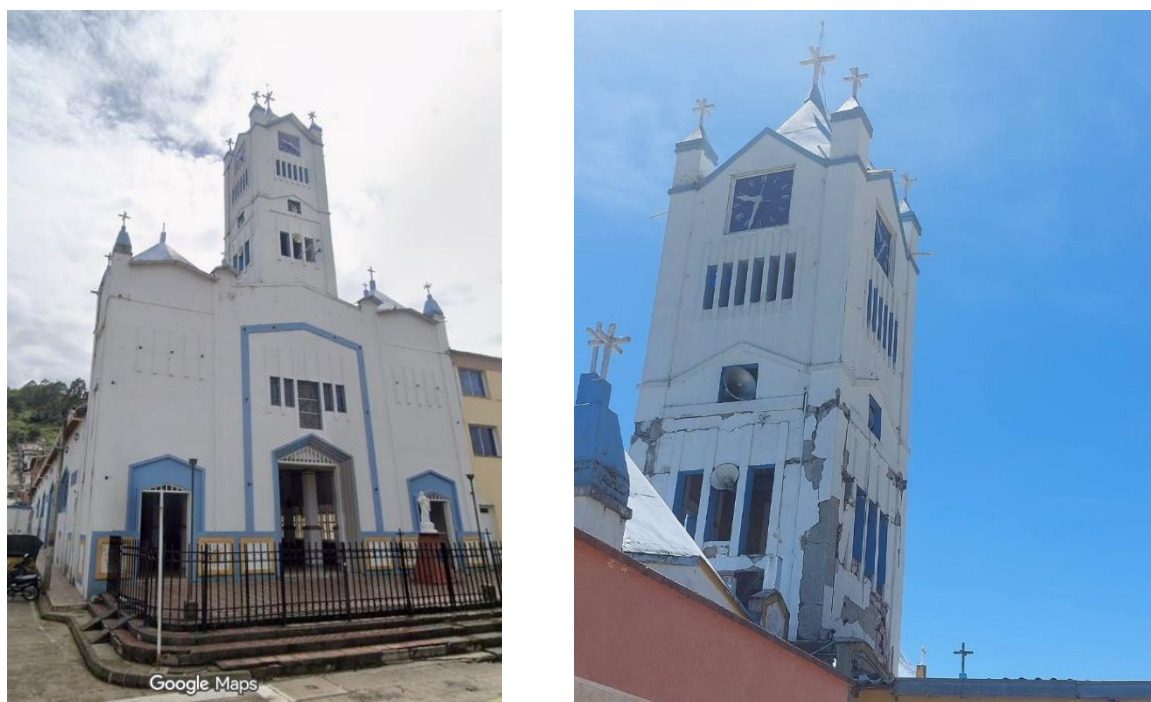
*Figure 22 Iglesia La Inmaculada Concepción; before (left photo) and after (right photo) earthquake.*

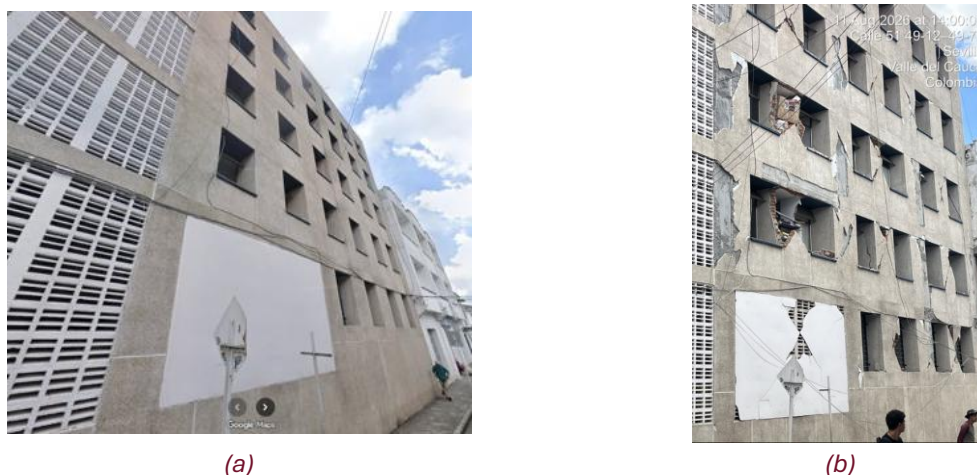
In the Municipality of Sevilla, Valle del Cauca at least 10 buildings, ranging from one to five storeys in height, collapsed during the seismic event. The Municipal Administration Building, shown in Figure 23, sustained extensive cracking, localised loss of façade and infill materials, and exposed masonry around several window openings. As this facility plays an important role in coordinating emergency and disaster-response activities, the observed damage may have significantly reduced the municipality's institutional response capacity.

*Figure 23 Municipal Administration Building. (a) before earthquake (b) after earthquake.*

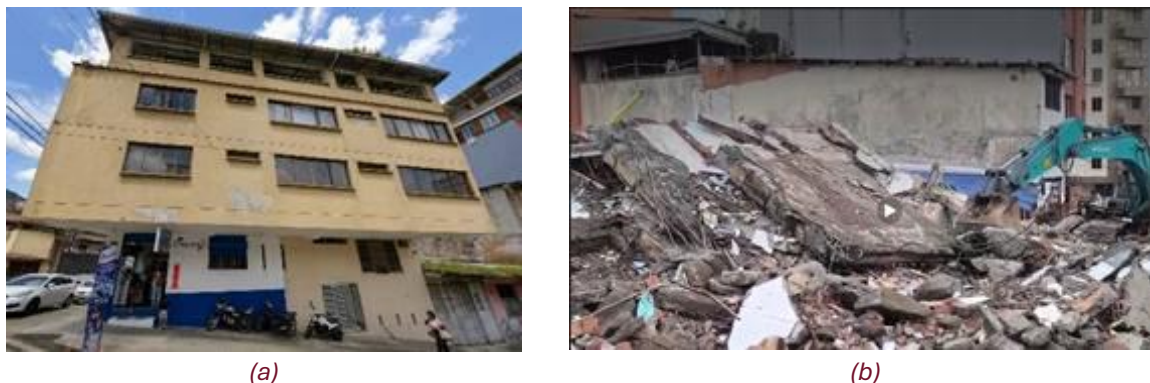
Figure 24 Edificio Naranjito in Buenaventura: (a) building condition before the earthquake; (b) complete collapse following the earthquake<sup>19</sup>

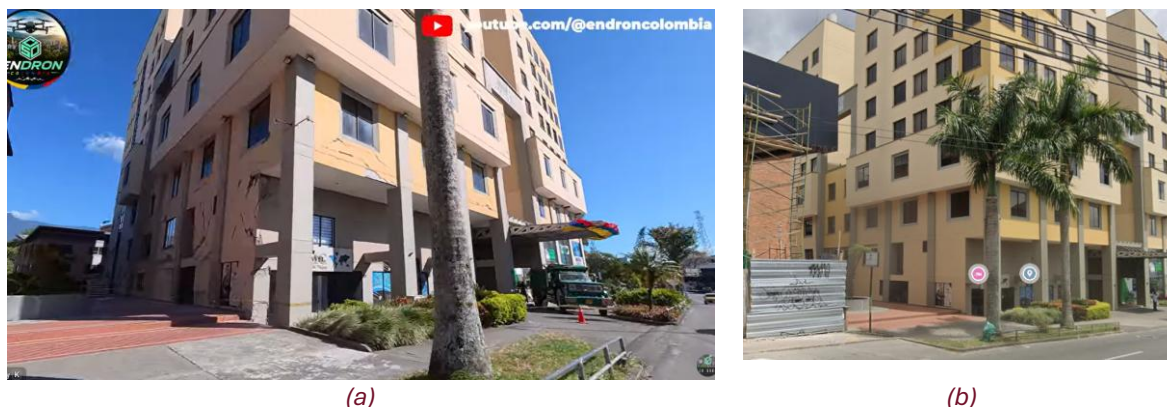
Figure 25 Edificio Armenia Hotel in Armenia: (a) building condition before the earthquake; (b) damage to walls following the earthquake<sup>20</sup>

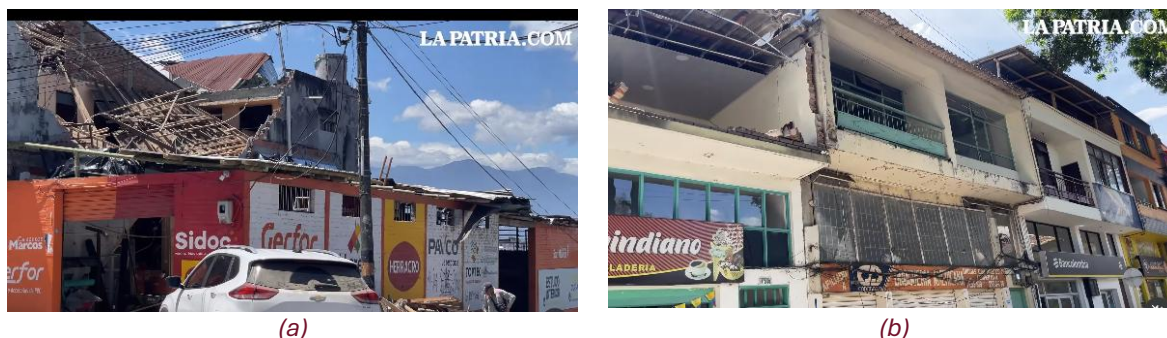
Figure 26 Montenegro, Quindío: (a) damage to roof (b) and facade<sup>21</sup>

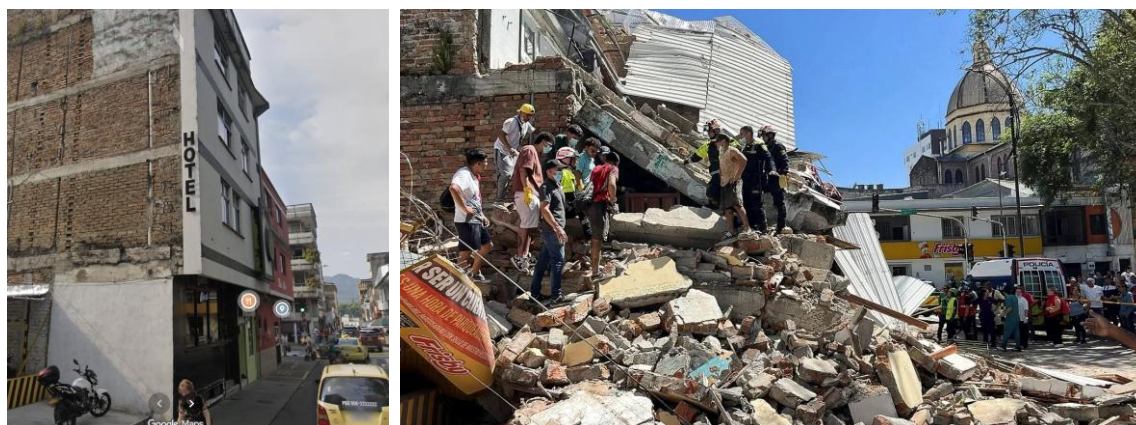
Figure 27 Collapse of 4 storey Hotel structure in Pereira<sup>22</sup>

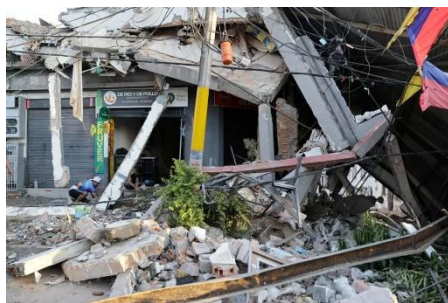
(a) Commercial Corner Block: collapse of a 3-story concrete frame with hollow clay block infill.<sup>23</sup>

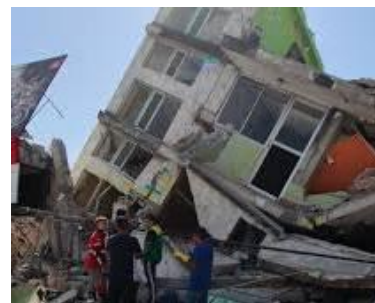
(c) Collapse of a multi-storey mixed residential building in Plaza de Bolívar<sup>24</sup>

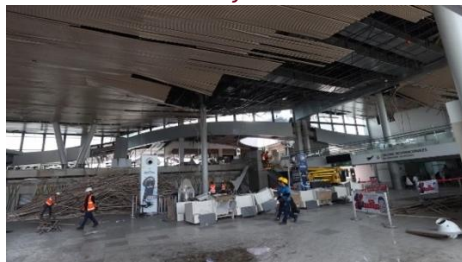
(d) Matecaña International Airport Terminal – detachment of the suspended ceiling and acoustic panel<sup>25</sup>

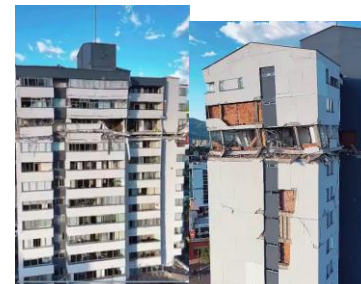
(f) 15 storey building with a soft storey at level 12<sup>27</sup>

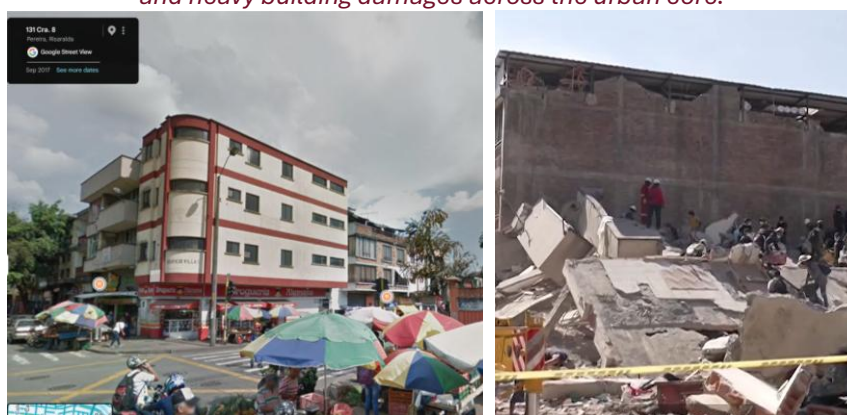
Figure 29 The collapse of Edificio Villa in Pereira; before (left photo) and after (right photo) earthquake<sup>28</sup>

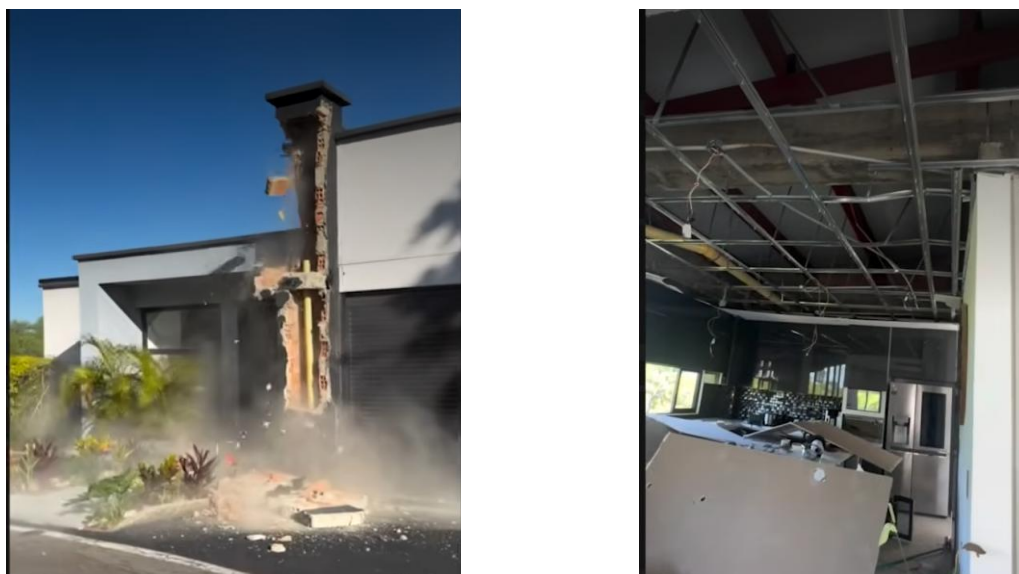
*Figure 30 Damage to residential houses – hollow brick walls, and internal ceilings<sup>29</sup>*

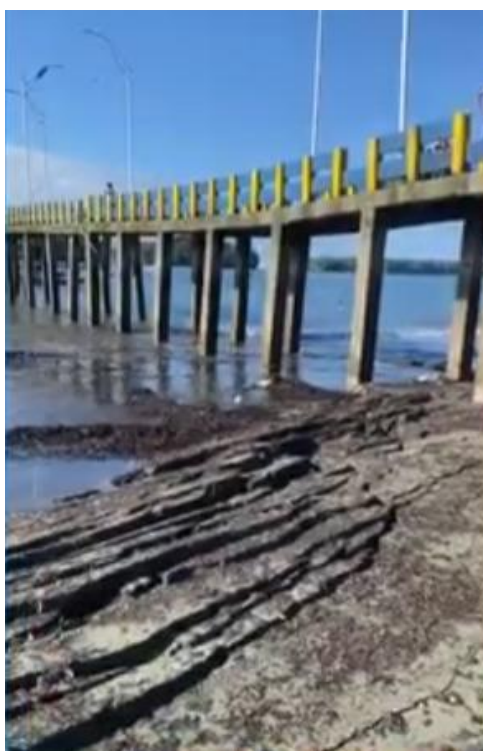
The only ground effect confirmed to date is lateral spreading at the Muelle de Juanchaco wharf (Figure 32), in the maritime zone of Buenaventura, where local media video shows the wharf deformed and partially failed. This is consistent with lateral spreading of loose, saturated waterfront soils moving seaward and consequent movement and distress of the overlying dock infrastructure.

Figure 32 Lateral spreading damage to the Muelle de Juanchaco wharf, Buenaventura, following the 10 August 2026 earthquake<sup>31</sup>

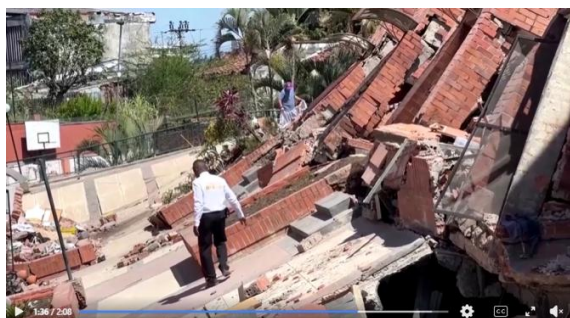
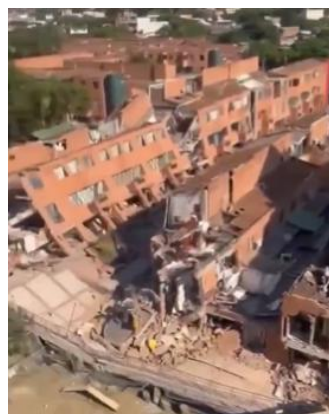
Evidence of foundation-related damage is limited. However, damage at the residential complex Pío XII in the El Lido neighbourhood of Cali may indicate an example of insufficient bearing capacity of the founding soils under seismic loading. Multiple residential blocks appear to have undergone rigid-body rotation (tilting) while remaining largely structurally intact, consistent with one-sided mobilisation of the soil bearing capacity under earthquake-induced overturning moments. The associated ground manifestation, characterised by ground uplift in front of the structures, is consistent with a seismically induced bearing capacity failure (Figure 33).

Figure 33 Possible foundation/substructure failure at the Pío XII residential complex in Cali: (a) rigid-body tilting of a residential block with adjacent ground uplift;<sup>32</sup> (b) podium slab collapse<sup>33</sup>

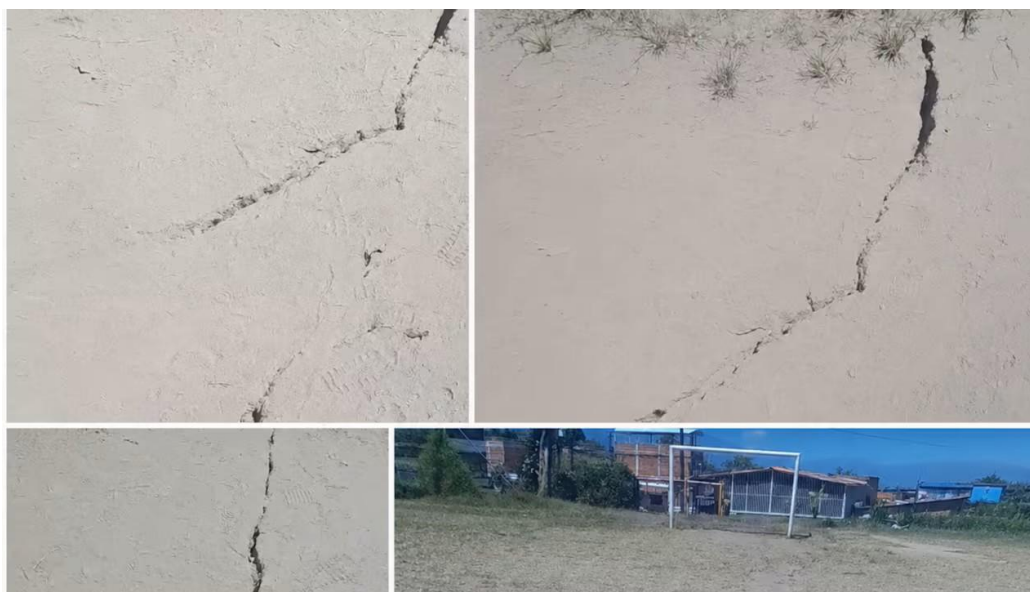
Photos and videos of the ground cracking are limited at the time of writing. Based on the evidence available so far, ground cracking was observed at a levelled football field in the Los Almendros sector of Armenia (Quindío) following the earthquake. The evidence was collected from social media posts (see Figure 34). The cracking showed an arcuate, tension-dominated pattern made up of a series of en-echelon segments, with individual cracks typically around ~5-15 cm wide. The downslope block appeared slightly displaced relative to the upslope side, consistent with minor lateral extension and early downslope movement of the levelled fill. No sand boils or ejecta were seen at this location.

*Figure 34 Ground cracking across a levelled football field in the Los Almendros sector, Armenia (Quindío), following the 10 August 2026 earthquake<sup>34</sup>*

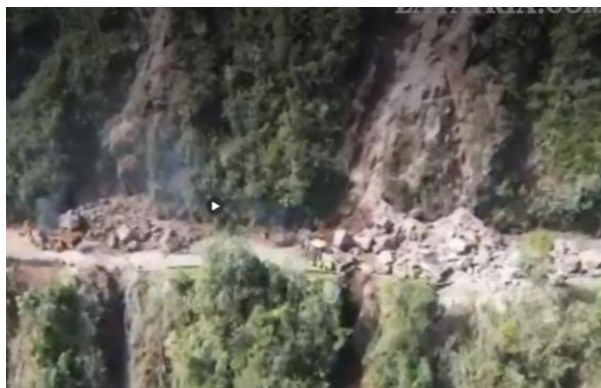
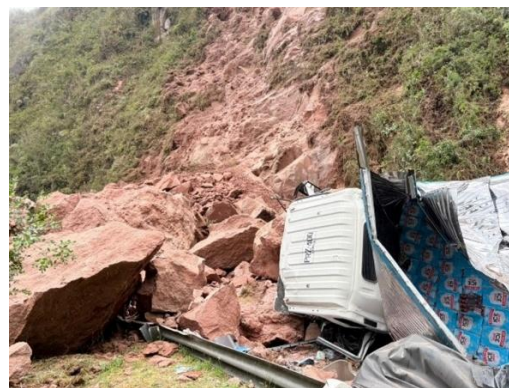
Available reporting indicates that most observed failures were localised slope failures and rock/debris falls rather than confirmed deep-seated or large-volume landslides. Notable concentrations of instability were reported along the Manizales-Bogotá corridor near Cerro Bravo, where multiple rock and vegetation slides affected the Manizales-Fresno-Mariquita-Bogotá road and damaged vehicles (Figure 35).

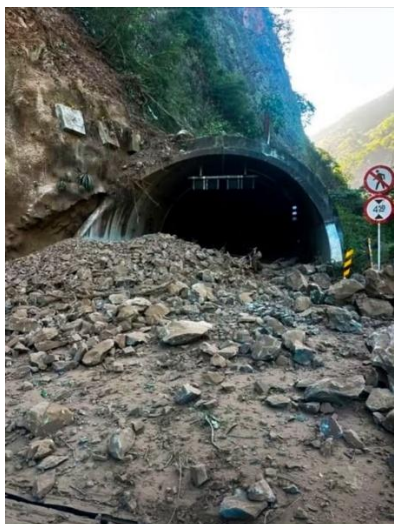
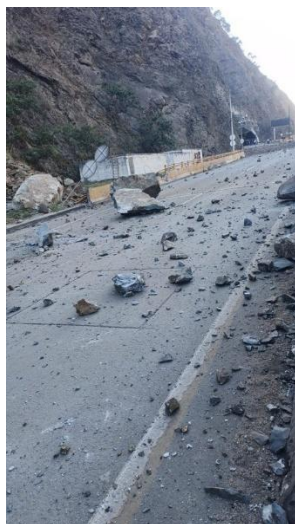
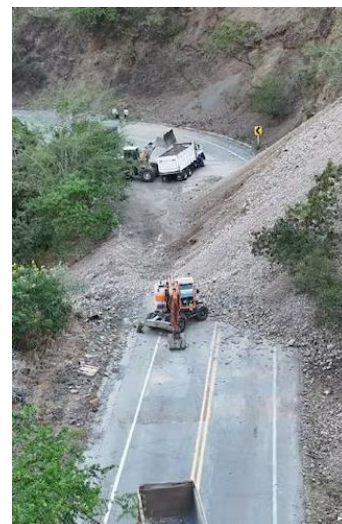
Significant failures were also reported along the Cali-Buenaventura corridor, where approximately 20 landslides were reported and the route was closed while emergency access was maintained by air (Figure 36).

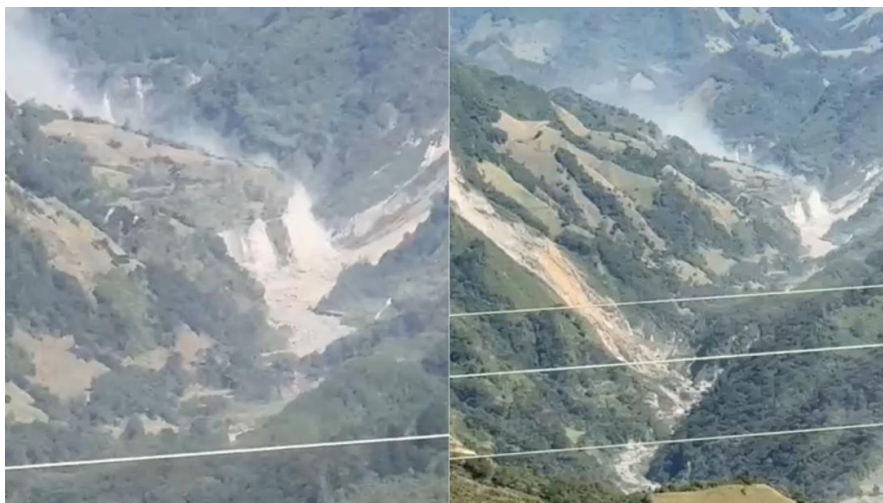
In Tolima, authorities investigated a possible landslide damming of the Río Gualí following observed landsliding (Figure 37), but an aerial inspection found no obstruction requiring escalation and the reported avalanche risk was ruled out.

*Figure 37 Landslides near the Río Gualí in Tolima.<sup>41</sup>*

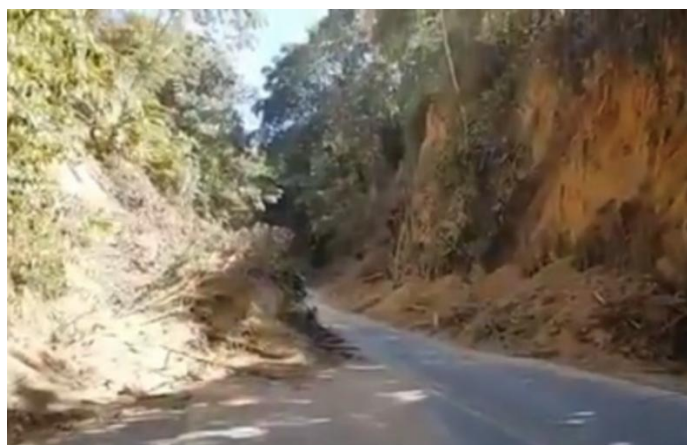
*Figure 38 Landslide along the Armenia-Pereira-Manizales corridor.<sup>43</sup>*

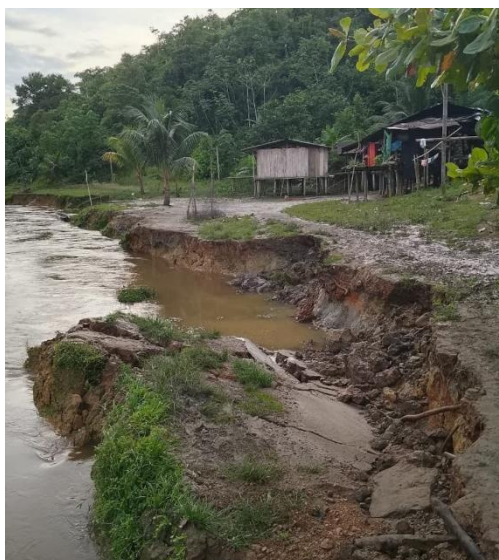
*Figure 39 Riverbank instability adjacent to residential dwellings affecting indigenous population across affected regions (Risaralda, Caldas, and Valle del Cauca)*

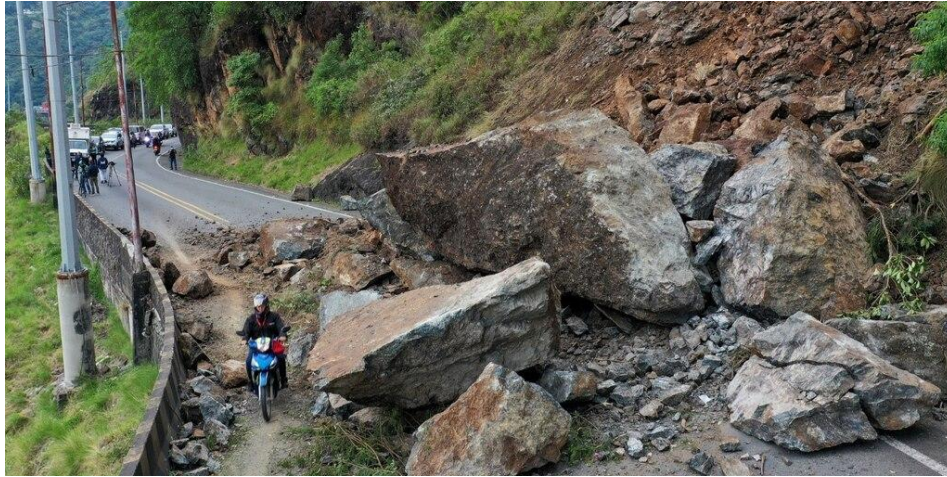
*Figure 40 Landslide along the Cali-Popayan-Manizales corridor.<sup>53</sup>*

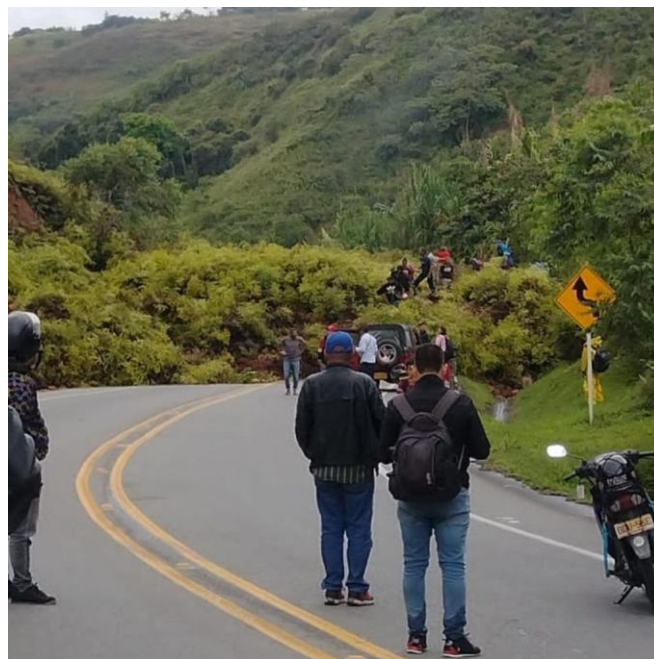
*Figure 41 Landslide along the Armenia-Pereira-Manizales corridor.<sup>53</sup>*

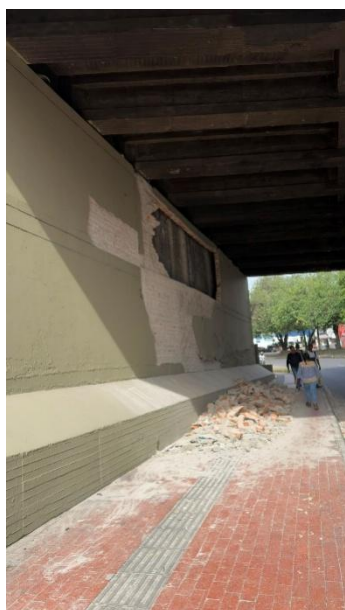
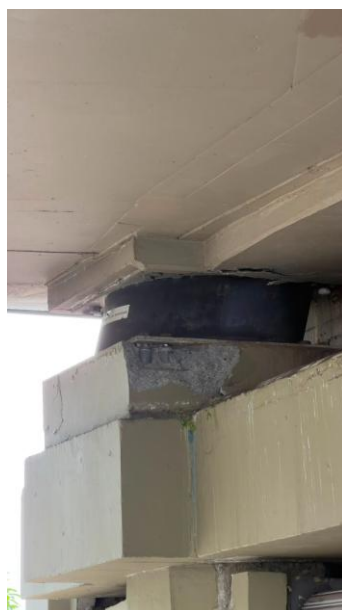
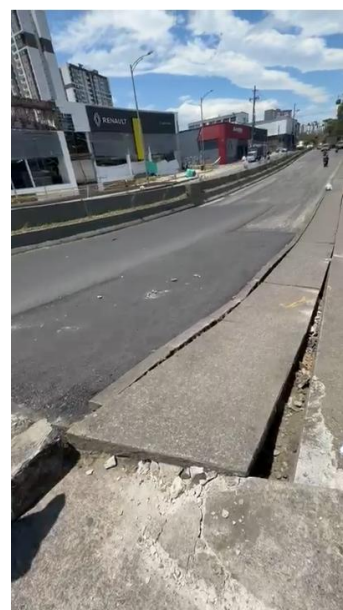
Preliminary field inspections of several bridges in Pereira identified generally limited structural damage, although localised earthquake-related effects were observed. The bridge at Calle 21 and Avenida Belalcázar remained in good condition, with only minor cracking of the asphalt approaches attributed to differential movement between the bridge and approaches (Figure 42). The bridge adjacent to Parque El Oso (Figure 43a), non-structural masonry walls near the abutments had failed and detached, and demolition of the affected walls is recommended. More significant localised effects were identified at the Calle 13 bridge (Figure 43b), where a seismic isolation bearing showed residual deformation and had not returned to its original position; the bearing support and anchorage area require further structural assessment and repair. At the Calle 17 bridge over Avenida Belalcázar (Figure 43c), approach settlement and road-surface cracking were observed.

*Figure 43 Earthquake-related damage observed during bridge inspections in Pereira (courtesy of Laura Calvo).*

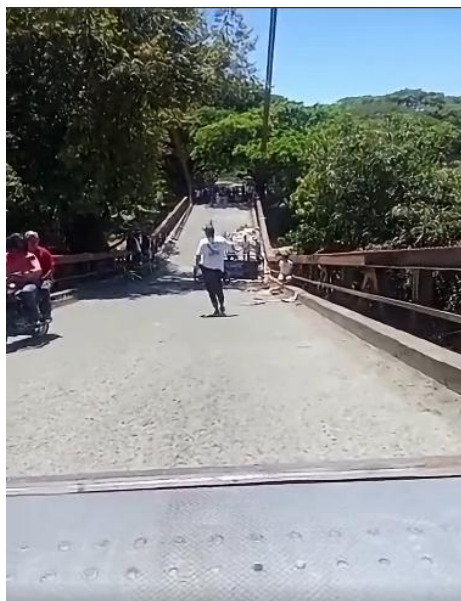
*Figure 44 La Unión–La Victoria road corridor is closed due to a bridge collapse<sup>54</sup>*

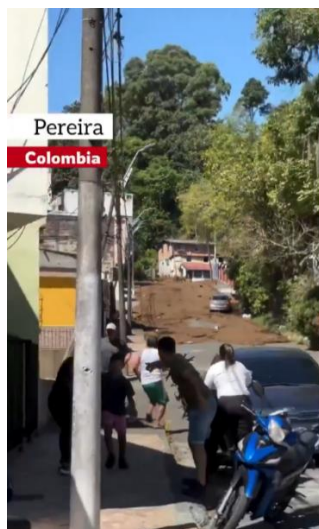
Localised flooding was reported in Pereira following the earthquake (Figure 45), the cause remains unclear. Based on the available information and location of the incident, it may have been associated with damage to water infrastructure rather than riverbank failure. No official

*Figure 45 Localised flooding reported in Pereira<sup>56</sup>.*
