Innovative seismic retrofit of concrete water supply tanks

R.G. Taylor & P.D. Wright

Concrete Tank Consultants (International) Limited, Wellington, New Zealand

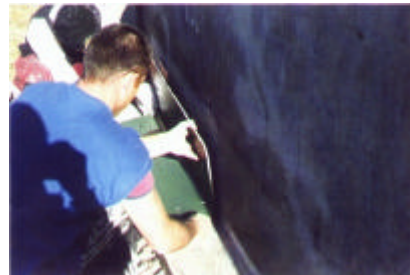
Figure 6: Installation of base L-shaped steel seismic shear coupons

The method of bonding on steel plates or coupons to transfer large in-plane wall shears at the base is illustrated in Figure 5. Installation of angle shaped steel plates on a tank is shown in Figure 6. Bonding of steel reinforcement to concrete has been known for a long time and the method has been used, for example, to boost the flexural strength of reinforced concrete bridge beams, among other applications. Awareness of the need for stringent quality control and site practices has probably been one of the restricting factors on the growth of this type of technology.

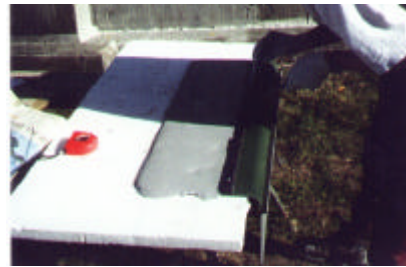
Figure 8: Steel L-shaped coupon under epoxy application

A coupon receiving the epoxy coating is shown in Figure 8.

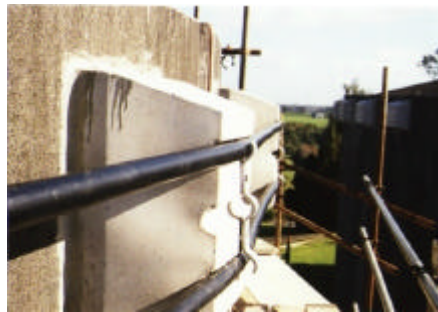
Figure 11: Close up of spacer block for roof strengthening and stressing cable make up

A system of supplementary external prestressing to the top of the walls was finally adopted and is shown in Figure 11 with discrete saddles a cost effective way to position strands to clear pilasters. Forming a continuous band of concrete at the top of the tank wall was not cost effective because of obstruction of the pilasters.

Two cables are draped over concrete saddles and tensioned to provide an inward force at each saddle. The post-tensioning strand comprised greased and HDPE factory sheathed 15 mm diameter superstrands in sets of four in each of two ducts. The two ducts were filled with grout contained by a 50 mm – 60 mm diameter HDPE tube. Provision was made for a future third cable with an unused central saddle on the spacer blocks (see Figure 11) in the event that non-seismic forces such as creep and thermal expansion had been under assessed.
