Seismic response of a cast-in-place steel fibre concrete joint connecting precast beams and columns

L. Tuleasca & J. M. Ingham

ABSTRACT: An experimental investigation to evaluate the response of a monolithic precast joint, with cast-in-place steel fibre reinforced concrete (SFRC), when subjected to earthquake-type lateral loading is described in this paper. The use of SFRC in monolithic precast joints subjected to high magnitudes of static and dynamic actions is desirable due to its isotropic nature. Design variables that control the response of a SFRC joint subjected to lateral loading were evaluated, with special attention given to the influence of these parameters on the cast-in-place joint between the double-tee beams and the column. Response of the test specimen was also examined in terms of beam plastic hinge spreading.

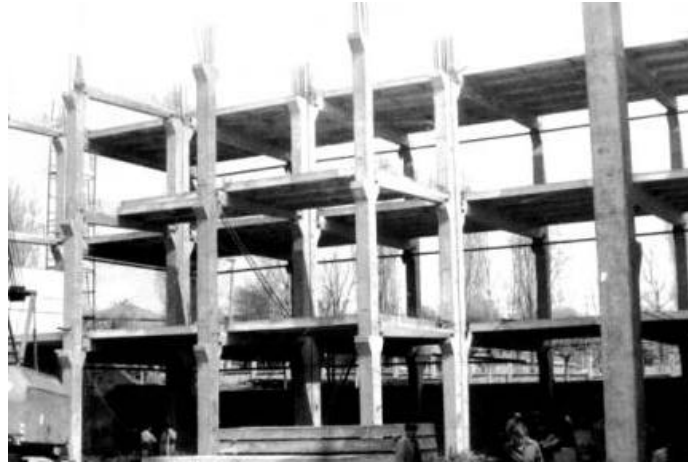
Figure 1 Multi-storey building structure

By testing a joint that used SFRC to connect precast beams to precast columns, it was intended to obtain information regarding joint behaviour, when longitudinally directed seismic actions were applied to a structure (Fig. 1). Cuciureanu and Mihul (1987) conducted testing considering the performance of precast double-tee beams and precast columns connected using a peripheral joint

Designers of the structure shown in Figure 1 provided the envelope of critical actions at the interface between the longitudinal beams and the column of the interior joint.

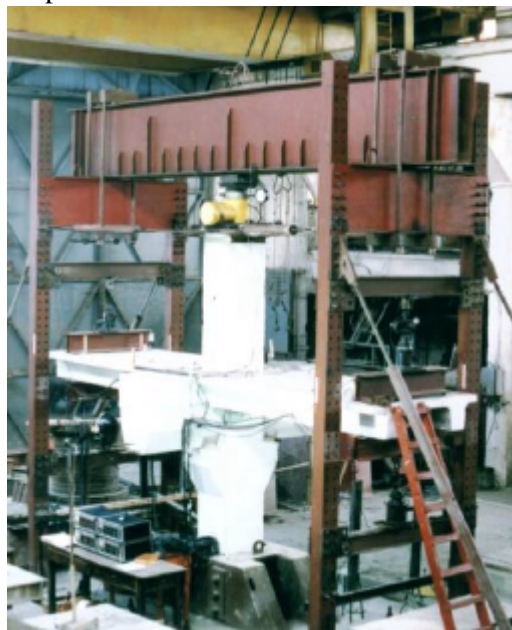
The test rig used in this study is shown in Figure 6 and consisted of:

- ? a steel foundation;
- ? two test frames supported by tilted tie bars and provided with transverse beams of 2.00 m span at the +5.00 m height, where a longitudinal 7.00 m length beam was fixed with steel yokes;
- ? horizontal crossed tie bars placed at an elevation of +4.00 m.

Figure 6 Test rig blueprint

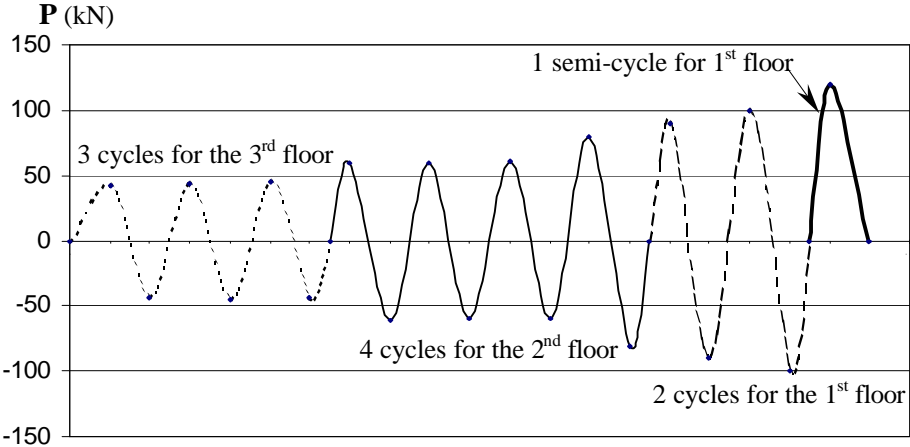
The experimental program was divided into four stages as shown in Figure 8. The first three stages considering three, four and two cycles of loading to the Serviceability Limit State response of an interior joint located at different heights in the building:

- ? cyclic loading ($P_{A, \text{max}} = P_{B, \text{max}} = 45 \text{ kN}$, $N=380 \text{ kN}$) for an interior joint at the 3rd floor;
- ? cyclic loading (three cycles to $P = 65 \text{ kN}$ and one cycle to $P_{\text{max}} = 75 \text{ kN}$, $N = 600 \text{ kN}$) for an interior joint at the 2nd floor;
- ? cyclic loading (one cycle to $P = 90 \text{ kN}$ and one cycle to $P_{\text{max}} = 100 \text{ kN}$, $N = 800 \text{ kN}$) for an interior joint at the 1st floor;

The last stage of the experiment considered a semi-cycle of loading to the damage control limit state loads ($P_{\text{max}} = 120 \text{ kN}$, $N = 800 \text{ kN}$) projected to develop for an interior joint located at the first floor height.

Figure 8 Loading history

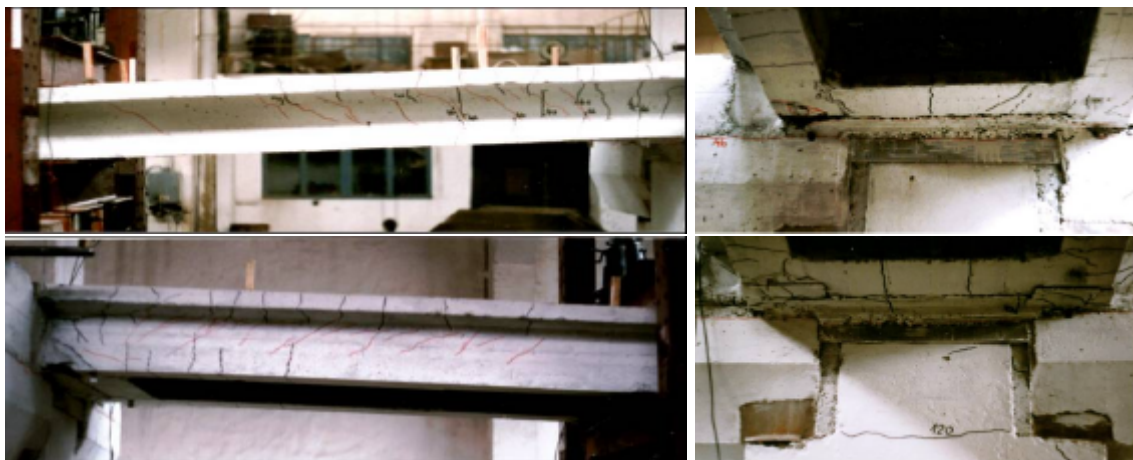
The condition of the test unit at the end of the 10th semi-cycle is shown in Figure 11.

Figure 11 Details of the tested joint at the Damage Control Limit State

In the 10th semi-cycle the crack widths in the longitudinal beam reached up to 8 mm, indicating significant yielding of the longitudinal reinforcement. Also, spalling of cover concrete developed at the longitudinal beam-joint interface for negative beam moments. At the interface between the fibre concrete and the precast elements, crack widths in the SFRC reached values of 8 mm on the upper surface and 2 mm on the lower surface. Cracking due to shear also developed in the longitudinal beams.
